# Experimental Evaluation Of Compression Strength And Bleed Characteristics Of Cement-Based Grout Made With Photon Attenuating Inclusions

A Thesis

Structural Engineering

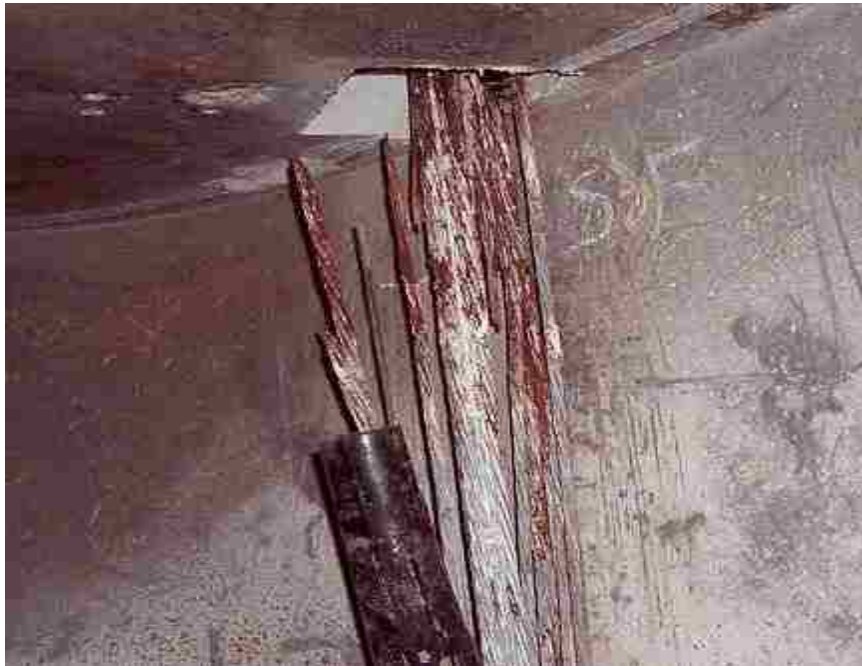
Figure 2.2 - Corroded tendon in the Sunshine Skyway Bridge (FDOT, 2002).

In 1999, attention was paid to the durability of PT tendons in the US when some PT bridges were found to exhibit tendon failures (Theryo, Hartt, & Paczkowsk, 2013). For instance, Florida Department of Transportation (FDOT) discovered in 2000 a failed corroded tendon in one of the piers of its iconic bridge, the Sunshine Skyway Bridge, just thirteen years after being opened to traffic (FDOT, 2002). The presence of voids inside the PT ducts was one of the major causes for this failure (Trejo et al., 2009). Figure 2.2 shows the corroded tendon in the Sunshine Skyway Bridge (FDOT, 2002).

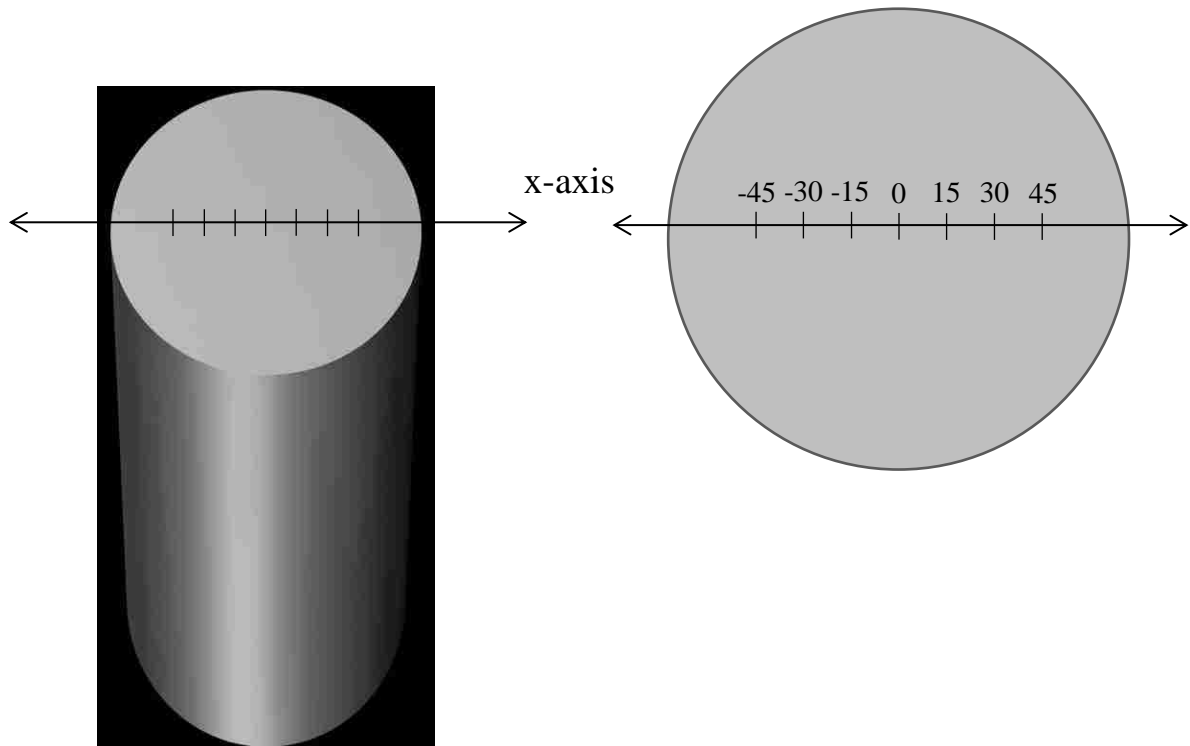
Figure 2.8 - Keller and Pessiki (2016) measured optical density for all specimens along x-axis.

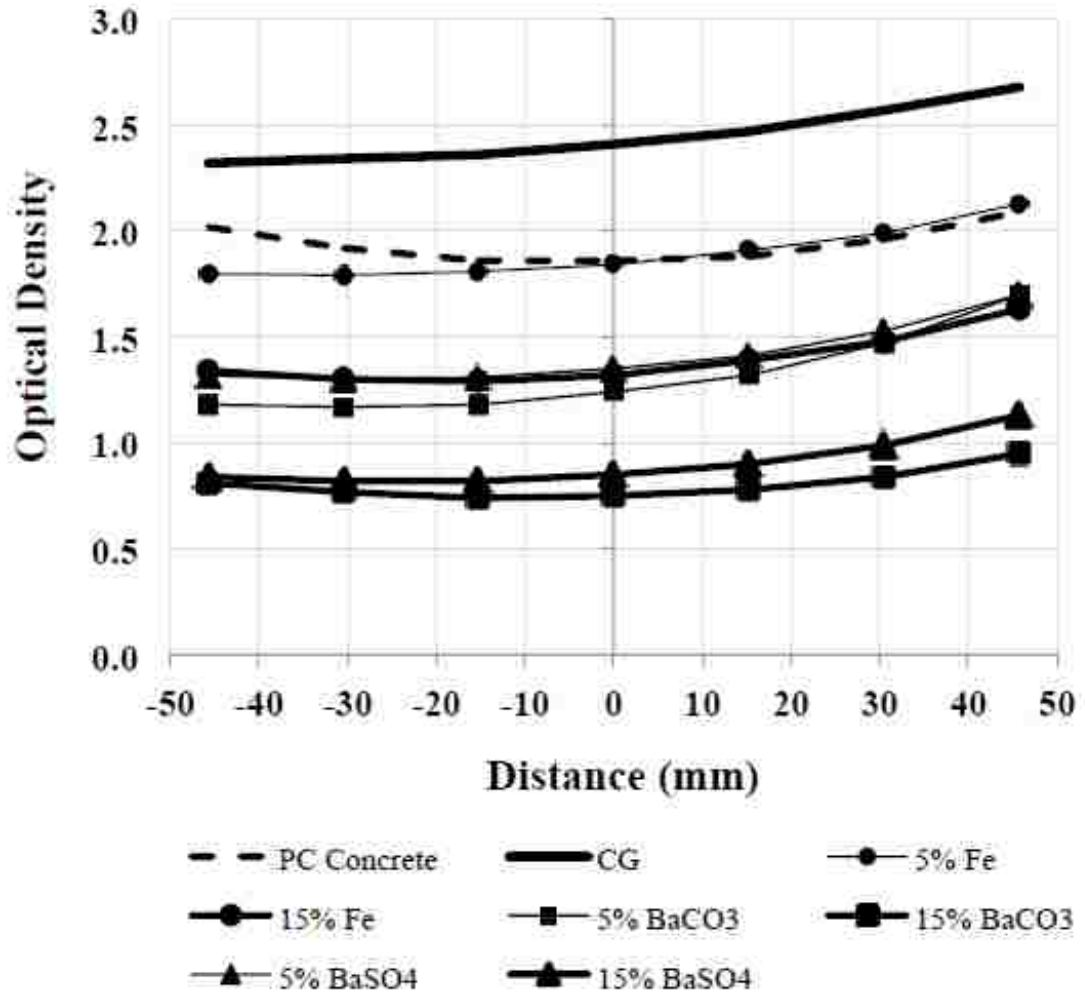
Figure 2.9 - Optical density measurements for 30 cm thick grout specimens with and without PAI “350 keV-12.85 mA-480 s-Agfa D4 film” (adapted from Keller & Pessiki, 2016).

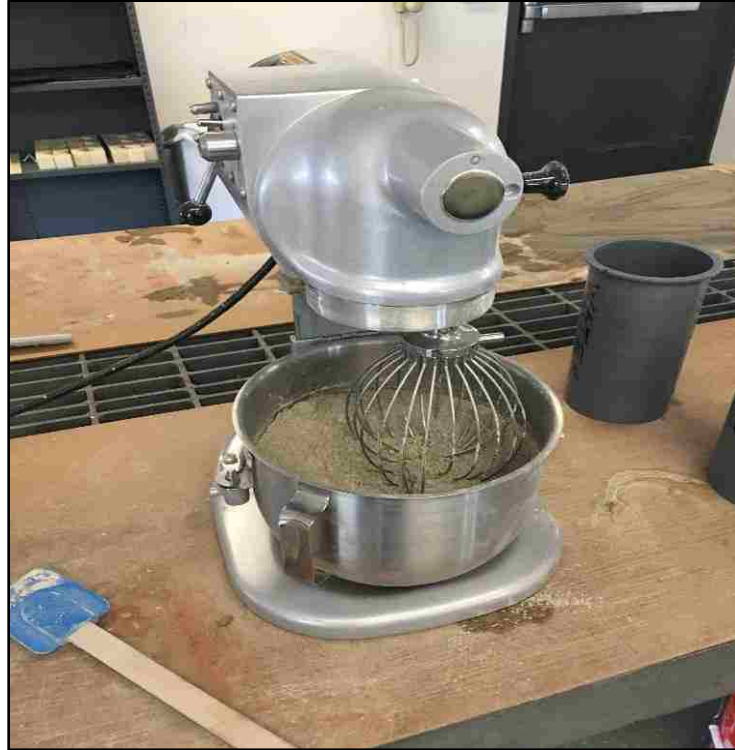
Figure 3.1 - Photograph of benchtop mixer.

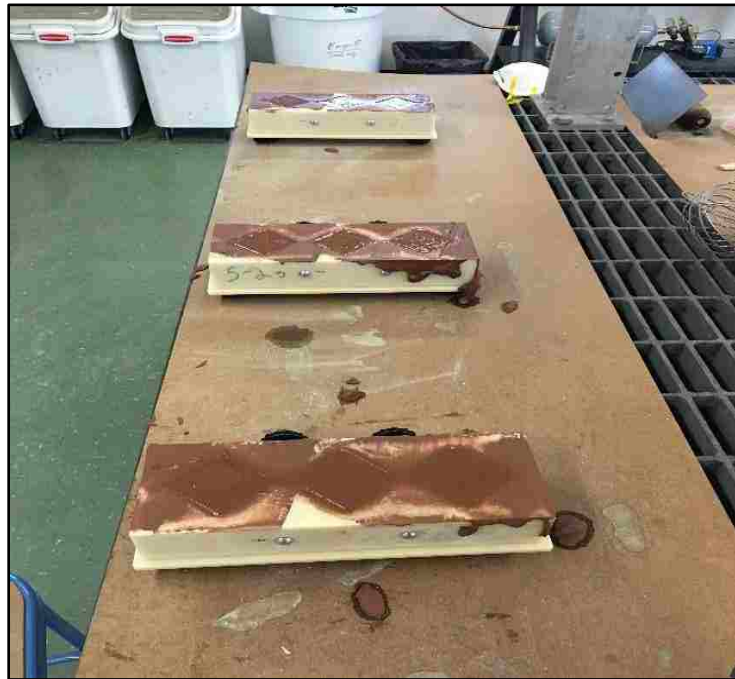
Figure 3.2 - Photograph of 9 50-mm grout cube specimens after molding.

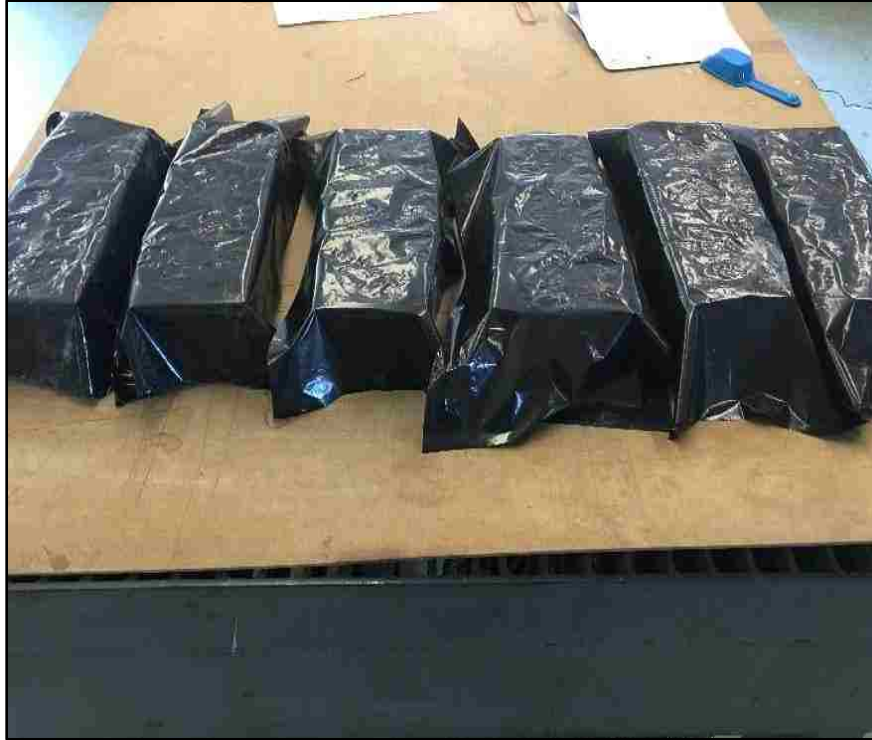
Figure 3.3 - Photograph of grout specimens covered with wet plastic sheeting prior to wet-curing.

As mentioned in Section 2.2.1, a deviation from ASTM C942 was made regarding curing the specimens. ASTM C942 requires that test specimens shall be placed in a moist room immediately upon completion of molding. Rather in this research, one hour after the start of mixing, the specimens were covered with wet plastic sheeting to reduce evaporation of water as shown in Figure 3.3. Specimens remained covered with the plastic sheet until they reached the age of 12 hours, and then they were immersed in a lime-saturated water bath. When specimens were at an age of 24 hours, they were removed from the molds and immediately returned to the water bath until they were tested in compression. Figure 3.4 shows the water bath filled with stripped specimens as well as those still in molds.

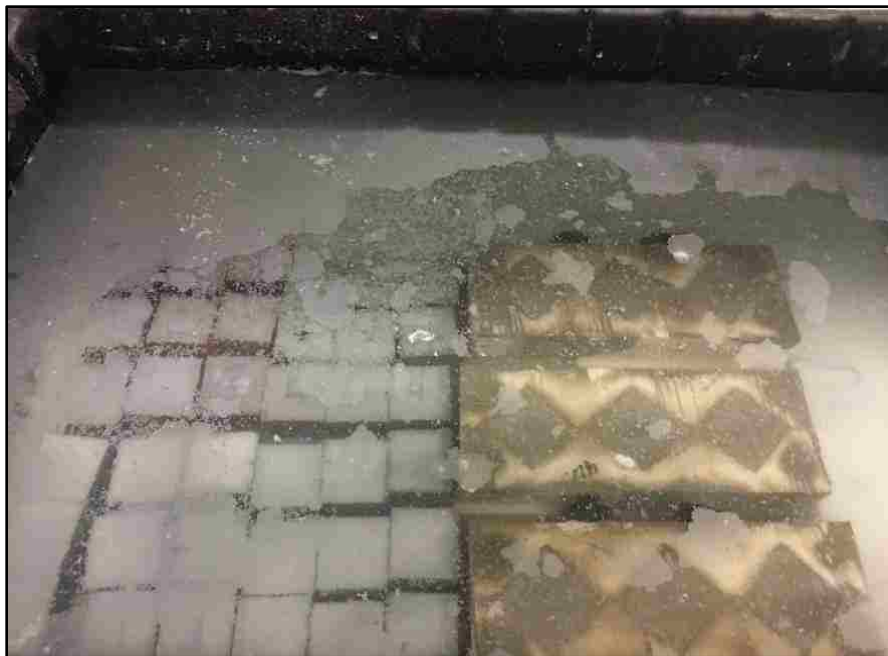
Figure 3.4 - Photograph of specimens immersed in a lime-saturated water bath for curing.

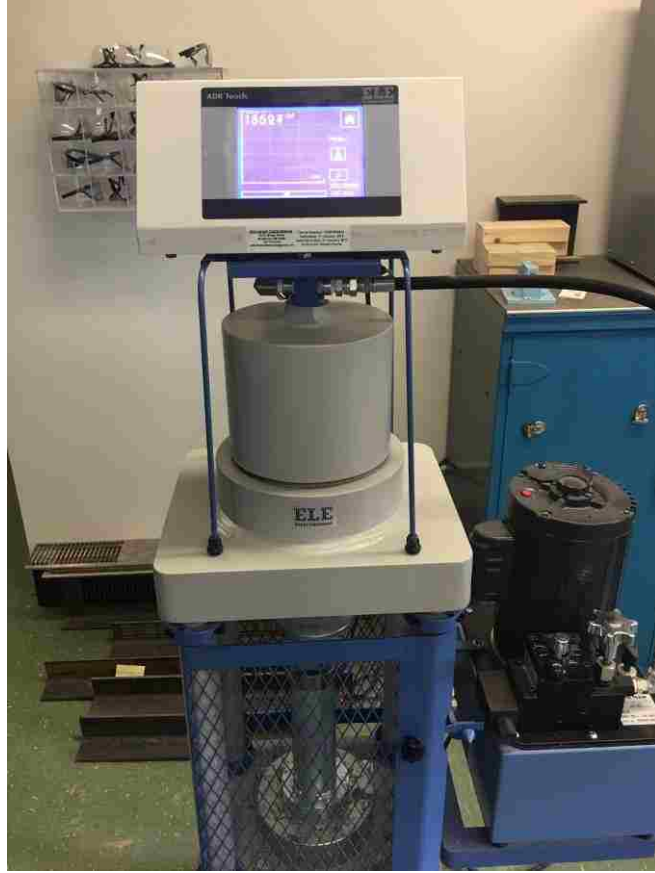
Figure 3.5 - Photograph of compression testing machine.

Each batch was tested at three different ages; 3, 7, and 28 days with a total of 3 cubes for each test. To perform a strength test, each cube was removed from its water bath, and its surfaces were wiped to a surface-dry condition. Each cube was then placed in the compression testing machine with two formed co-planar surfaces against the machine platens. Specimens were loaded within a range of 900 to 1800 N/s. A photograph of the machine used to compress specimens is shown in Figure 3.5.

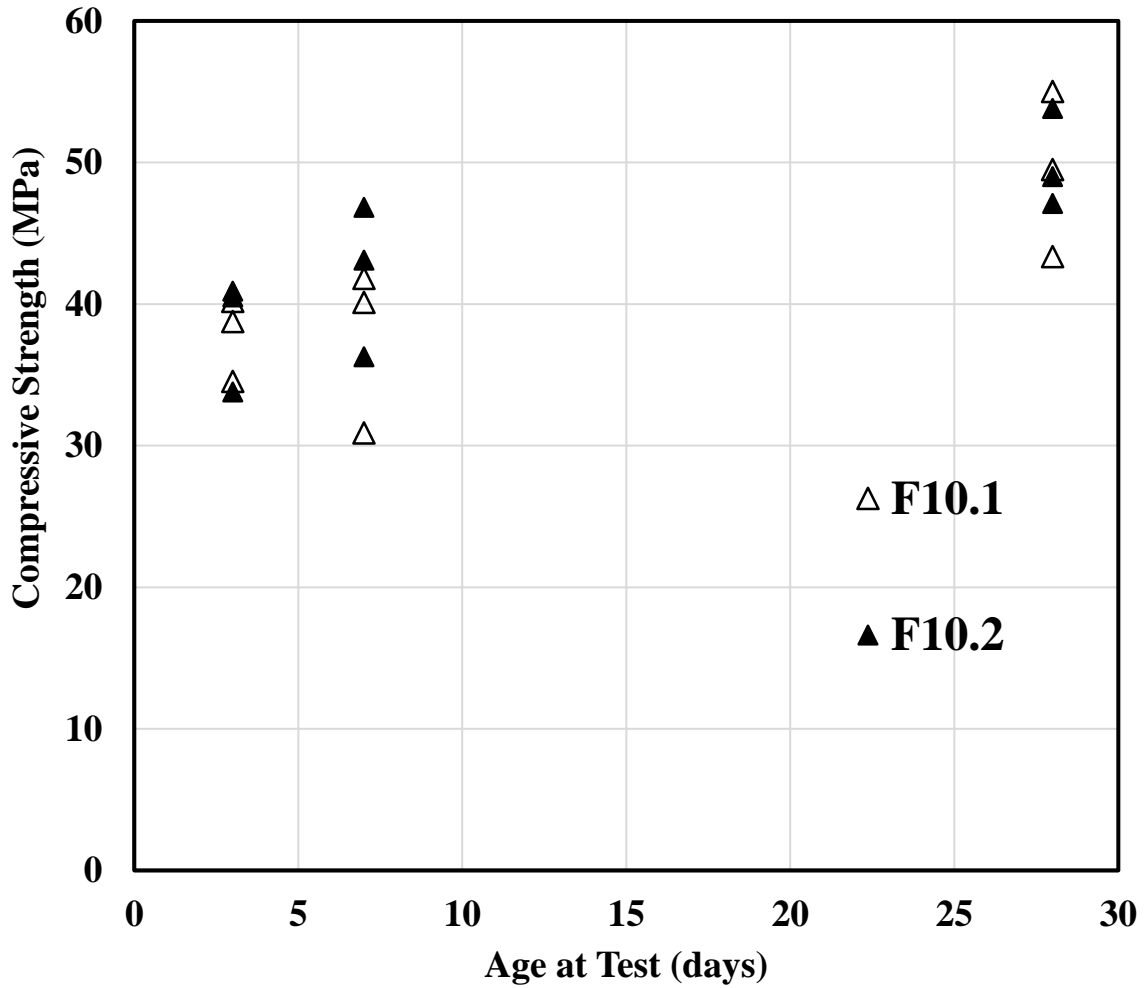
Figure 3.9 - Compressive strength results of Specimens F10.1 and F10.2.

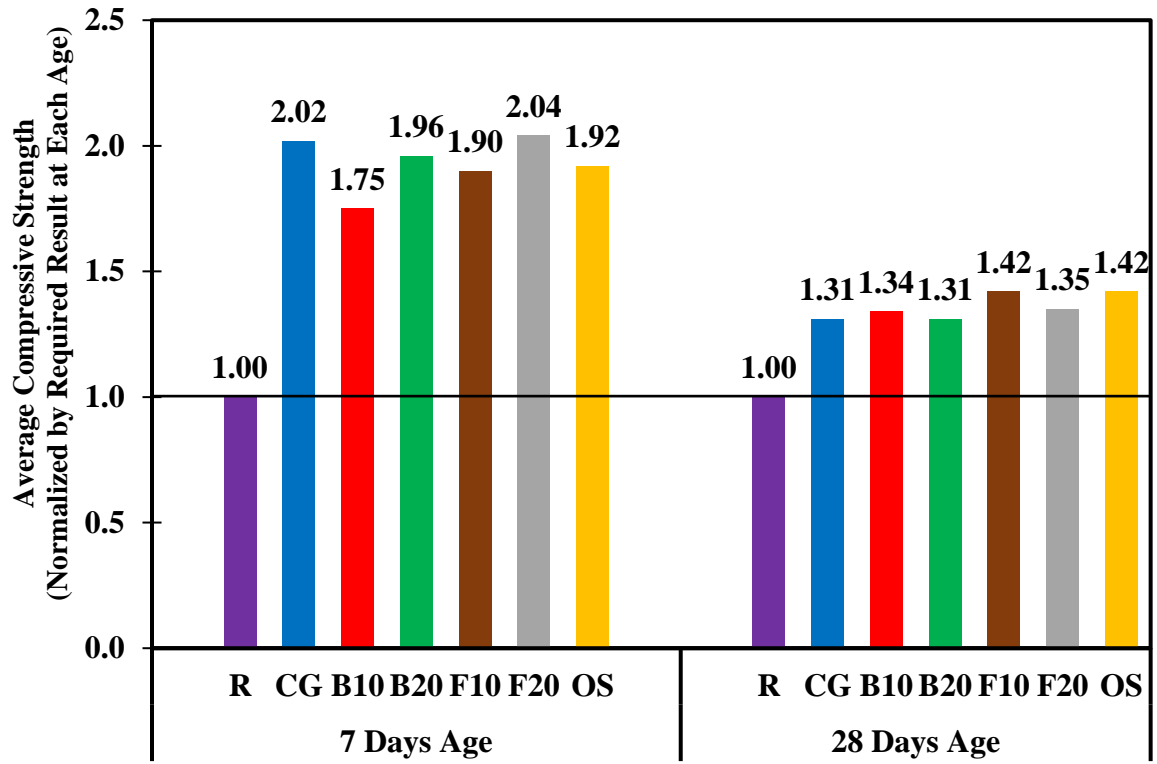
Figure 3.13 - Normalized average compressive strengths of all specimens compared to the required results (R).

\* PTI M55 requires that compression strength of grout must be at least 21 MPa at age 7 days.

\*\* PTI M55 requires that compression strength of grout must be at least 35 MPa at age 28 days.

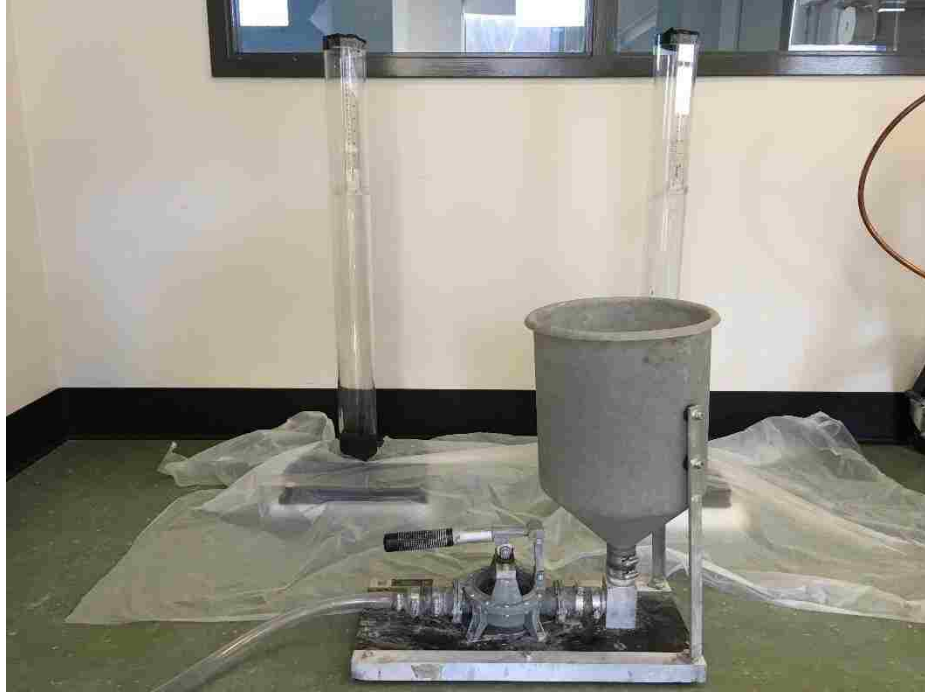
Figure 4.1 - Photograph of grout pump used to pour grout into test tube.

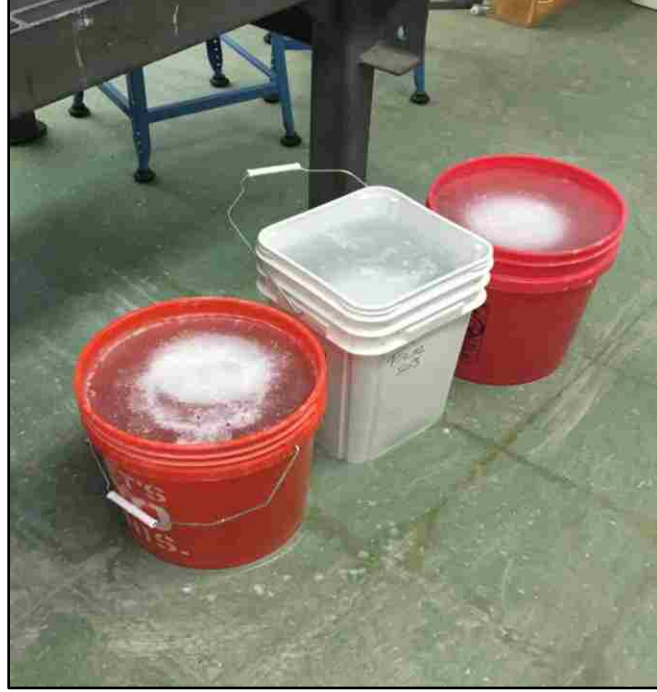
Figure 5.1 - Specimens CG (left), B10 (middle), and B20 (right) during curing.

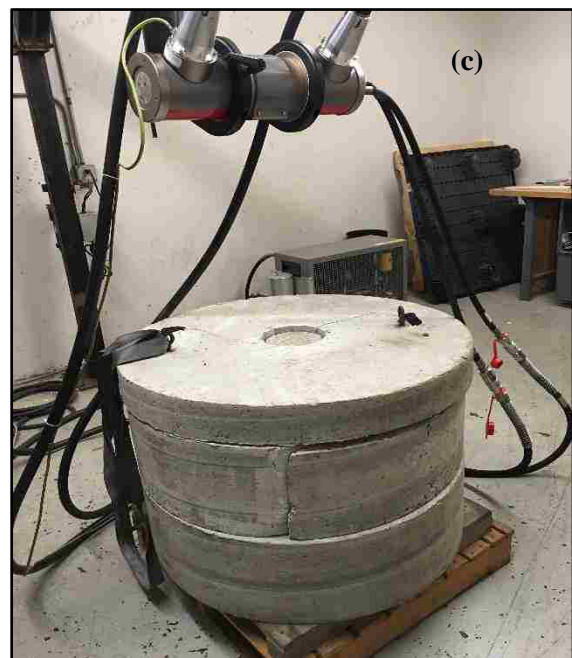
Figure 5.2 - Radiographic imaging: (a) shielding block assembly geometry (Keller & Pessiki, 2015), (b) shielding block assembly before installing the removable wall panel, and (c) final test configuration.

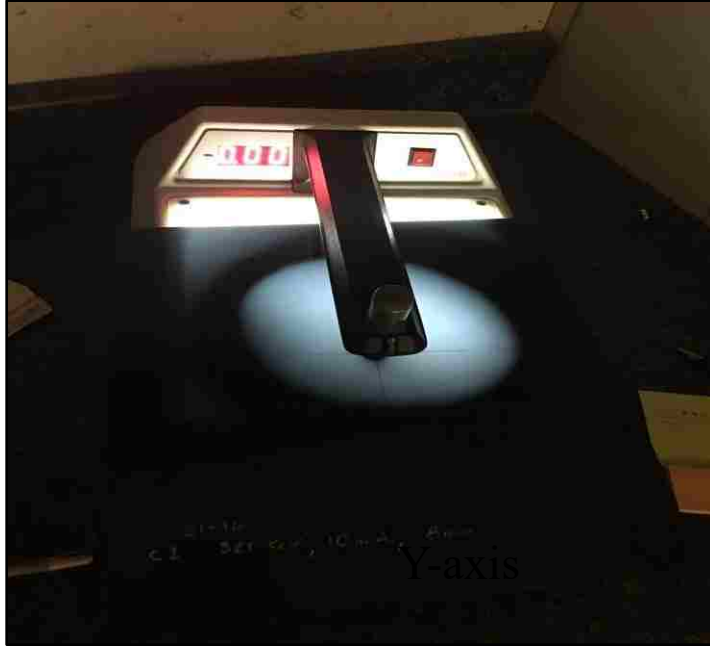
Figure 5.3 - Photograph of the densitometer used to make optical density measurements.

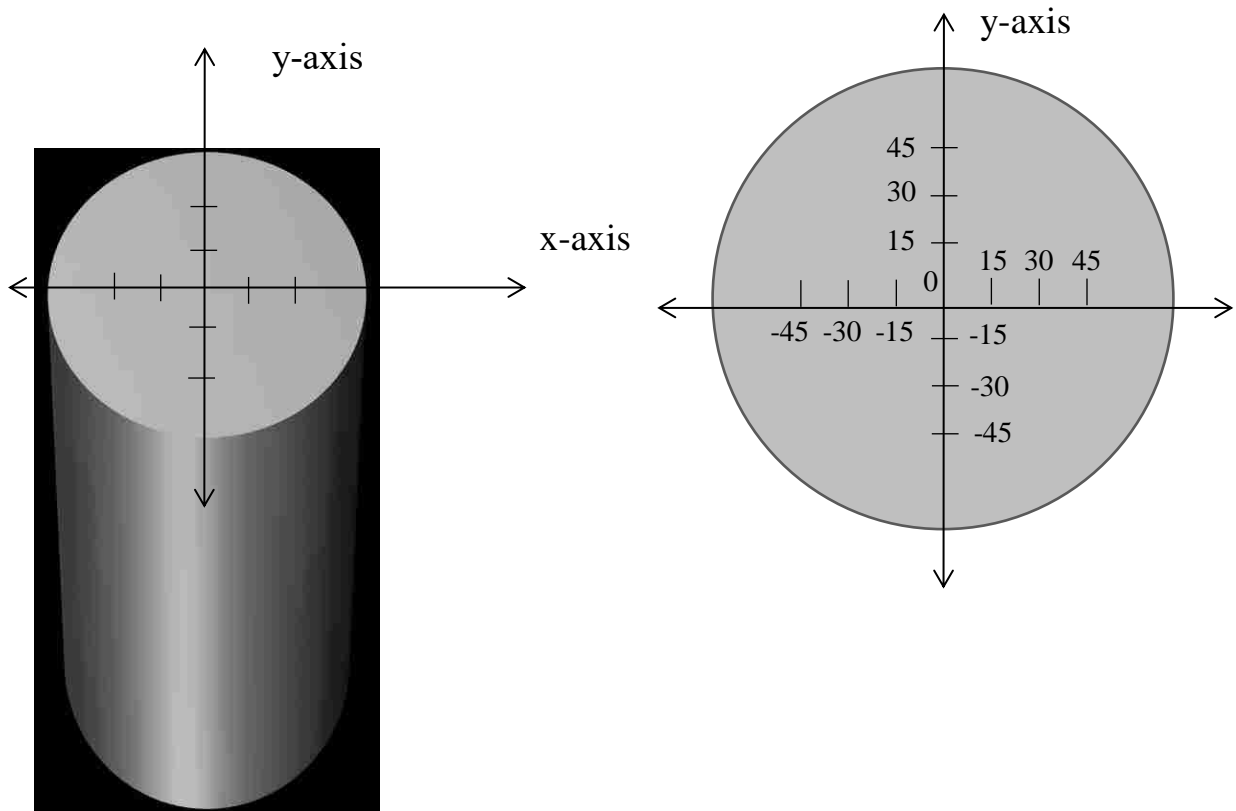
Figure 5.4 - Optical density was measured along the diameter of the cylinders along x- and y-axes.
