## High density polyethylene pipe in highway applications

High density polyethylene pipe in highway applications

Department: Civil and Construction Engineering Major: Civil Engineering (Structural Engineering)

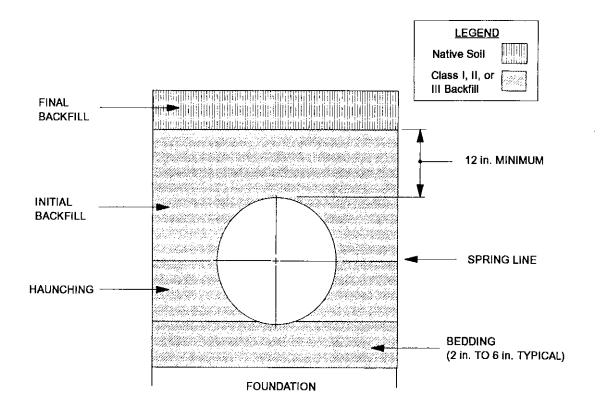
Figure 2.5. Hancor recommended backfill envelope.

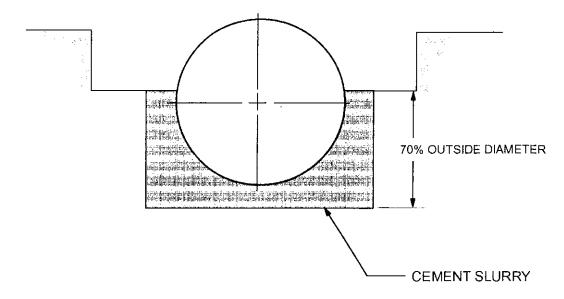
Figure 2.6. 'Best' backfill according to Amster Howard.

pipe until it appears on the other side. The slurry is poured to a height of 70% of the outside diameter of the pipe. The trench is excavated so that a minimum of 3 in. is clear on all sides.

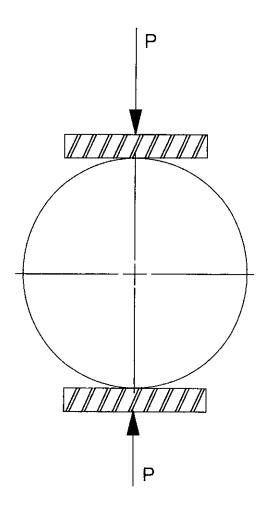
Parallel plate tests consisted of placing specimens between two rigid plates and applying a line load to the pipe (see Fig. 3.1). The rate of head travel was controlled and the desired stiffness values were calculated at 5 % deflection. Additionally, stiffness at 10 and 30 % deflection were also calculated. Ultimate loads of pipe specimens were also obtained and the behavior noted.

Figure 3.1. Schematic of parallel plate test.

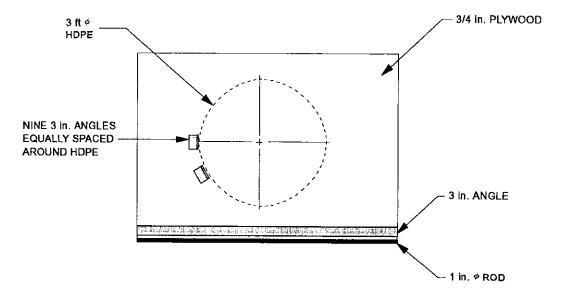
Figure 3.8. End view of pipe connection to plywood.

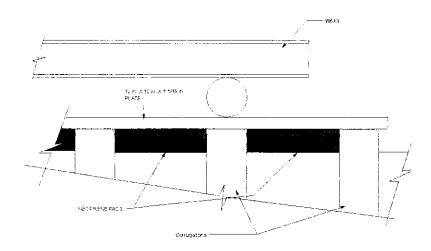
steel plate. In testing Specimen A36 (i.e., manufacturer A, diameter 36-in.) the plate was placed directly on the pipe; this resulted in a premature failure of the specimen by "folding over" of the corrugations under the load plates. Subsequent tests utilized neoprene pads in the valley of corrugations as shown in Fig. 3.9 which eliminated the folding over problem.

Figure 3.9. View of neoprene pads used in HDPE pipe corrugation valleys.

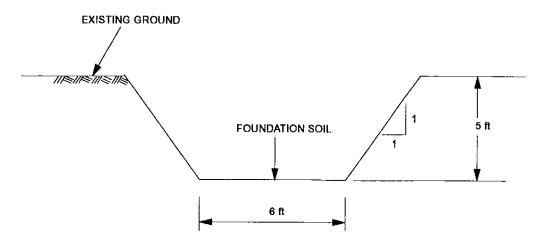
The bedding was then prepared according to the type of test to be run. In the following descriptions specimens are designated as ISU1, ISU2, ISU3, and ISU4. As previously noted, all specimens were 3-ft in diameter from Manufacturer C. For ISU1, the pipe was placed on the bottom of the trench with no further foundation preparation (Fig. 3.15).

Figure 3.15. Trench geometry for ISU1.

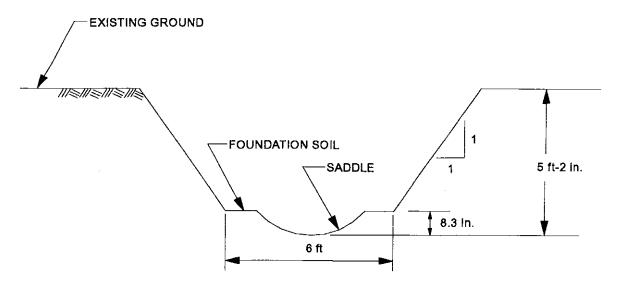
The foundation preparations for ISU2, ISU3, and ISU4 followed the provisions of Class B bedding as per the Iowa DOT specifications. This specification requires that 15% of the total pipe height rest in a saddle cut from compacted or natural ground. Templates were prepared and used to check the concave saddle cut from the natural ground. A 2-in. cushion of sand was then placed in the entire saddle and smoothed by hand (see Fig. 3.16).

Figure 3.16. Trench geometry for ISU2, ISU3, and ISU4.

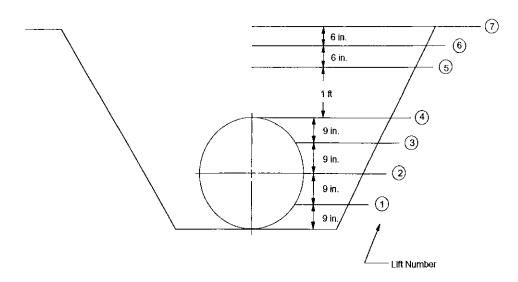
Figure 3.17. Schematic of backfilling process.

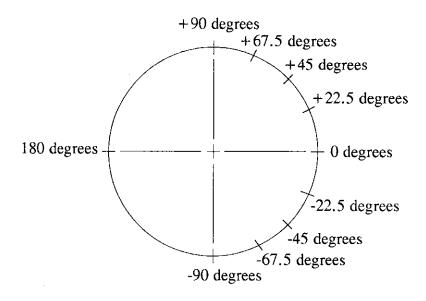
Figure 4.1 shows the strain gage orientation and designation used in the parallel plate tests. Illustrated in Fig. 4.2 through 4.4 are the results of the parallel plate tests on the pipe specimens from each manufacturer during tests to the 5% deflection limit. In some figures (i.e., Fig. 4.2c, Fig. 4.3d, etc.) the ordinate axis shows tensile strains while in the other figures (i.e., Fig.4.3g, 4.4b, etc.) the ordinate axis shows compressive strains. As has been previously noted, due to testing machine limitations, several of the larger diameter specimens had to be shorter than the ASTM required length. To take this variation into account, in Figs. 4.2 through 4.4, load/length (lb/ft) has been plotted vs circumferential strain. Each graph represents a location around the pipe circumference. The graph in each figure at the top right of the page (Fig 4.2a, 4.3a, and 4.4a) is the location directly under the upper load platen.

Figure 4.1. Strain locations for parallel plate tests.

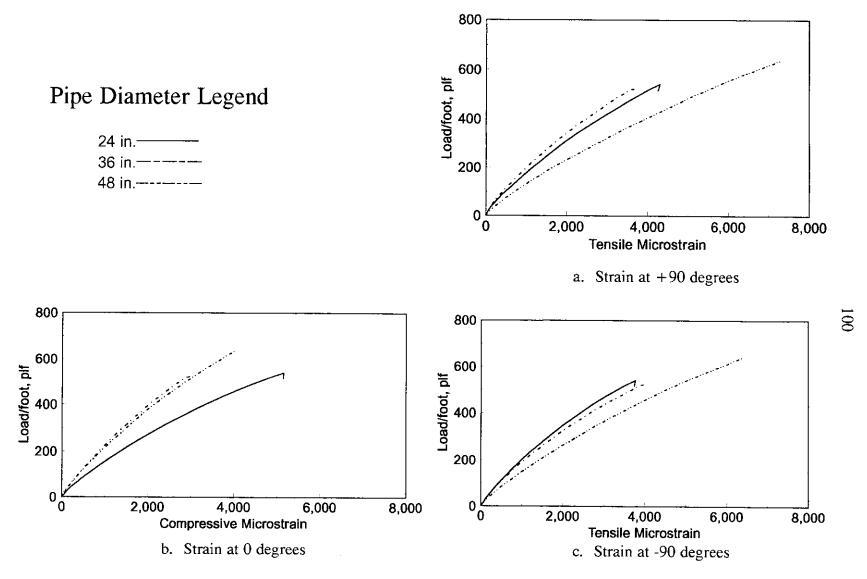
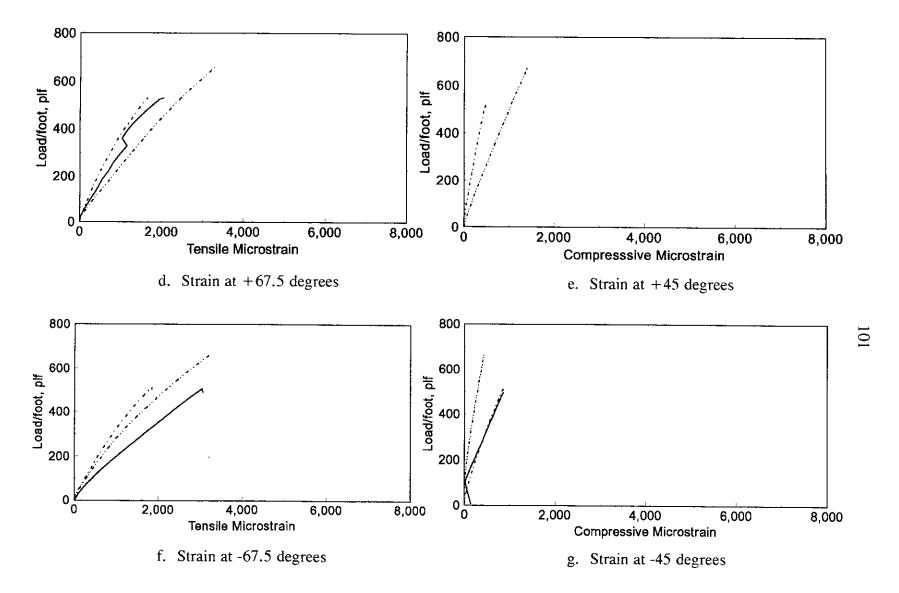
Figure 4.4. Manufacturer C, circumferential strain to 5% deflection.

Figure 4.4. Continued.

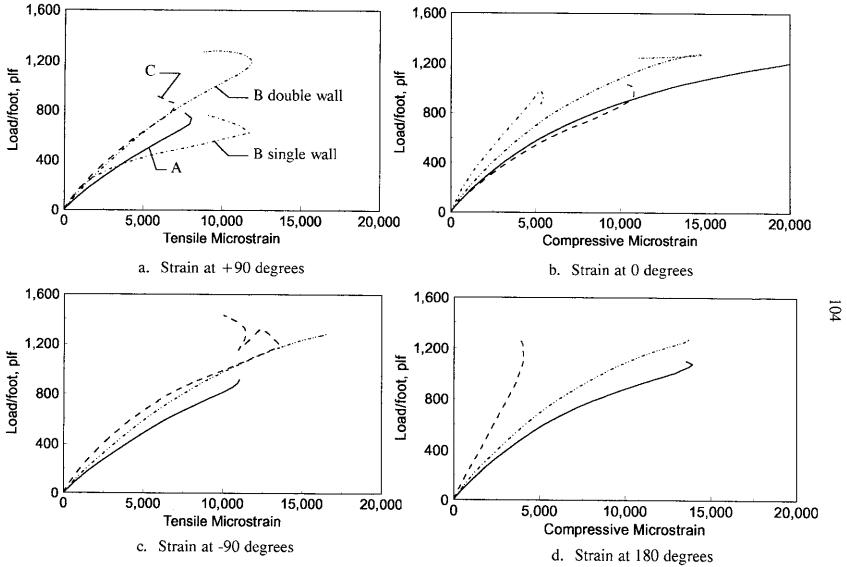
Comparisons of the circumferential strains for all manufacturers for each size pipe are shown in Figs. 4.5 through 4.8. For the 24-in, specimens (Fig. 4.5), Manufacturer C's profile reached the highest ultimate load. Note, the highest ultimate load may not be shown in the figures if the strain gages on a given specimen had failed prior to reading the ultimate load; ultimate load was recorded from the test machine. Manufacturer B's two different profiles performed substantially different from one another. No clear trends are observed for the various 24-in, diameter specimens; however in general, specimens from Manufacturer A had the highest strains. This is not observed at the crown where the single-walled specimen from Manufacturer B had higher strains and at one springline where the strains are slightly lower than those for Manufacturer C.

Figure 4.5. HDPE 24 in. diameter pipes: load/ft versus circumferential strain to failure.

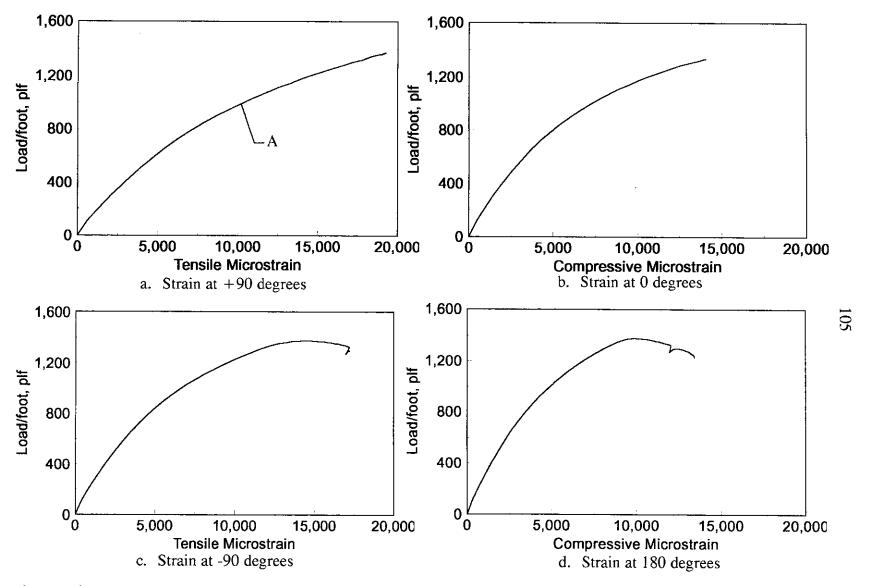
Figure 4.6. HDPE 30 in. diameter pipes: load/ft versus circumferential strain to failure.

The behavior of a 30-in. diameter specimen from Manufacturer A is shown in Fig. 4.6. Ultimate strains at all locations were generally between 12,500-microstrain and 17,500-microstrain, indicating that significant deformation occurred at all locations monitored. The shape of the curves indicate that one springline location and the invert failed at about 1400-plf. Manufacturer A was the only one that provided a 30-in. diameter specimen for testing.

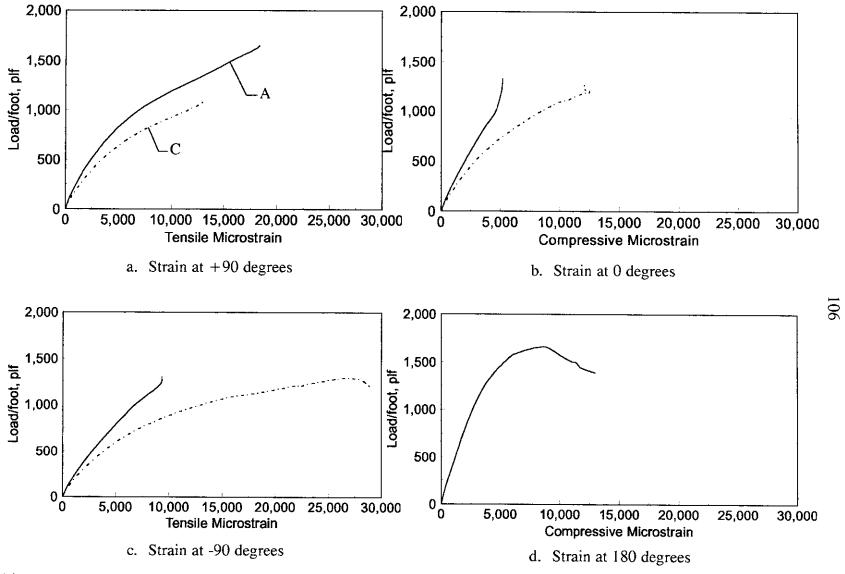
Figure 4.7. HDPE 36 in. diameter pipes: load/ft versus circumferential strain to failure.

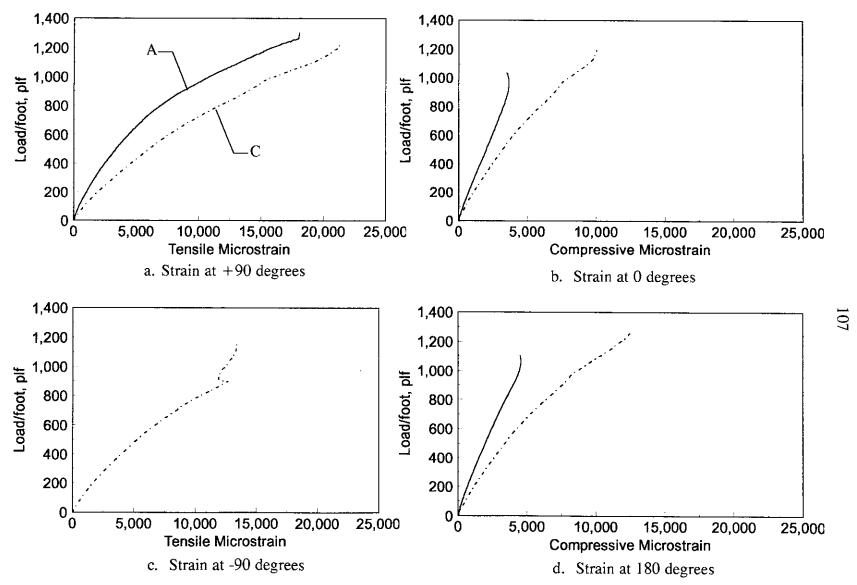
Figure 4.8. HDPE 48 in. diameter pipes: load/ft versus circumferential strain to failure.

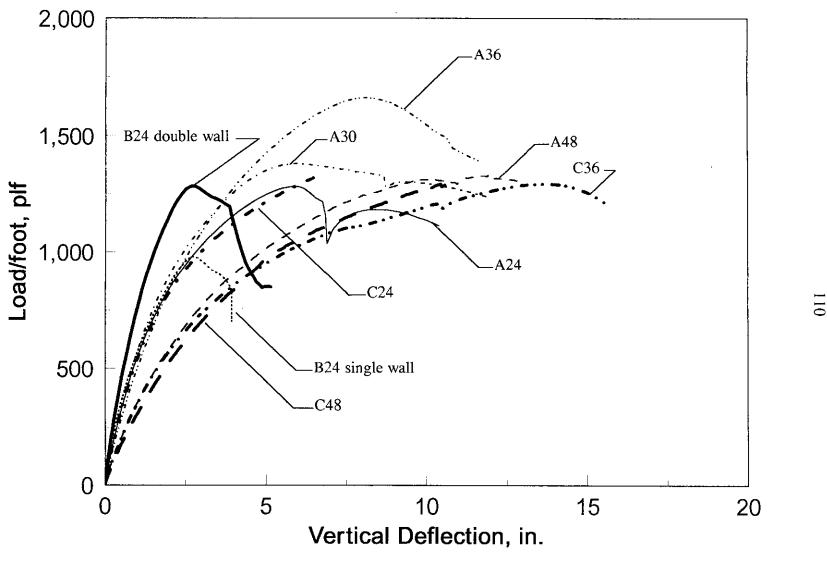
Figure 4.9. Load/ft vs. change in vertical inside diameter.

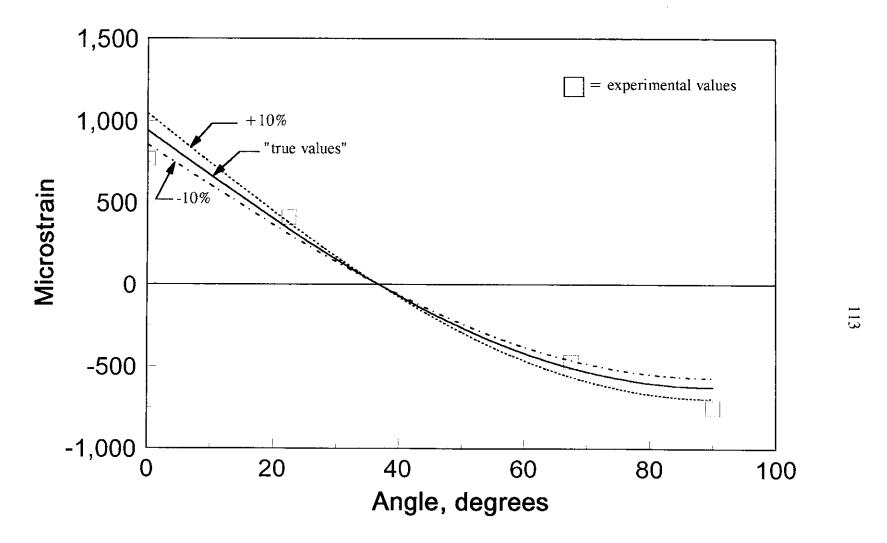
Figure 4.11. Theoretical vs. experimental strain for parallel plast specimen C24 at 130 plf.

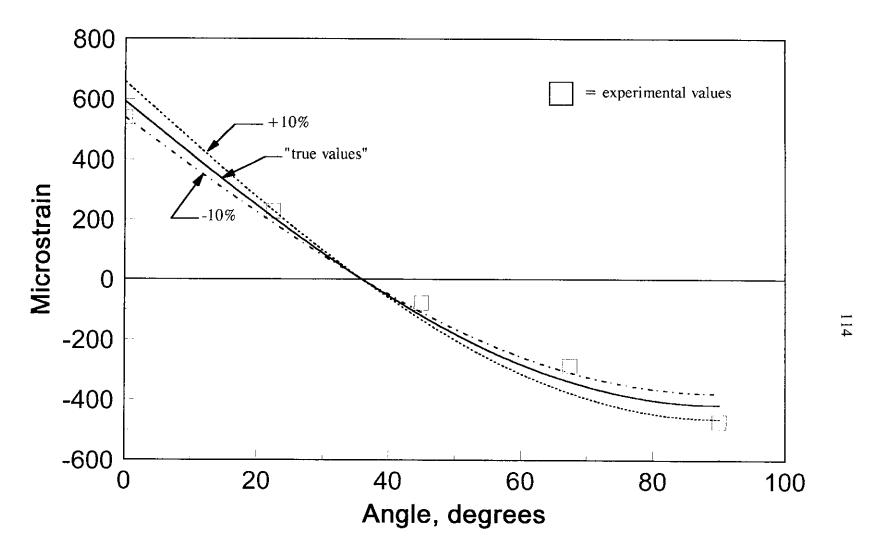
Figure 4.12. Theoretical vs. experimental strain for parallel plate specimen C36 at 113 plf.

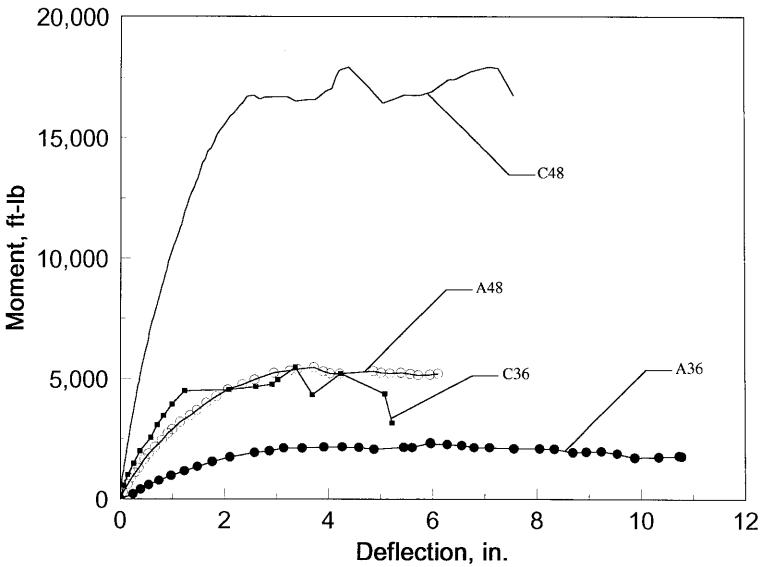
Figure 4.13. Moment vs. midspan deflection for failure tests.

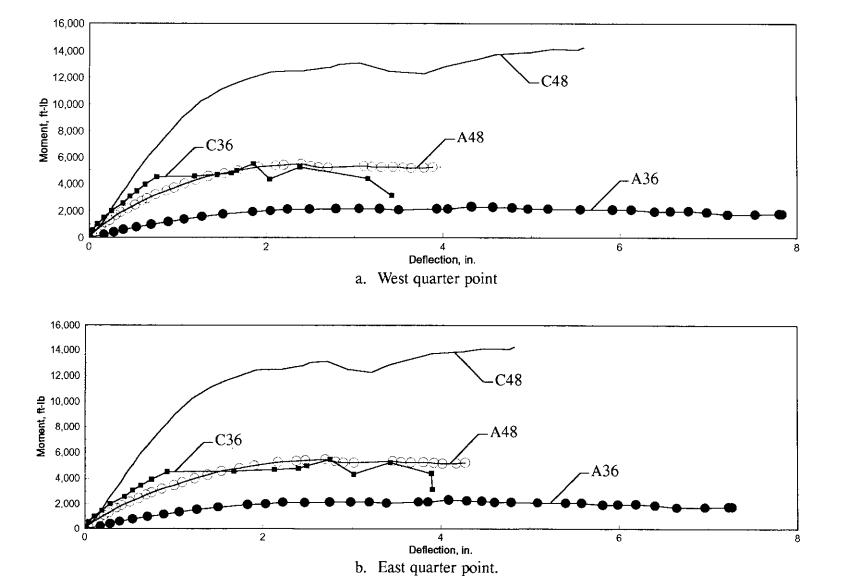
Figure 4.14. Moment vs quarter point deflection for failure tests.

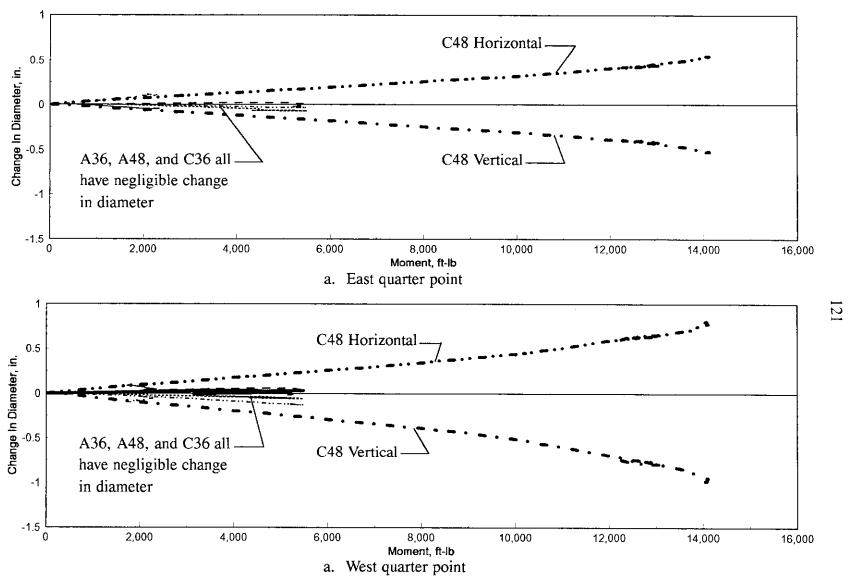
Figure 4.16. Moment vs. change in inside diameter at quarter points.

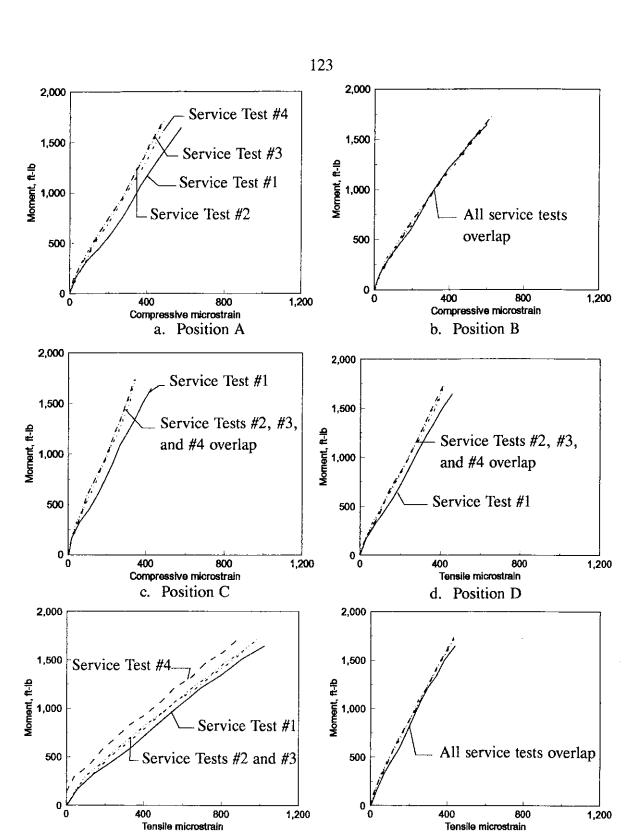
Figure 4.17 shows the location and designation of strain gages used during flexural testing; as previously noted these longitudinal gages were on the inside surface of the pipe specimens. Illustrated in Fig 4.18 are representative service load test data for Specimen

Figure 4.18. Moment vs. longitudinal strain for specimen A48 under service loads.

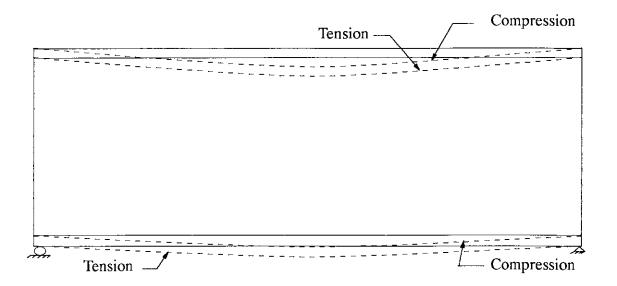
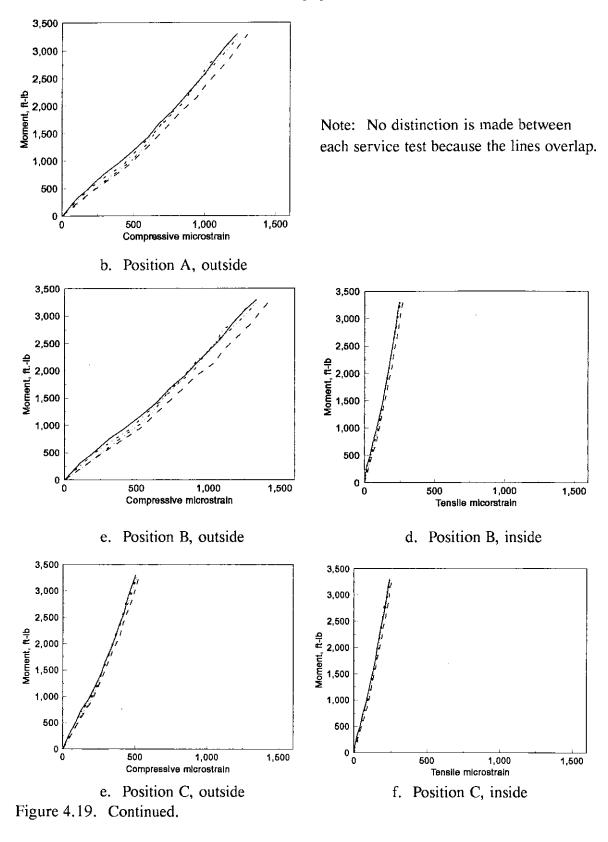
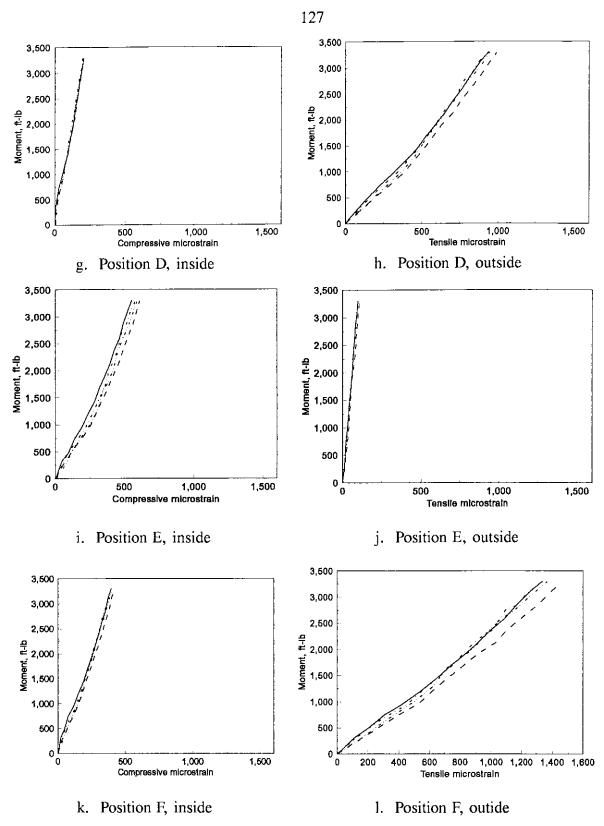
Illustrated in Figure 4.19 is the behavior of Specimen C48. The wall profile of Specimen C48 is very different from other specimens and therefore this specimen exhibited significantly different behavior. Strains for the specimen are given at the quarter and center points on the inside as before with the addition of strain from additional gages on the outside of the specimen wall at the quarter points and at the centerline. The strains on the inside wall of the pipe at all locations are opposite in sign to those of other specimens. Different strain behavior might be expected based on the change in inside diameter data presented earlier. The fact that Specimen C48 was the only one that had any significant

a. Sketch of deflected shape

Figure 4.19. Moment vs. longitudinal strain and deflected shape for specimen C48 under service loads.

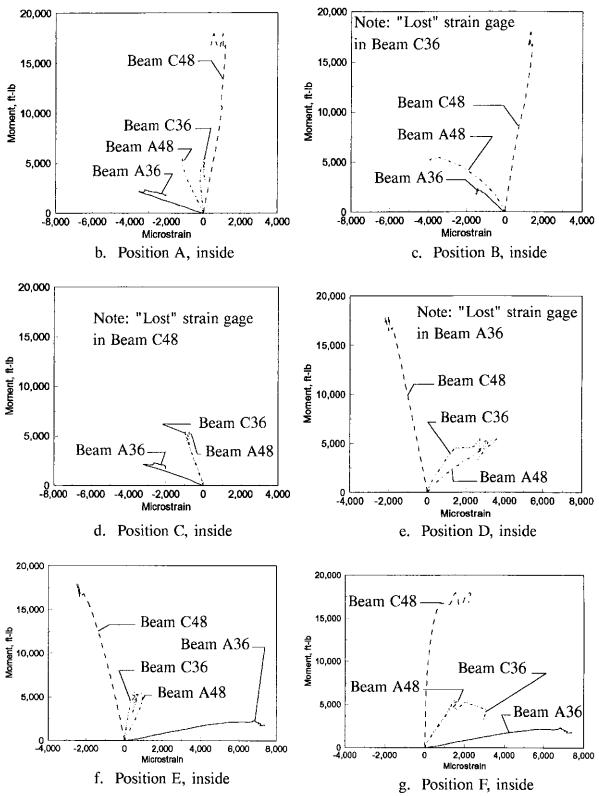
Figure 4.20 shows the comparisons of the longitudinal strains (+ strain= tension; - strain = compression) of each of the specimens during their failure tests. This shows that the least stiff specimen (A36) has higher magnitudes of longitudinal strain than the other specimens except at Position B. It also illustrates the difference in signs of longitudinal strains between specimen C48 and the remaining specimens. Clearly, as previously noted, flexural stiffness is not only a function of pipe diameter but is heavily dependent on the wall profile geometry.

Figure 4.20. Moment vs. longitudinal strain for failure tests.

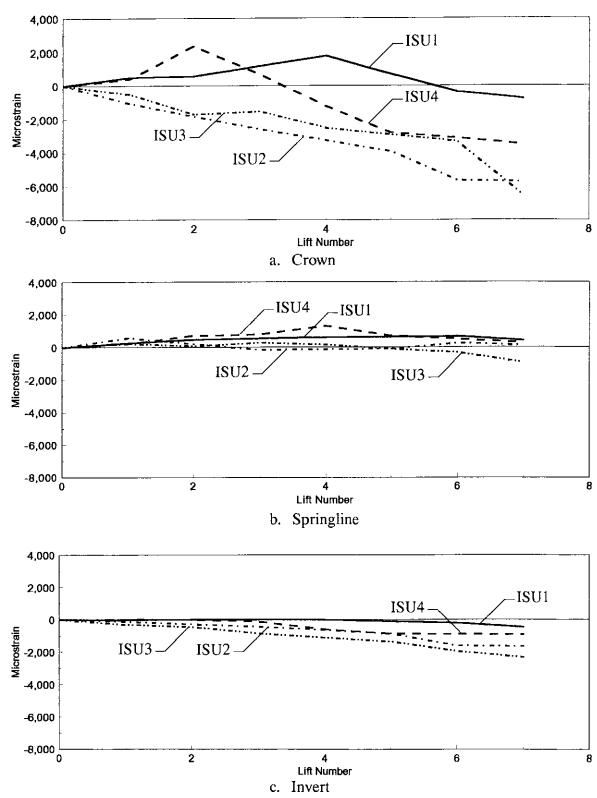
Figure 4.21. Backfilling circumferential strain at Section 2.

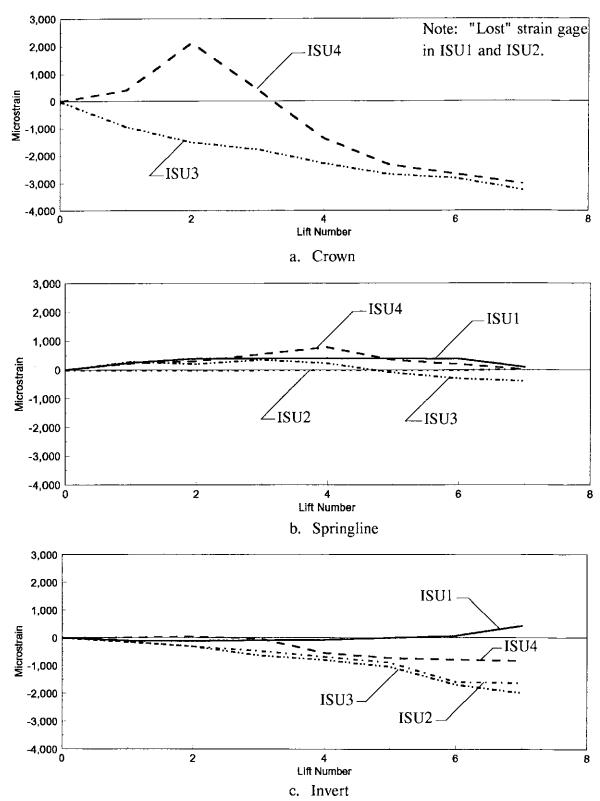
Figure 4.22. Backfilling circumferential strain at Section 4.

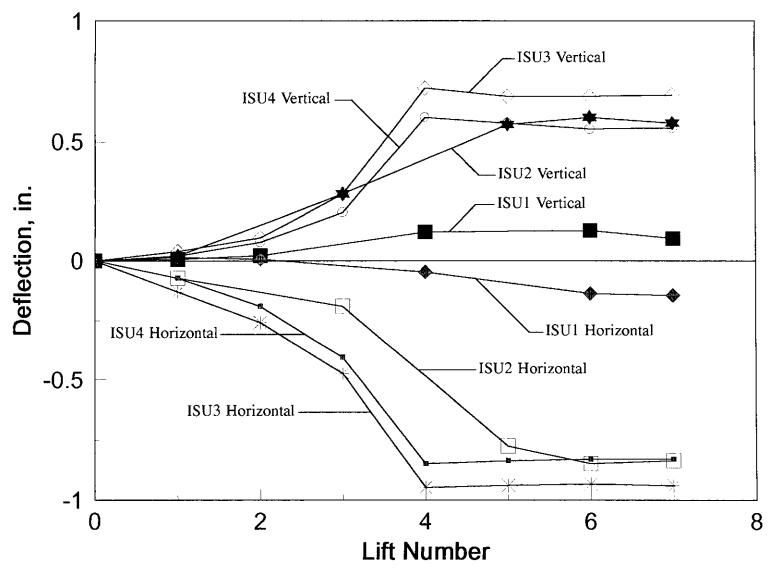
Figure 4.24. Changes in inside diameter at Section 2 during backfilling.

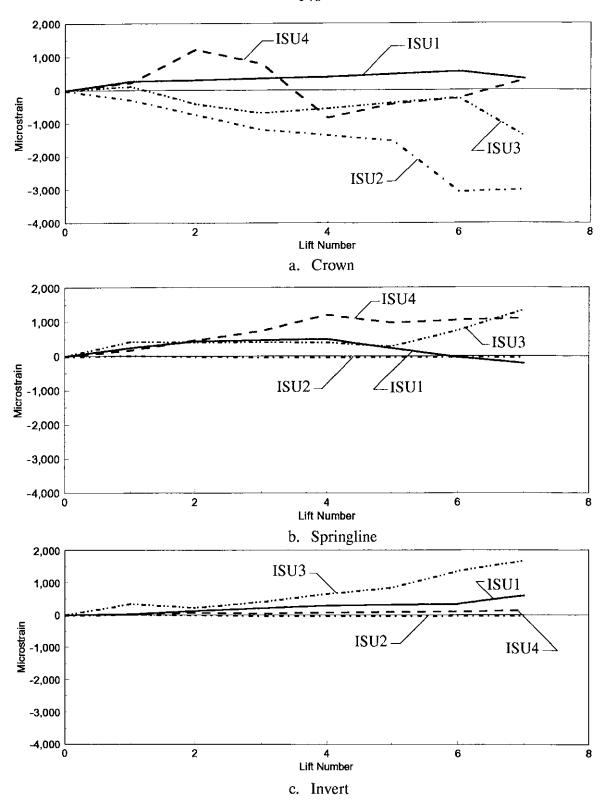
Figures 4.27 through 4.29 show the longitudinal strains which occurred during backfilling at three locations: crown, springline, and invert. There is no clear trend in the strains for a given specimen or at a given section. The random variation of the longitudinal strain data for a given specimen can be attributed to longitudinal differences in tamping sequence, actual mechanical effort applied, and differences in the type and quantities of backfill materials used. The differences between ISU2 and ISU4, which have the same backfill condition, can be explained by the fact that the trench in ISU2 was narrower than that of ISU4. The dimensions of the top and cradle of the trench were essentially the same, however the total width of the bottom of the trench in ISU4 was significantly larger. ISU4 had nearly vertical slopes whereas ISU2 had slopes more nearly equal to 1:1. This difference resulted in different backfill restraint and horizontal loads.

Figure 4.27. Backfilling longitudinal strain at Section 2.

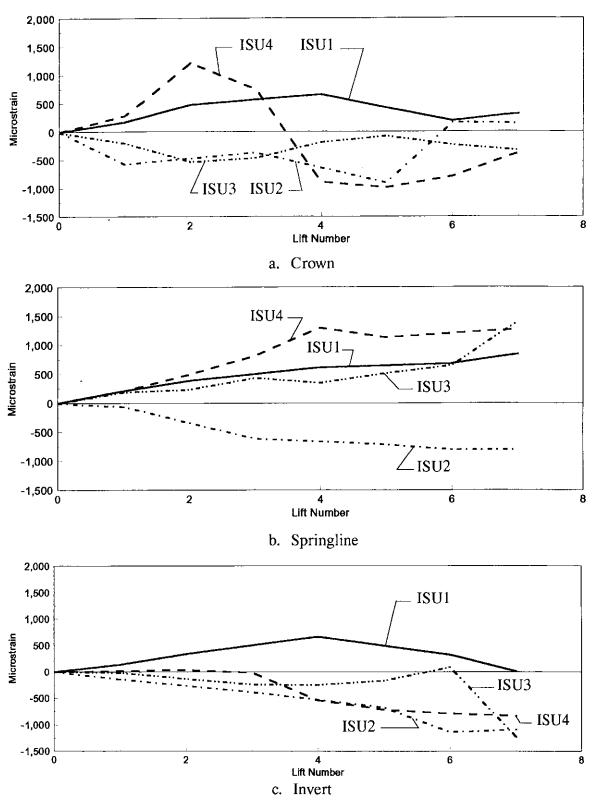
Figure 4.28. Backfilling longitudinal strain at Section 4.

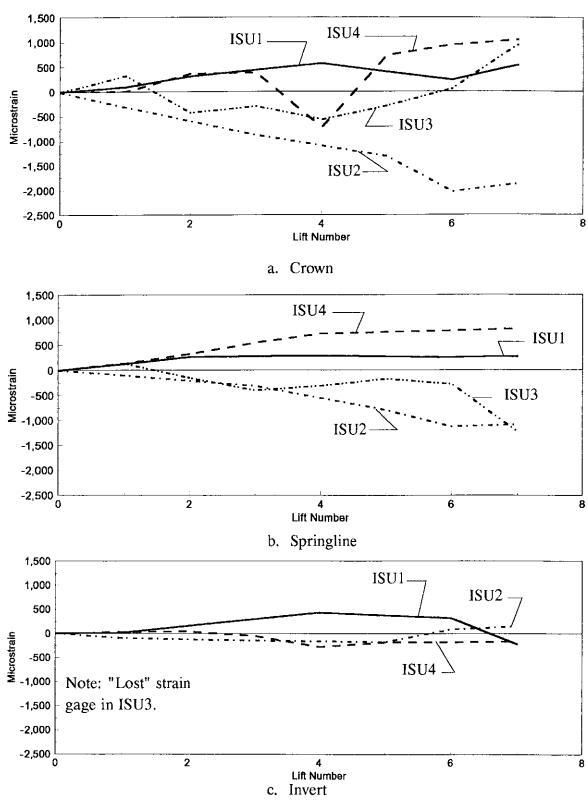
Figure 4.29. Backfilling longitudinal strain at Section 6.

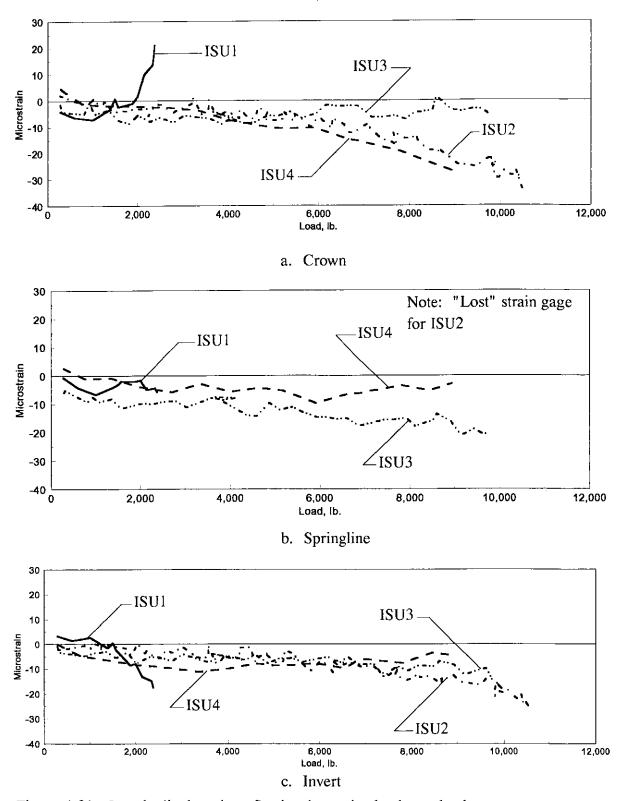
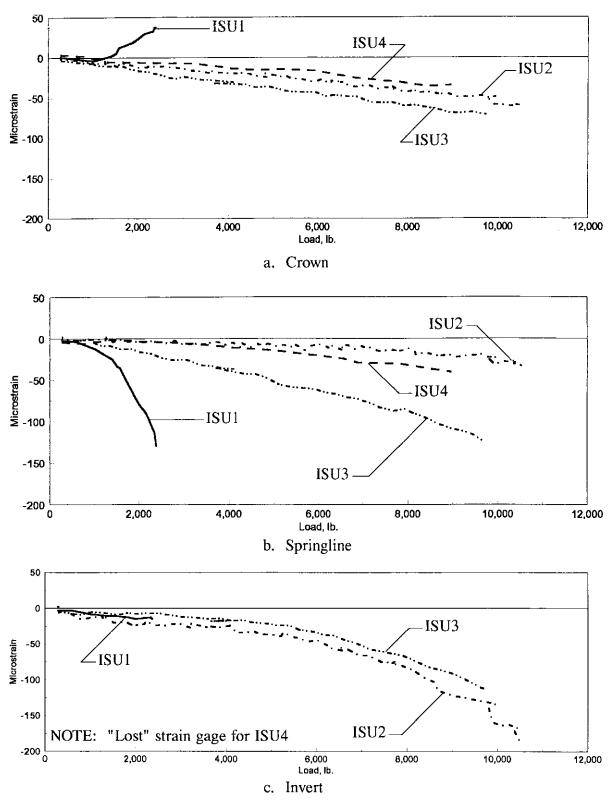
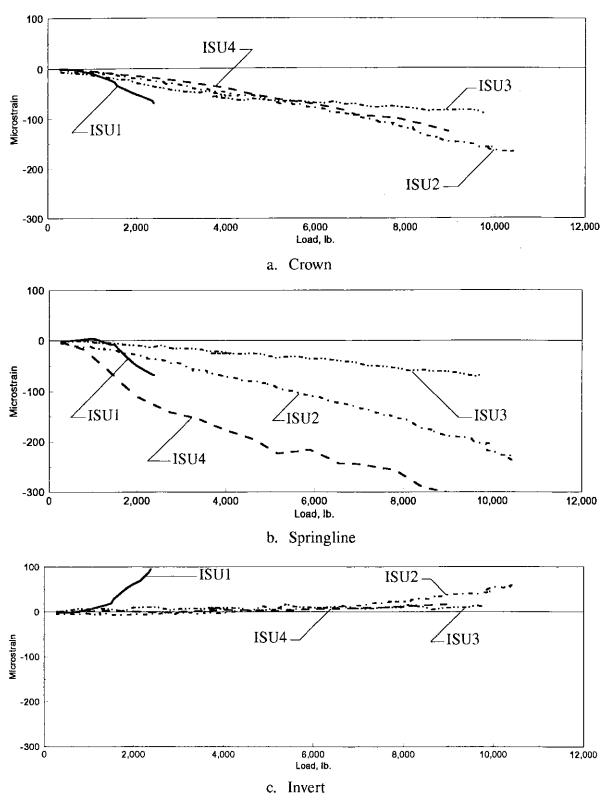
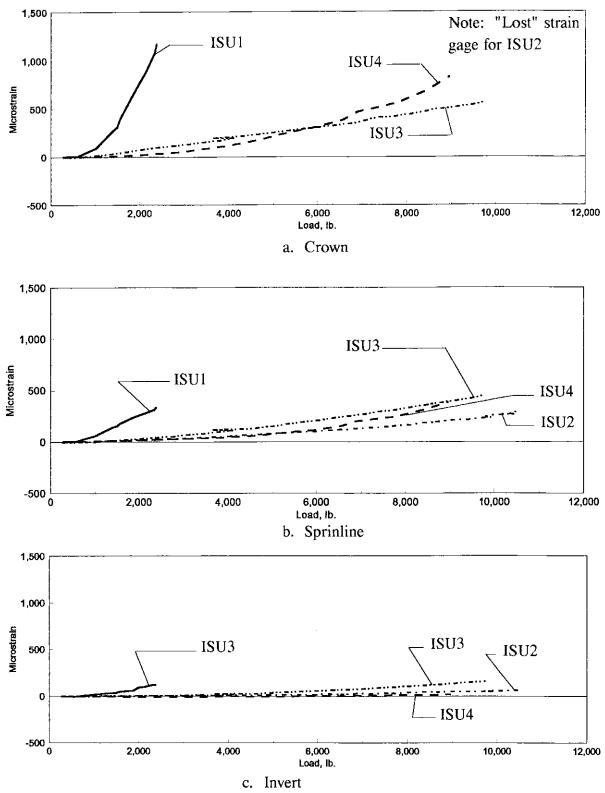
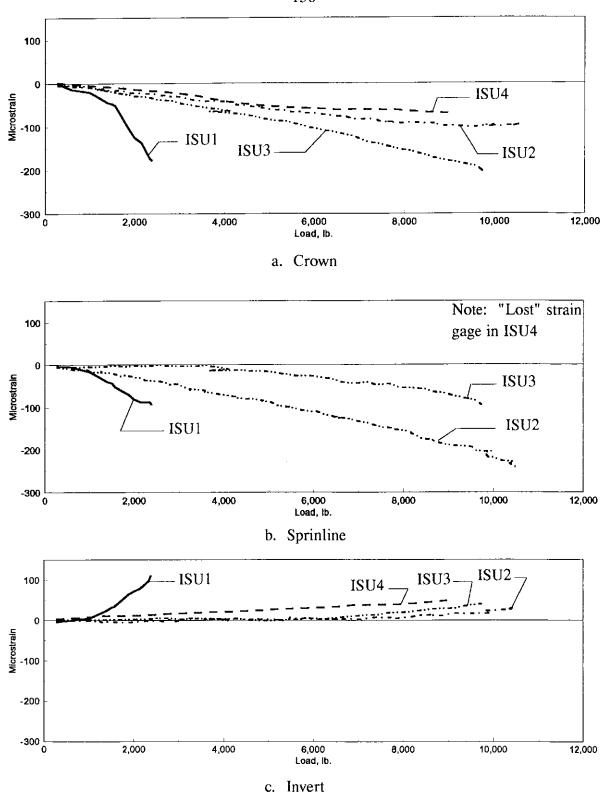
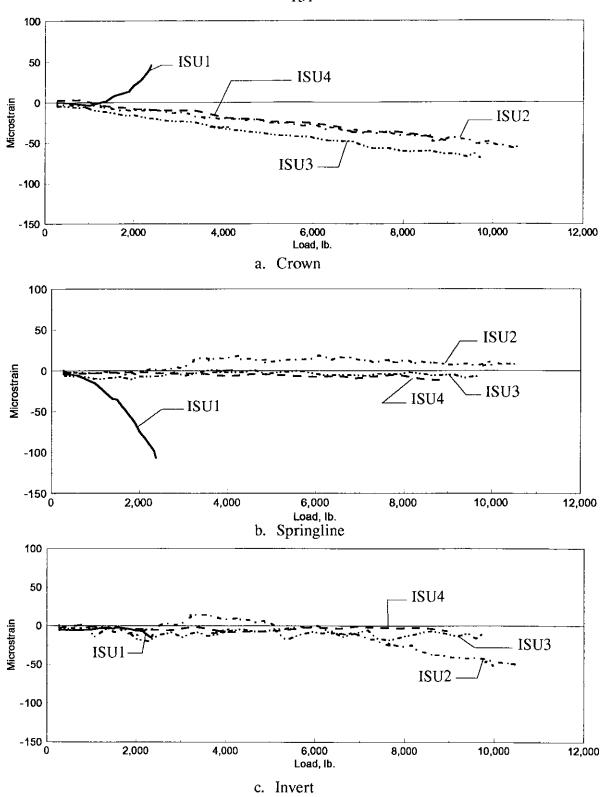
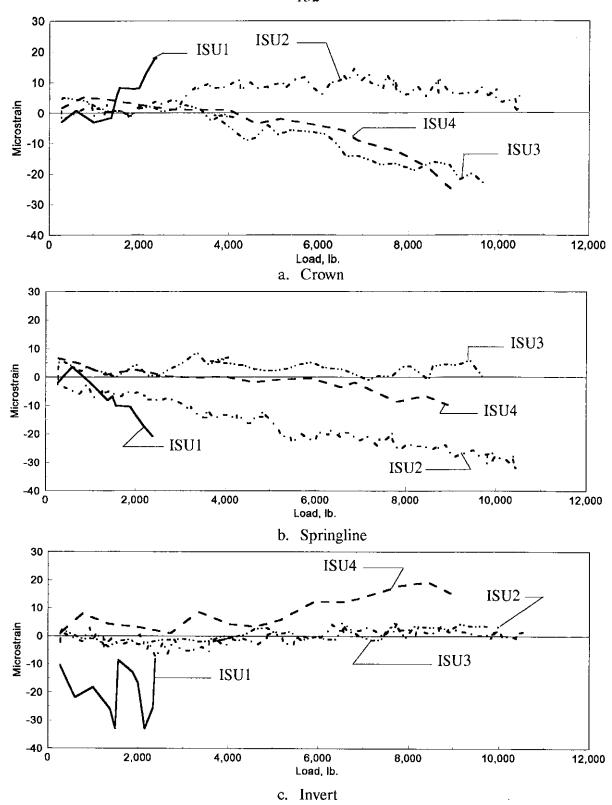
Figure 4.31. Longitudinal strain at Section 1: service load test; load at center.

Figure 4.32. Longitudinal strain at Section 2: service load test; load at center.

Figure 4.33. Longitudinal strain at Section 3: service load test; load at center.

Figure 4.34. Longitudinal strain at Section 4: service load test; load at center.

Figure 4.35. Longitudinal strain at Section 5: service load test; load at center.

Figure 4.36. Longitudinal strain at Section 6: service load test; load at center.

Figure 4.37. Longitudinal strain at Section 7: service load test; load at center.

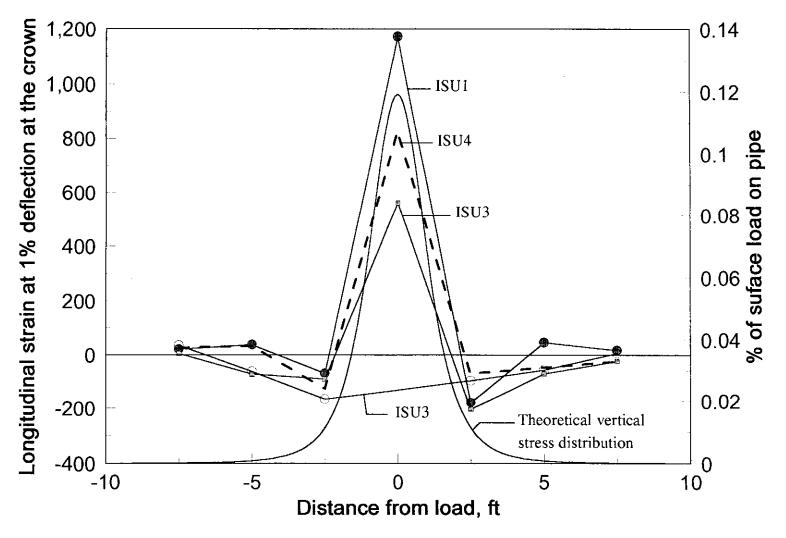
Figure 4.38. Comparison of theoretical vertical stress distribution and experimental strain at the crown.

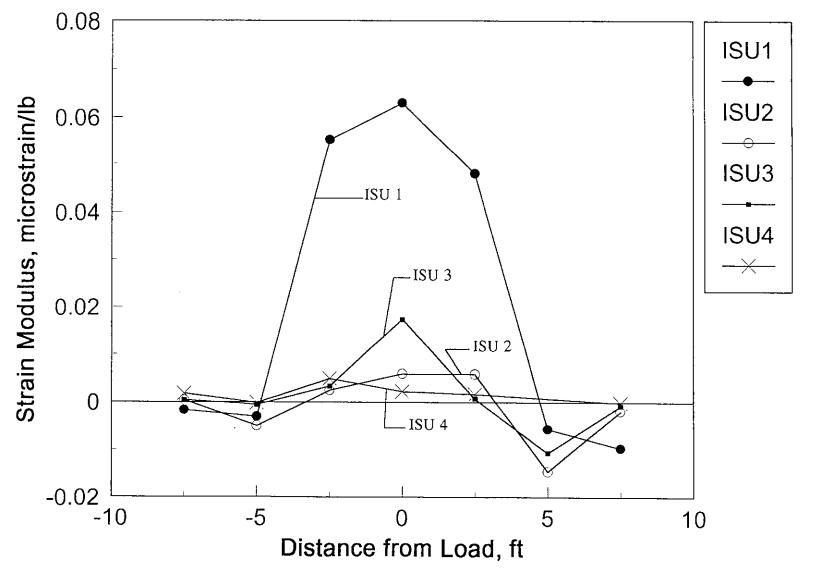
Strain modulus is defined as the slope of the linear portion of the load-strain curve and indicates the strain rate during loading. Figures 4.40 through 4.42 show the variation in longitudinal strain modulus versus the distance from applied load. The data presented in these figures show several things: (1) symmetrical behavior of the specimen with respect to the specimen centerline, (2) the relative magnitudes of the rate of change of longitudinal

Figure 4.42. Longitudinal strain modulus at the invert versus distance from load.

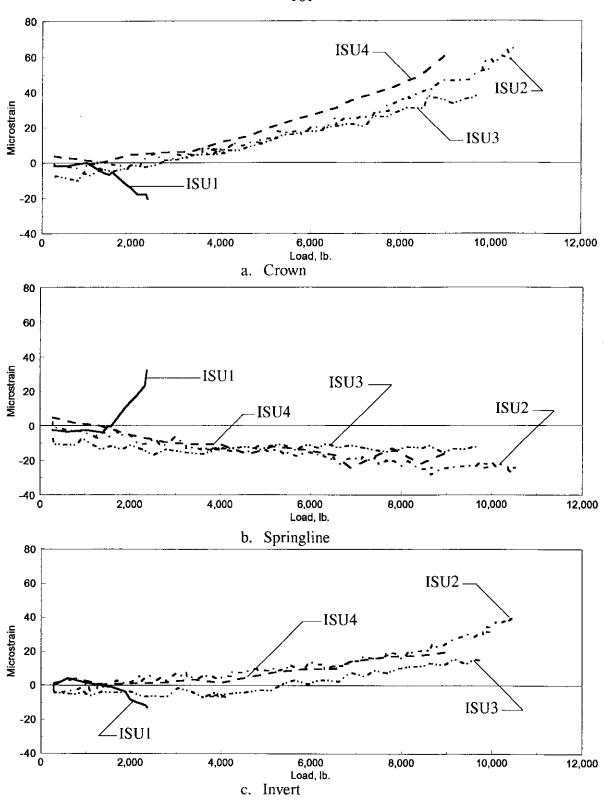
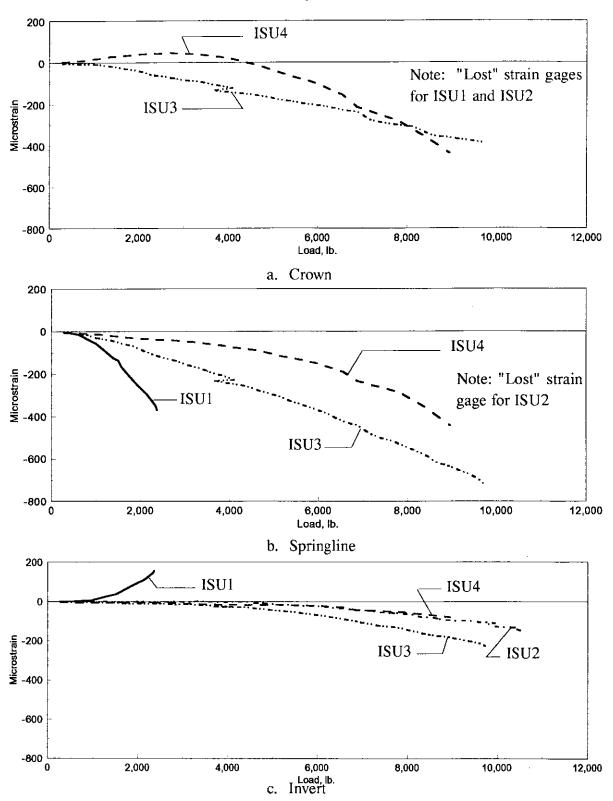
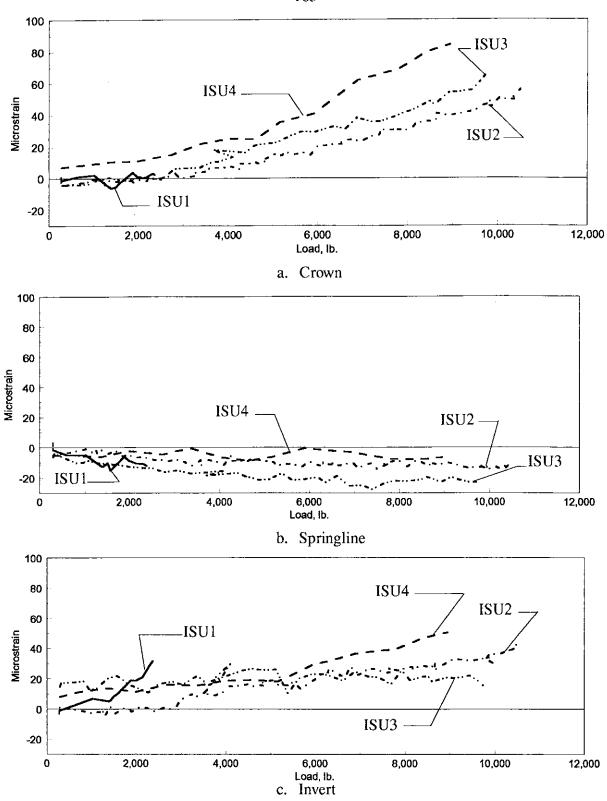
The circumferential strain data collected during the same service tests as described above are shown in Figs. 4.43 through 4.45. Each figure shows three graphs representing the strains at the crown, the springline, and the invert. The section numbers are the same as for longitudinal strains (see Fig. 3.12). At Section 4 (directly under the load), the largest strains occur at the springline. Vertical load on the soil above the pipe is transferred to the pipe, causing significant deformations and strain at the springline. Also of importance is the fact that the circumferential strains at the invert at Section 4 (Fig. 4.44c) are smaller than the strains at the springline or crown in all specimens. The strains at the invert of Sections 2 and 6 are nearly the same magnitude as the strains at the springline. These strains are small because the specimens were all placed on a continuous supporting base that provided significant restraint against bending deformations. The difference in sign of the strains between ISU1 and the other tests is attributed to the lack of compacted fill in the haunch area. This causes the invert to flatten under applied load and induces tension (positive) strains. This change in sign of the strain is not as pronounced at Sections 2 or 4 because the effect of the load is reduced significantly 5 ft from the load point. Circumferential strains at the crown of each specimen at Section 4 generally are

Figure 4.43. Circumferential strain at Section 2: service load test; load at center.

Figure 4.44. Circumferential strain at Section 4: service load test; load at center.

Figure 4.45. Circumferential strain at Section 6: service load test; load at center.

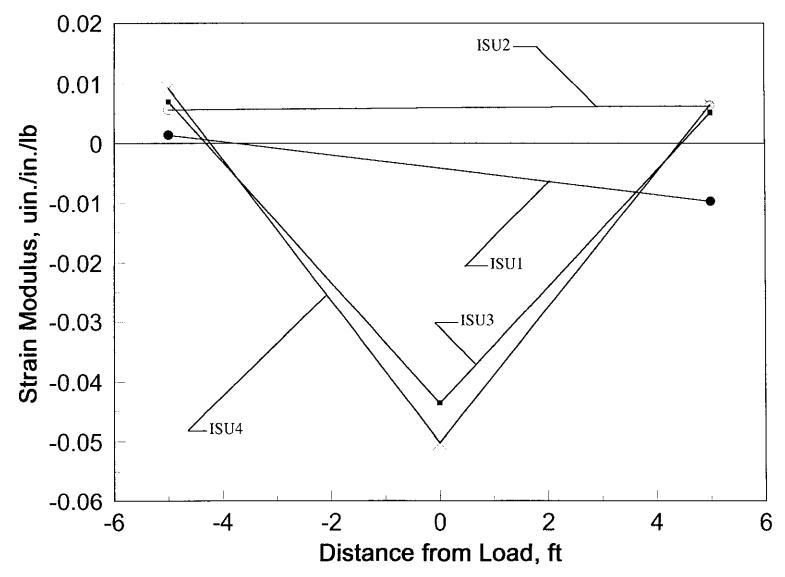
Graphs of the variation of circumferential strain modulus versus distance from load are shown in Figs. 4.46 through 4.48. It should be noted that only three sections were instrumented with circumferential strain gages (see Fig. 3.12). As the graphs show, nearly all circumferential strain takes place at the center section (Section 4) and the only other position with noticeable circumferential strain is at the springline of Sections 2 and 6 of ISU1. As previously noted for the other graphs there is excellent symmetry relative to the

Figure 4.46. Circumferential strain modulus at the crown versus distance from load.

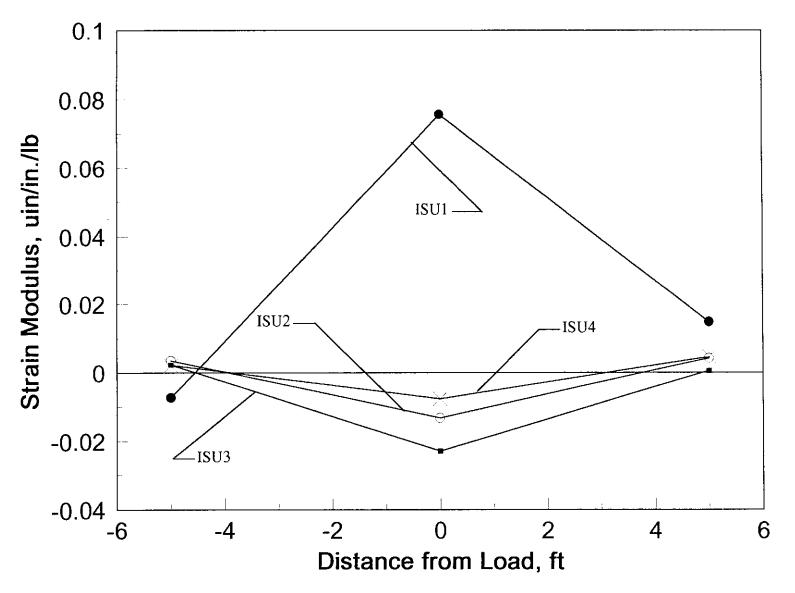
Figure 4.48. Cicumferential strain modulus at the invert versus distance from load.
