## High density polyethylene pipe in highway applications

High density polyethylene pipe in highway applications

Department: Civil and Construction Engineering Major: Civil Engineering (Structural Engineering)

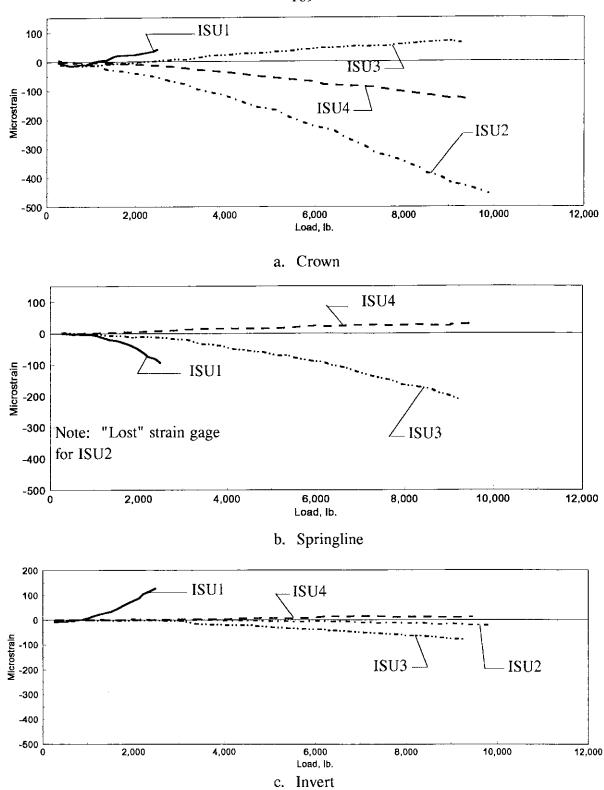
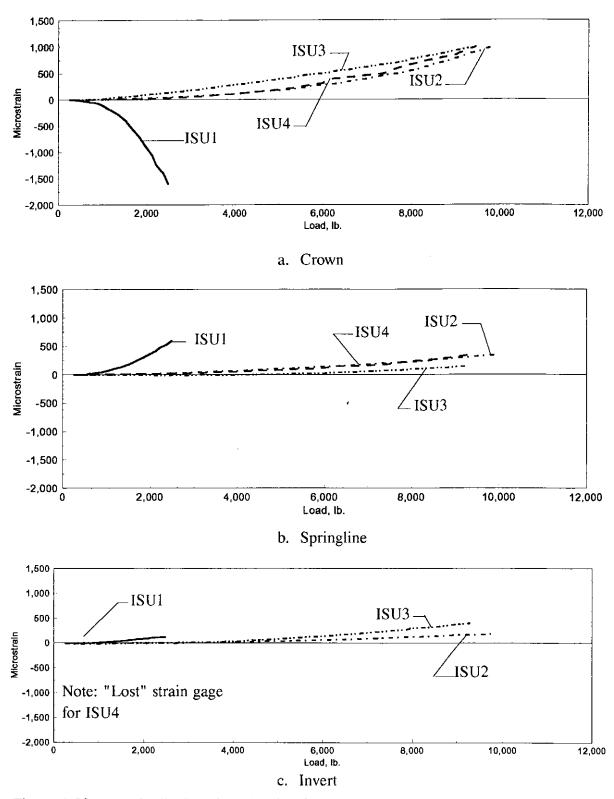
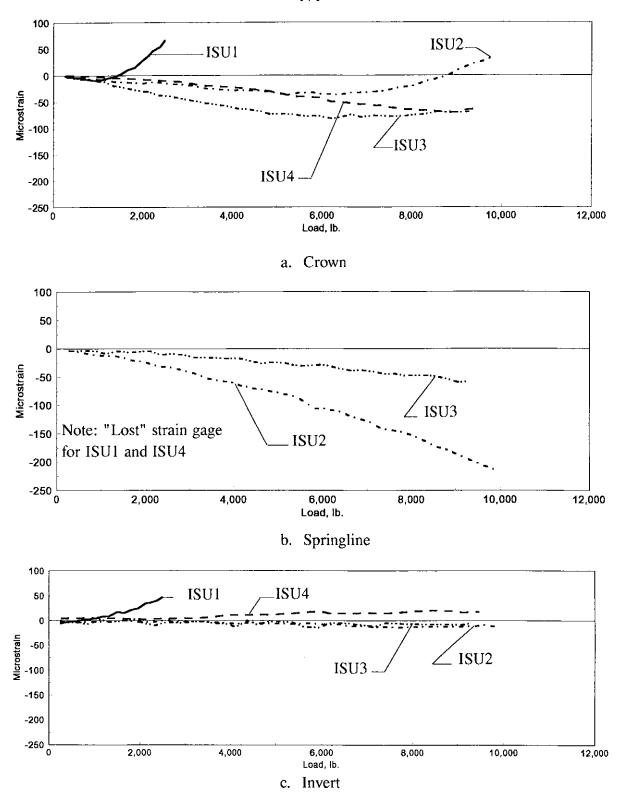
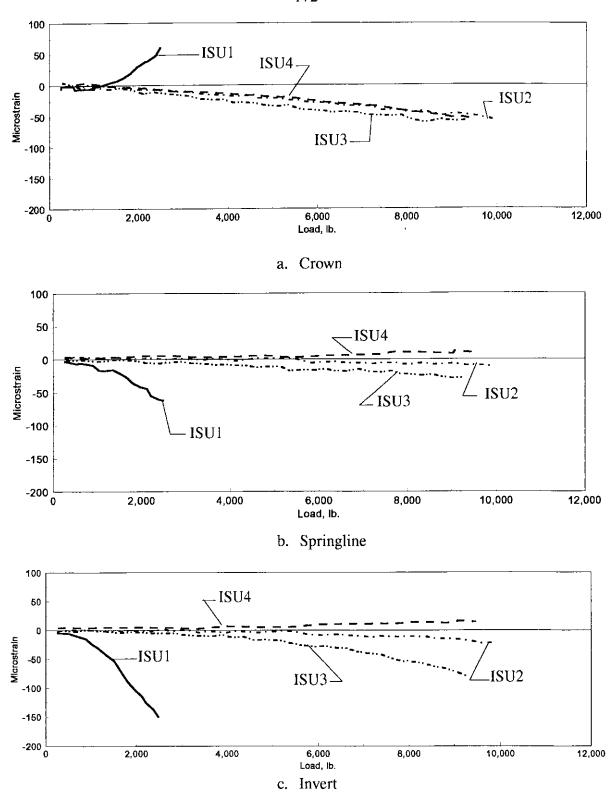
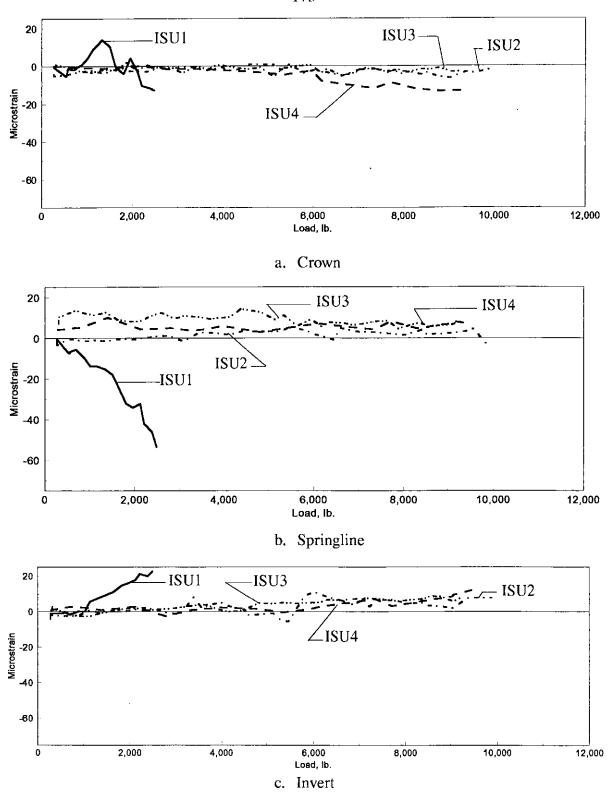
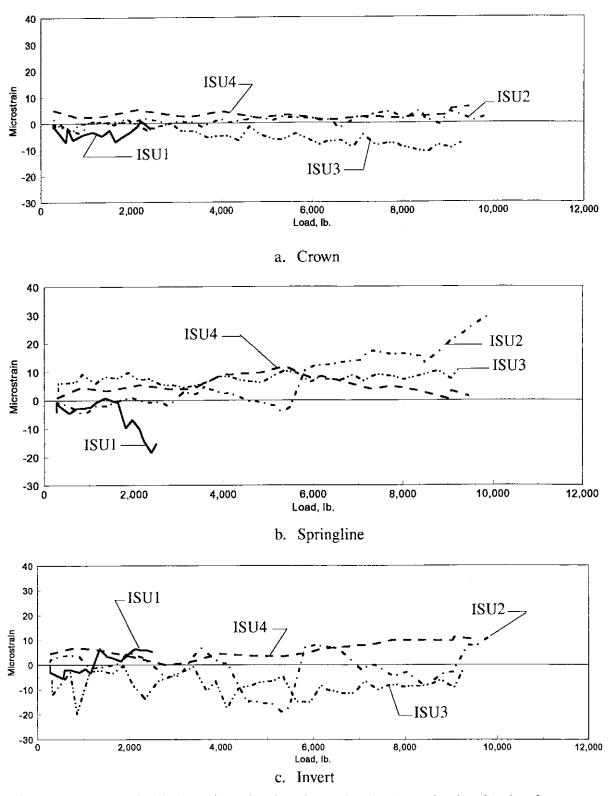
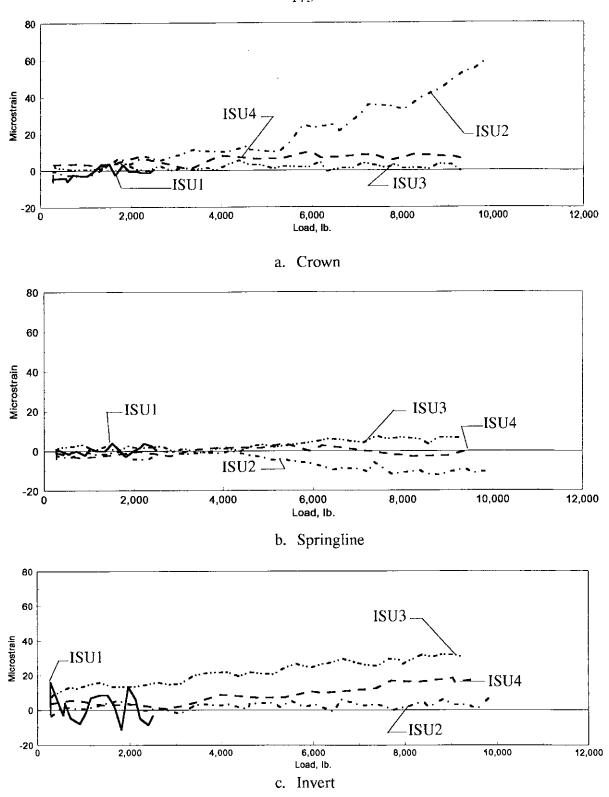
Figure 4.49. Longitudinal strain at Section 1: service load test; load at Section 2.

Figure 4.50. Longitudinal strain at Section 2: service load test; load at Section 2.

Figure 4.51. Longitudinal strain at Section 3: service load test; load at Section 2.

Figure 4.52. Longitudinal strain at Section 4: service load test; load at Section 2.

Figure 4.53. Longitudinal strain at Section 5: service load test; load at Section 2.

Figure 4.54. Longitudinal strain at Section 6: service load test; load at Section 2.

Figure 4.55. Longitudinal strain at Section 7: service load test; load at Section 2.

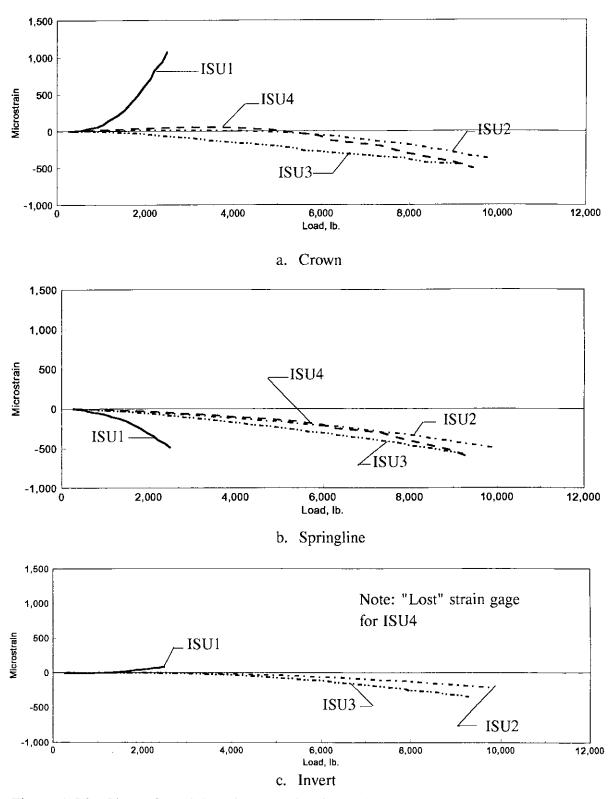
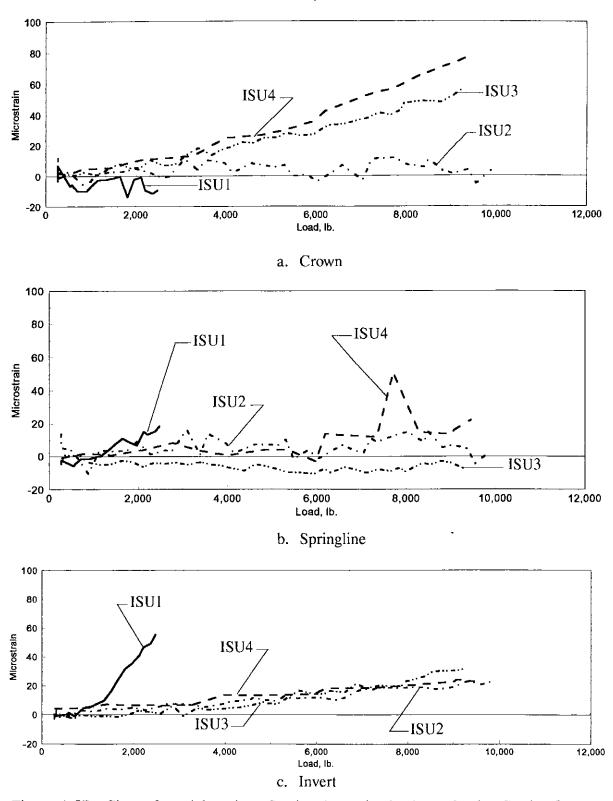
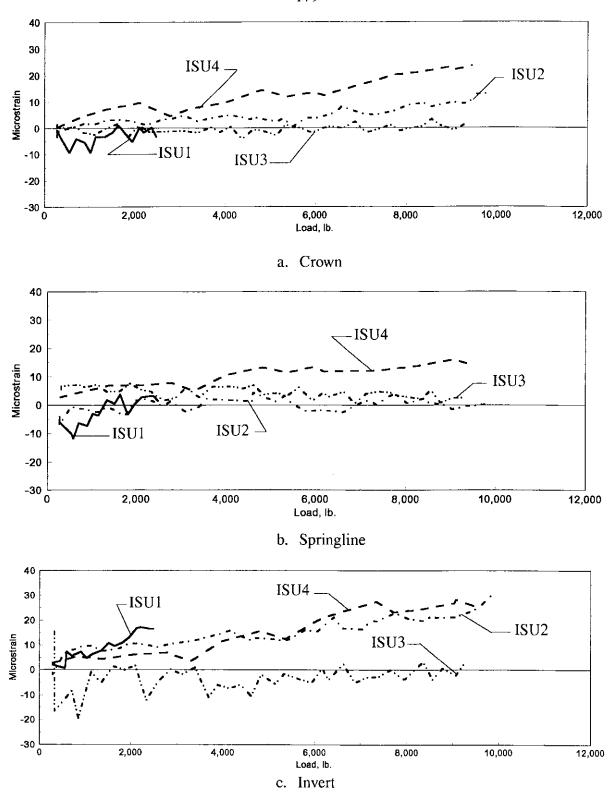
Figure 4.56. Circumferential strain at Section 2: service load test; load at Section 2.

Figure 4.57. Circumferential strain at Section 4: service load test; load at Section 2.

Figure 4.58. Circumferential strain at Section 6: service load test; load at Section 2.

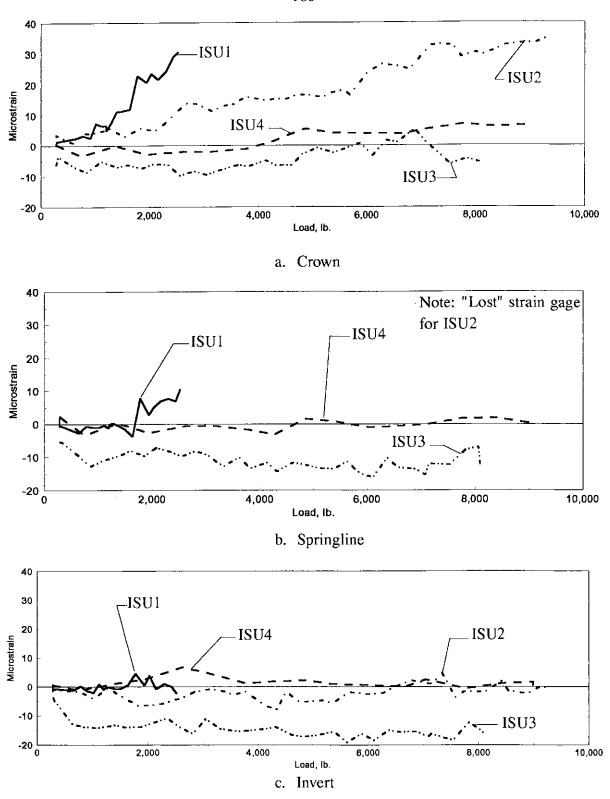
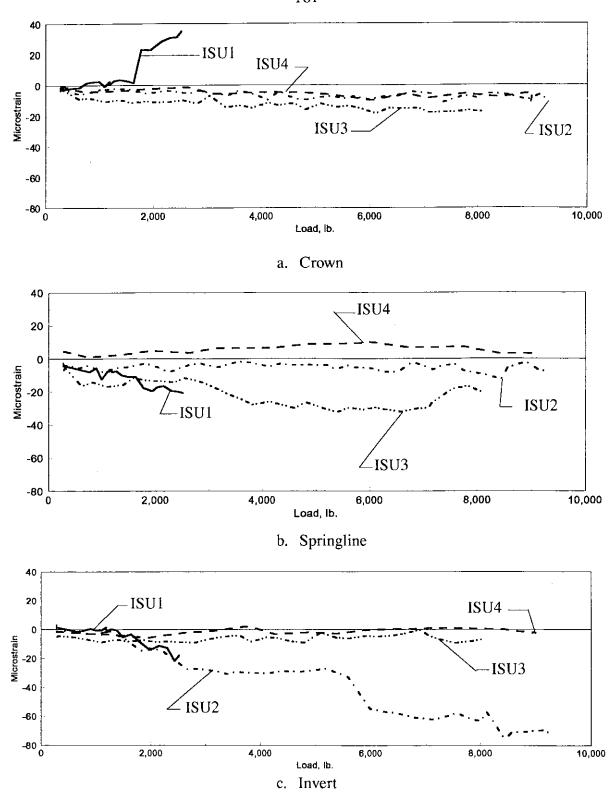
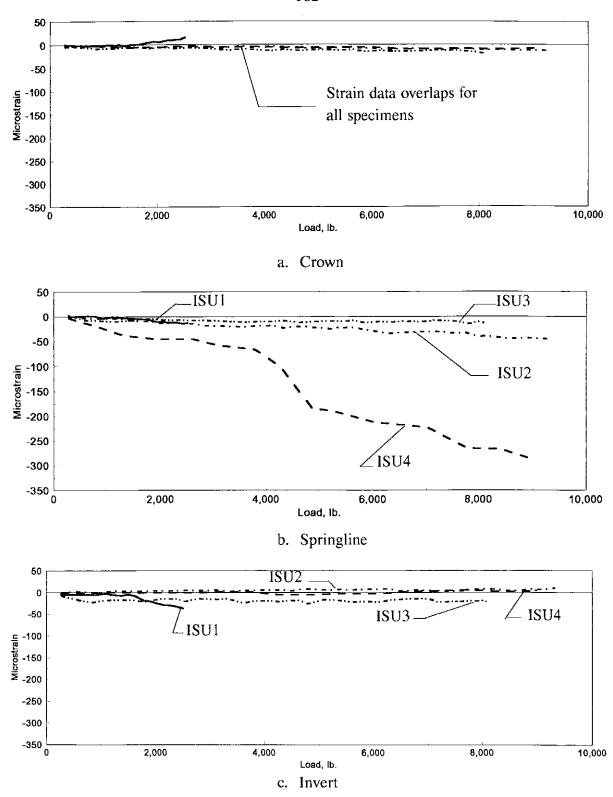
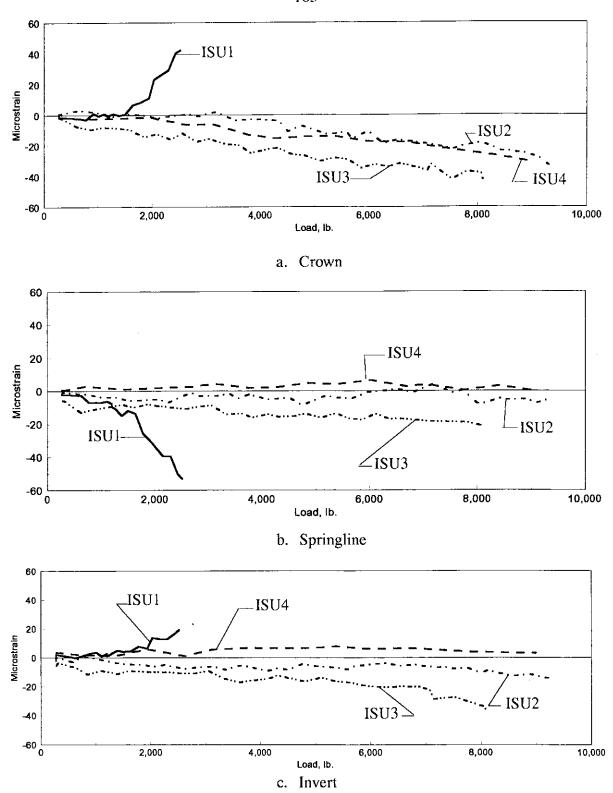
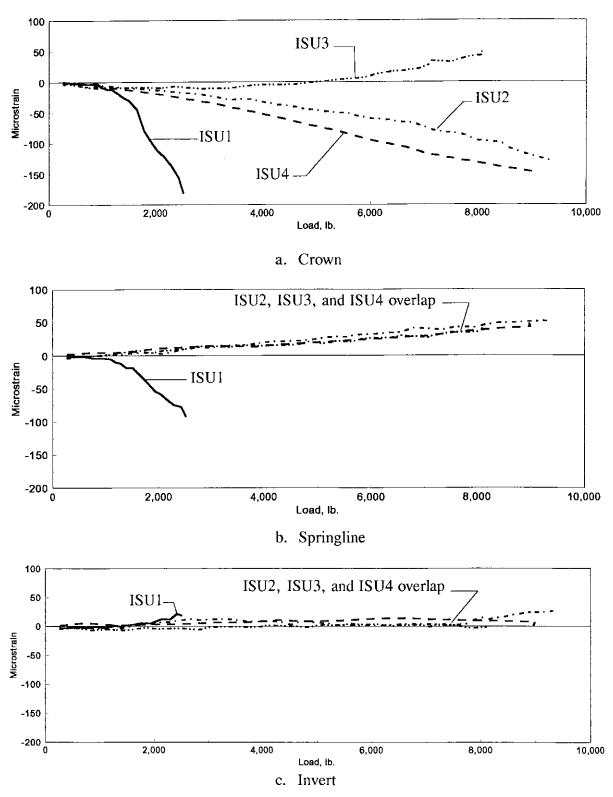
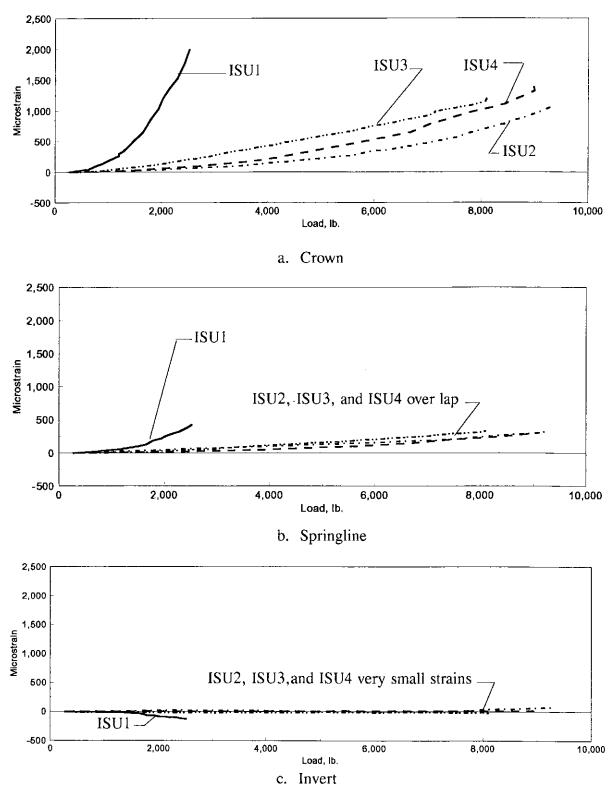
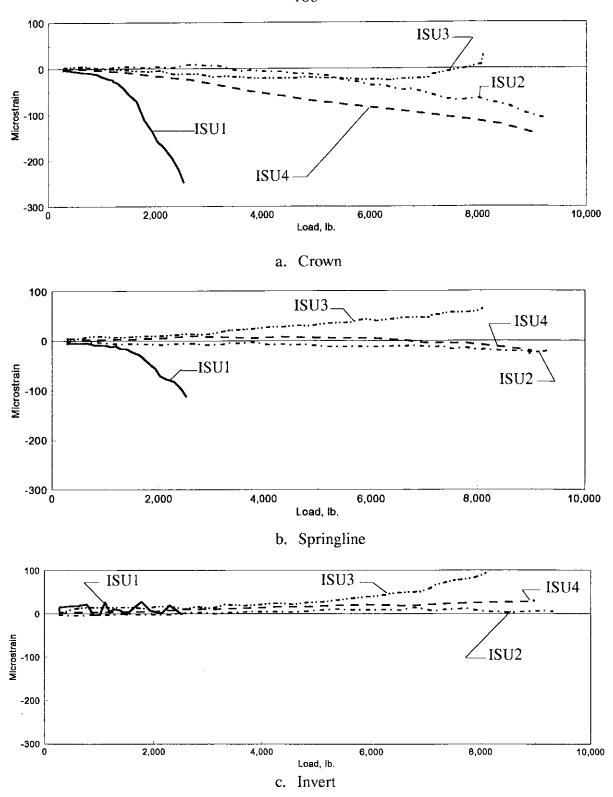
Figure 4.59. Longitudinal strain at Section 1: service load test; load at Section 6.

Figure 4.60. Longitudinal strain at Section 2: service load test; load at Section 6.

Figure 4..61 Longitudinal strain at Section 3: service load test; load at Section 6.

Figure 4.62. Longitudinal strain at Section 4: service load test; load at Section 6.

Figure 4.63. Longitudinal strain at Section 5: service load test; load at Section 6.

Figure 4.64. Longitudinal strain at Section 6: service load test; load at Section 6.

Figure 4.65. Longitudinal strain at Section 7: service load test; load at Section 6.

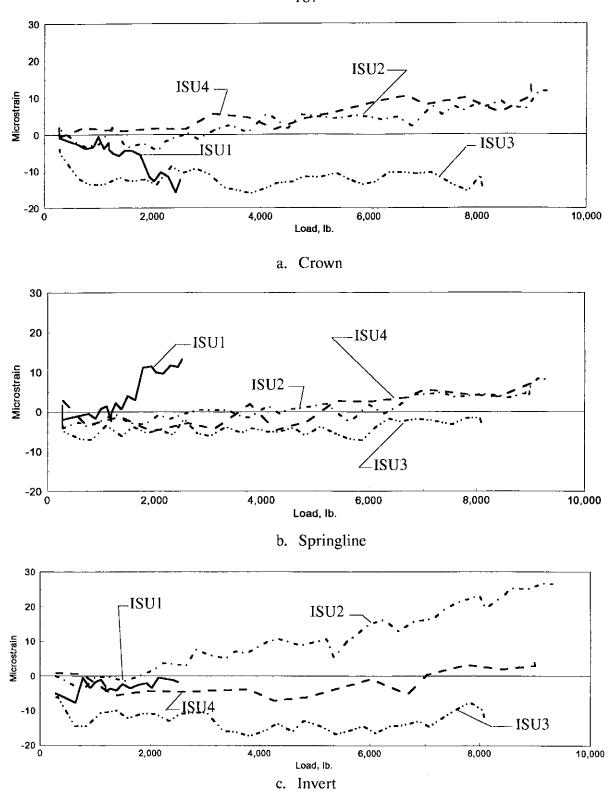
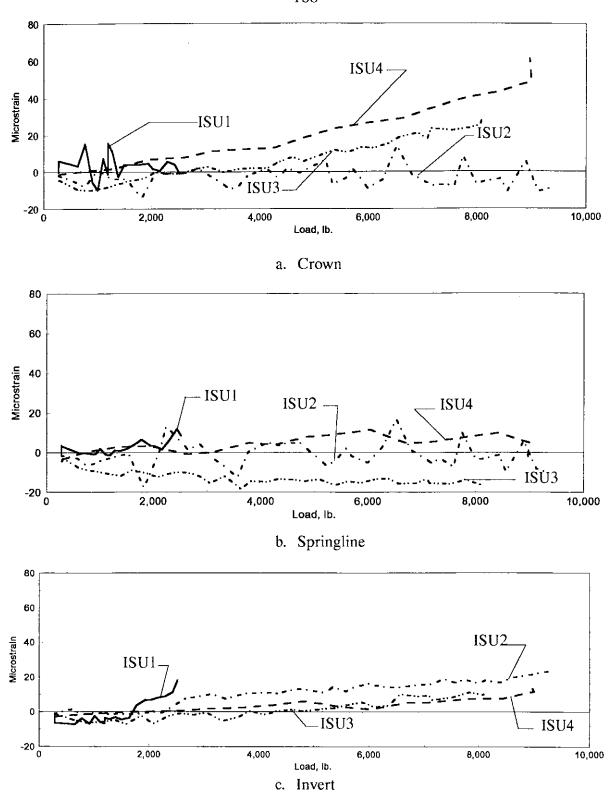
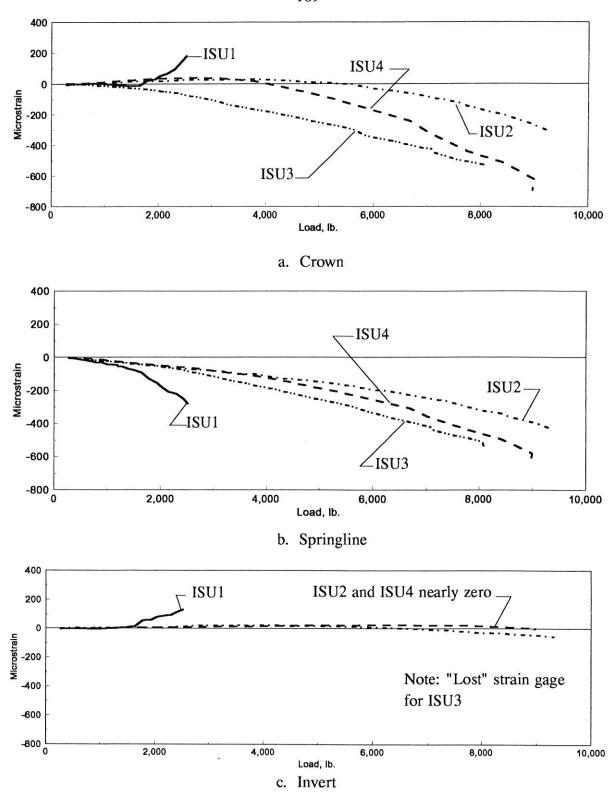
Figure 4.66. Circumferential strain at Section 2: service load test; load at Section 6.

Figure 4.67. Circumferential strain at Section 4: service load test; load at Section 6.

Figure 4.68. Circumferential strain at Section 6: service load test; load at Section 6.

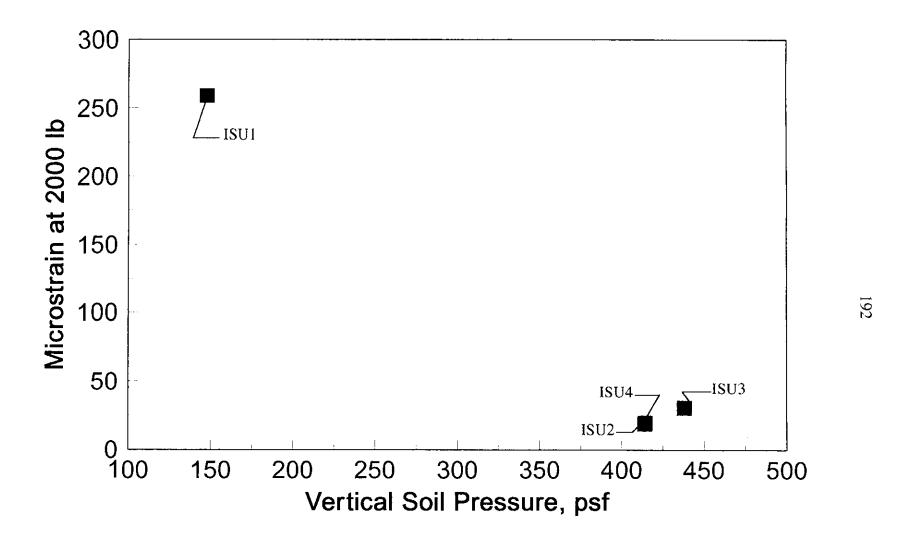
Figure 4.69. Longitudinal strain at 2000 lb of applied load versus vertical soil pressure.
