## Lessons learned from offshore oil and gas incidents in the Arctic and other ice-prone seas

Amos Necci<sup>\*</sup>, Stefano Tarantola, Bogdan Vamanu, Elisabeth Krausmann, Luca Ponte

European Commission, Joint Research Centre (JRC), Ispra, Italy

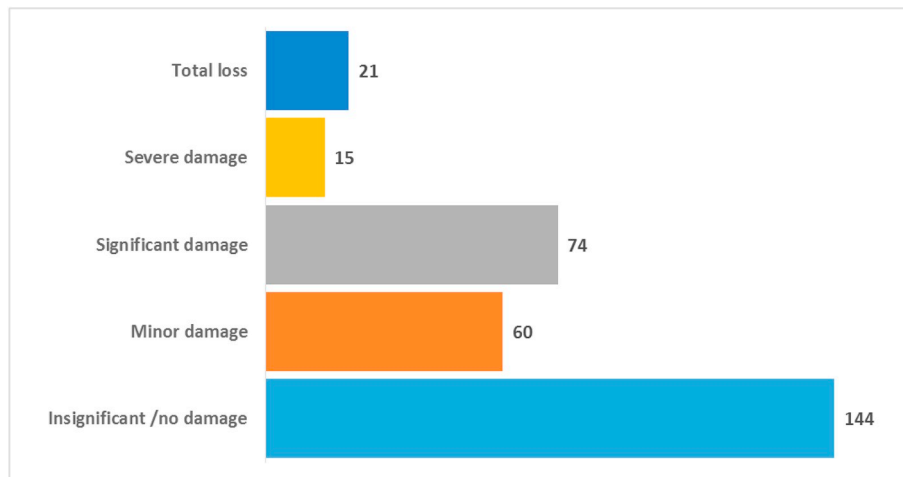
Fig. 1. Distribution of incidents into categories that define the damage extent.

First, the incidents were categorized depending on their severity. Fig. 1 summarizes the number of incidents collected in the dataset by the extent of damage suffered by the structure. The WOAD database has a five-class categorization for damage, which can be “Insignificant/no damage”, “Minor damage”, “Significant damage”, “Severe damage” and “Total loss”. Using the same classification as described for Fig. 1, Fig. 2 shows different charts per geographic area, each summarizing the relative number of incidents by damage category in one region. The size of each chart is proportional to the number of incidents reported in the respective region. Note that, while Fig. 2 is meant to provide a visual and illustrative representation of the statistics, Table A1 can be consulted to complement the illustration with numerical data (see Annex A).

Intuitively, the number of incidents per category should decrease with an increase in the severity class. However, this is a pattern which was not observed in our results. The reason may be the different regulatory requirements and industry practices in the various regions of this study which can lead to different incident reporting procedures and criteria. For example, in the North Sea area, strict regulation together with a long-time tradition and solid stance of the operators with respect to the reporting of incidents covering the entire spectrum of severity, including near misses. In other jurisdictions governed by less restrictive regulatory frameworks, operators might not be obliged to report the ‘less relevant’ events (e.g. in the Caspian/Black Sea region there are no incidents categorized as insignificant or minor). Consequently, the ratio

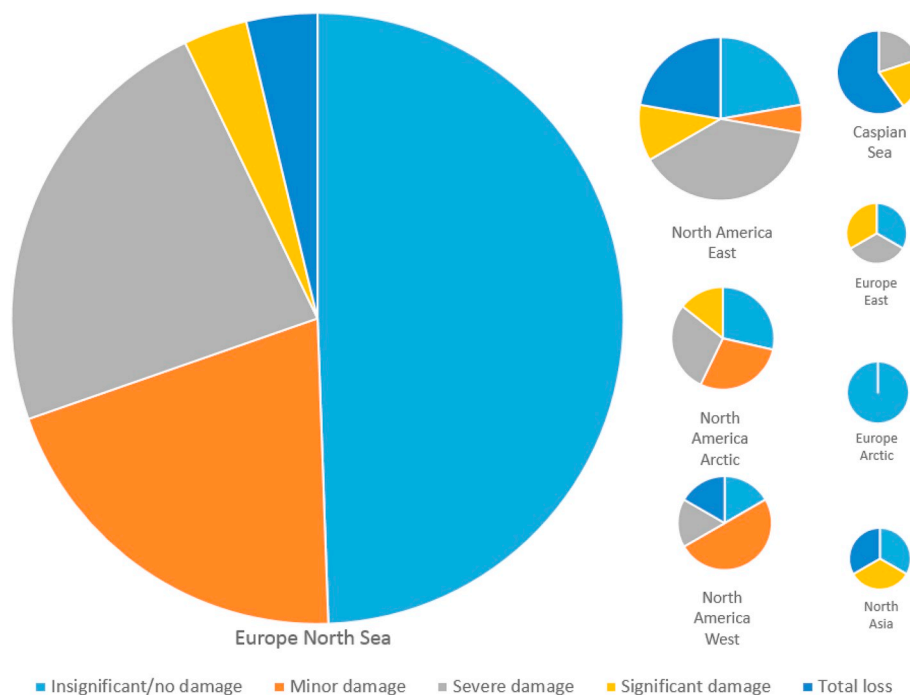
Fig. 2. Relative damage extent distribution per geographic location.

The majority of incidents was recorded in the North Sea region, summing up to 86% of the total number. However, prudence should be exercised when drawing any conclusions based on the interpretation of these results. The 86% share of incidents in the North Sea must not be seen as an indicator of an inadequate level of safety in the region; the reality is quite the opposite, with this region being recognized as a reference when it comes to the regulation, control, and safety of offshore operations. Hence, when reading these results one must consider:

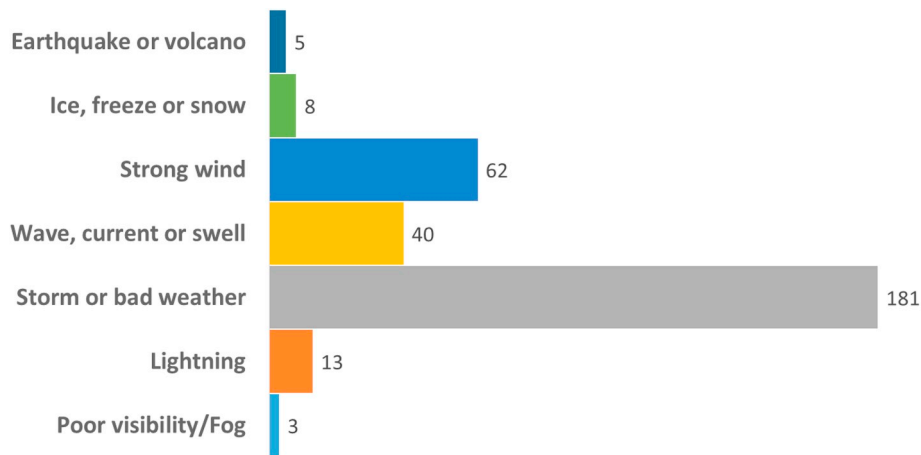
Fig. 3. Distribution of incidents by natural event trigger.

The main natural hazards affecting offshore operations are extreme meteorological conditions. Fig. 3 summarizes the number of incidents collected in the set by type of natural hazard trigger. Natural hazard classes were not provided by the WOAD database and hence were defined in the framework of this study as: “Poor visibility/Fog”, “Lightning”, “Storm or bad weather”, “Wave, current or swell”, “Strong

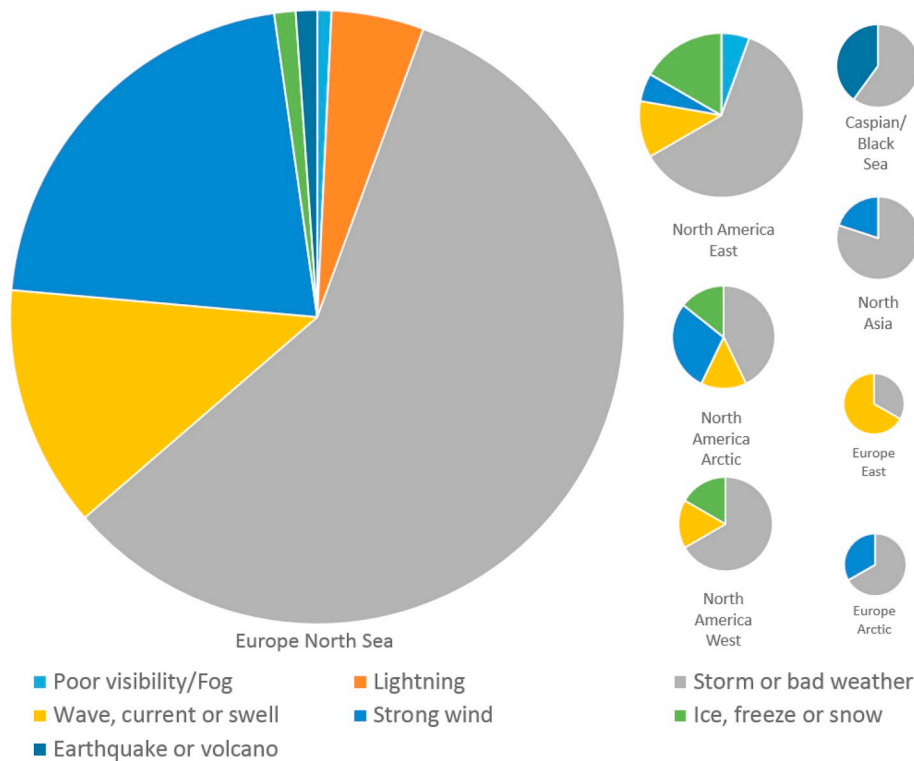
Fig. 4. Relative distribution of incidents per natural hazard trigger and geographic location.

Using the same classification as for Fig. 3, Fig. 4 shows the relative number of incidents by natural hazard trigger and region. The size of each chart is proportional to the number of incidents reported in the respective region. While Fig. 4 provides a visual and illustrative representation of the statistics, Table A2 complements the illustration with numerical data (see Annex A).

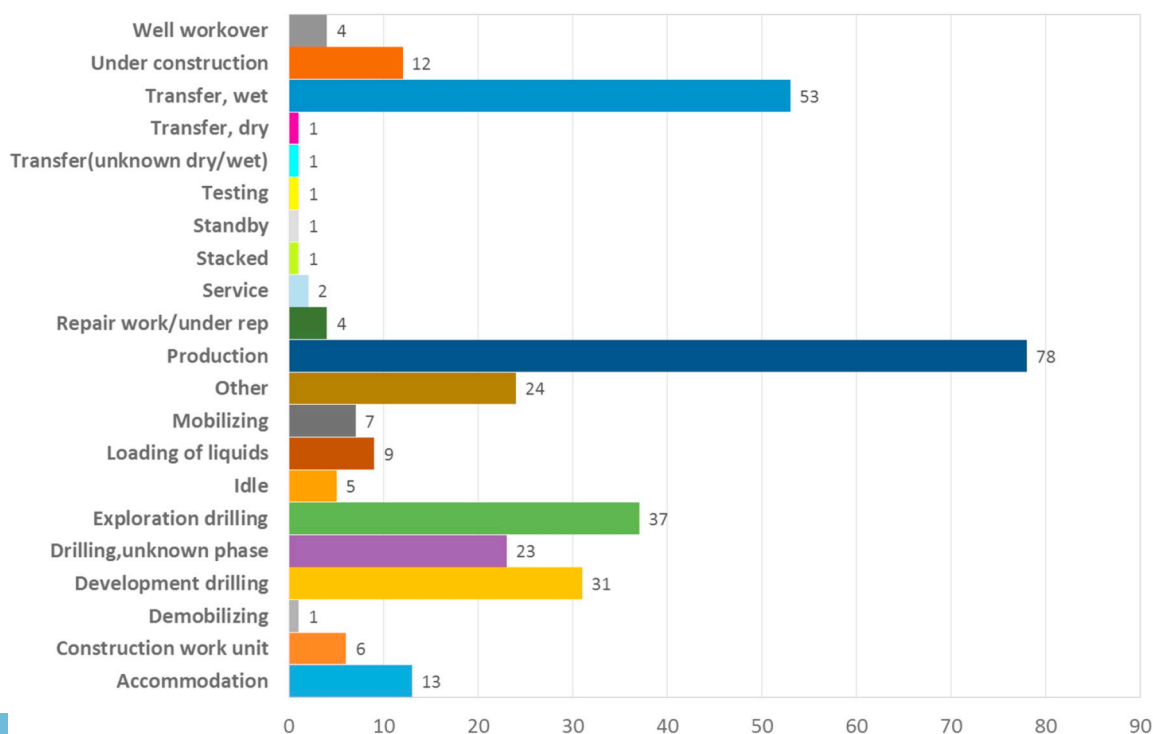
Fig. 5. Distribution of events into categories that define the type of operation performed at the time of the incident.

The number of incidents differs significantly depending on the type of structure and operations affected by a natural event. Fig. 5 reports the distribution of the events by the type of operations ongoing at the time of the incident. The WOAD database has its own classification for operations. Among those listed in the WOAD, the types of operation that appear in the selected dataset are “Accommodation”, “Construct, work unit”, “Demobilizing”, “Development Drilling”, “Drilling unknown phase”, “Exploration Drilling”, “Idle”, “Loading of liquids”, “Mobilizing”, “Other”, “Production”, “Repair work/under repair”, “Service”, “Stacked”, “Standby”, “Testing”, “Transfer (unknown dry/wet)”, “Transfer, dry”, “Transfer, wet”, “Under construction” and “Well workover”.

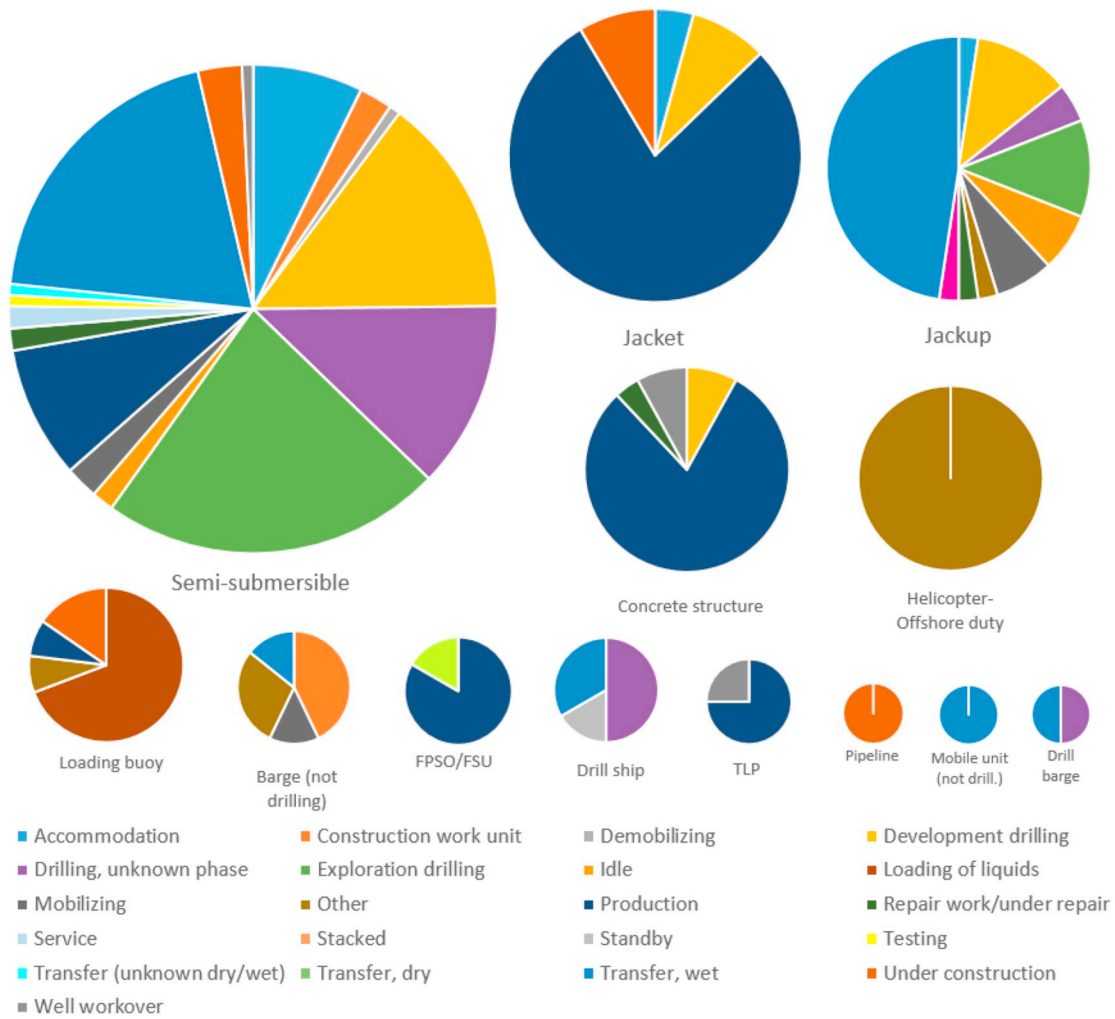
Fig. 6. Relative distribution of events by operation and structure type.

Overall, the most frequently damaged offshore structures were semi-submersible platforms, followed by jackets, jackups and concrete base structures (Fig. 6). A high number of incidents involved helicopters and loading buoys, while other structures were affected to a lesser degree by natural hazards.

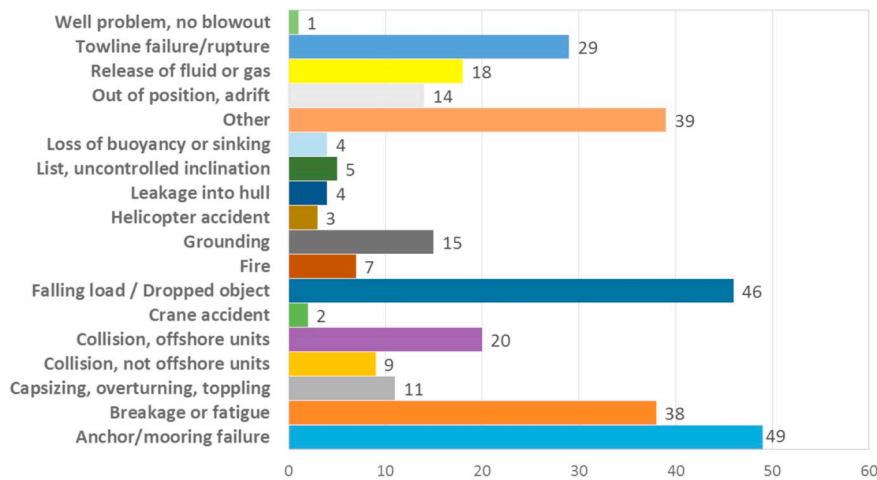
Fig. 7. Distribution of incidents into categories that define the type of impact.

This section analyses the dynamics of incidents to understand the incident causes and attempts to relate the type of events to the structure types. Fig. 7 depicts the distribution of the incident categories, each representing one specific scenario. The WOAD database has its own classification for impact categories and it classifies them under the field “Main event”. Among all the categories listed in WOAD under the section “Main event”, the ones that actually appear in the dataset are: “Anchor/mooring failure”, “Breakage or fatigue”, “Capsizing, overturning, toppling”, “Collision, not offshore units”, “Collision, offshore units”, “Crane accident”, “Falling load/Dropped object”, “Fire”, “Grounding”, “Helicopter accident”, “Leakage into hull”, “List, uncontrolled inclination”, “Loss of buoyancy or sinking”, “Other”, “Out of

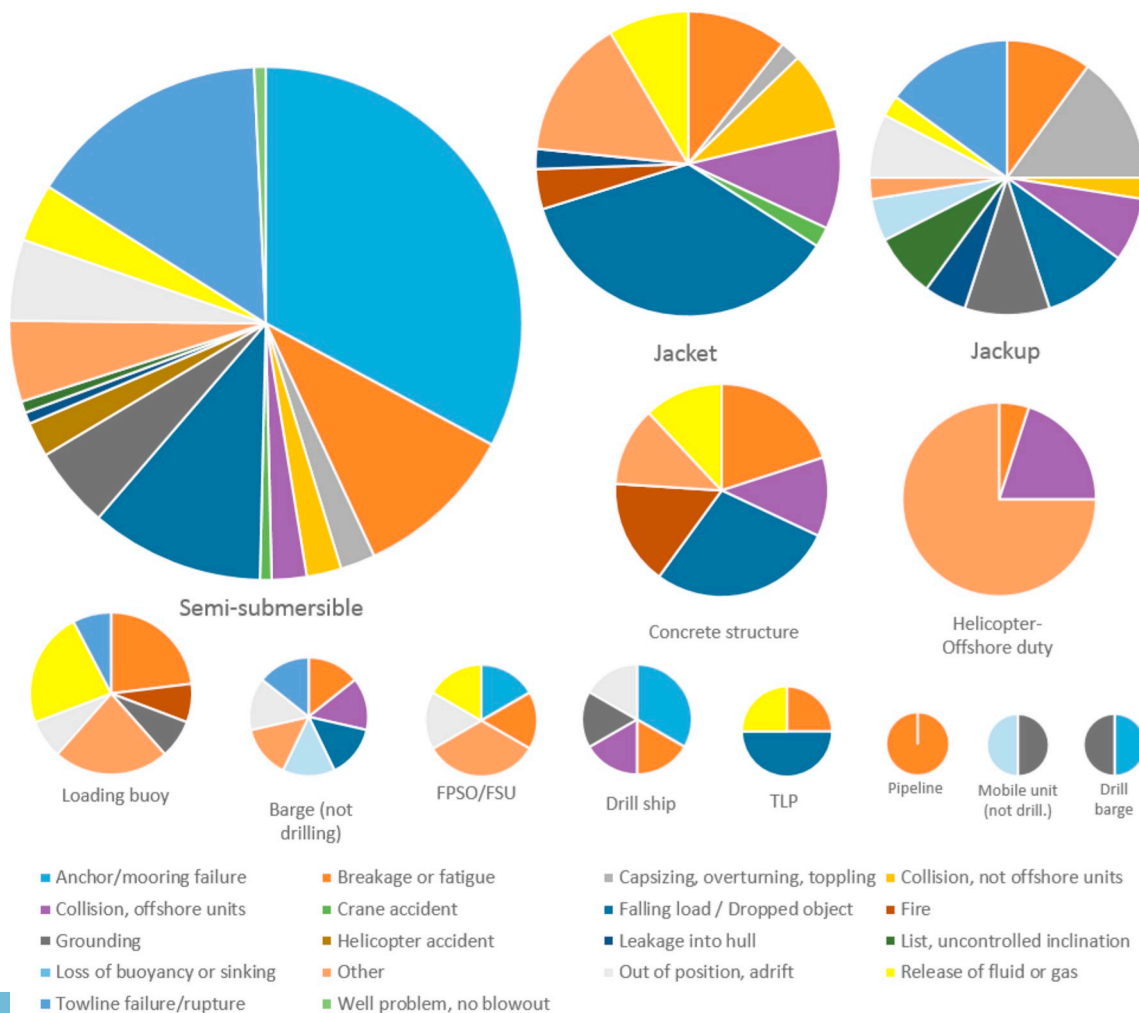
Fig. 8. Relative distribution of impact categories per structure type.

statistics, while Table A4 in the Annex shows the numerical data that complements Fig. 8. “Anchor/mooring failure” describes incidents that follow the loss of control of the operation due to the snapping of one or more mooring lines. It is in absolute the most frequent impact scenario with 49 records (Fig. 7), affecting “Semi-submersible” rigs in particular, but also “drill ships”, “FPSO/FSUs” and “Drill barges” (Fig. 8). This

in this category, multiple failures were recorded. These include a few cascading events in which the components that were ripped off also collided with other parts, damaging them. In 11 cases, the waves exceeded the design “air gap” (the distance between the underside of the lowest deck and the highest wave crest) hitting the deck’s bottom, ripping away connection bridges or washing on the deck. This event category concerns all kind of structures, but fixed structures (jacket and concrete base), semisubmersible platforms, loading buoys and jackups have the highest relative incident share for this event category when compared to other structures (Fig. 8).

Rigs, platforms, and FPSOs may capsize during heavy weather due to design issues or operations. Failure of primary structural components such as main braces, jacket legs, deck legs, and piles often lead to listing or capsizing of units (Kaiser, 2007). Incidents of this kind are collected in the categories “Capsizing, overturning, toppling” and “List, uncontrolled inclination”, which have the highest number of records (7 out of 11 and 4 out of 5, respectively) for “Jackup” structures. The number of events recorded under the label “Towline failure” is also significant. Most towline failures occurred during towing operations conducted in stormy weather. This type of failure exhibits a particular propensity to cascade into more serious events. In other more severe events (e.g. “Grounding” and “Loss of buoyancy or sinking”), the towline failure was the initial event that, in conjunction with other circumstantial factors and failures, evolved to the final aggravated outcome. “Jackup” rigs feature a worryingly high number of “Towline failures” and, in absolute numbers, the most numerous incidents during transport operations. “Semi-submersible”, “Drill barges” and other MODUs follow in this list. It is
