Localized Damage Detection in Structures: A Statistics Based Algorithm Using a Densely Clustered Sensor Network

A Thesis
Presented to the Graduate and Research Committee
of Lehigh University
in Candidacy for the Degree of
Master of Science

in
Structural Engineering

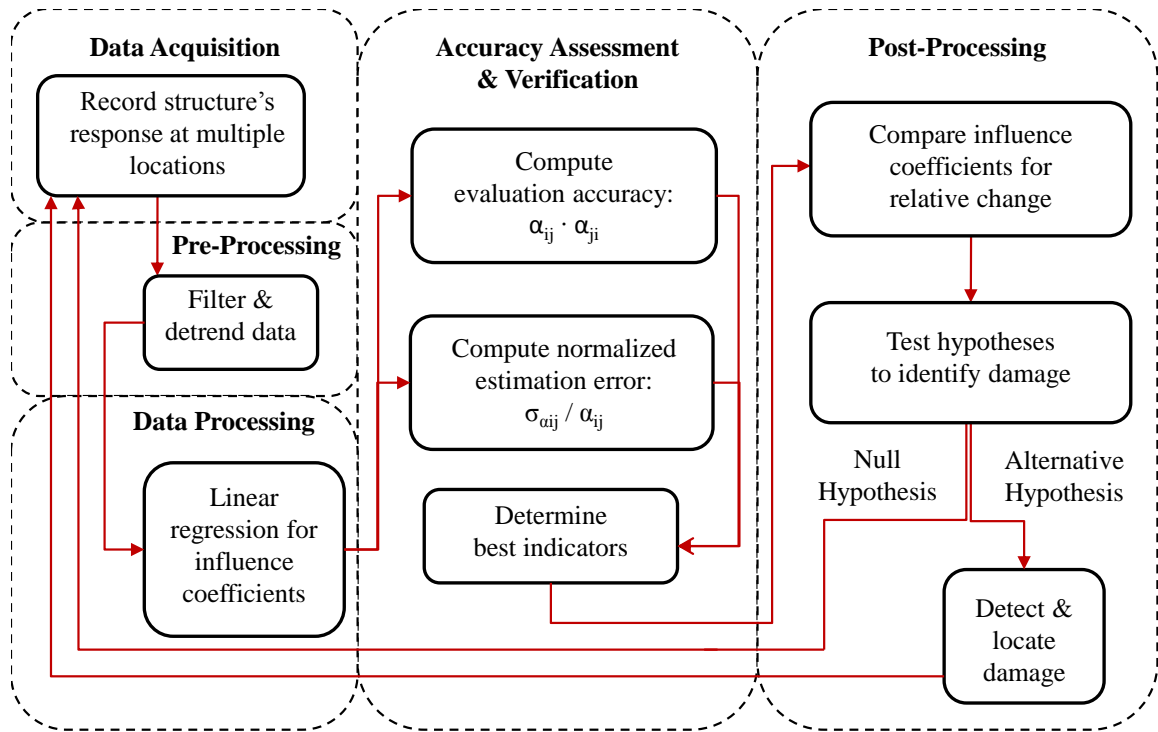
Figure 2.3: Methodology for damage detection

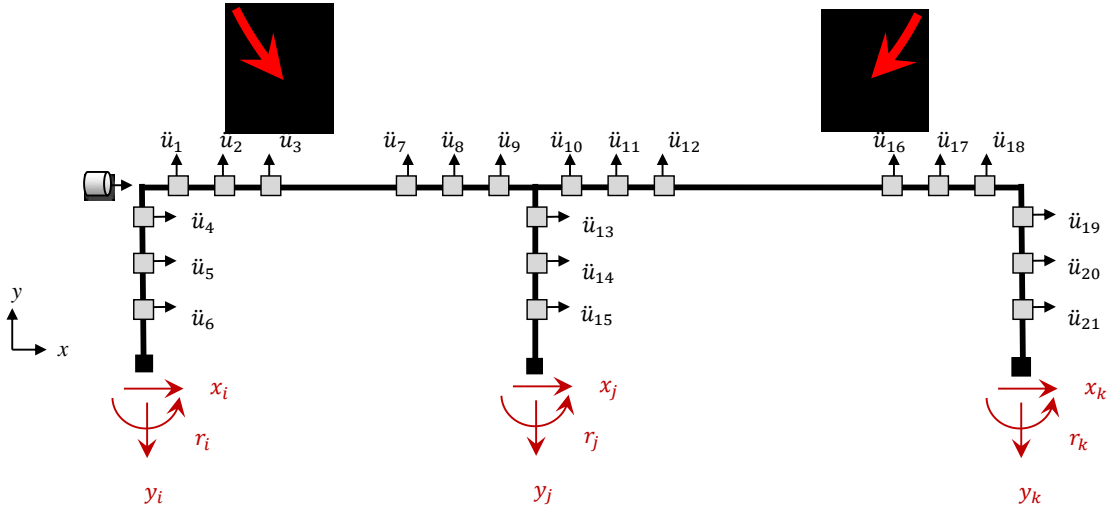
Figure 4.1. Two-bay frame can represent either a two-span bridge girder or a two-bay building frame

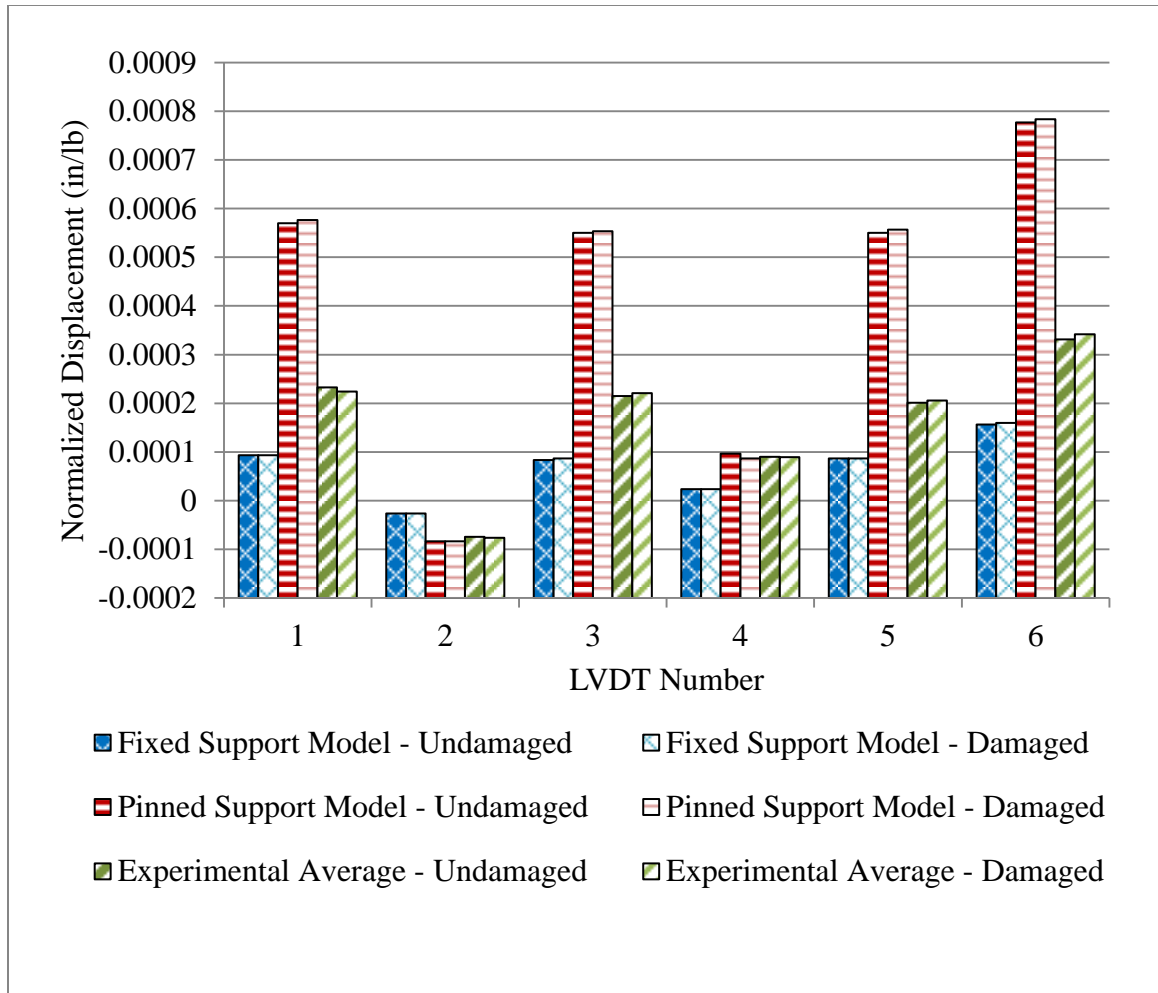
Figure 4.25. Comparison of experimental displacements to simulated displacements for undamaged and damaged cases

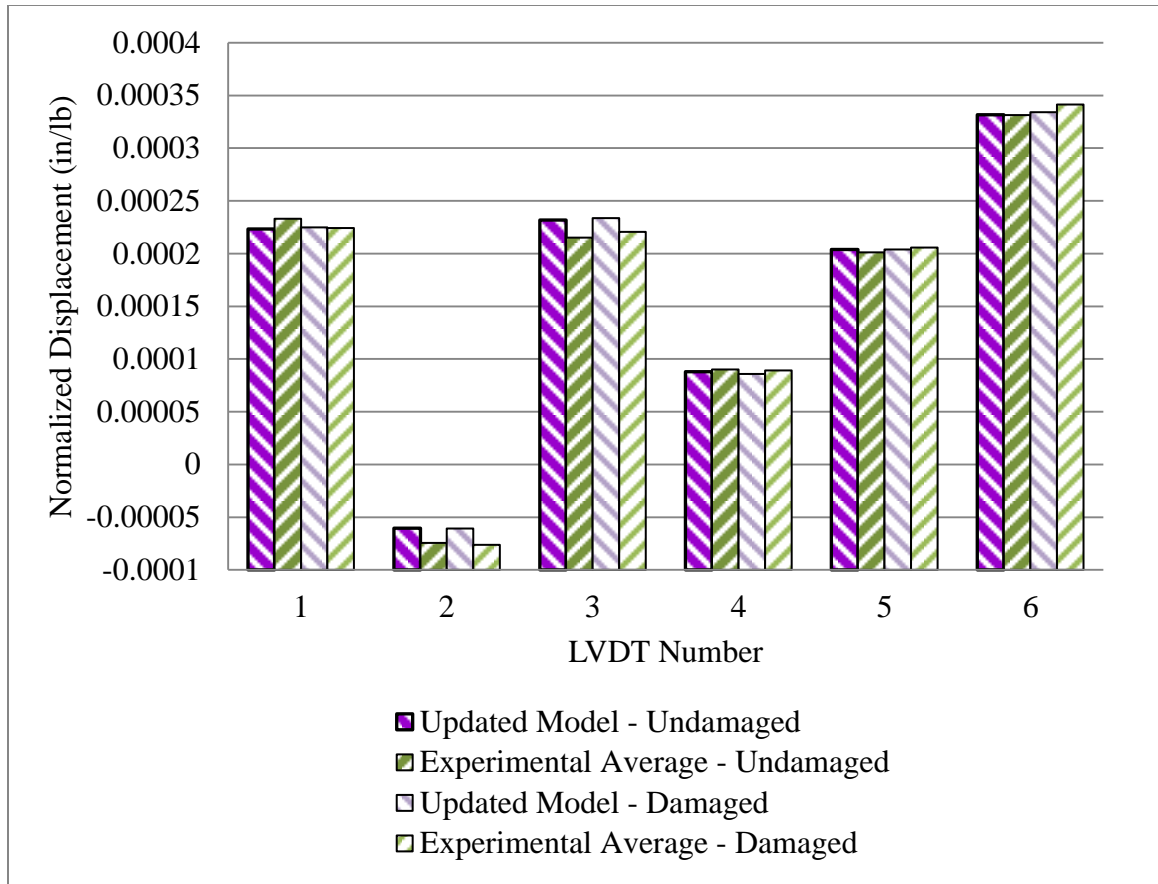
Figure 4.27. Comparison of updated simulated results to experimental displacements for the undamaged and damaged cases

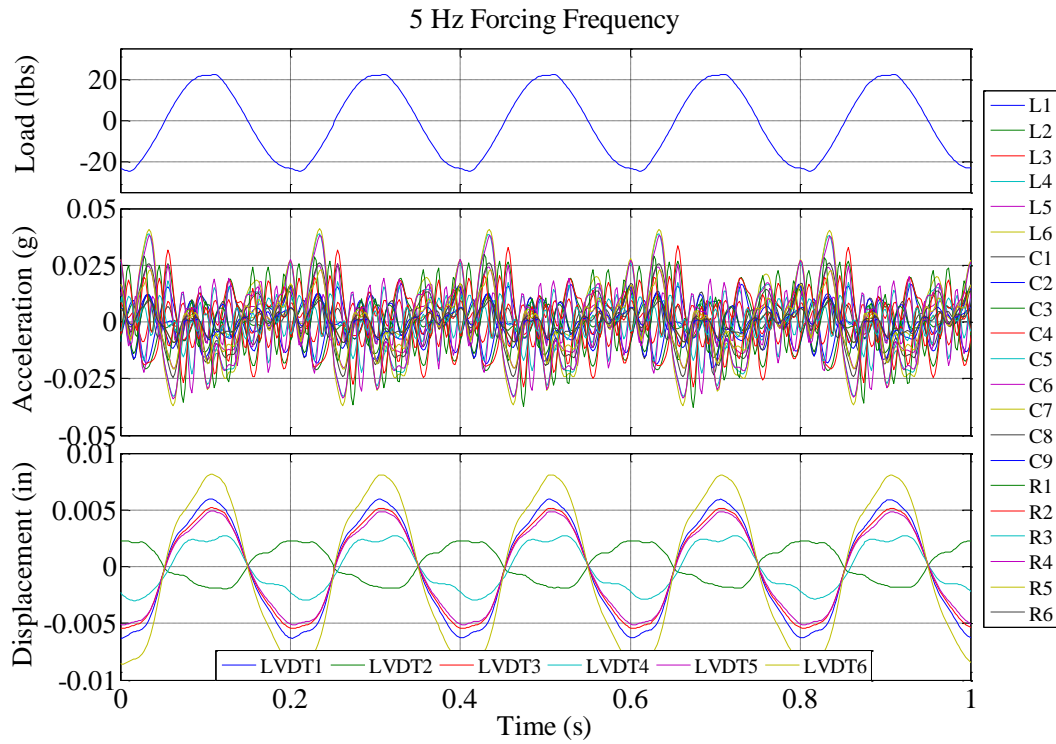
Figure 4.28. Time histories for load, accelerations, and displacements at 5 Hz sine

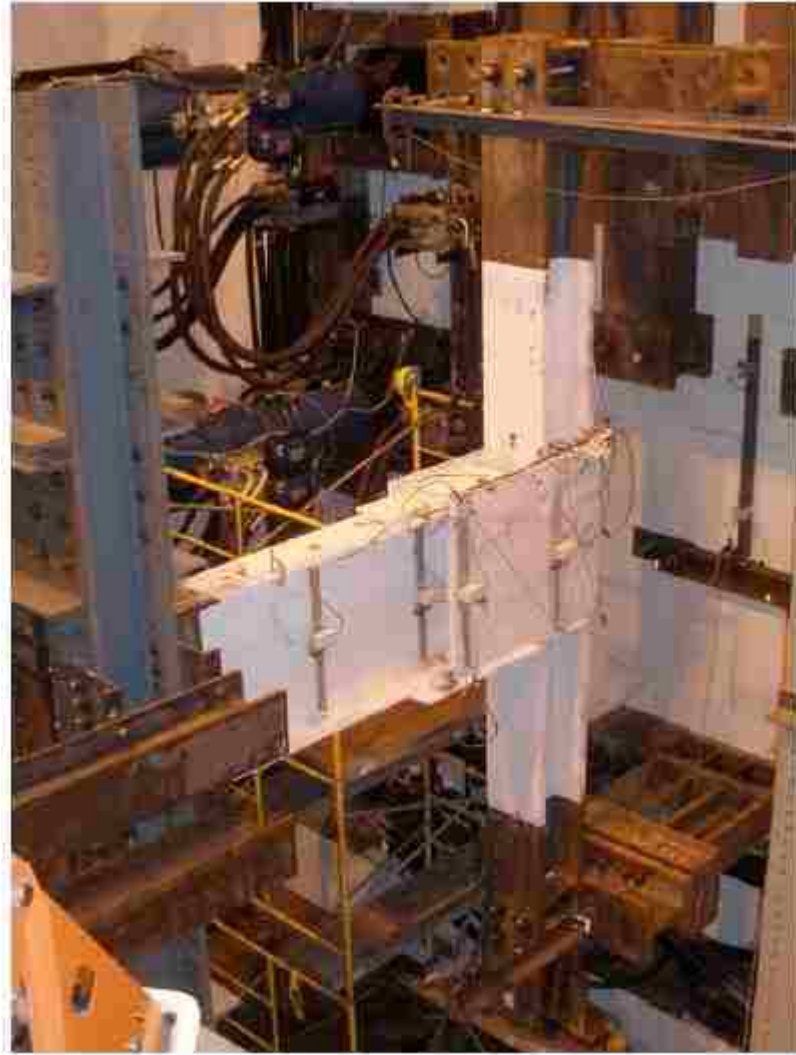
Figure 5.1. Typical experimental test setup at Lehigh’s ATLSS Center

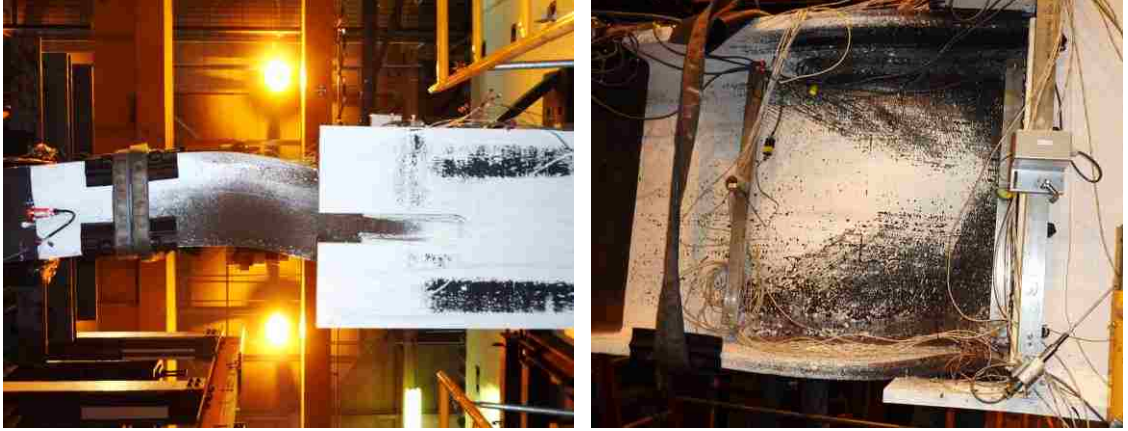
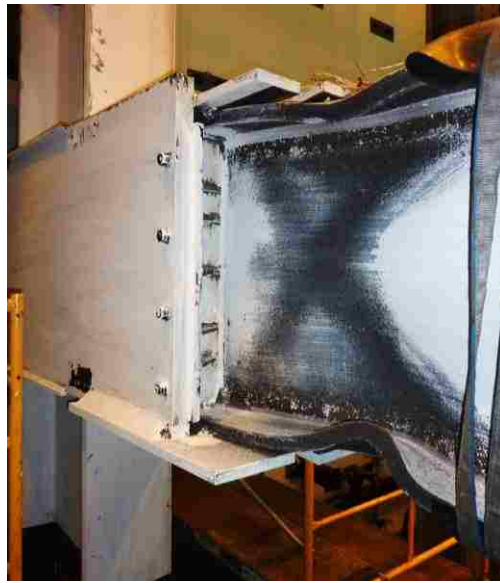
Figure 5.7. Photos from Test A Damage Class 7

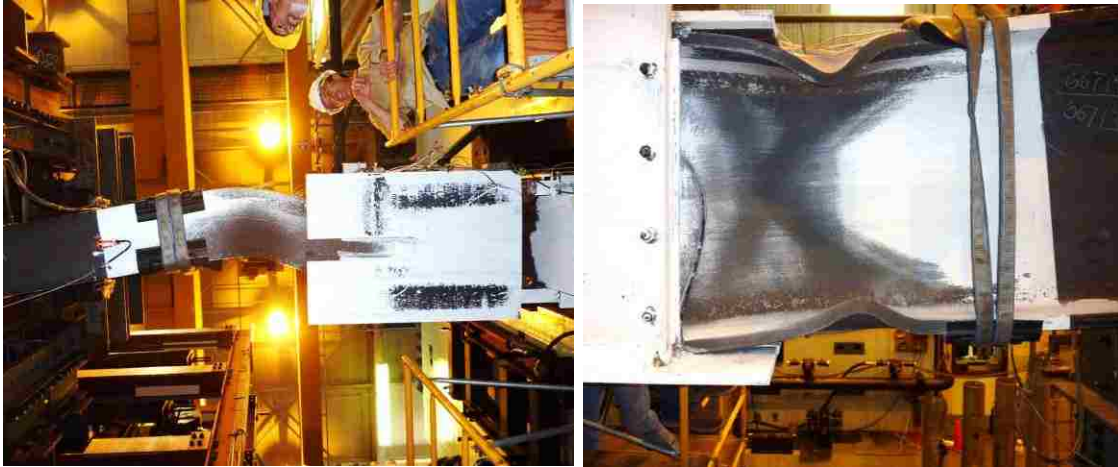
Figure 5.8. Photos from Test A Damage Class 8

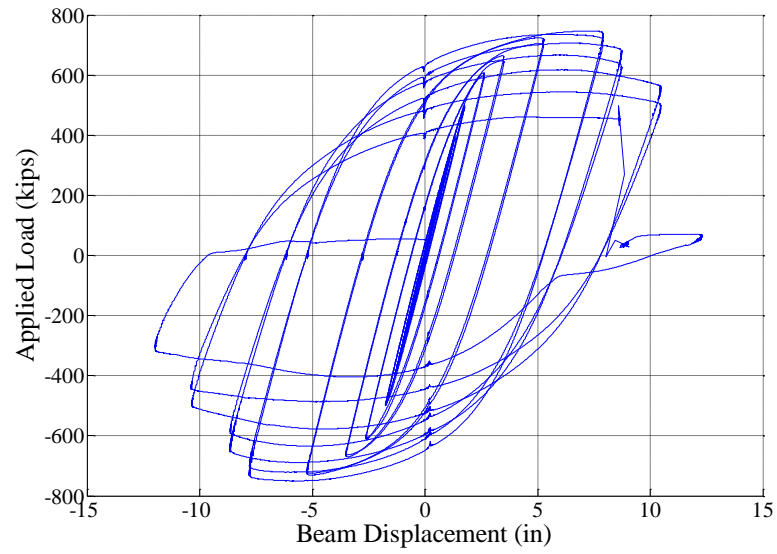
Figure 5.10. Force-displacement curve for Test A

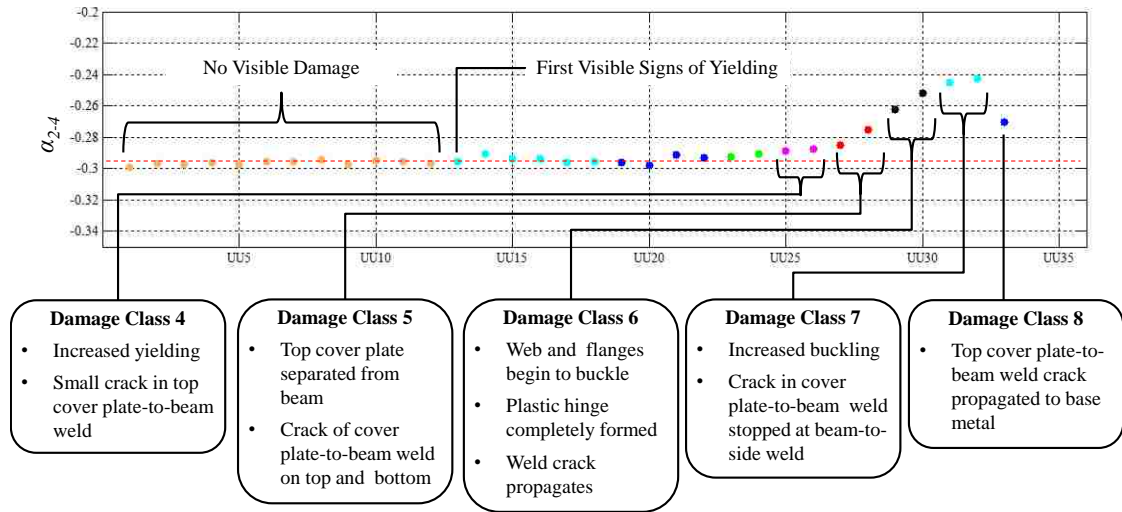
Figure 5.21. α_{2-4} for Test A UU sections shown with progressive damage classes

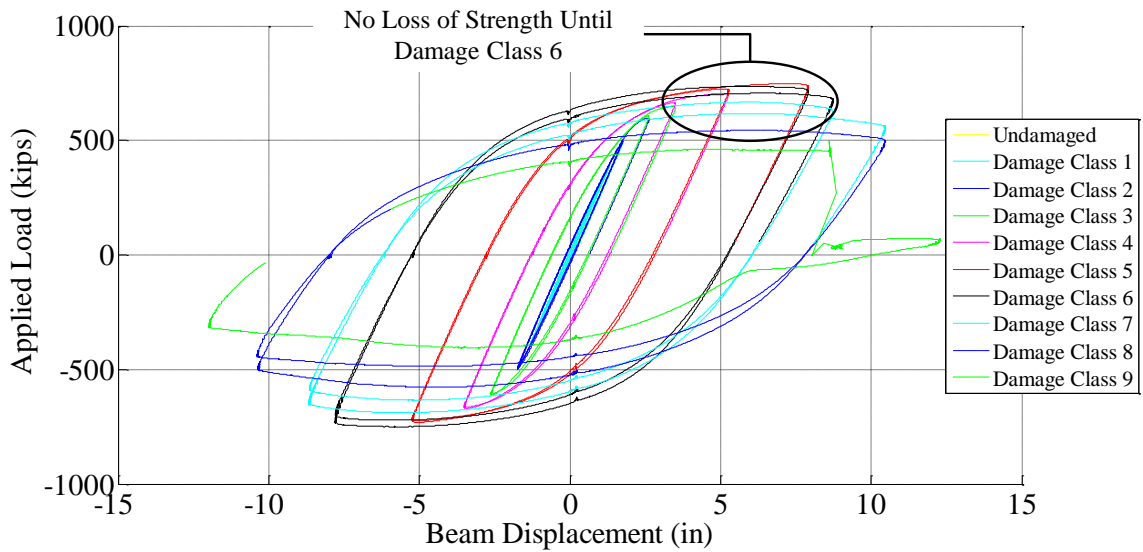
Figure 5.22. Test A load-displacement plotted by damage class showing where loss of strength occurs
