# Optimizing Portland cement concrete mix design to environmental and construction variables with the aid of computer design software

**Optimizing Portland cement concrete mix design to environmental and construction variables with the aid of computer design software**

A thesis submitted to the graduate faculty  
in partial fulfillment of the requirements for the degree of  
**MASTER OF SCIENCE**

Major: Civil Engineering (Geotechnical Engineering)

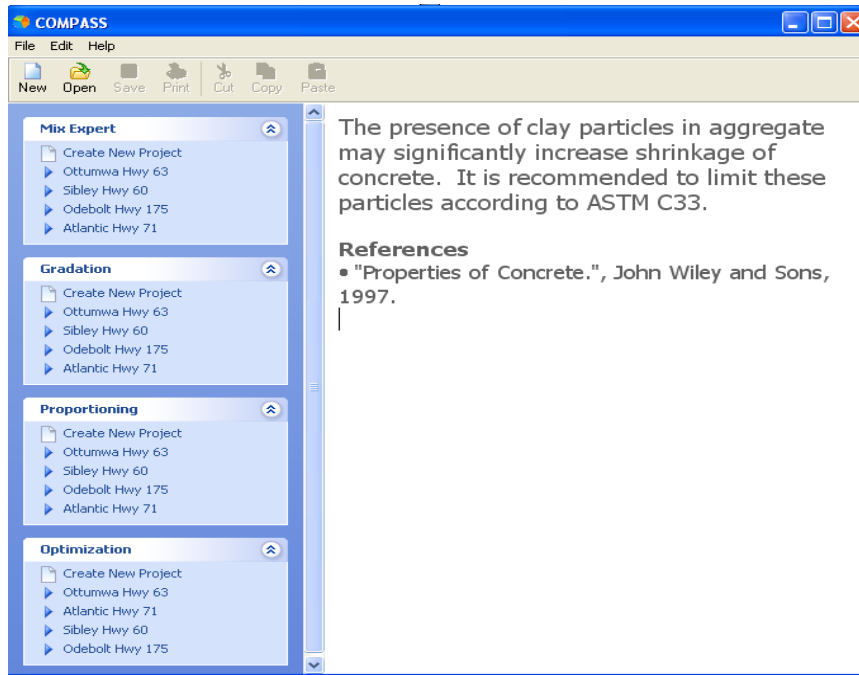
Figure 2.1 COMPASS Modules

The program begins by offering the user a random concrete fact that changes each time the program is opened (Figure 2.1). Upon starting the program, the user can then choose which module of COMPASS to begin their analysis. It is recommended that the user begin with the mix expert module. This module provides the user with a list of concrete characteristics, shown across the top bar in Figure 2.2. The user can select which characteristics are the most beneficial for their particular paving project. COMPASS considers these selections and gives recommendations for the mix proportions. The user can then elect to accept or decline the information provided (Figure 2.3).

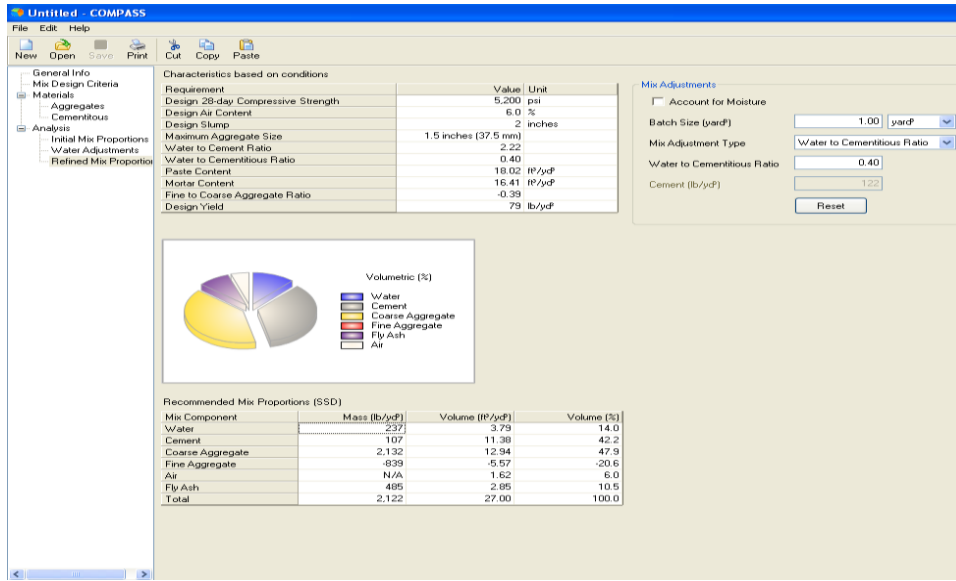
Figure 2.4 Initial Mix Proportioning

COMPASS also creates virtual batches of concrete, which the user can utilize to develop mix proportions. The user can accept these initial mix proportions or refine them by using the commands shown on the right of Figure 2.4. When the mix proportions are adjusted, COMPASS creates multiple concrete batches that appear in a randomly ordered list (Figure 2.5). The adjusted batches meet the criteria set forth by the initial mix proportions. However, they vary slightly in the quantity of individual ingredients in order to optimize the mix proportions. These virtual batches can be created and tested in the laboratory or the user can simply choose a mix from the list.

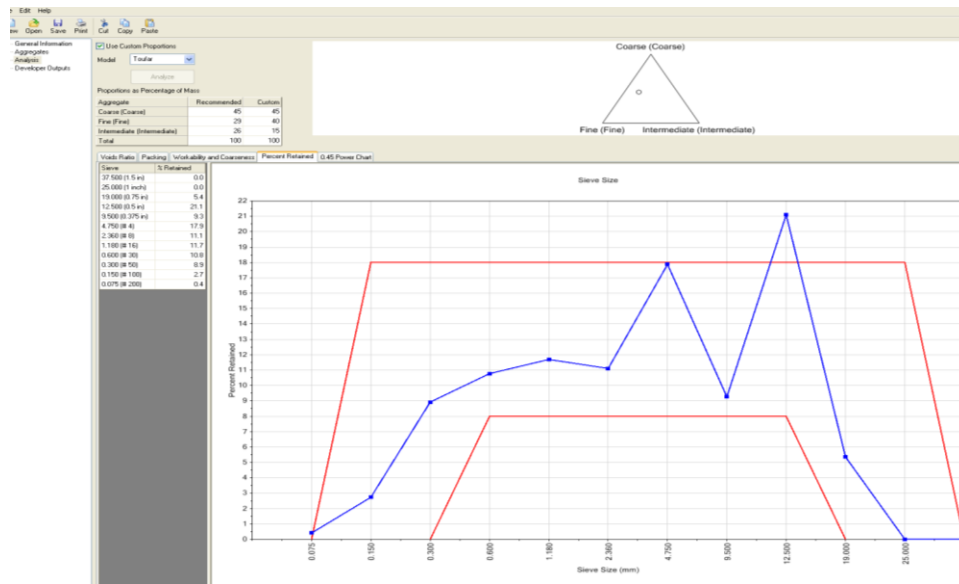
Figure 2.6 COMPASS Aggregate Gradation Chart

COMPASS verifies the aggregates and their gradations. It utilizes the unit weights of the aggregates and the sieve analysis to create a gradation chart and optimum amounts of each aggregate (Figure 2.6). Along with typical gradation charts, COMPASS produces a 0.45 power chart (Figure 2.7). Traditionally, the 0.45 power curve has been used to create uniform gradations for asphalt mix designs. It is increasingly being used to develop uniform gradations for PCC mix designs. The 0.45 power curve is based on the mathematically combined percent passing gradation determined in accordance with IM 531. (18)

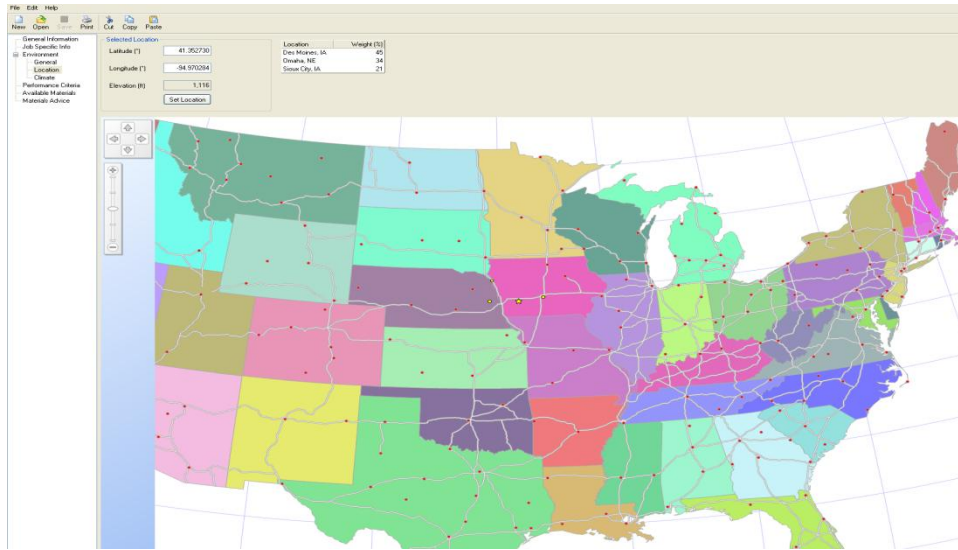
**Figure 2.8 COMPASS Weather Module**

There is also a module of COMPASS that allows the user to assess the weather patterns in the region of paving (Figure 2.8). The weather module is linked to the National Oceanic and Atmospheric Administration (NOAA) weather database around the country. When a project location is selected in COMPASS, the weather database is activated for weather stations near that region. Using an algorithm, the most applicable weather stations are selected and the weather information is obtained from those weather stations. The weather information for the specified location is calculated from a weighted average that is interpolated from the selected weather stations. The weather database contains average hourly readings for the entire year, based on 30 years of historical data. The user can select the dates of paving in COMPASS and be given averages of the weather patterns a region will experience during the particular time of paving. This information is beneficial in determining when the optimal time to place concrete will occur. <sup>(1)</sup>

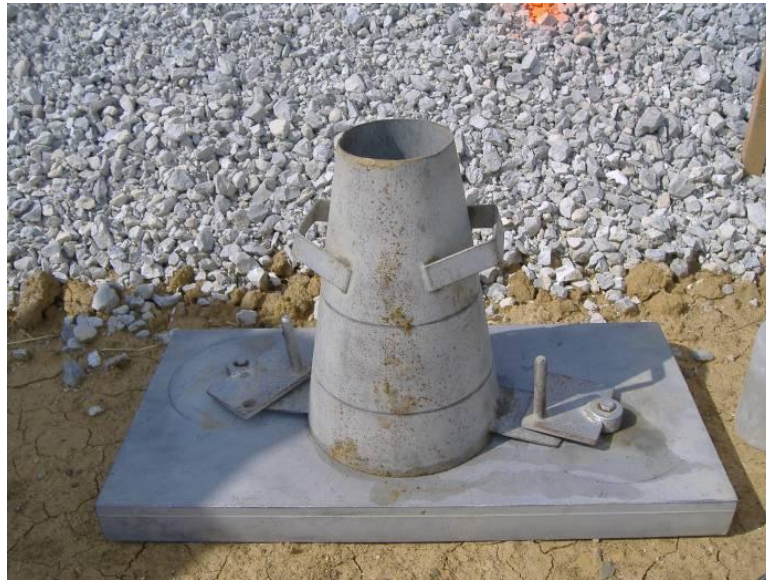
**Figure 4.1 Slump Cone**

Field tests were conducted to assess workability, bleeding and permeability characteristics. The workability and bleeding characteristics were tested at the time of paving. The permeability was tested after the slab had hardened and cured, typically seven days after paving. The workability was assessed by slump cone (Figure 4.1) and air pot (Figure 4.2) tests. These tests were done according to ASTM C 143 and ASTM C 231, respectively.

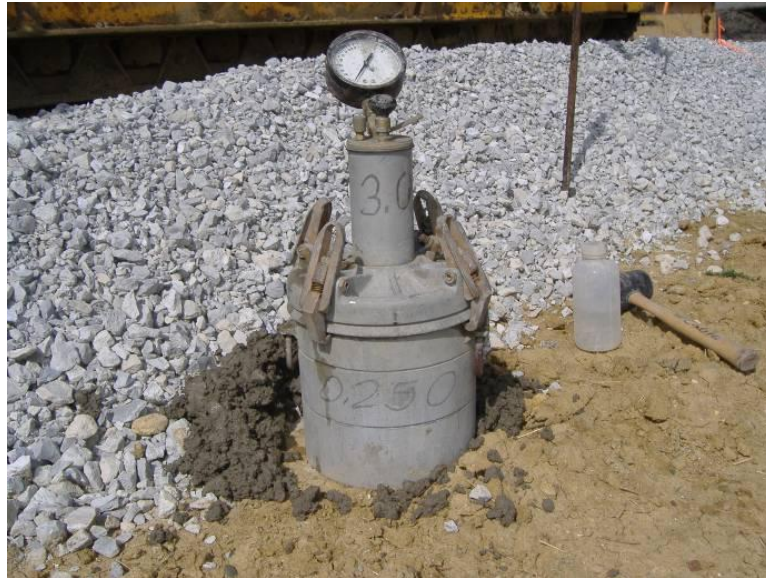
**Figure 4.2 Air Pot**

The air tests were used to determine the target air content in front of the paver in the fresh concrete. Most concrete samples were taken before the concrete passed under the placer. Typically, these air contents were around eight percent. Iowa DOT specifications state that six percent air content is needed in the hardened concrete. The fresh concrete air content was higher than IDOT

specifications because a loss of air occurs as the concrete passes under the paver and through the vibrators.

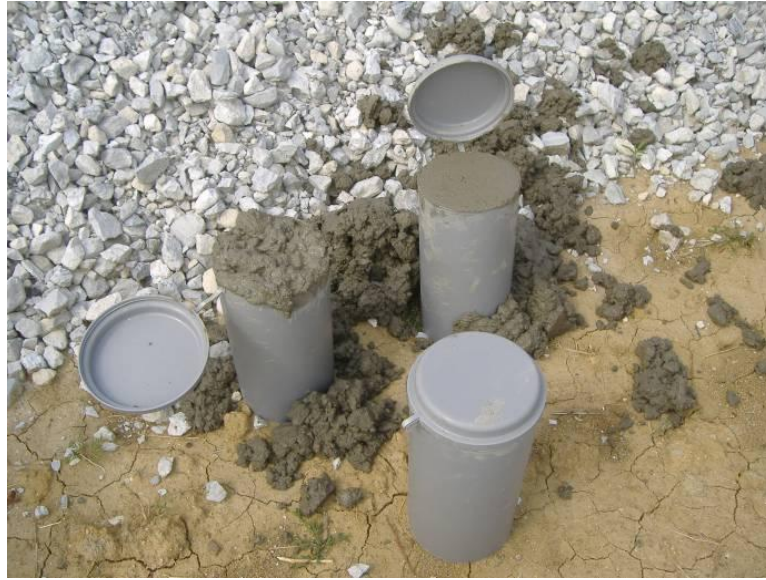
**Figure 4.3 Cylinder Molds**

Cylinder samples were cast according to ASTM C 31 for use in strength testing in the laboratory. The samples were cast at the time of paving to assure the same batch of concrete being tested for workability and permeability was also tested for strength. These samples were cast using 4 x 8 inch cylinder molds. Cylinders were cast in sets of three (Figure 4.3) and there were three sets made for each project, yielding a total of nine cylinders for each project.

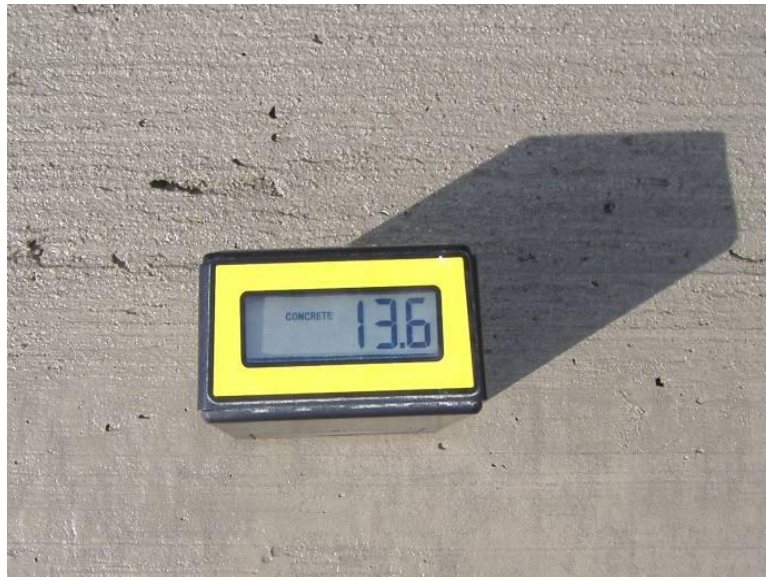
**Figure 4.4 James Instrument, Inc. M-60 Aquameter**

The surface moisture of the slab was tested at three different locations on the slab; at the paver, before, and after the texture machine using a James Instrument, Inc. M-60 Aquameter (Figure 4.4). This information was used to aid in determining a ranking for the amount of bleeding the slab experienced.

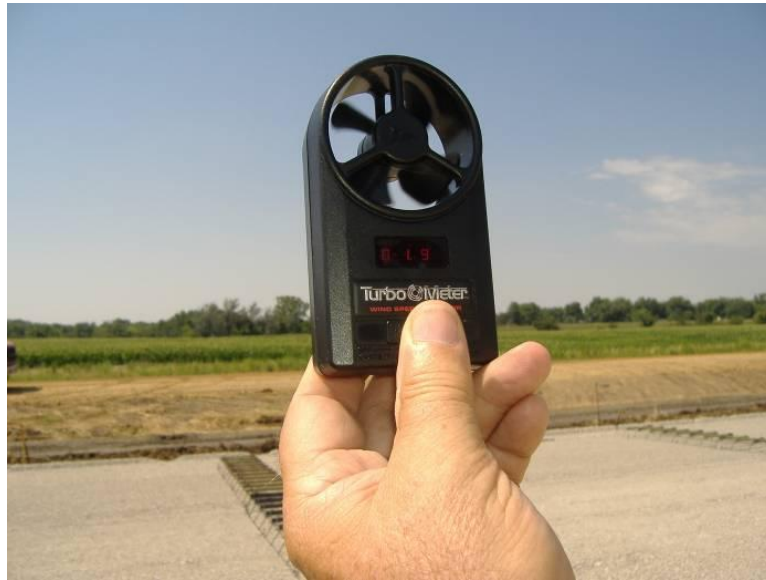
**Figure 4.5 Davis Instruments Turbometer**

Bleeding rates were also affected by daily weather. Nova Lynx 110-WS-18A Portable Weather Stations were set up at the beginning of paving each day to more accurately measure and record weather data. This data was compared to climate data in COMPASS. Along with these portable weather stations, handheld weather devices for measuring air temperature, relative humidity, wind speed and direction, and slab moisture were used to gather data alongside the paver (Figure 4.5 and Figure 4.6).

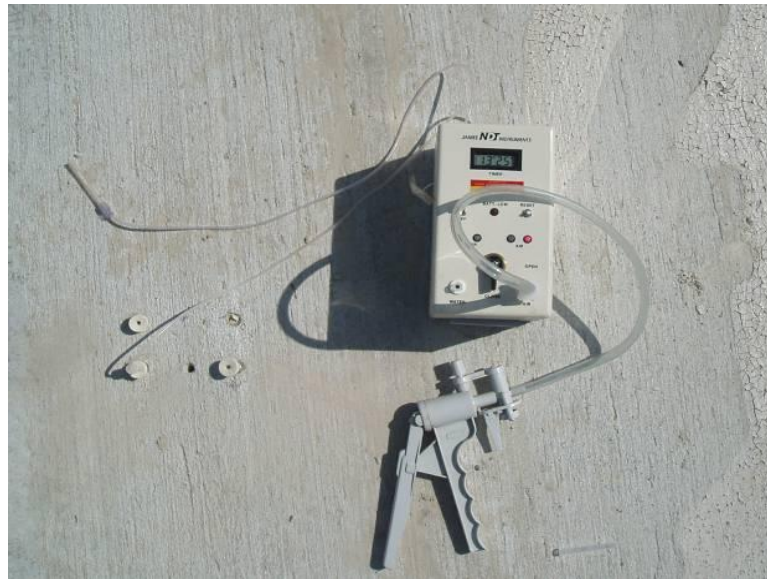
**Figure 4.7 James Instrument Permeability Meter**

Permeability tests were conducted with a Poroscope Plus permeability meter manufactured by James Instruments, Inc. (Figure 4.7). This machine required that a series of four holes, two inches deep, be drilled into the concrete (Figure 4.8). A rubber plug was inserted into the holes and the permeability machine was attached to the plugs (Figure 4.8). The test hole was pressurized with air to a pre-determined pressure. The machine measured the time it took for a pressure change of five pounds per square inch to occur. This amount of time was then compared to a chart of time ranges to determine if the permeability was in an acceptable range. The machine can also test for water permeability, however only air permeability tests were conducted. This was done at approximately the same locations where the cylinder samples were cast. This was to ensure that the same concrete batch was being tested throughout the process.

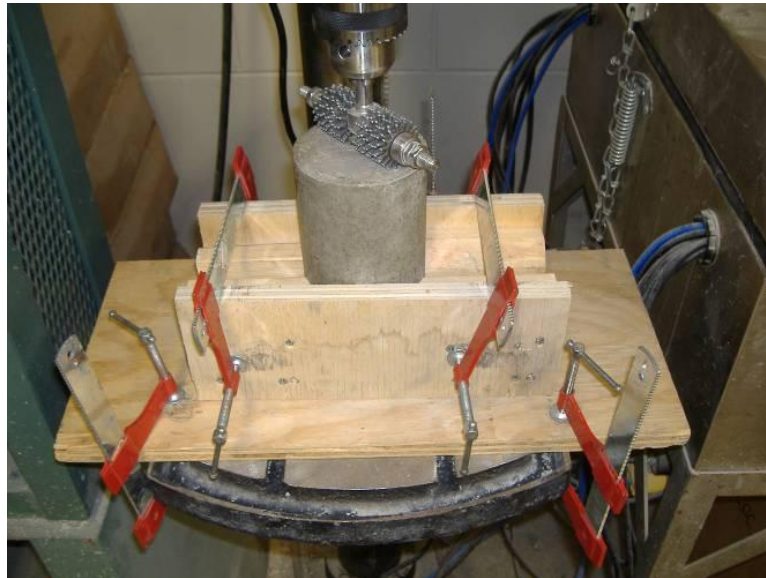
**Figure 4.9 Abrasion Testing Apparatus**

Along with these field tests, laboratory tests for abrasion, strength, and segregation characteristics were done. Abrasion tests were conducted according to ASTM C 944. To run this test, cylinders were mounted in a wooden jig on the drill press (Figure 4.9). The test was done on one end of the cylinder, then the cylinder was weighed to record the total mass lost (Figure 4.10). The cylinder was flipped over and the test was conducted on the remaining end of the cylinder, and then weighed again to record total mass lost.

If the cylinders were initially cured on an uneven surface, they were trimmed prior to testing to create a flush surface. Trimming the cylinders will cause more aggregate surface to become exposed, causing less abrasion to occur.

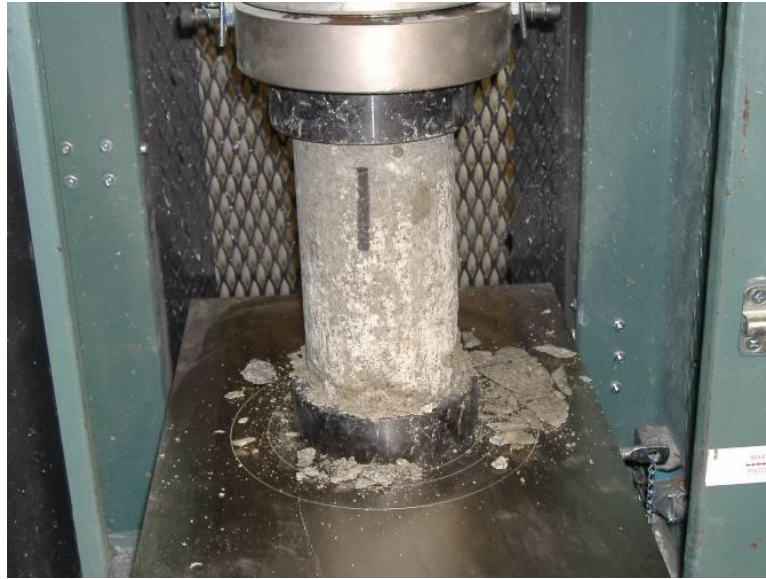
**Figure 4.11 Strength Testing**

The strength tests were conducted according to ASTM C 39. For each project, three sets of samples were cast during paving, creating nine cylinders for each project. Cylinders were wet cured for 7, 14, and 28 days. One cylinder from each of the three sets was selected randomly and tested for strength on the respective dates (Figure 4.11). This gave three different strength values for each date of testing. These values were then averaged to show the strength gain occurring over time for the project.

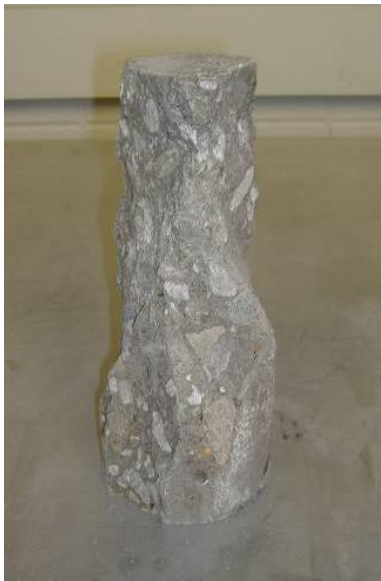
**Figure 4.12 Visual Segregation Inspection**

The evaluation of the segregation characteristic was another visual inspection of the concrete. The amount of segregation was ranked on a scale of one to five, one being very segregated and five being very uniform. Segregation inspections were done on the cylinder samples after the strength tests had been conducted (Figure 4.12).

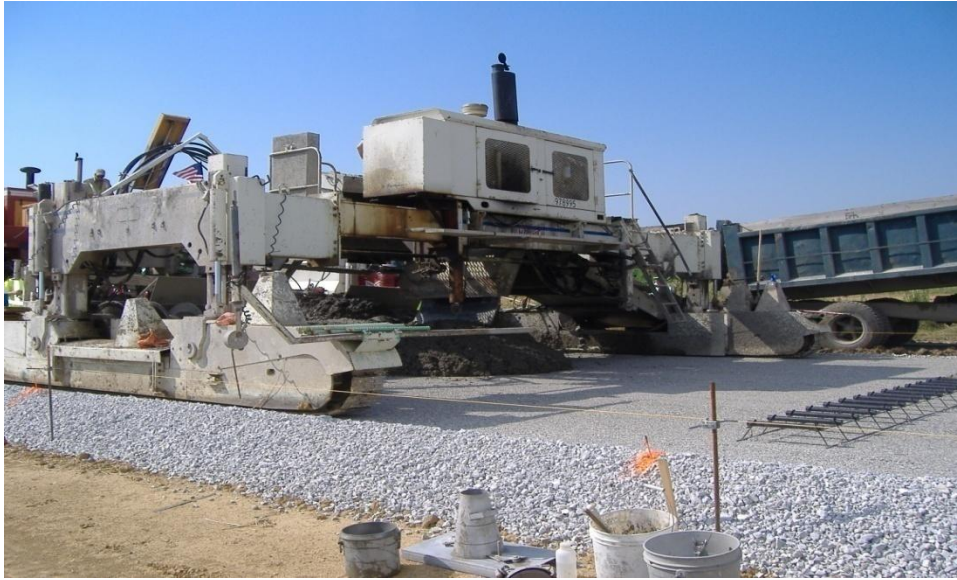
**Figure 4.13 New Pavement Construction**

In addition to evaluating these six characteristics, contractor techniques were also observed. Some of the projects observed were new constructions and some were overlays (Figures 4.13 and 4.14). There were also various pavement depths and widths that occurred throughout the projects.

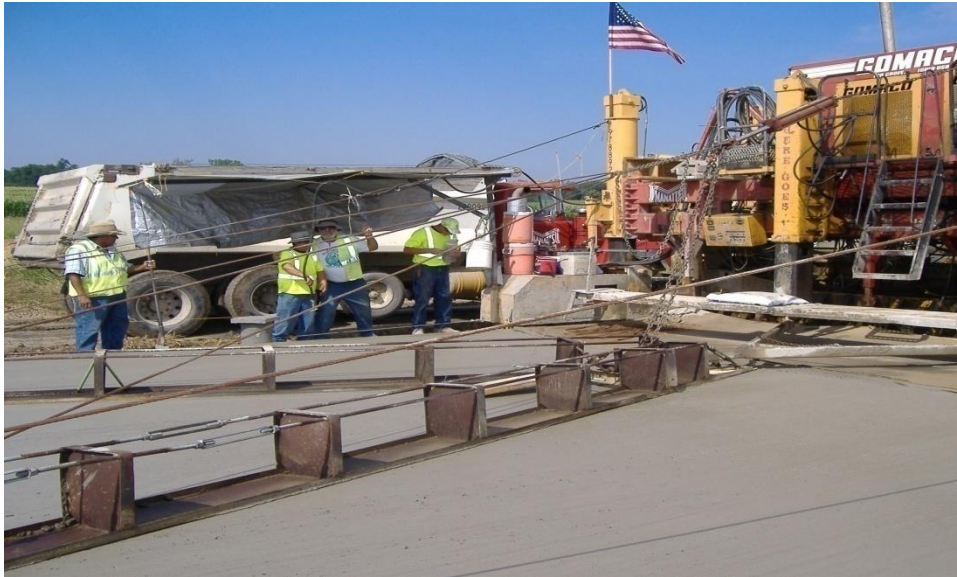
**Figure 4.15 V-Float**

There was also a difference in finishing techniques used on the slab. Most projects were finished with standard magnesium hand floats. One contractor utilizes a V-float to finish the slab (Figure 4.15). It is a float designed by the contractor to help them achieve a smooth pavement surface. This enables them to use less man-power and they believe it produces a better finish on the slab.

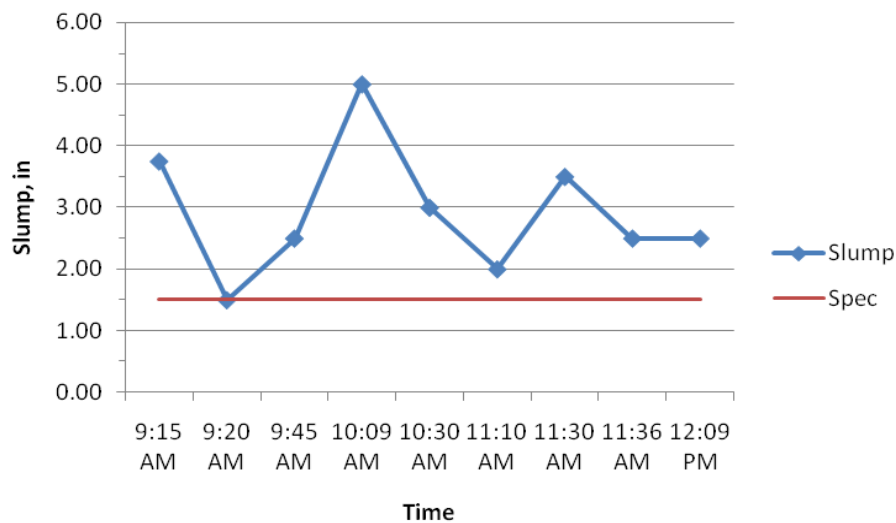
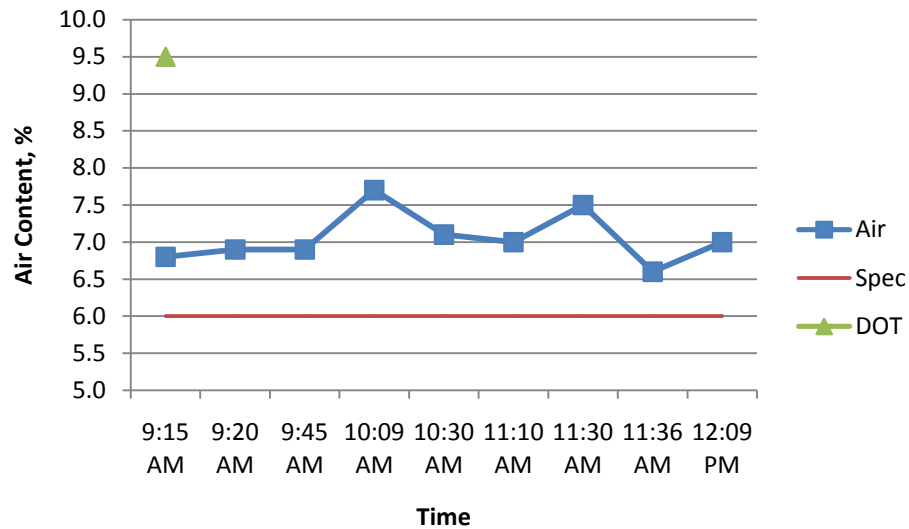
The following figures show the workability test results for Cass County. The DOT specification for slump on this project was one and one half inches and specification for air content in hardened concrete is six percent. Contractors have found that by batching the concrete with an air content around ten percent will allow them to achieve the specification at six percent in the hardened concrete. The concrete will lose roughly four percent of the air content as it passes through the paver. Figure 5.1 and Figure 5.2 show a graphical representation of the data. The highest slump value recorded for the project was five inches. The highest value of air content recorded was 7.5 %.

Figure 5.1 Cass County Slump Test Results

**Figure 5.2 Cass County Air Test Results**

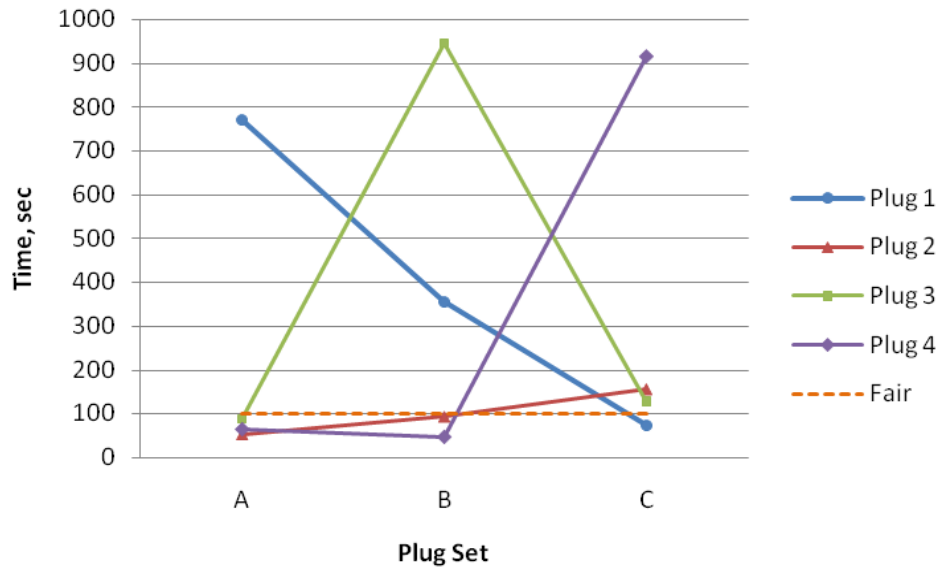
**Figure 5.3 Cass County Permeability Test Results**

The permeability tests results are shown in Figure 5.3. The dashed line on the graph represents the range where the 'fair' permeability range begins. There is a lot of scatter in the data, not only within each test site, but throughout the entire project. The permeability times were averaged over the project to produce an overall permeability time of 320 seconds.

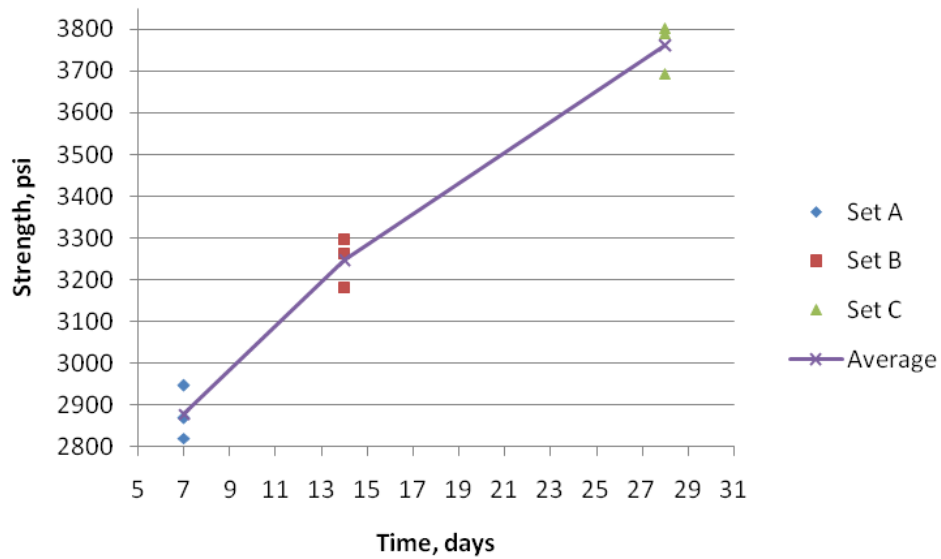
**Figure 5.4 Cass County Strength Test Results**

Figure 5.4 shows the strength test results for Cass County. There was a 12.8% strength increase between 7 and 14 day breaks and a 30.7% strength increase between 7 and 28 days. The final 28 day strength was 3760 psi.

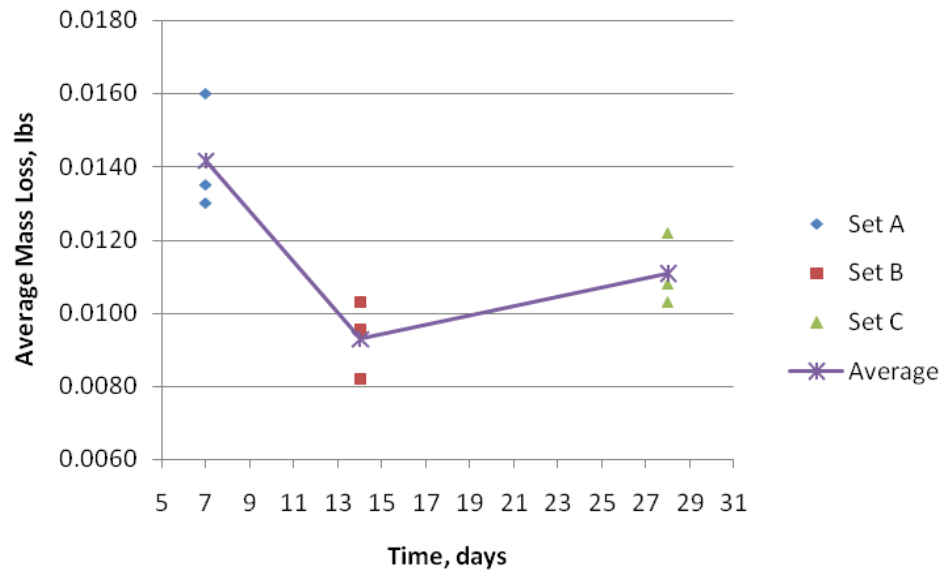
**Figure 5.5 Cass County Abrasion Test Results**

The abrasion tests were conducted at the time of the strength tests, 7, 14, and 28 days. Figure 5.5 shows the mass loss during the abrasion testing for Cass County. It can be seen that the longer the concrete cured, the less mass it lost. The amount of mass lost is reflective of the strength gain in the concrete. The total mass lost from the 7 to 28 day tests was 0.0031 lbs.

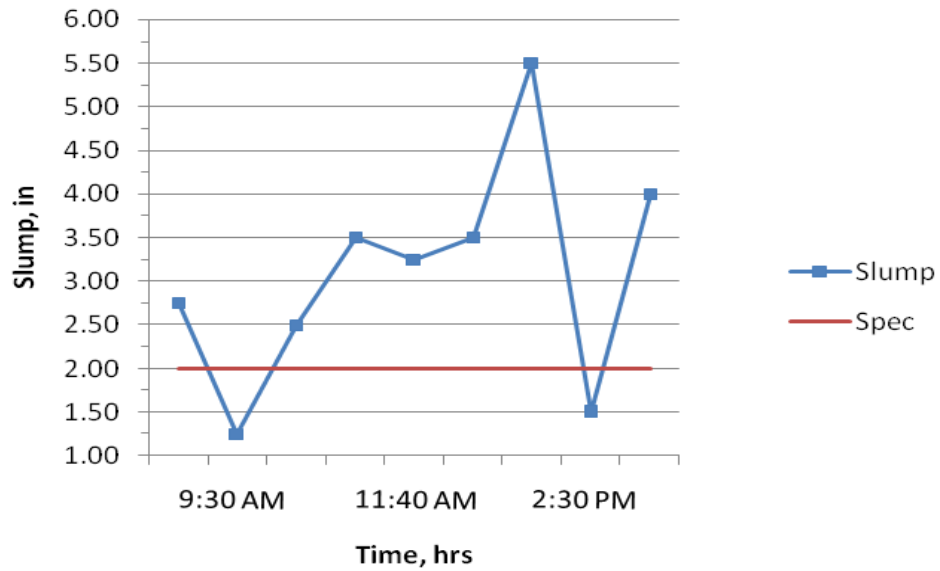
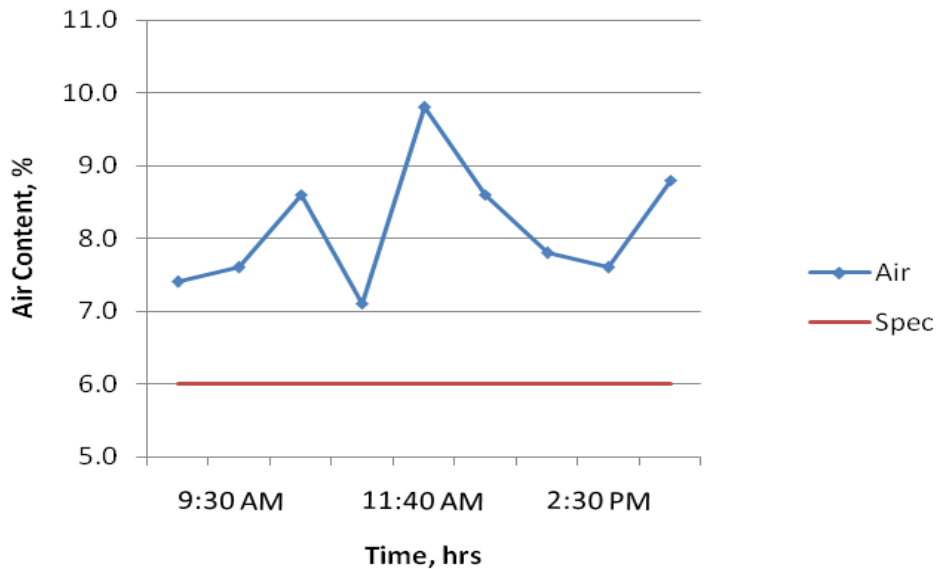
Figure 5.7 show a graphical representation of the data. The highest value of slump recorded for this project was 5.5 inches. The highest value of air content recorded was 9.8 %.

Figure 5.6 Sac County Slump Test Results

Figure 5.7 Sac County Air Test Results

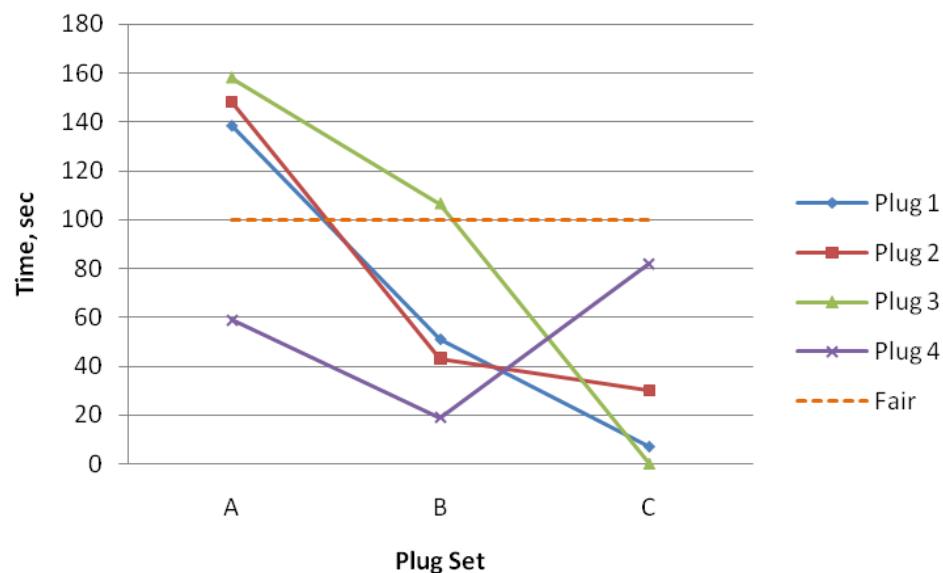
**Figure 5.8 Sac County Permeability Test Results**

Figure 5.8 shows the permeability results for Sac County. Most of the plugs had a permeability time lower than the fair category (dashed line on graph). This can be related to the installation of the plugs. If the plugs were not sealed correctly, the data will not be accurate. The data was very scattered throughout this project. The permeability times were averaged over this project to yield an overall permeability time of 70 seconds. This is below the fair range.

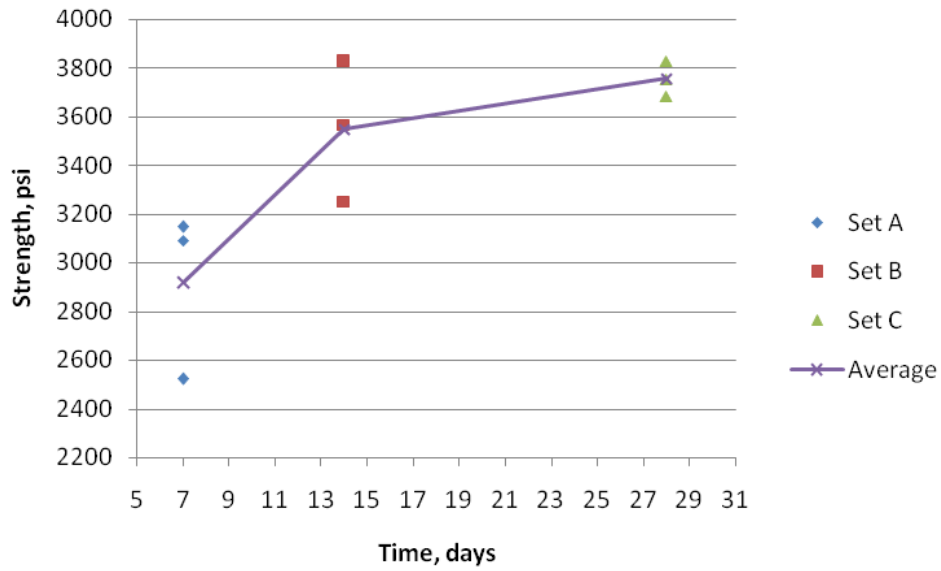
**Figure 5.9 Sac County Strength Test Results**

The strength test results for Sac County can be seen in Figure 5.9. There was a 21.5% strength increase between 7 and 14 day breaks and a 28.6% strength increase between 7 and 28 days. The maximum average strength reached at 28 days for this project was 3760 psi.

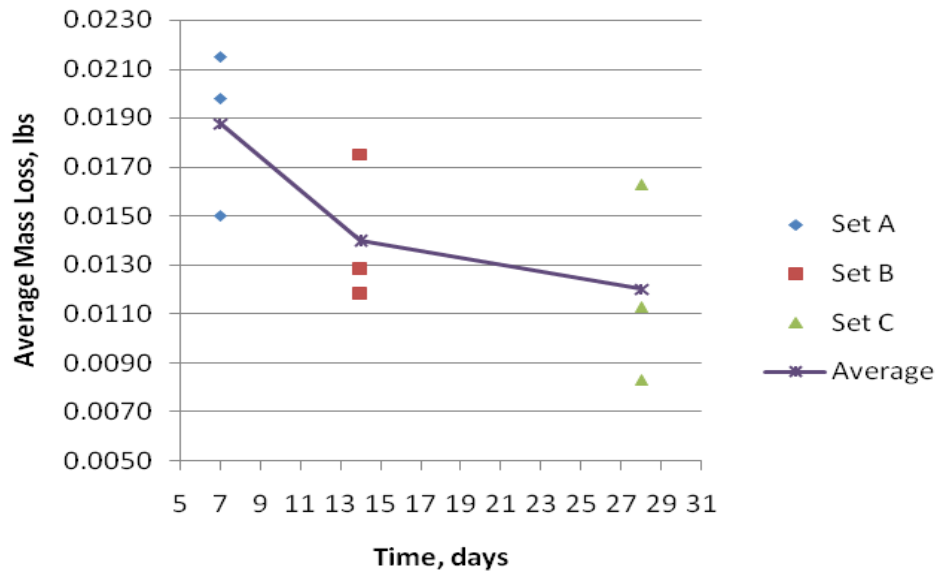
**Figure 5.10 Sac County Abrasion Test Results**

Figure 5.10 shows the results of the abrasion testing for Sac County. The abrasion tests were conducted at the time of the strength tests, 7, 14, and 28 days. It can be seen that the longer the concrete cured, the less mass it lost. The amount of mass lost is reflective of the strength gain in the concrete. The total mass lost from the 7 to 28 day tests was 0.0068 lbs.

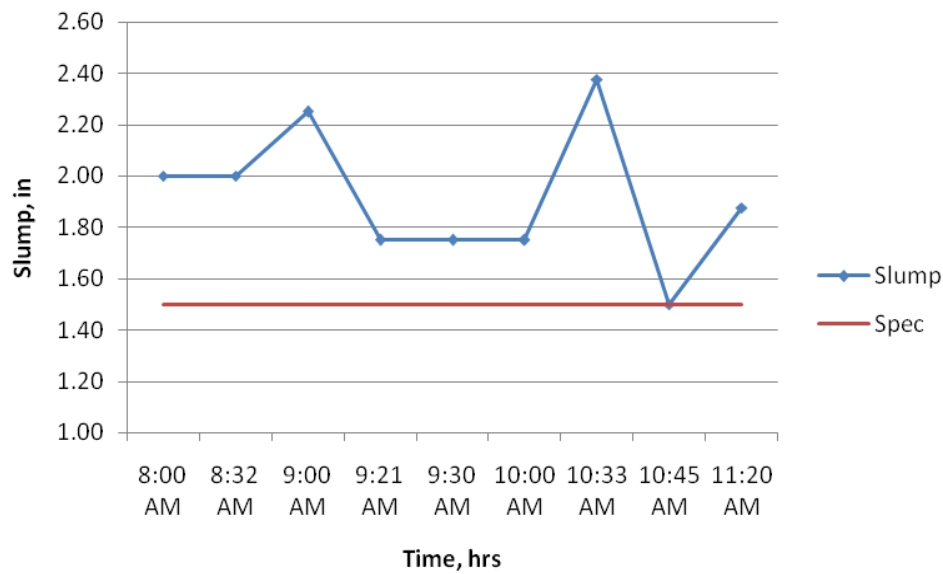
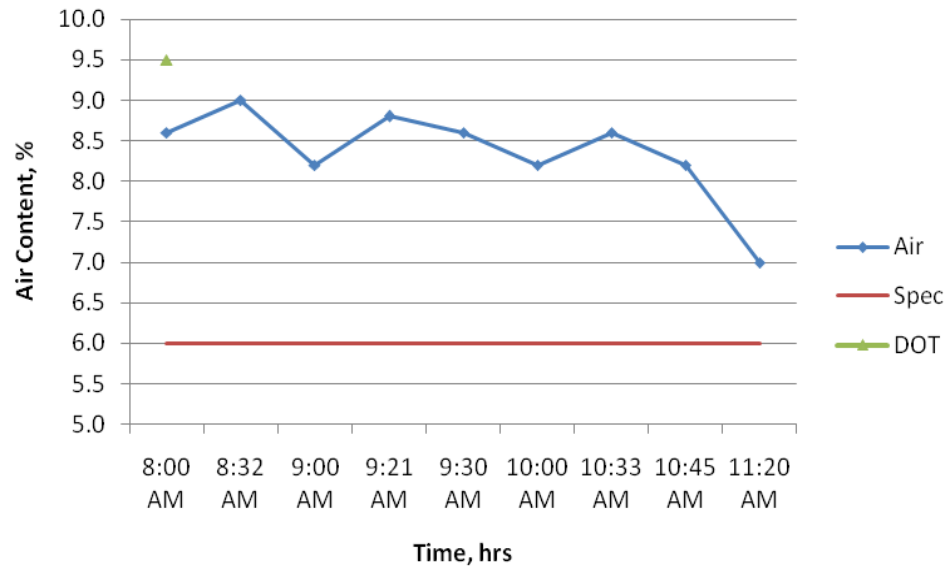
Figures 5.11 and 5.12 are the workability test results for Osceola County. The DOT specification for slump on this project was one and one half inches and specification for air content in hardened concrete was six percent. The concrete was batched ten percent air to account for air loss that happens as the concrete passes through the paver. The highest value of slump recorded for Osceola County was 2.4 in. The highest value of air content was 9.0%.

**Figure 5.11 Osceola County Slump Test Results**

**Figure 5.12 Osceola County Air Test Results**

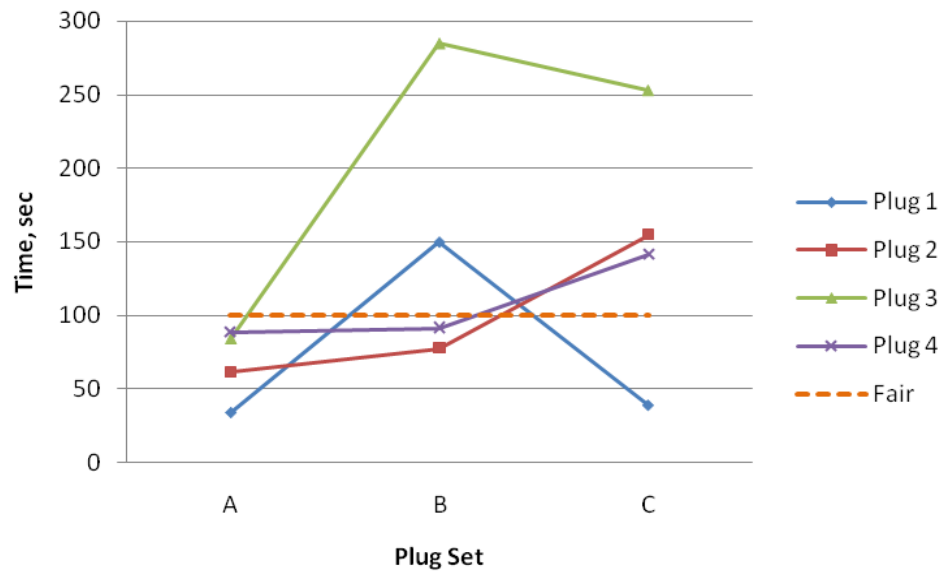
**Figure 5.13 Osceola County Permeability Test Results**

The results of the permeability testing can be seen in Figure 5.13. Roughly half of the test plugs recorded times that were below the fair mark. Again, this could be related to the installation of the plugs. The average value of permeability time for the entire project was found to be 120 seconds. This is just above the fair range.

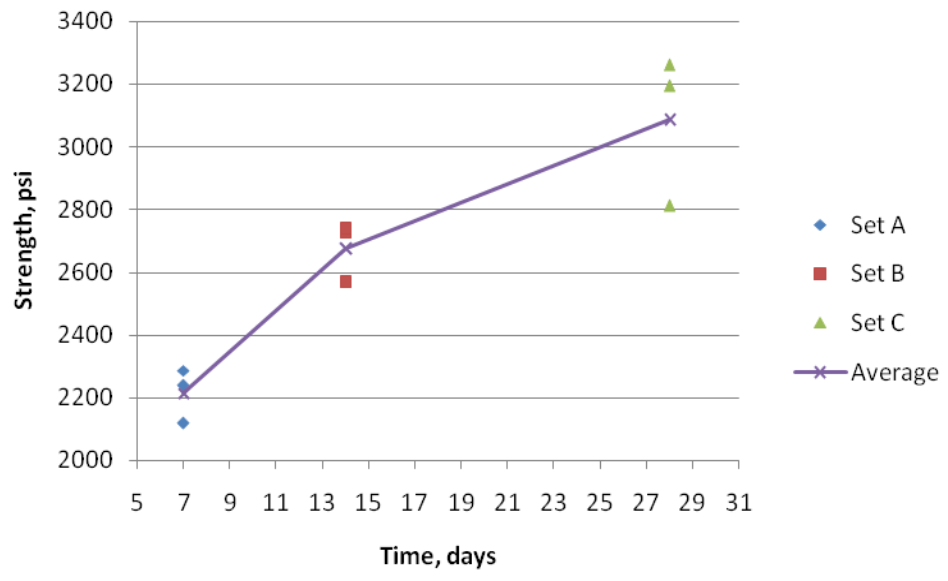
**Figure 5.14 Osceola County Strength Test Results**

The following graph (Figure 5.14) shows the strength test results for Osceola County. There was a 20.9% strength increase between 7 and 14 day breaks and a 39.5% strength increase between 7 and 28 days. The highest strength value 3090 psi.

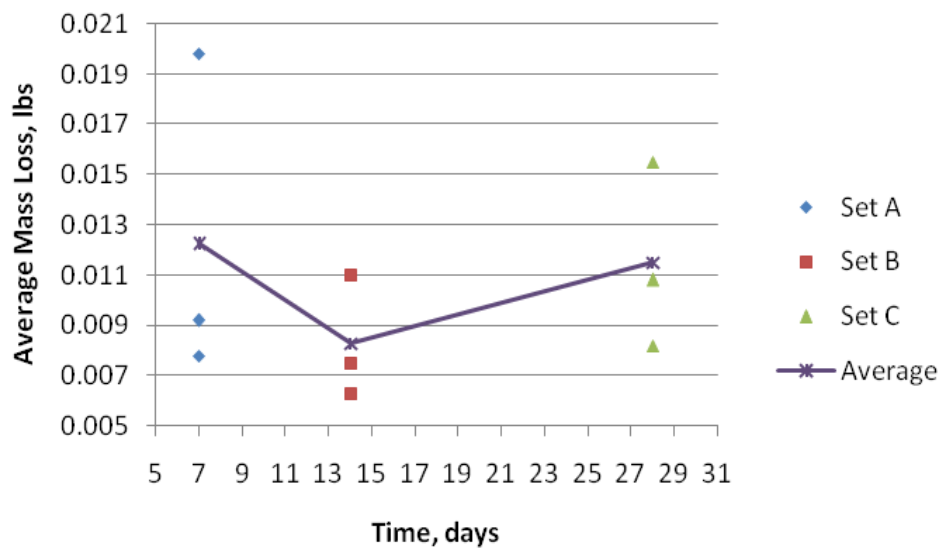
**Figure 5.15 Osceola County Abrasion Tests Results**

The abrasion test results can be seen in Figure 5.15. The abrasion tests were conducted at the time of the strength tests, 7, 14, and 28 days. The samples appeared to lose more mass at 28 days than at 14. This could be attributed to the trimming of the samples. If the samples were trimmed prior to testing, this would expose more aggregate faces and cause less abrasion to occur. The total mass lost from the 7 to 28 day tests was 0.004 lbs.

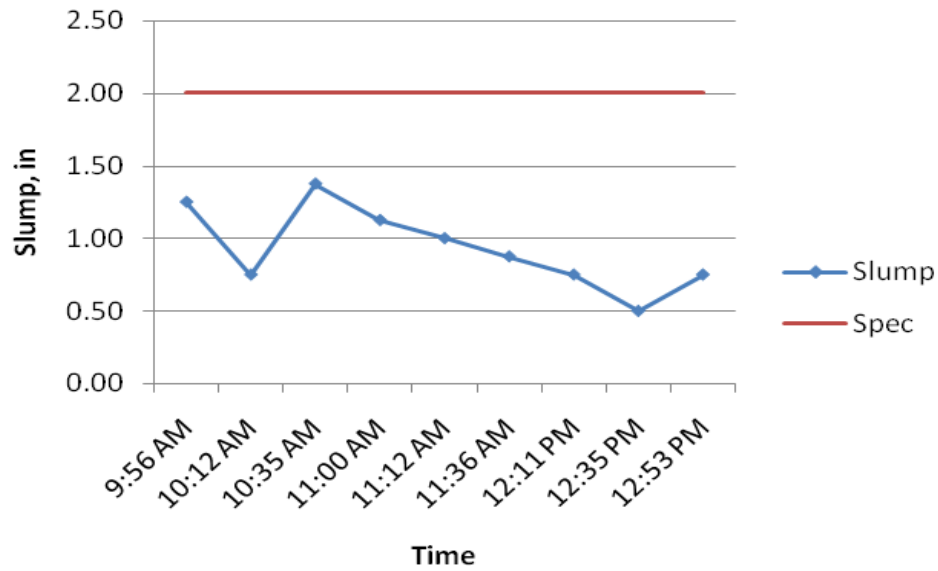
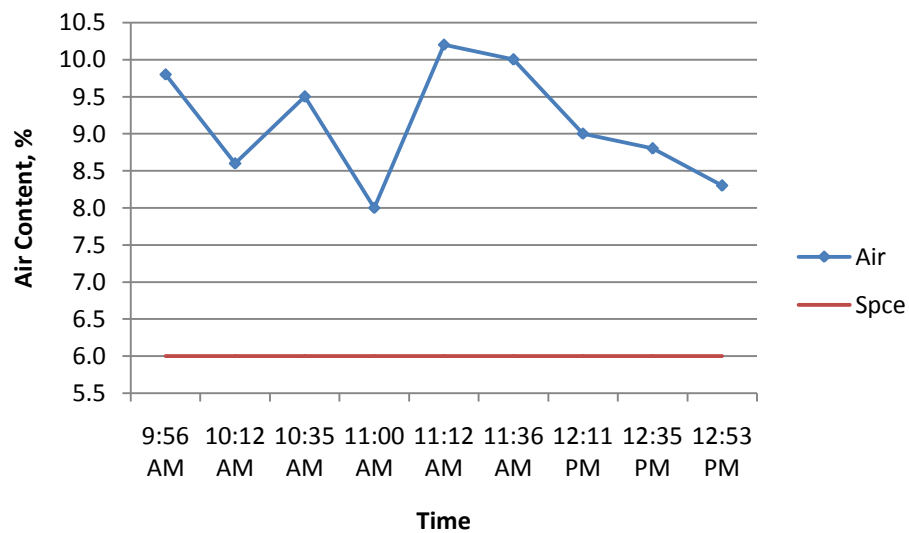
Figure 5.17 show a summary of the workability data. The highest value of slump recorded was 1.375 inches. The highest value of air content recorded was 10.2%.

Figure 5.16 Wapello County Slump Results

Figure 5.17 Wapello County Air Test Results

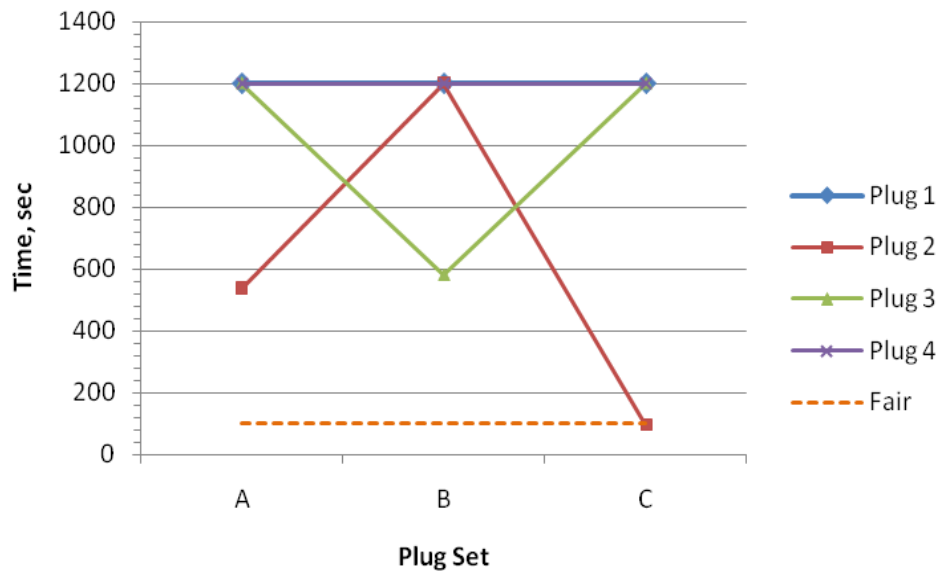
**Figure 5.18 Wapello County Permeability Test Results**

The permeability results for Wapello County can be seen in Figure 5.18. The permeability test results were the best for this project. The slab performed as expected and produced very good permeability results. The average value of permeability time recorded for this project was 16 minutes.

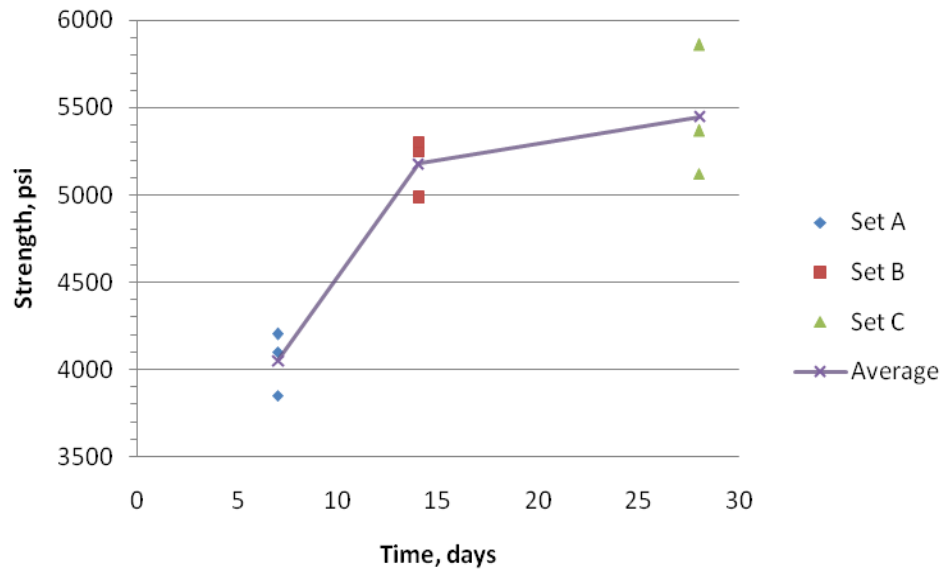
**Figure 5.18 Wapello County Strength Results**

Figure 5.19 shows the strength results for Wapello County. There was a 27.8% strength increase between 7 and 14 day breaks and a 34.5% strength increase between 7 and 28 day breaks. The final strength value achieved for Wapello County was 5450 psi.

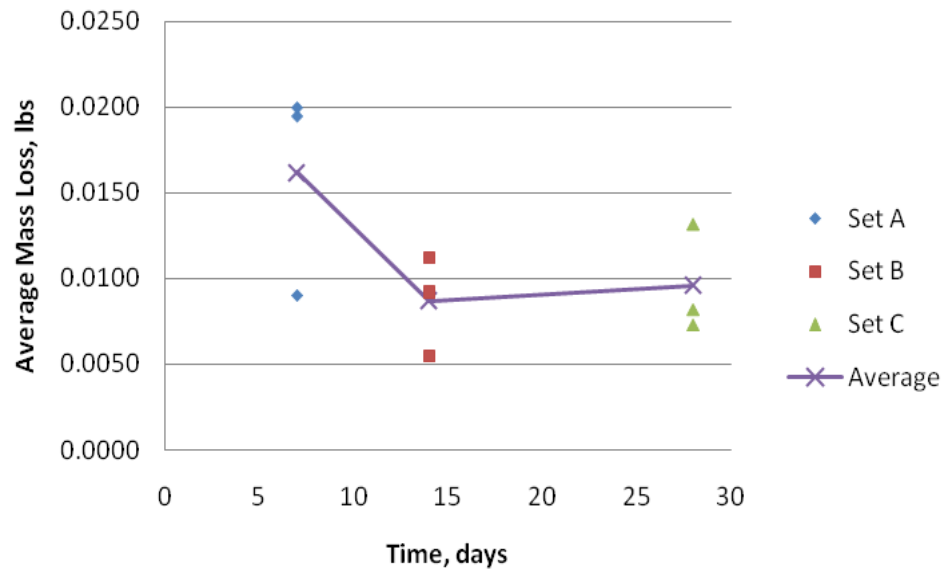
**Figure 5.19 Wapello County Abrasion Results**

The abrasion results can be seen in Figure 5.19. There was more mass lost at the 28 day strength than at the 14 day strength. This could be a result of trimming the samples prior to testing. By trimming the samples, the aggregate faces become more exposed and yield a harder surface to resist abrasion. The total mass lost from 7 to 28 days was 0.0066 lbs.
