# Optimizing Portland cement concrete mix design to environmental and construction variables with the aid of computer design software

**Optimizing Portland cement concrete mix design to environmental and construction variables with the aid of computer design software**

A thesis submitted to the graduate faculty  
in partial fulfillment of the requirements for the degree of  
**MASTER OF SCIENCE**

Major: Civil Engineering (Geotechnical Engineering)

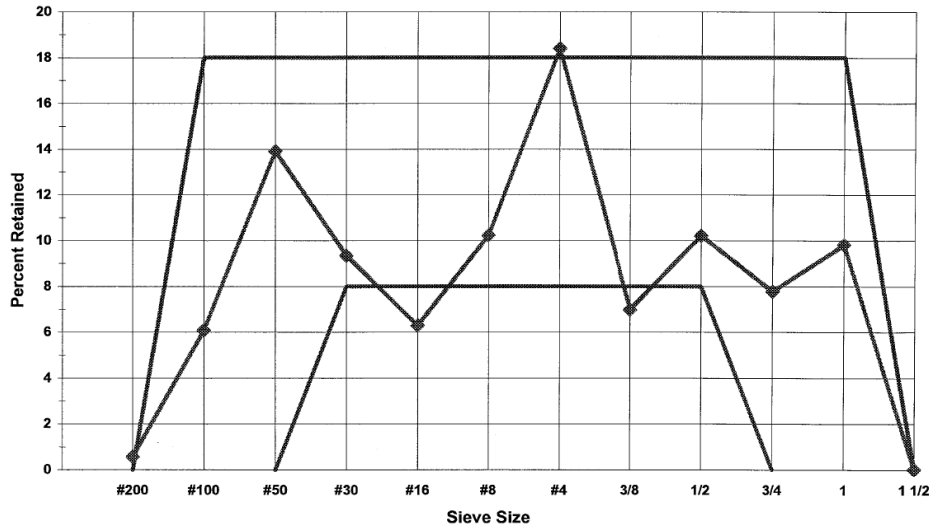
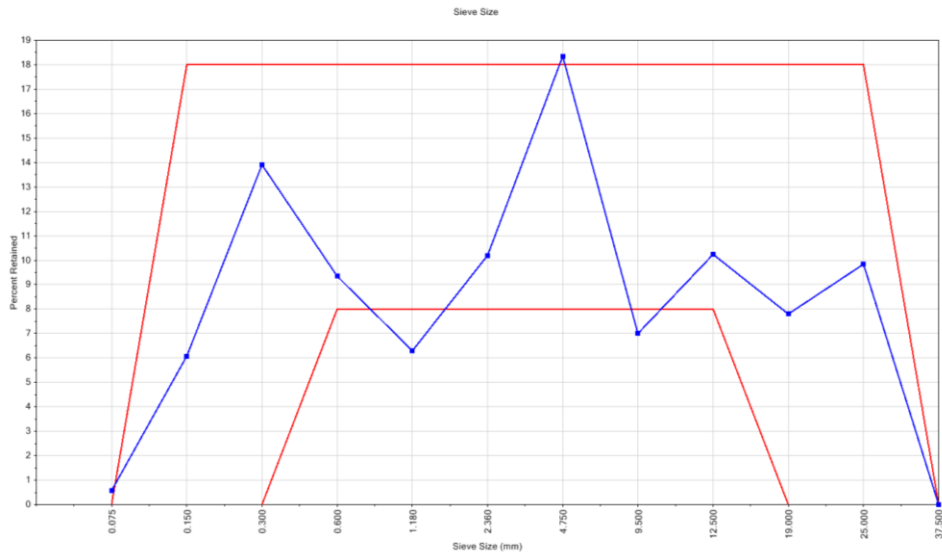
**Figure 5.20 Cass County DOT Gradation**

Figures 5.20 and 5.21 show the DOT and COMPASS aggregate gradations for Cass County. These graphs are based on the percent retained on the sieves. It can be seen that both graphs are very similar.

**Figure 5.21 Cass County COMPASS Gradation Prediction**

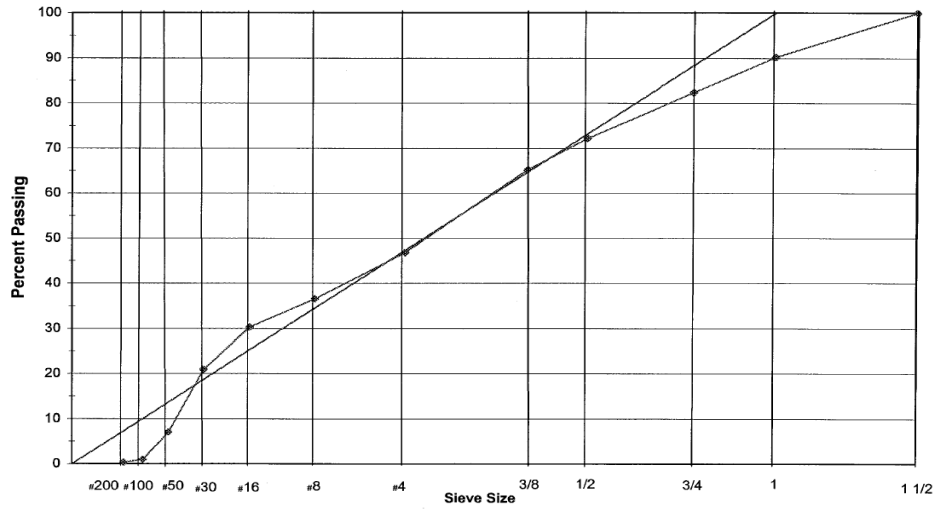
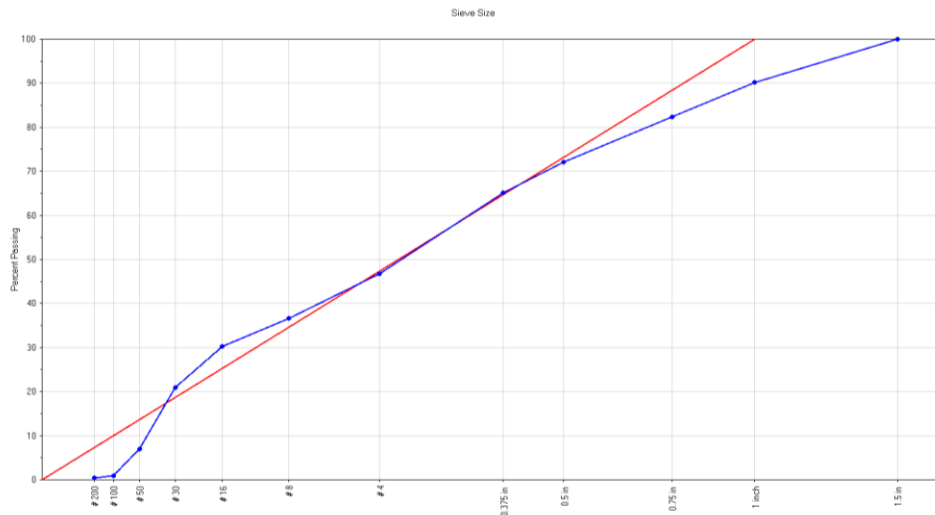
**Figure 5.22 Cass County DOT 0.45 Power Chart**

The 0.45 power charts for Cass County can be seen in Figures 5.22 and 5.23. Like the aggregate gradation charts, these charts are very similar in shape. Both graphs come very close to the 0.45 line in the middle of the sieve series.

**Figure 5.23 Cass County COMPASS 0.45 Power Chart**

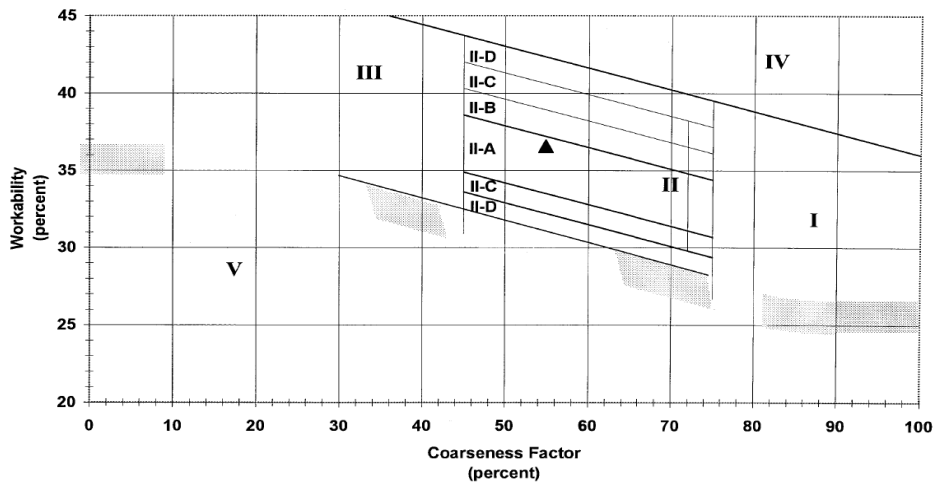
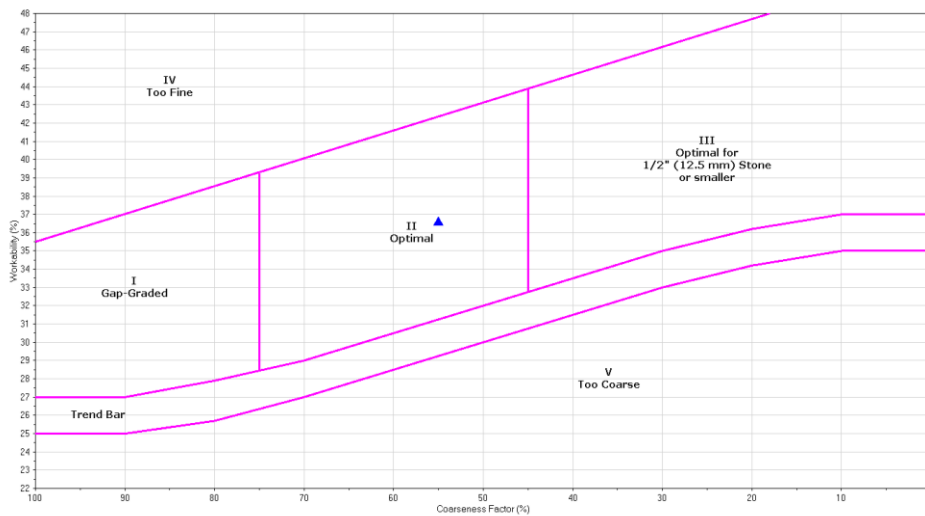
**Figure 5.24 Cass County DOT Workability Chart**

It can be seen from the DOT workability chart that Cass County has a workability ranking of 36% (Figure 5.24). COMPASS predicted that Cass County would have a workability ranking of 36% (Figure 5.25). The DOT coarseness factor was 55% which matches the coarseness factor of 55% from COMPASS.

**Figure 5.25 Cass County COMPASS Workability Chart**

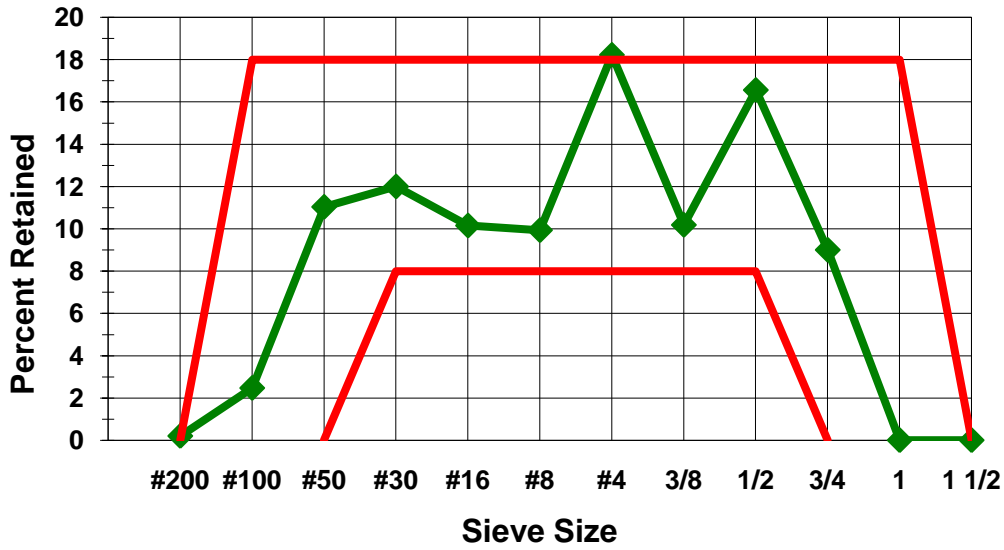
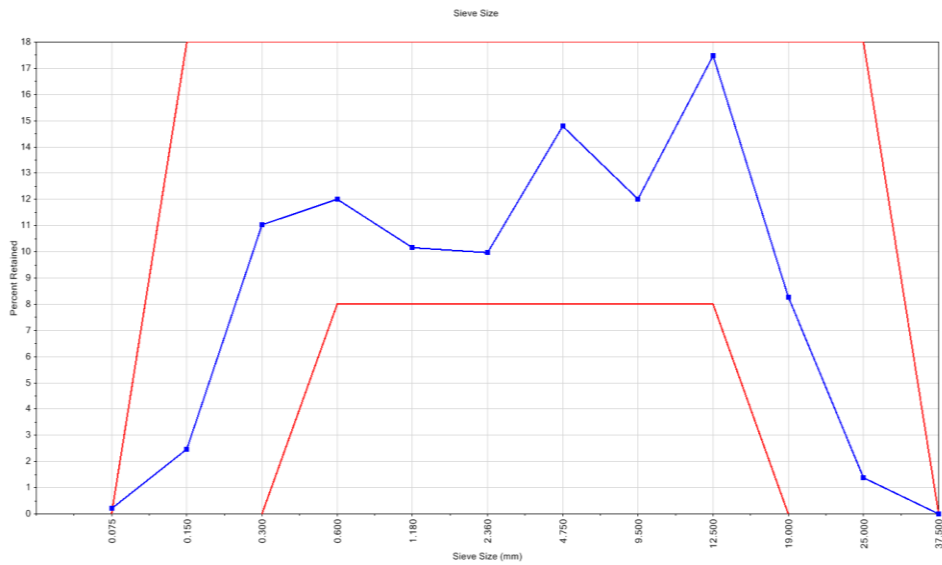
Figure 5.26 Sac County Gradation Chart

Figures 5.26 and 5.27 show the DOT and COMPASS aggregate gradations for Sac County. These graphs are based on the percent retained on the sieves. It can be seen that both graphs are very similar in shape, having peaks in the gradation on the larger sieves.

Figure 5.27 Sac County COMPASS Gradation Chart

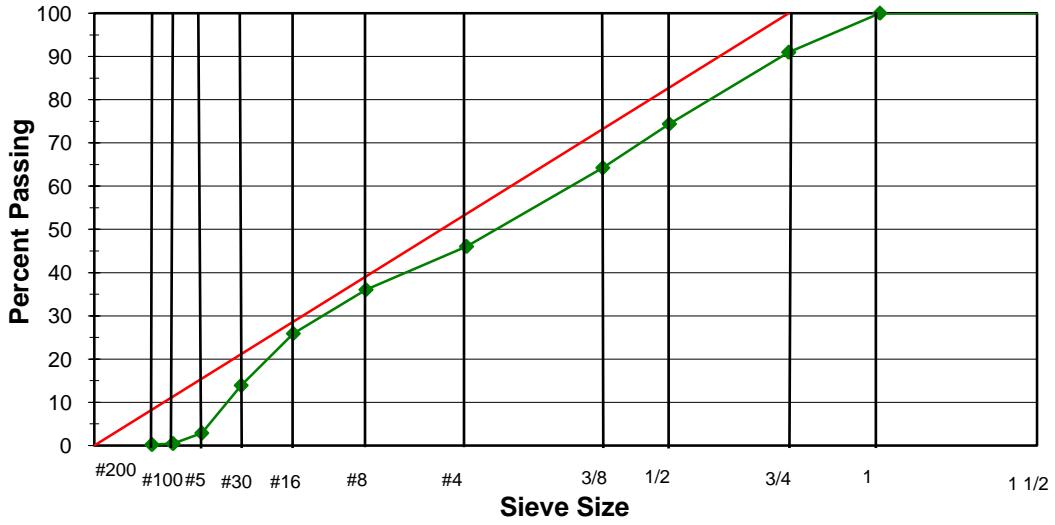
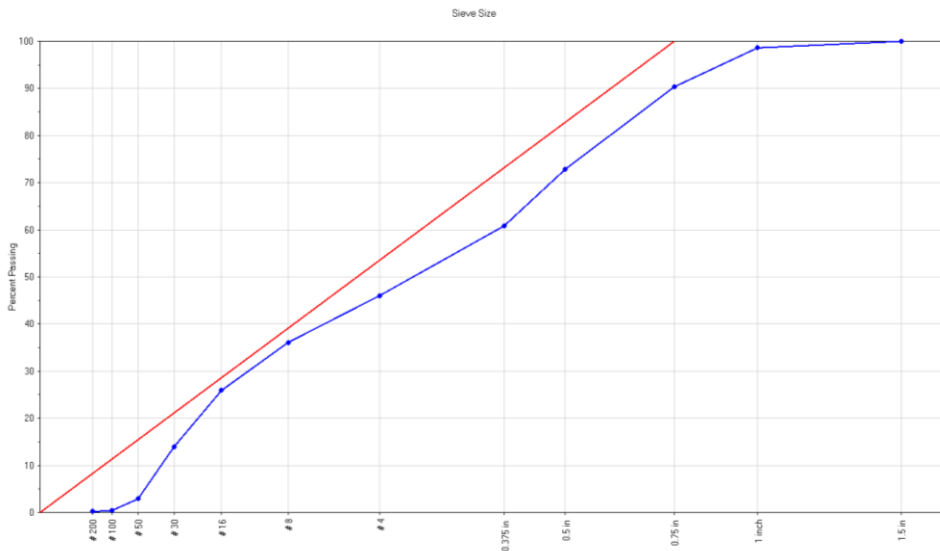
**Figure 5.28 Sac County 0.45 Power Chart**

The Sac County 0.45 power chart from the DOT and COMPASS are shown here (Figures 5.28 and 5.29). These graphs have the same curvature, coming close to the 0.45 line at the lower end of the graph.

**Figure 5.29 Sac County COMPASS 0.45 Power Chart**

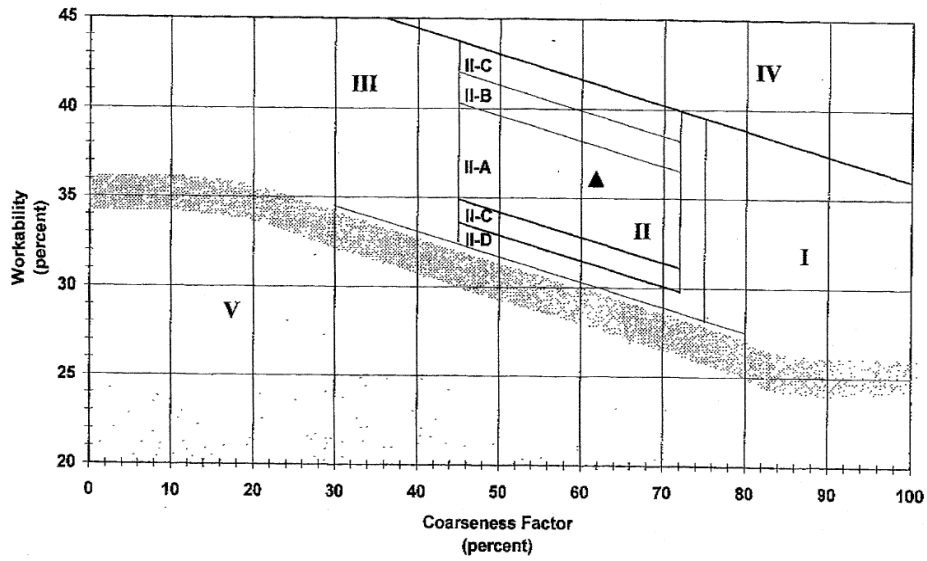
**Figure 5.30 Sac County DOT Workability Chart**

For Sac County, the DOT workability ranking was 36%, with a coarseness factor of 61% (Figure 5.30). COMPASS predicted that Sac County would have a workability ranking of 36% with a coarseness factor of 61% (Figure 5.31).

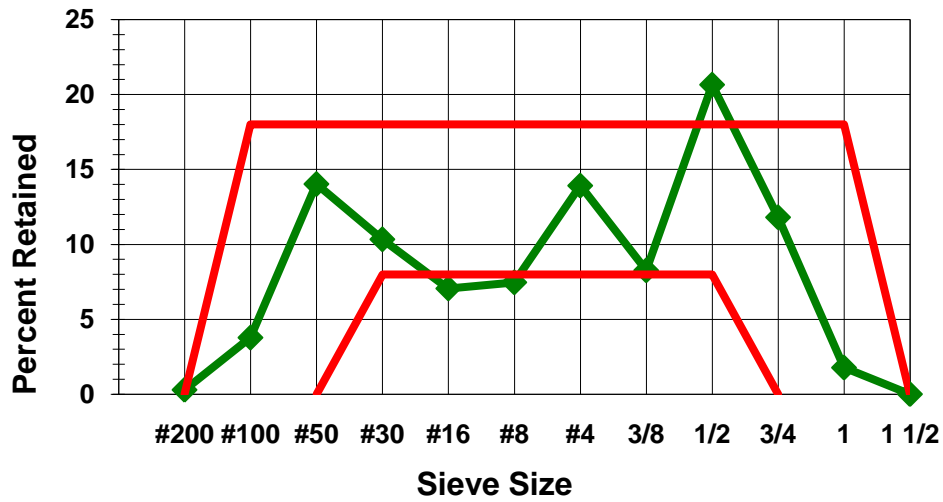
**Figure 5.38 Wapello County DOT Gradation**

For Wapello County, the aggregate gradation charts are shown in Figures 5.38 and 5.39. These graphs were produced by the DOT and COMPASS are very similar in shape to one another.

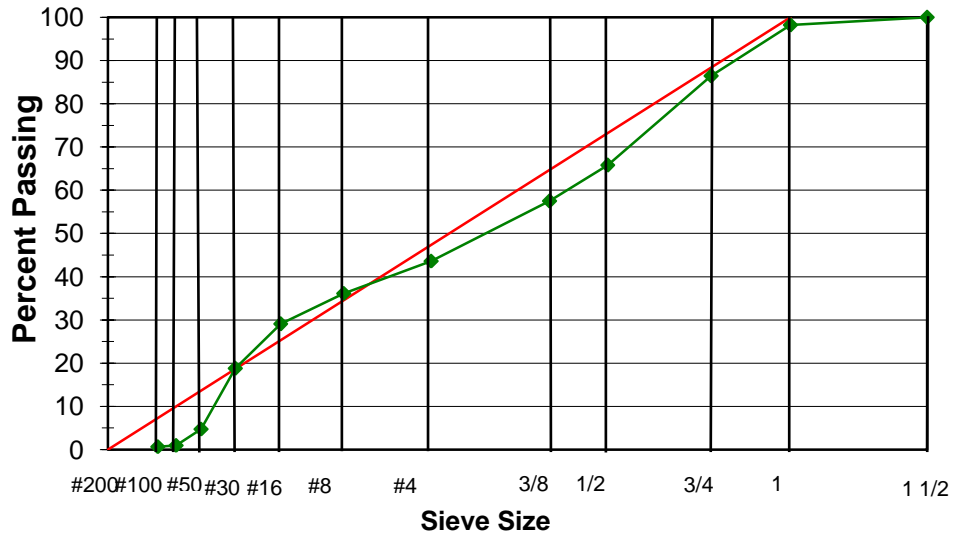
**Figure 5.40 Wapello County 0.45 Power Chart**

The 0.45 power charts for Wapello County can be seen in Figures 5.40 and 5.41.

These charts are similar in shape, with the COMPASS chart having a gradation closer to the 0.45 line on the smaller sieve sizes.

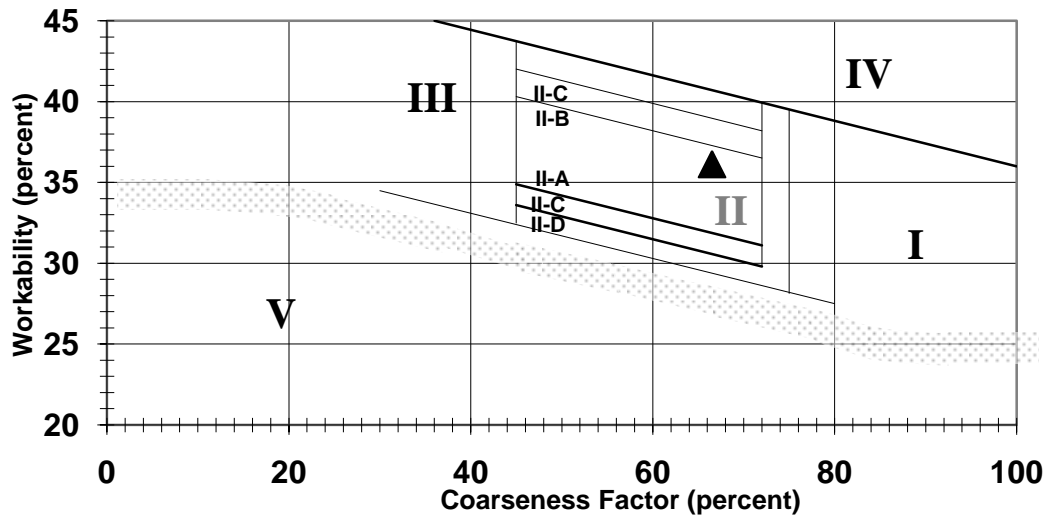
Figure 5.42 Wapello County Workability Chart

The DOT workability factor for Wapello County was 36% (Figure 5.42). The coarseness factor was 67%. From COMPASS, the workability factor was found to be slightly lower, at 33%, with a coarseness factor of 67% (Figure 5.43).
