## Performance of Concrete Incorporating Colloidal Nano-Silica

Mohamed Sabry Zeidan

**Doctor of Philosophy in Civil Engineering**

**University of Nevada, Las Vegas**

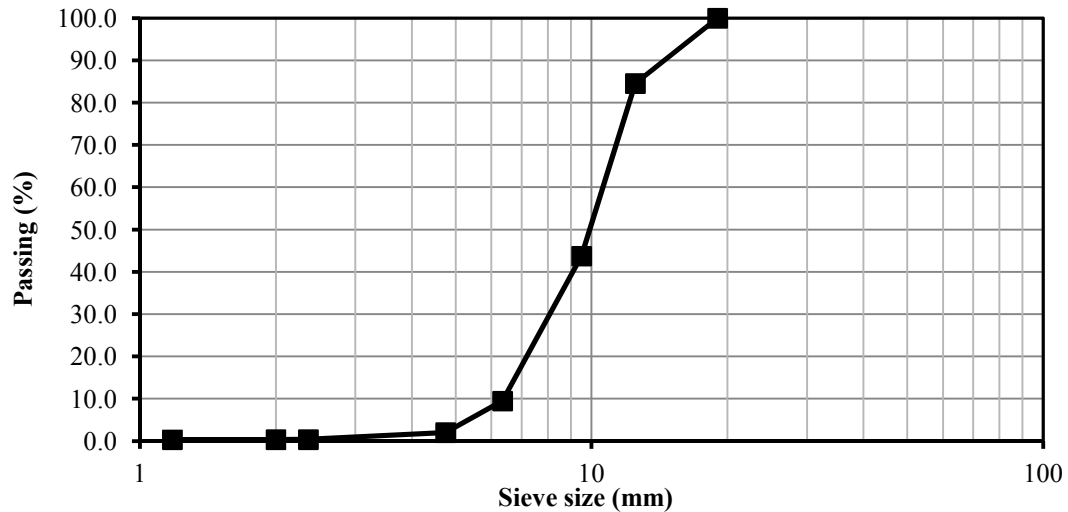
Figure 1 Gradation curve for the coarse aggregate.

specific weight was 2.78, its absorption was 0.80% and its fineness modulus was 3.00. Figures 1 and 2 show the gradation curves of the coarse and fine aggregates used in this study (except for Chapter 7), respectively. The moisture contents of coarse and fine aggregates were measured each time before mixing and the mixing water was adjusted for these moisture contents. For ASR testing, a different type of natural aggregate, from one source of known reactivity, is used with different sizes as coarse and fine aggregates. For mortar bar testing (ASTM C1260), fine aggregate graded according to the specifications was used to make the mortar. Both fine and coarse aggregates (reactive) were used for testing the change in concrete strength due to ASR as will be described in Chapter 7.

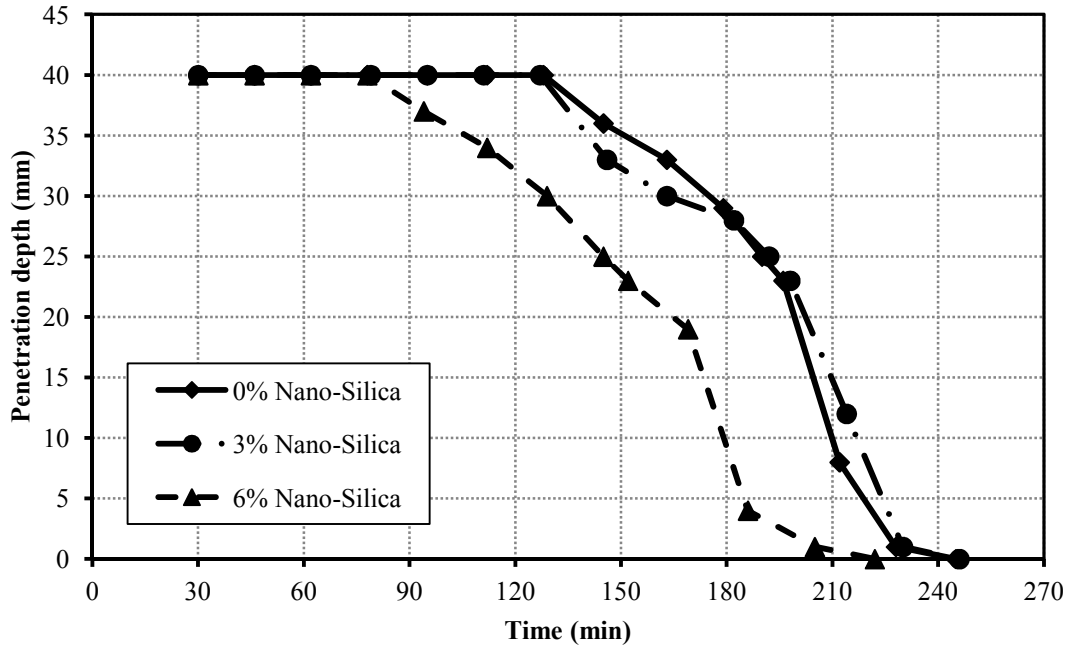
Figure 3 Vicat needle penetration depths for pastes without fly ash.

Generally, the results of Vicat needle testing indicate that using nano-silica has an impact on shortening of both of the initial and final setting times. For mixtures without fly ash (Group A), adding 6% nano-silica reduced the initial setting time by around 25%, while the final setting time was reduced by around 10%. However, 3% of added nano-silica did not have a considerable effect on setting times in this case. The effect of nano-silica could be more readily observed in case of mixtures incorporating fly ash (Group B). Class F fly ash may generally extend the setting time of cement paste due to the slow hydration process. However, adding 6% of nano-silica to the fly ash concrete reduced the initial and

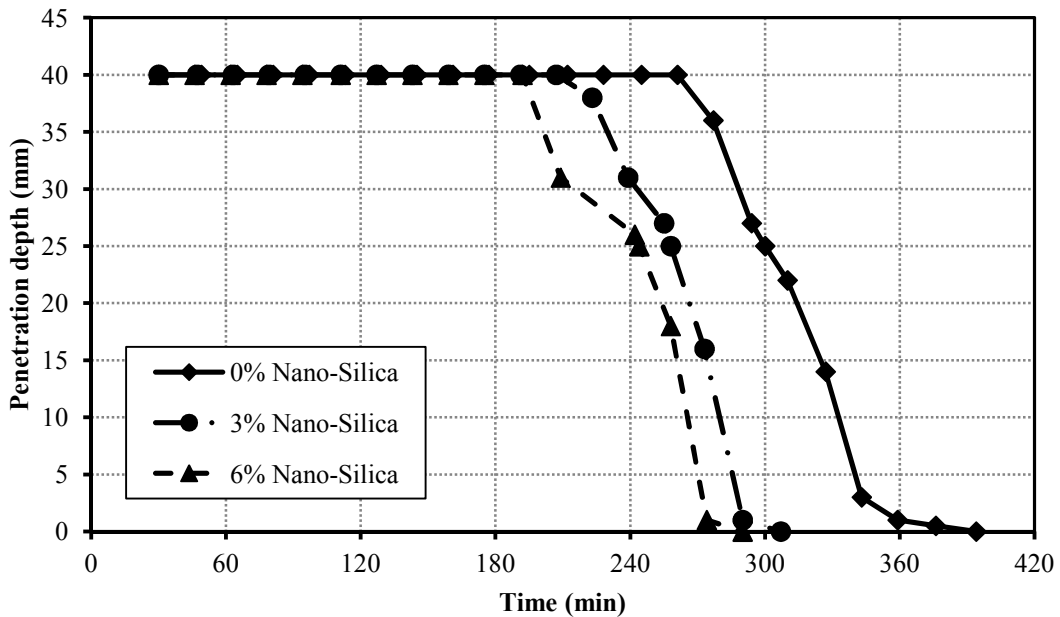
Figure 4 Vicat needle penetration depths for pastes including 30% fly ash.

final setting time by around 25%, while this reduction was around 20% in case of adding 3% of nano-silica.

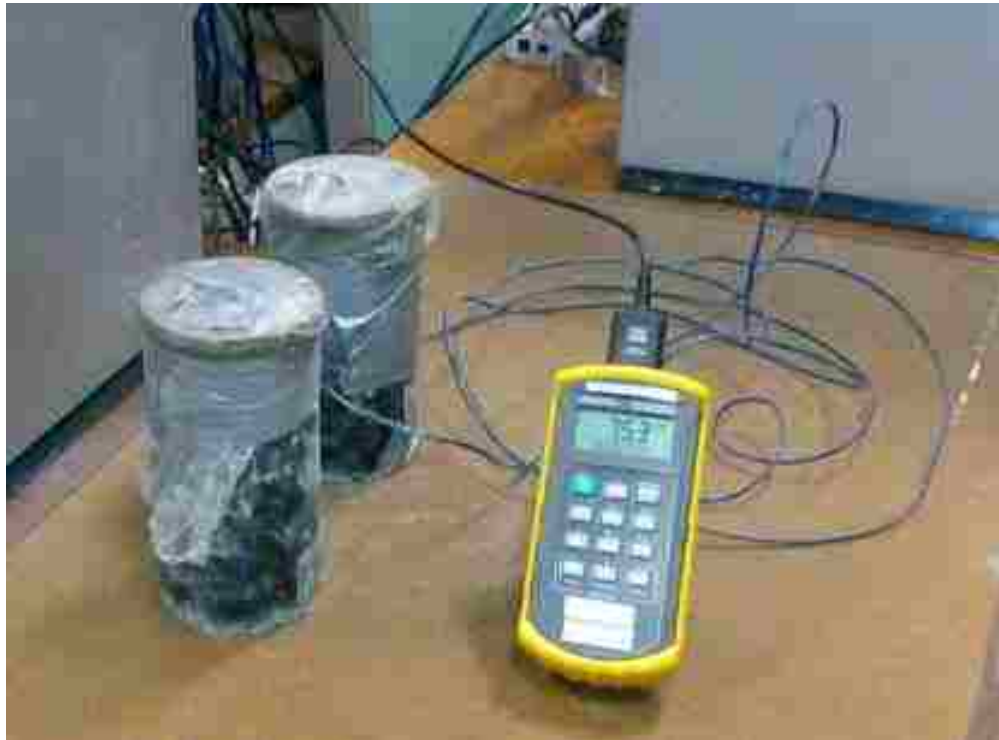
Figure 5 Adiabatic temperature test setup.

In order to monitor the change in temperature in the different concrete mixtures during the early hydration period, the adiabatic temperature test was conducted. Immediately after mixing, a 4×8 inches concrete cylinder mold is prepared and a thermocouple is inserted at 4" below of the cylinder top surface (mid height) in order to measure the temperature of the mixture according to ASTM C1064. The cylinder molds were covered and sealed to prevent moisture loss during the test and were kept in room temperature ( $73 \pm 3^{\circ}\text{F}$ ). The adiabatic temperature of concrete was recorded every 2 minutes using a data

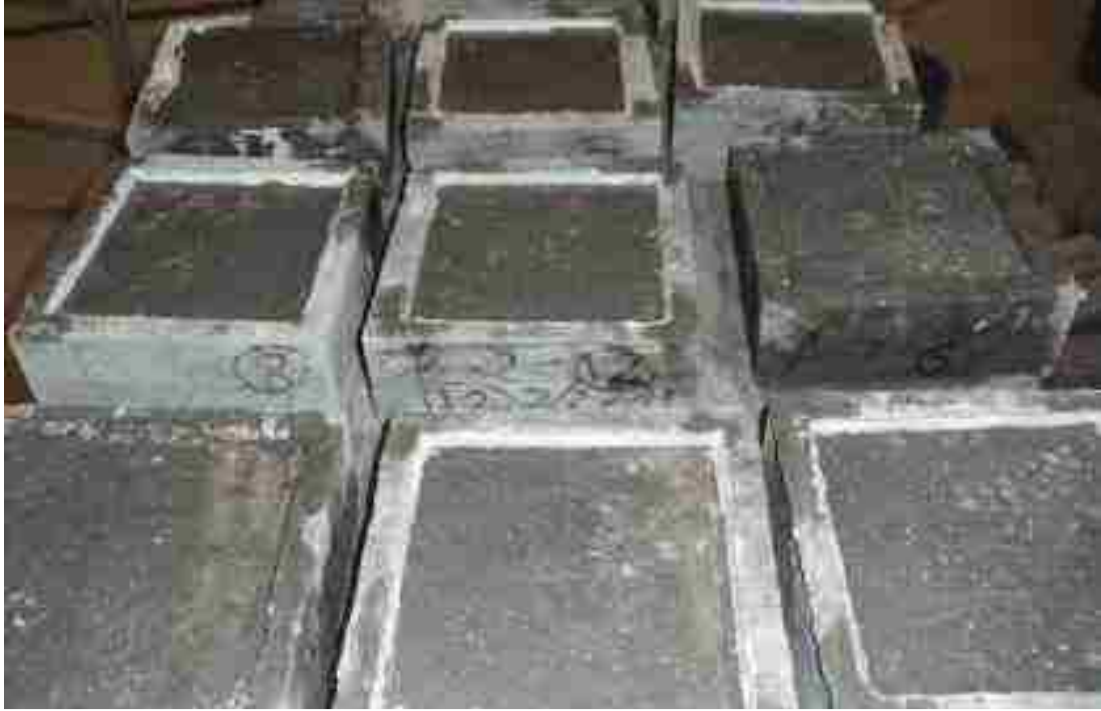
Figure 21 Surface scaling specimens during testing.

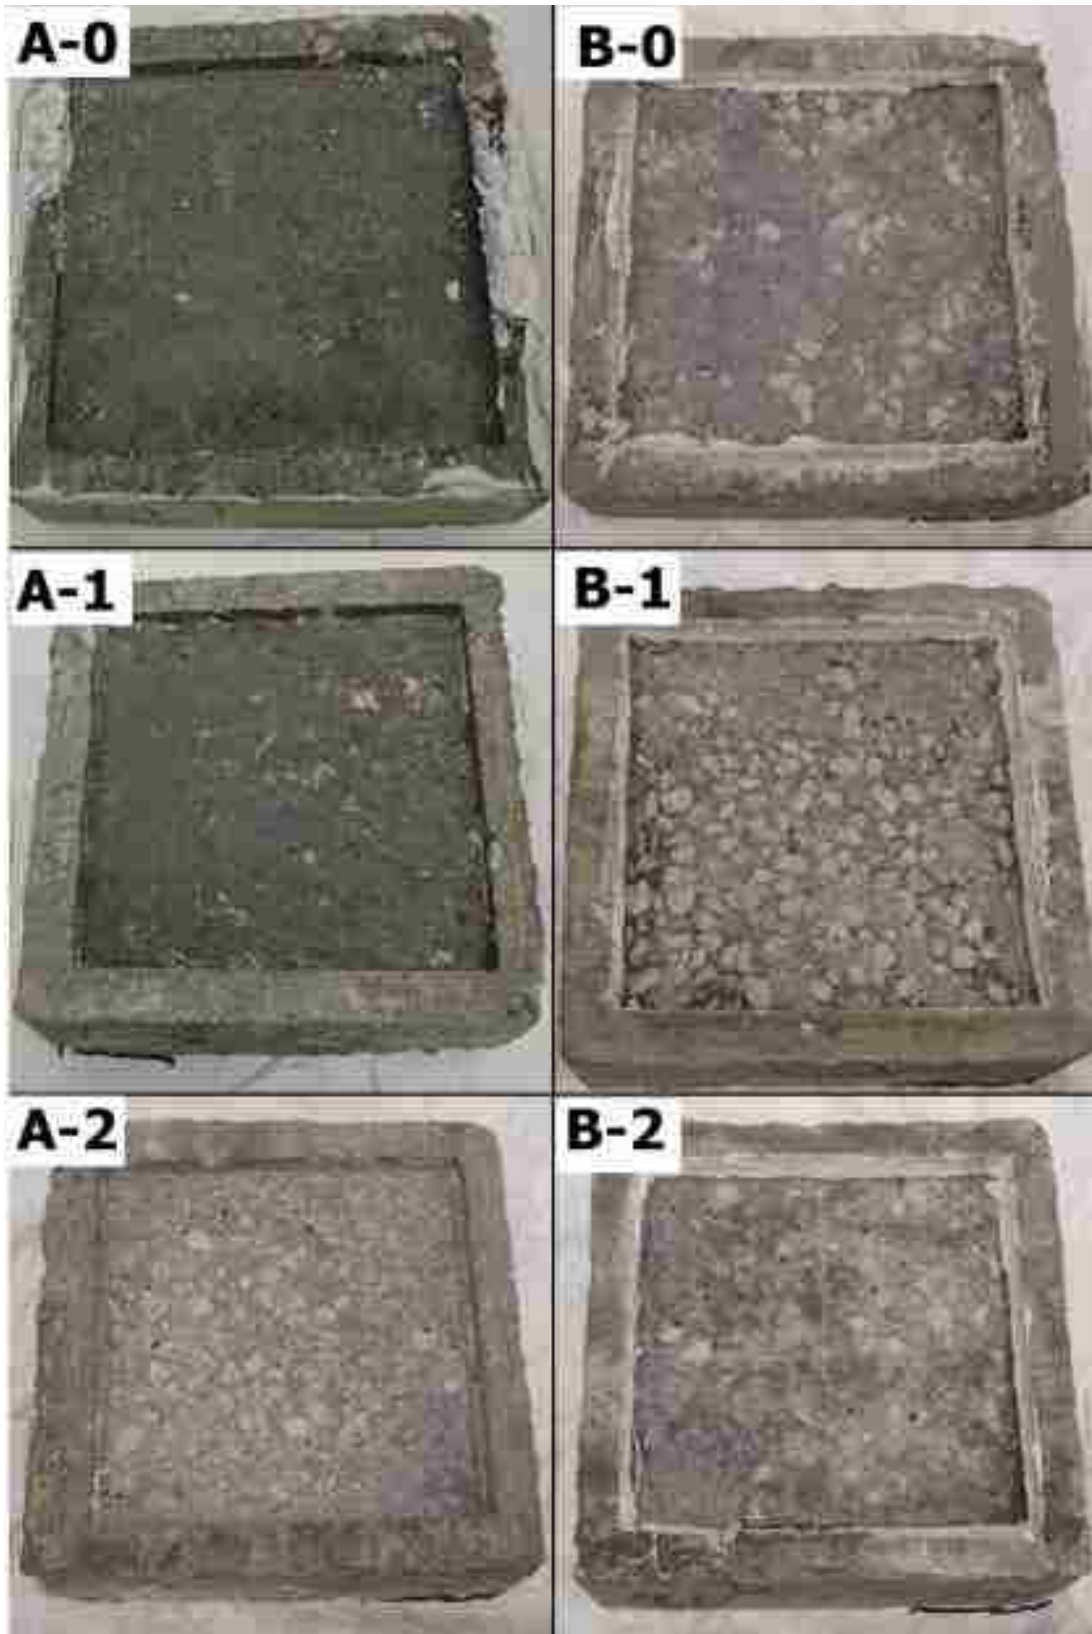
Figure 23 Scaling on the surface of the specimens after 60 cycles of exposure.

damage may affect the accuracy of this method. The severe damage causes aggregate to represent most of the surface exposed to the salt solution (see specimen B-1 in Figure 23). On the other hand, for Group A specimens, the addition of nano-silica resulted on higher levels of damage. Linking these results to the porosity results presented in chapter 5, the addition of nano-silica increased the percentage of the micro-pores (less than 0.1  $\mu\text{m}$  in diameter). Generally, it may be observed that the level of scaling in the different mixtures had a good agreement with the results of the porosity testing presented in Chapter 5. For instance, the highest level of damage was observed in mixture B-1 which had the highest percentage of micro-pores (79.7% of total pores). This reduction in pore diameters might have led to higher ice crystallization pressure (Scherer, 1999) as this may prevent the pressure relief to the larger pores or air voids.

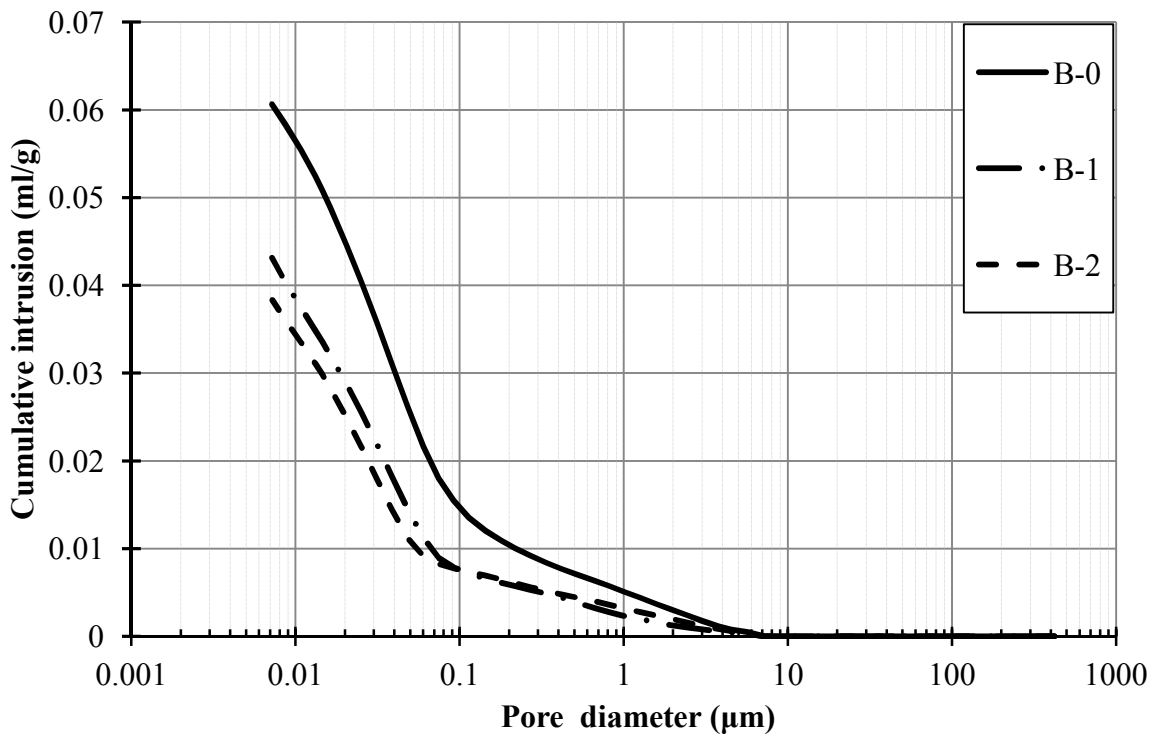
Figure 25 Pore size distribution for mixtures with fly ash (Group B).

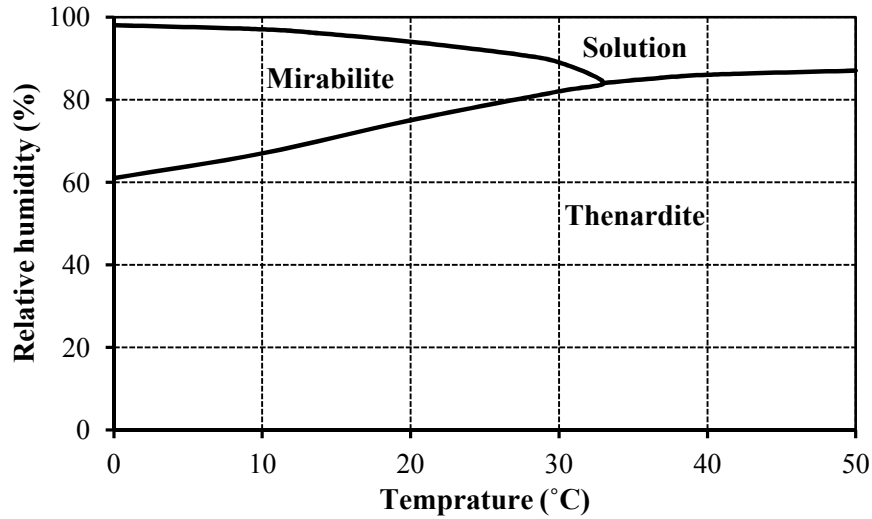
Figure 29 Phase diagram for sodium sulfate (Flatt 2002).

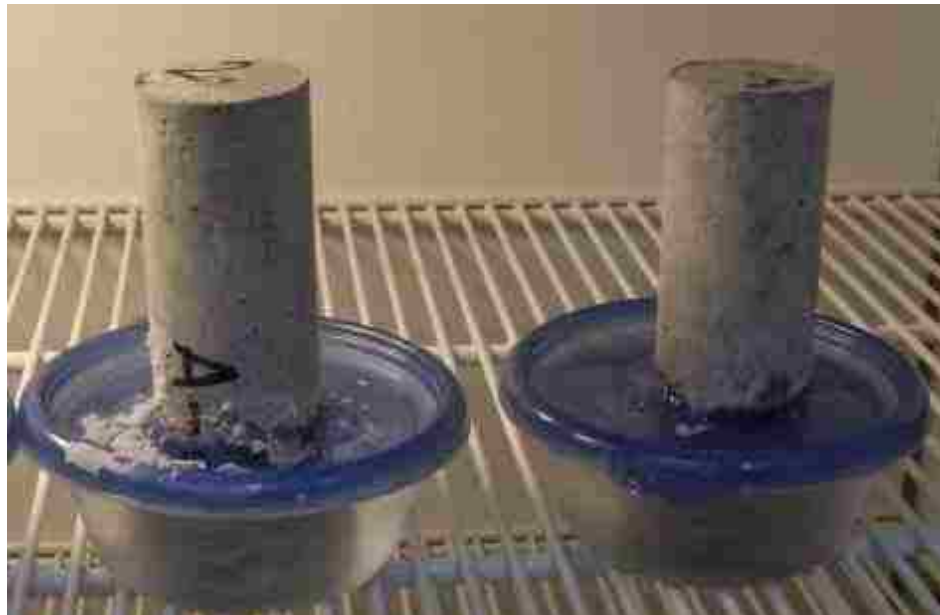
Figure 31 Specimens partially immersed at the early cycles of testing.

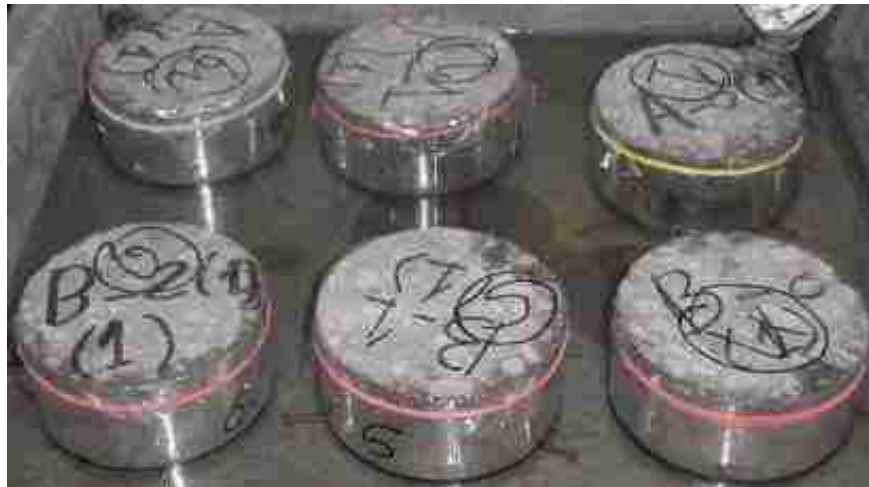
Figure 32 Specimens during absorption testing.

sides and top seals) to the nearest 0.01g and they were placed in a pan filled with tap water. The water level was kept at 1 to 3 mm above the bottom exposed surface during the eight days test duration. Figure 32 shows some of the specimens during the test procedure. During the test, the increase in mass of the specimens was monitored at specific times up to 8 days according to ASTM C1585. The absorption,  $I$  (mm), was calculated as the mass change in each specimen divided by the product of the cross section and the density of water. As specified by ASTM C1585, the absorption values were then plotted against the square root of the time in seconds.

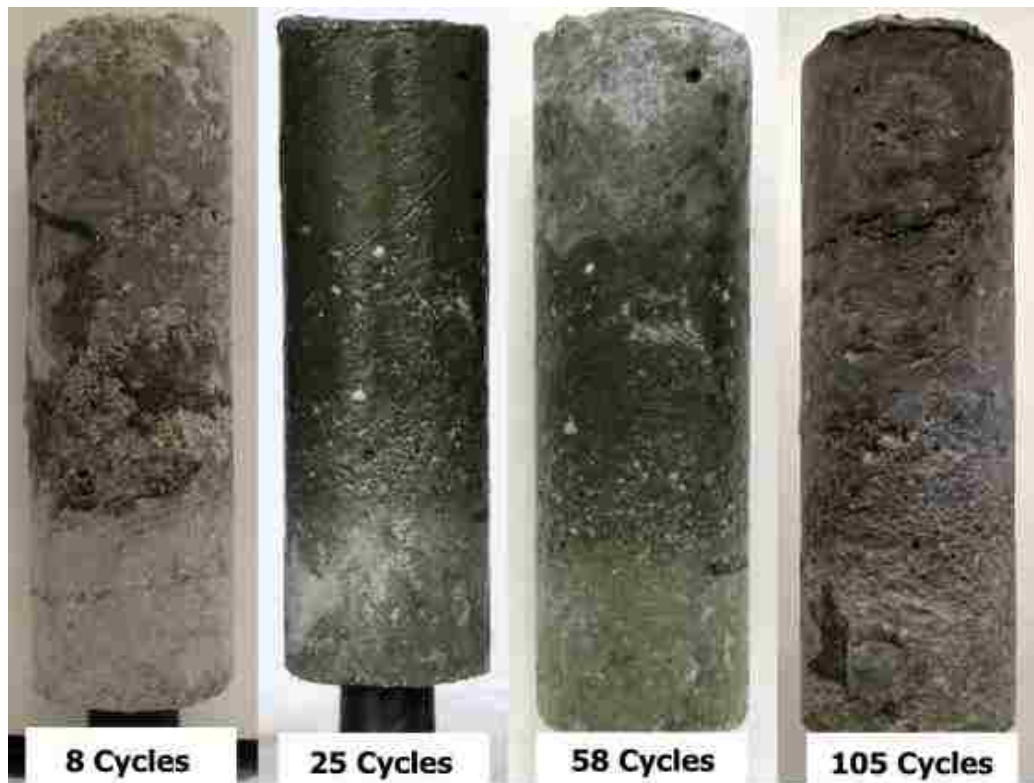
Figure 35 Damage in A-1 specimen at different ages of exposure.

in the damage observed in the tested specimens. This also conforms to the visual inspection of the specimens (Figures 34 through 39) which indicate no or inconsiderable damage at the immersed portions of the specimens although these parts are more vulnerable to the chemical attack.

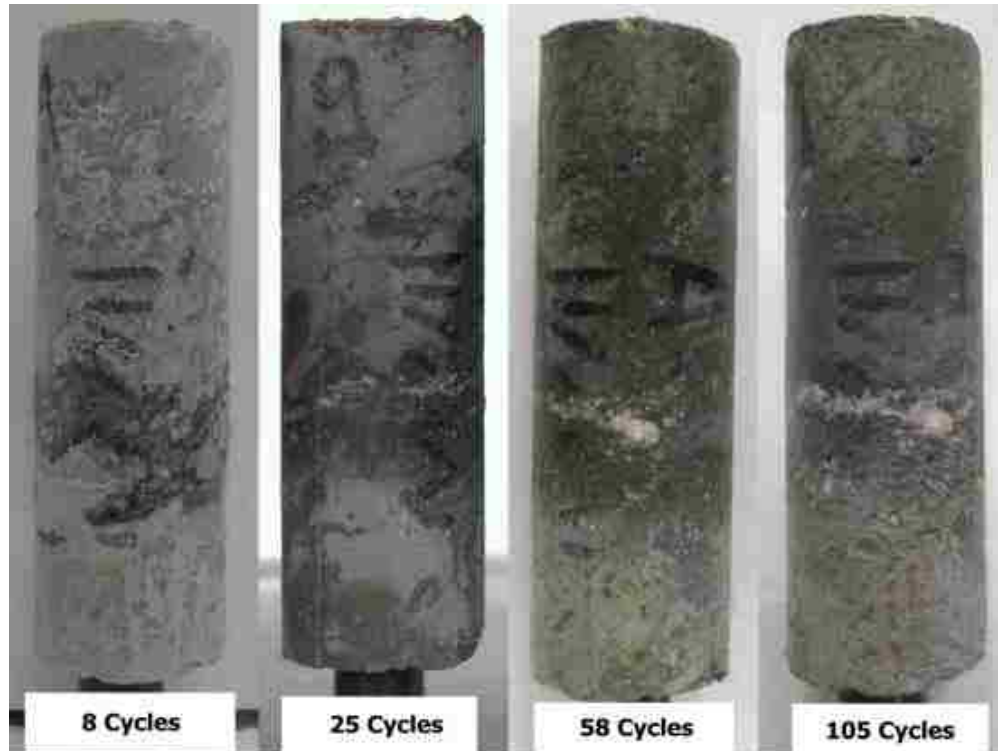
Figure 36 Damage in A-2 specimen at different ages of exposure.

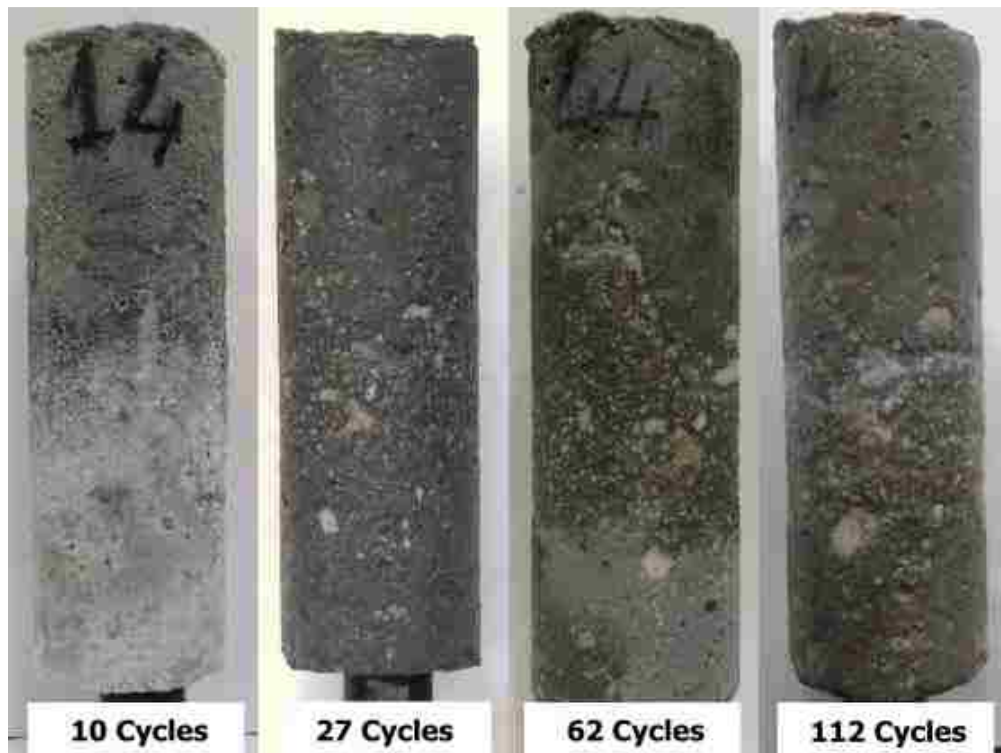
Figure 37 Damage in B-0 specimen at different ages of exposure.

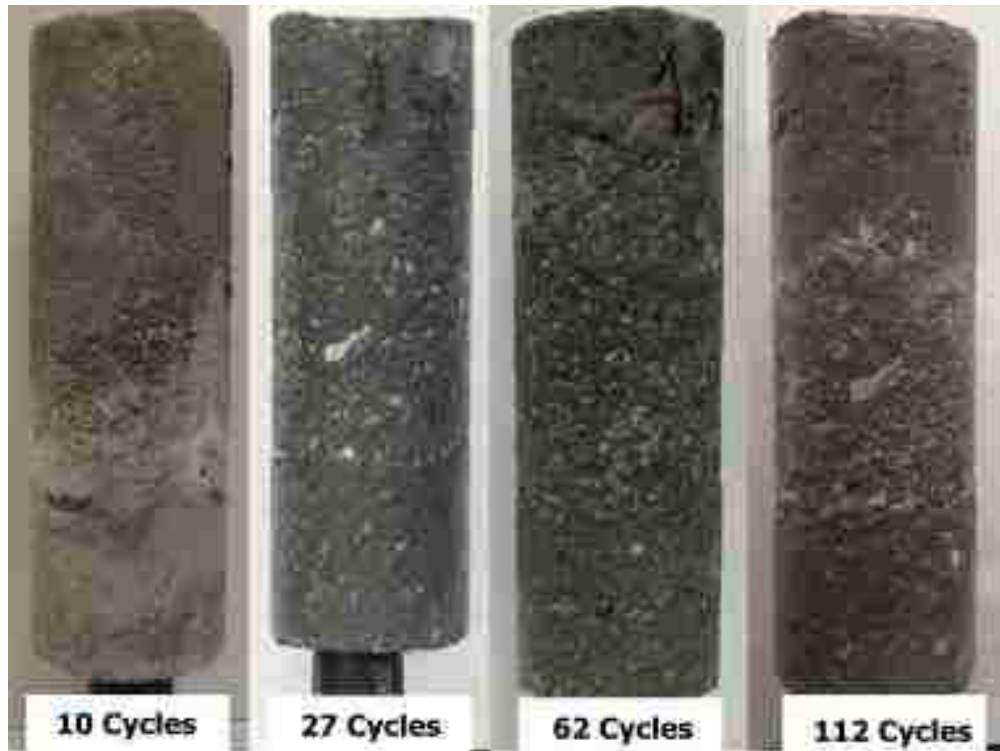
Figure 38 Damage in B-1 specimen at different ages of exposure.

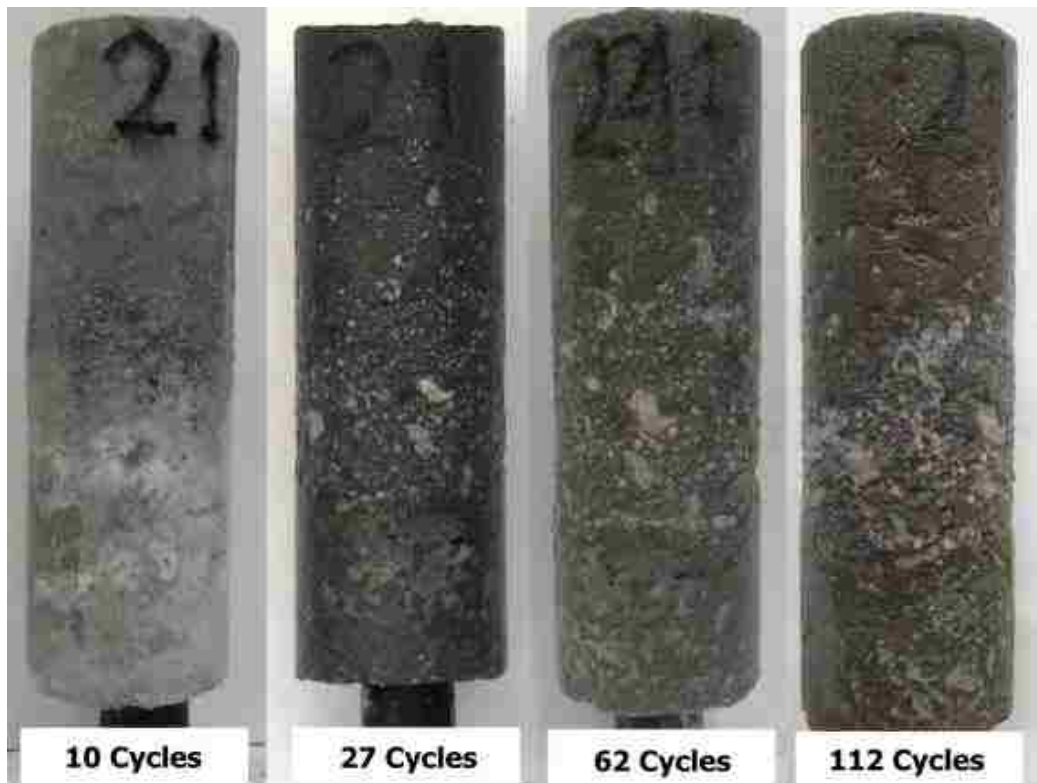
Figure 39 Damage in B-2 specimen at different ages of exposure.

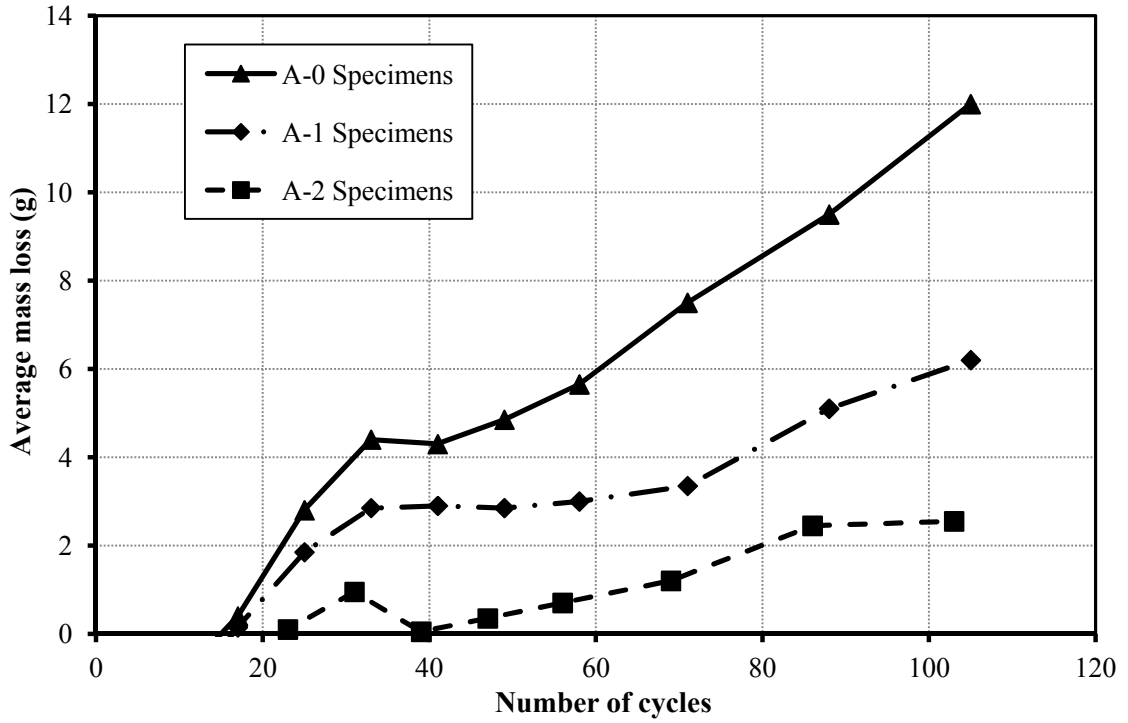
Figure 40 Average mass loss in Group A specimens partially immersed in sodium sulfate.

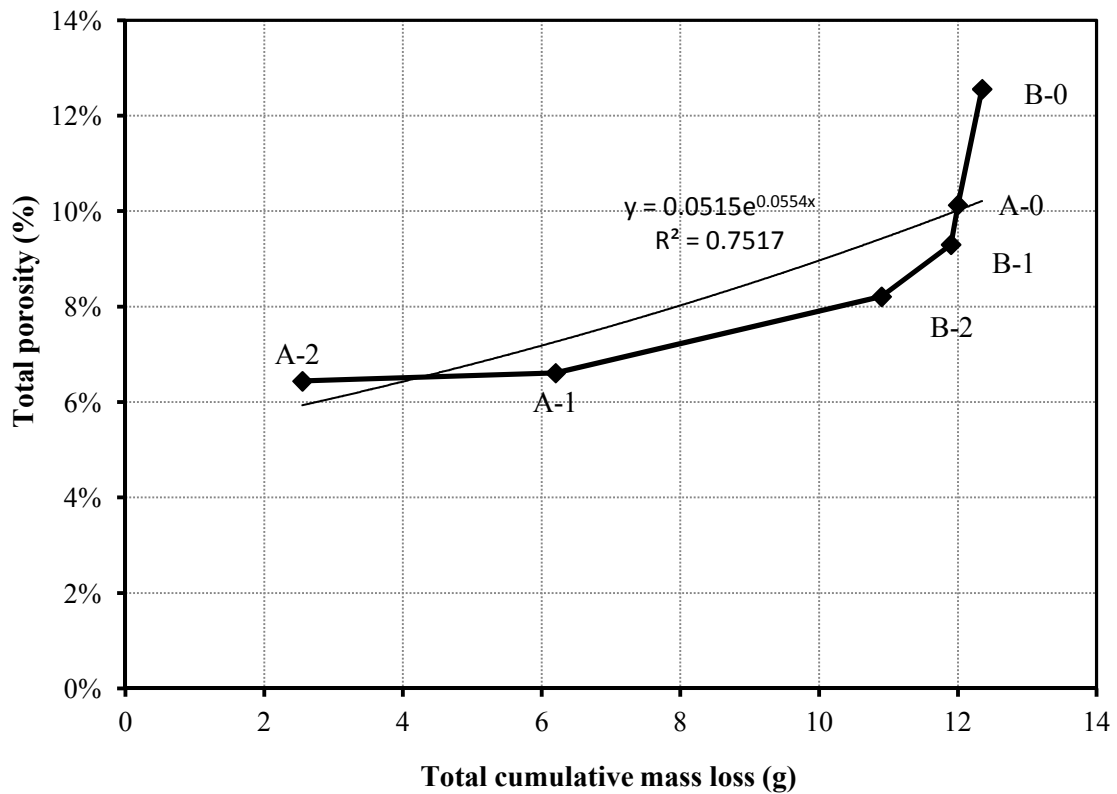
Figure 42 Relationship between total porosity and mass loss caused by PSA.

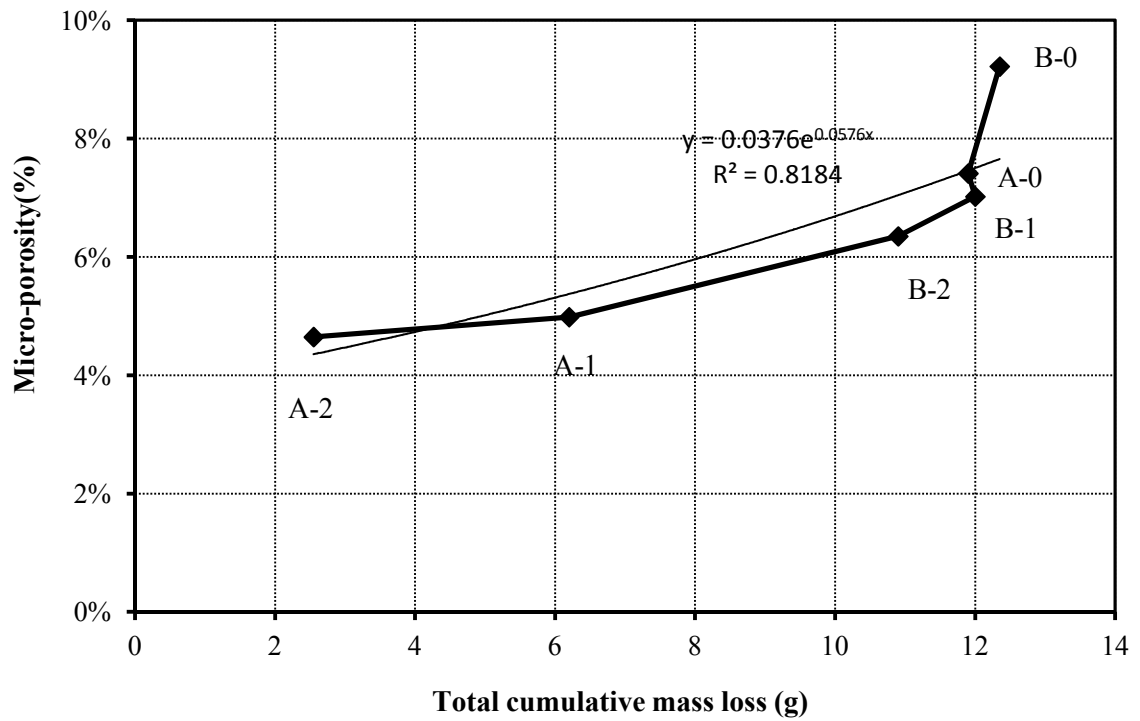
Figure 44 Relationship between micro-porosity and mass loss caused by PSA.

Figure 44 may emphasize the combined effect of total porosity and pore size on the damage caused by PSA. For instance, mixtures A-1 and A-2 experienced the lowest mass loss for all the tested mixtures although they had relatively high percentage of micro-pores (75% and 72%). However, taking into account their micro-porosity percentages (4.98% and 4.65%), they are considered as the lowest which conforms with the mass loss results. Moreover, mixture B-0 having the highest micro-porosity percentage (9.22%) experienced the highest level of damage in terms of mass loss.

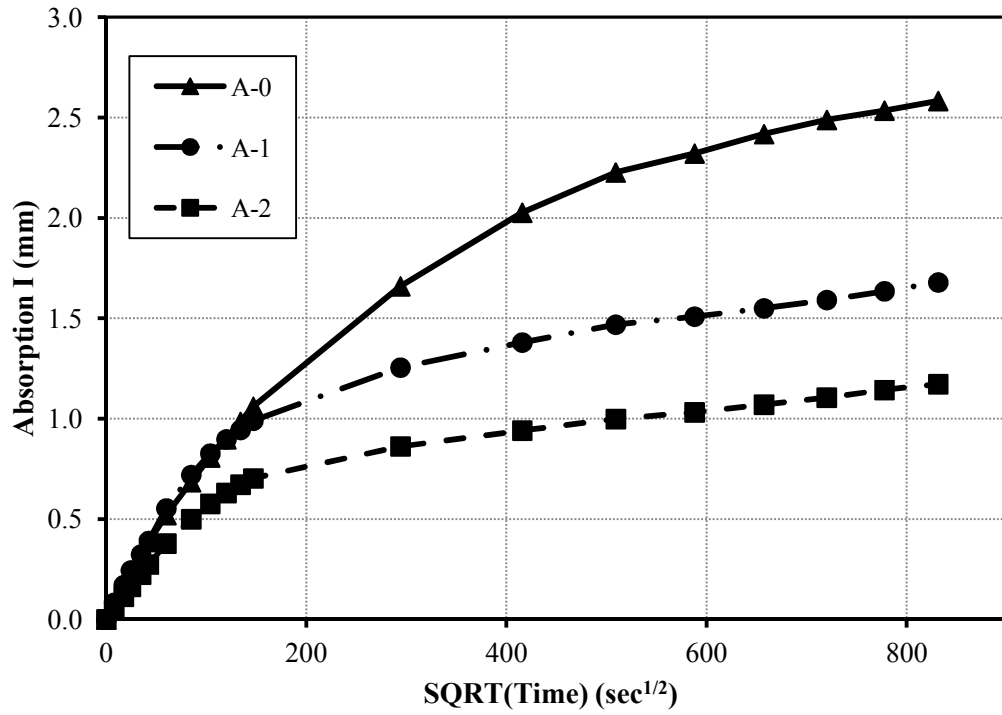
Figure 45 Absorption-time relationships for Group A specimens.

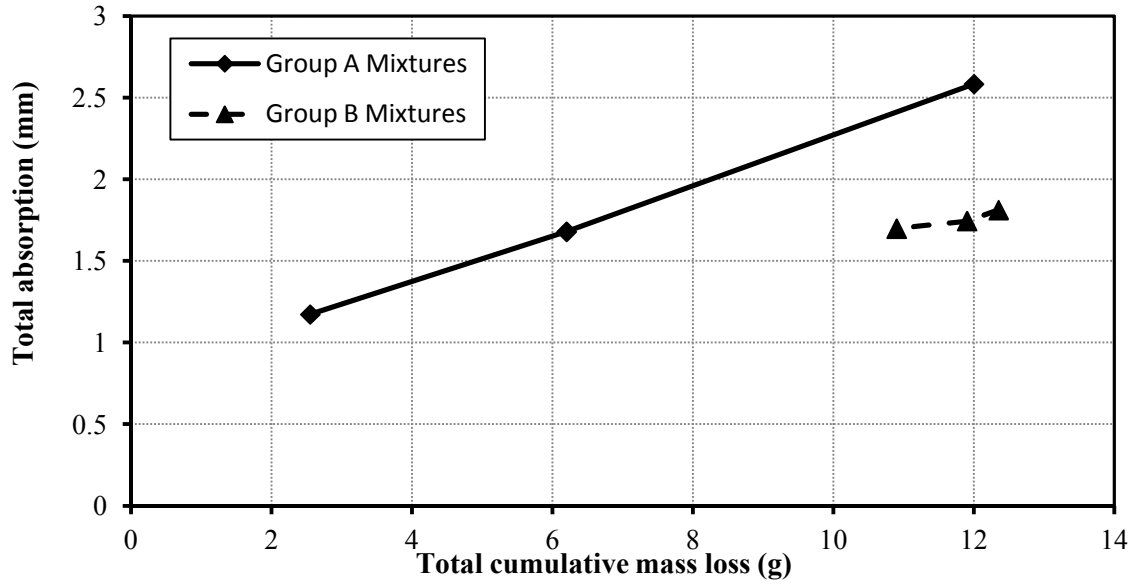
Figure 47 Total absorption related to the total mass loss due to PSA.

Figure 47 shows the relationship of the total absorption against the cumulative mass losses at the end of PSA exposure for the six tested mixtures. Generally, linear trends can be observed for both of the tested groups. For instance, for Groups A and B mixtures, the mass loss values at the end of exposure correlated to the total absorption with coefficient of correlation exceeding 0.99 and 0.94, respectively. These correlations indicate that the increase of absorbed solution during PSA exposure led to larger amounts of salt subflorescence which caused more damage at the specimens' surface above the solution for each of the studied groups of mixtures. Moreover, the relationship between the total mass loss caused by PSA and the initial and secondary absorption rates were also examined as shown in Figures 48 and 49, respectively. Realizing that the secondary absorption rate represents the relatively long term absorption behavior, it should be expected that this values should be related to the PSA damage. For Group A mixtures, the secondary absorption rates strongly correlate to the total mass loss (coefficient of correlation of 0.99). The initial absorption rates follow the same nearly linear trend, but at a lower correlation coefficient (0.86). Nevertheless, this correlation did not apply for Group B specimens as no obvious linear trend could be observed for those mixtures.

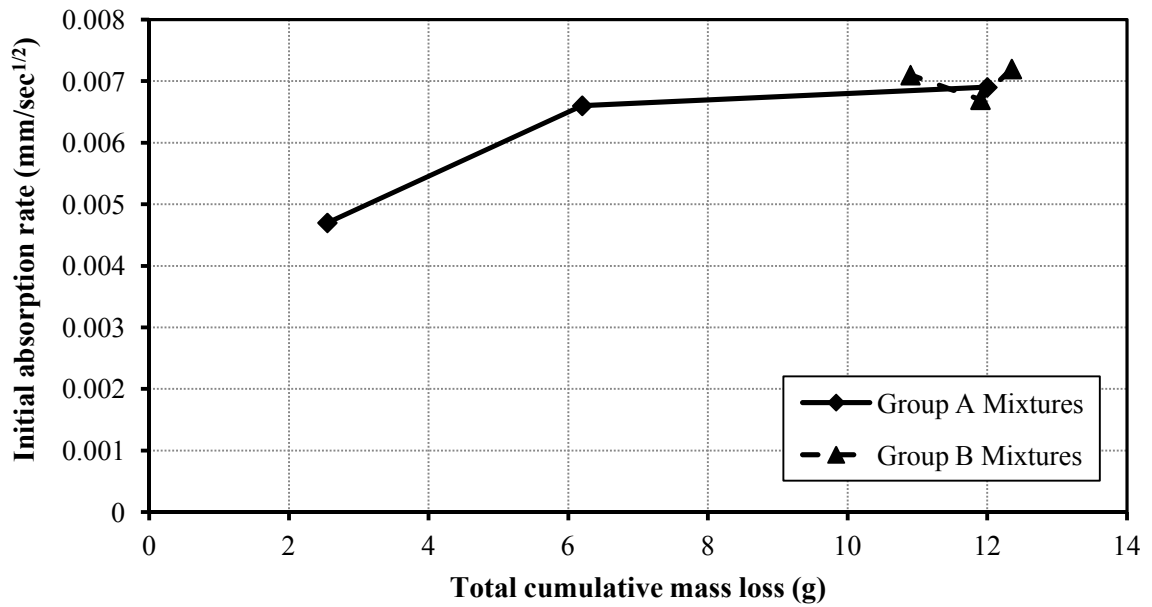
Figure 48 Initial absorption rate versus the total mass loss due to PSA.

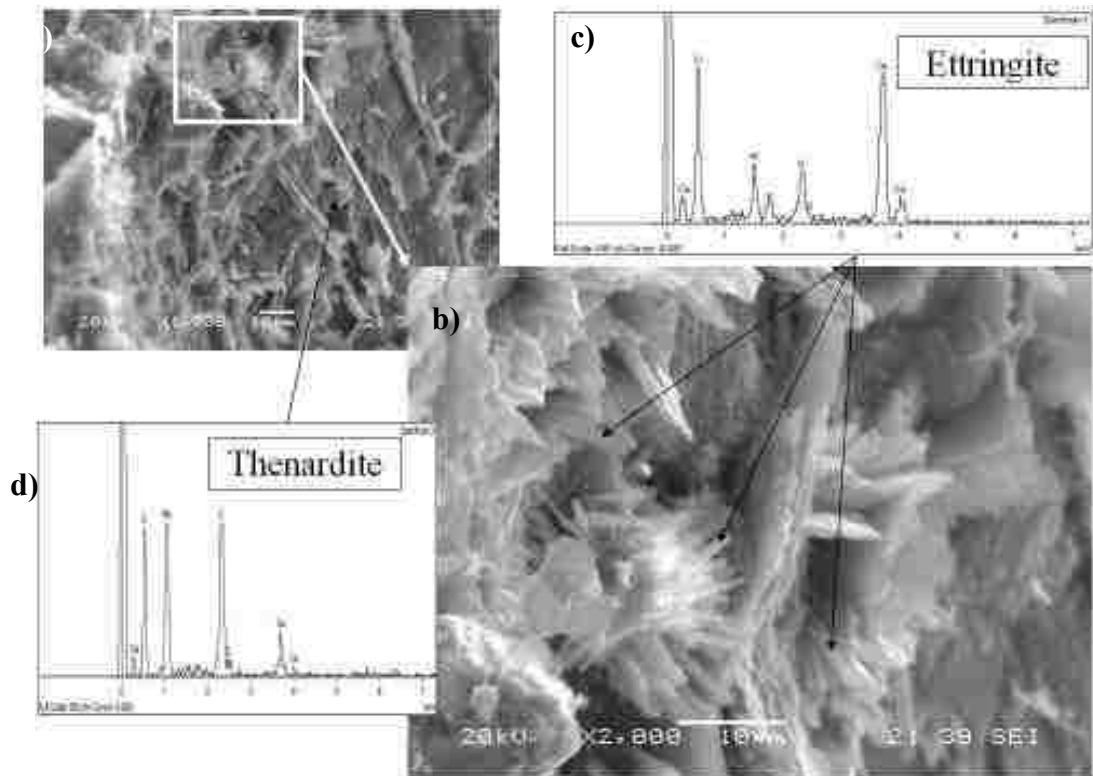
Figure 53 SEM micrographs and EDX spectra for a sample taken from the immersed portion of specimen A-2: a) 1000X magnification micrograph, b) 2000X magnification micrograph, c) EDX spectrum for ettringite, and d) EDX spectrum for thenardite.

sample taken from the immersed portion of specimen A-2 indicates the formation of ettringite crystals on the wall of the void although these crystals are relatively small and scattered. Furthermore, similar observation may be seen in Figure 55 which shows a sample taken from the immersed portion of specimens A-0. Gypsum crystals were also detected in some of the immersed samples less frequently (see Figure 56).

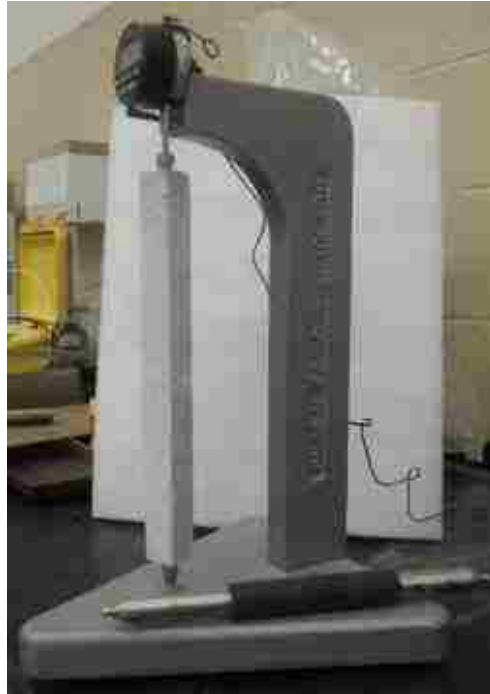
Figure 57 Length comparator and mortar bar specimen.

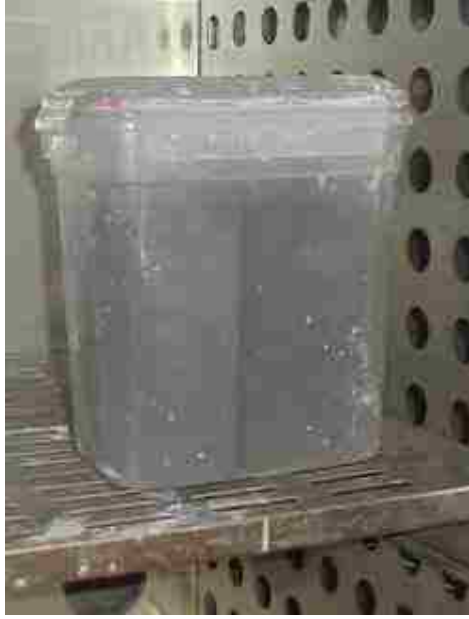
Figure 58 Containers and concrete cylinders inside the oven.

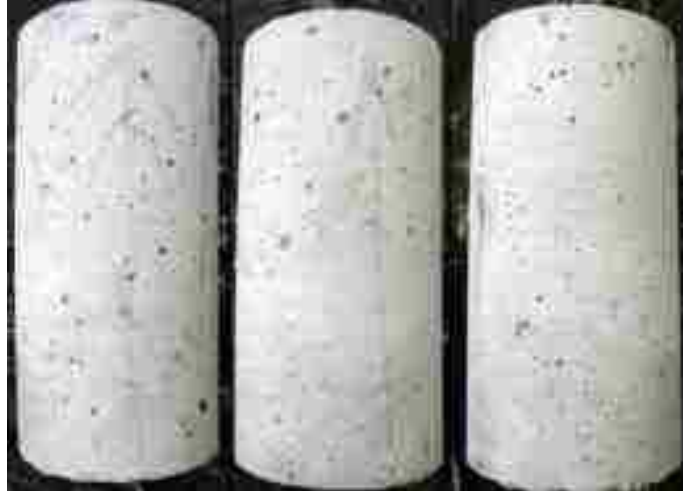
Figure 62 Concrete cylinders after 180 days of exposure.

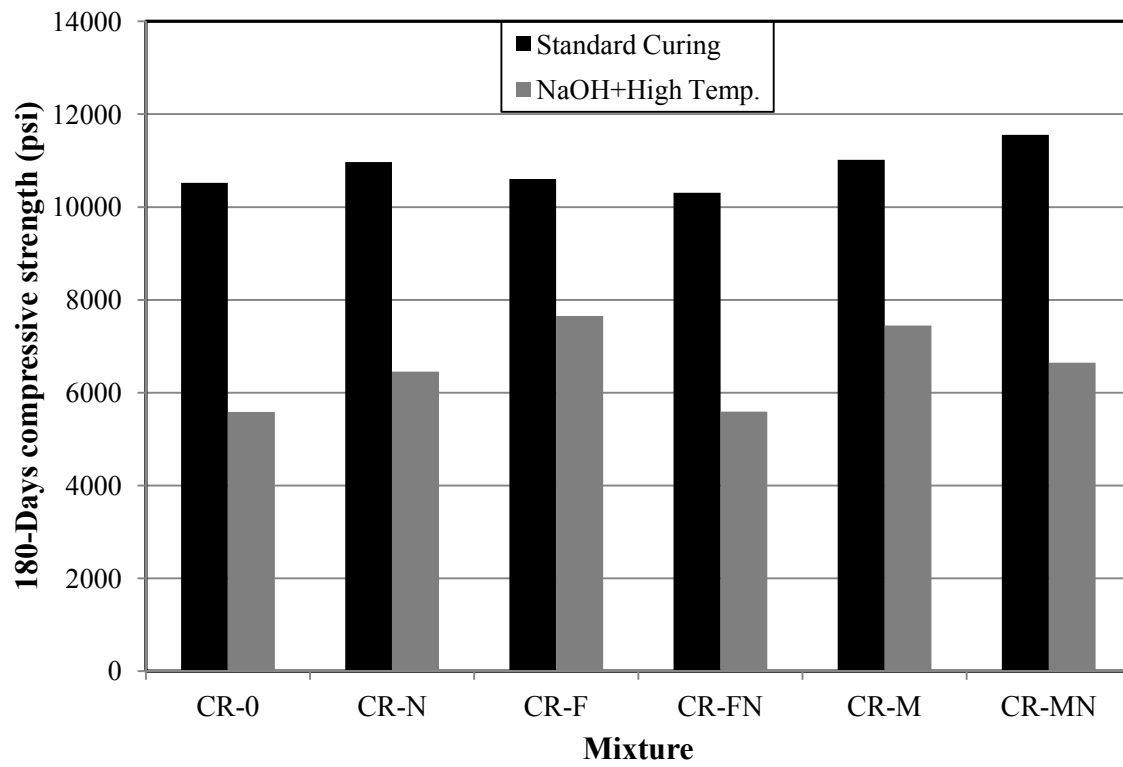
Figure 64 Compressive strength of concrete at 180 days.
