# Remote monitoring and security of covered bridges in the United States

A thesis submitted to the graduate faculty  
in partial fulfillment of the requirements for the degree of  
MASTER OF SCIENCE

Major: Civil Engineering (Structural Engineering)

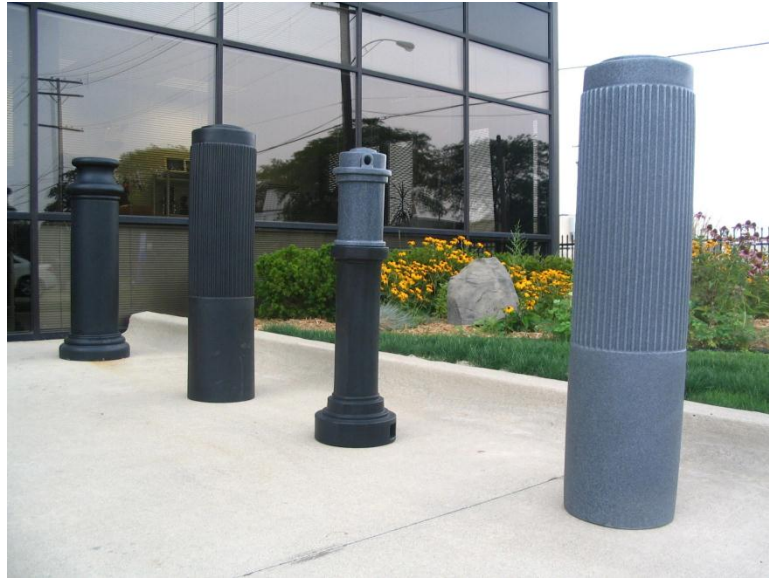
There are many types of bollards including fixed, removable, and retractable. A bollard is a cylindrical tube that is usually 12 to 24 inches in diameter and can vary on how far it sticks out of the ground. There is a wide range of material that the bollard can be including wood, concrete, steel, or plastic however plastic would not be a very suitable option for a covered bridge site.

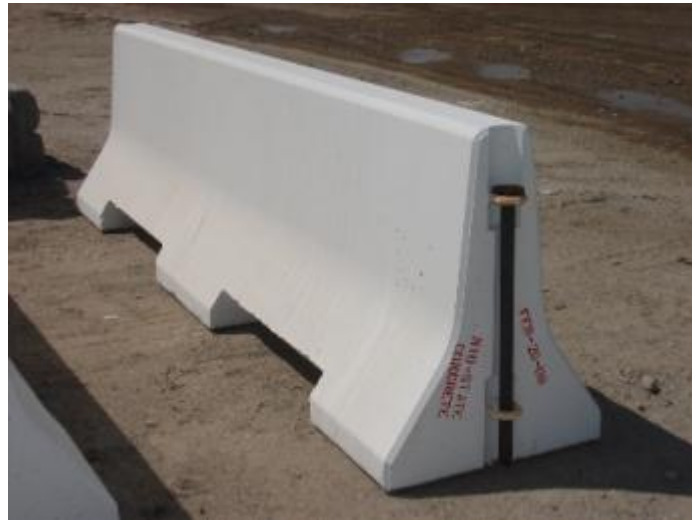
Also known as Jersey barrier since it was first used on the New Jersey Turnpike, K-rail is used to deflect motor vehicles safely. Due to the negative aesthetic impact on the bridge site the K-rail will more than likely not be an ideal solution for a barrier.

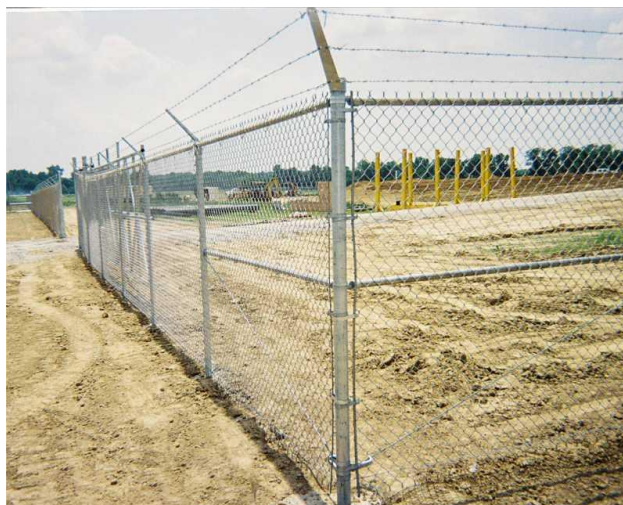
The fabric used for the chain link fence should be galvanized, aluminized, or plastic-coated woven steel. The fabric should be connected to the posts with the same gauge wire that the fabric itself is made out of. Therefore if the wire is constructed of 8 gauge steel then the wire connecting it to the fence post should also be 8 gauge. If a fabric is used that has openings larger than 2 square inches then the fence itself will be much easier to climb for intruders and should be avoided when possible. The use of privacy slats are commonly used with chain link fences but should be avoided on bridge sites since it allows intruders the ability to approach the fence without detection from the outside.

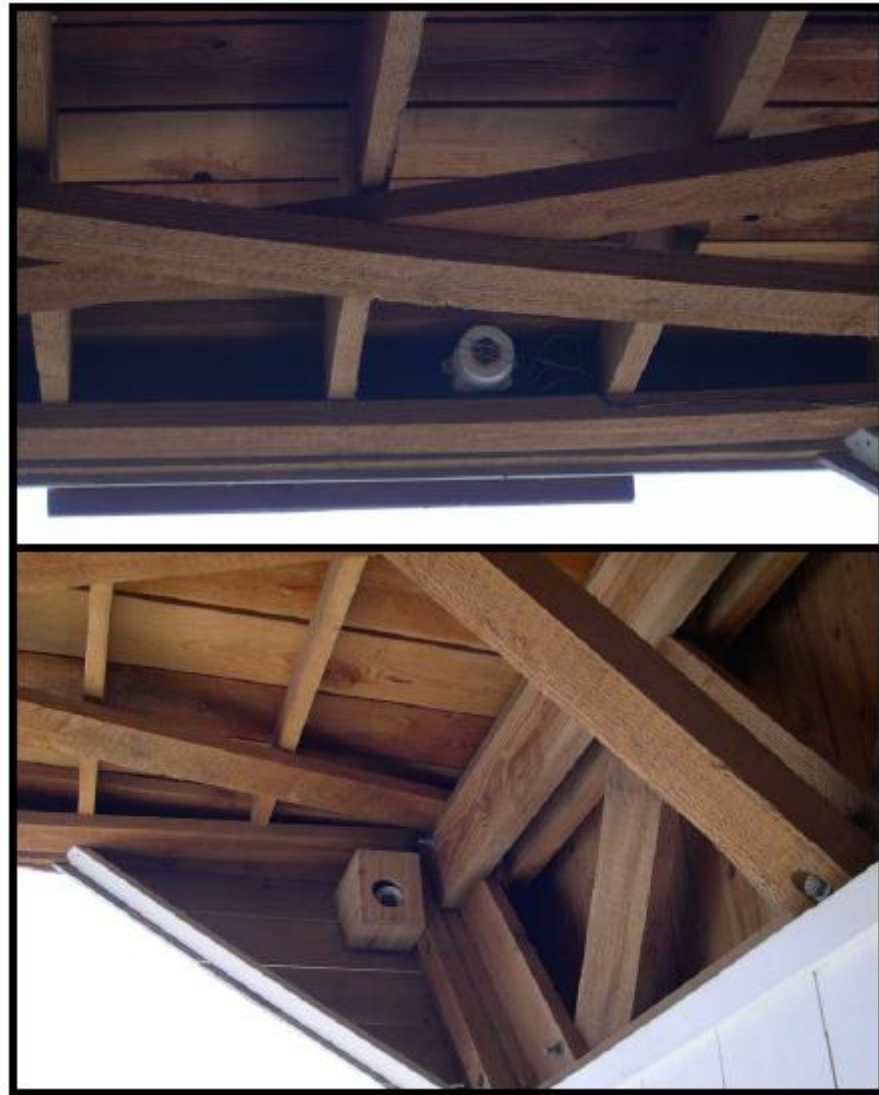
**Figure 9: Flame Detector in Covered Bridge without Encasement (top) and With Encasement (Bottom)**

box around the equipment in order to give the appearance of a bird house as seen in Figure 9. By using the same wood as the surrounding bridge members were built with, the flame detector is not as aesthetically distracting as it is without the use of an encasement system. The simple act of painting the existing encasement of equipment to match its surroundings can be beneficial and detract from its aesthetic impact.

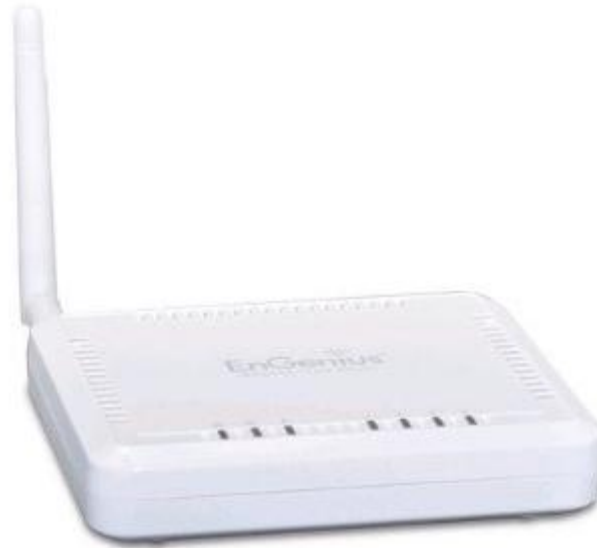
An 11G Wireless Nano Router (ESR-1221 EXT) was used in order to extend a wireless signal to the equipment being used on the bridge. This specific type of router has an upgradeable antenna for an increased distance in wifi area.

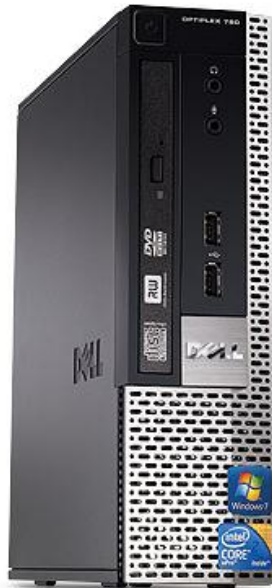
**Figure 11: Dell Optiplex 780 Personal Computer**

The personal Computer used on this project was the Dell OptiPlex 780 Small Form Factor and is used to monitor the entire system in real time. It is also used to store images that are taken by all cameras during the case of an alarm being set off.

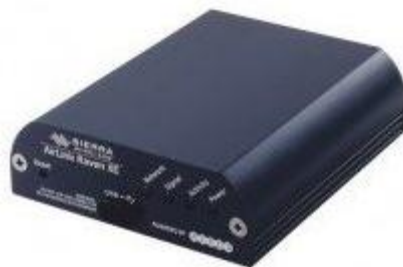
**Figure 12: Raven XE EV-DO Rev**

A Raven XE EV-DO Rev is used in addition with an antenna to act as a wireless cellular broadband modem so that all information can be accessed wirelessly from remote locations.

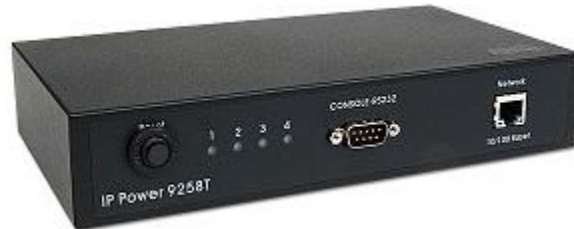
**Figure 13: Web Based Remote Power Switch**

The RPS-ESP-IP Power 9258T with Deltronix Tier 1 Software/Firmware installed was used

to allow personnel to remotely control (4) outlets at one time. This specific type of remote power switch has a timer function allowing a reboot or shut down times without any monitoring by in-field personnel.

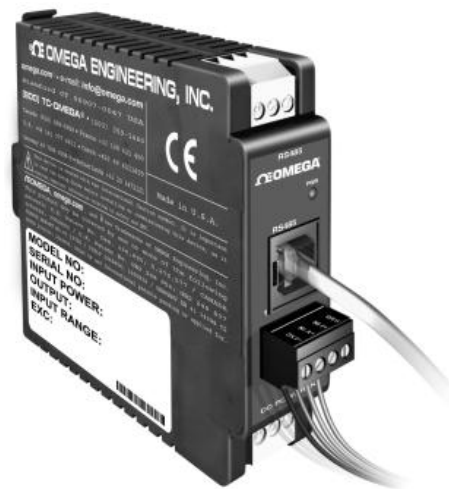
**Figure 15: Omega IDRX-PR Signal Conditioner**

Two Omega IDRX-PR signal conditioners are used for every flame detector at all bridge sites. There are two per flame detector in order to reduce false positives.

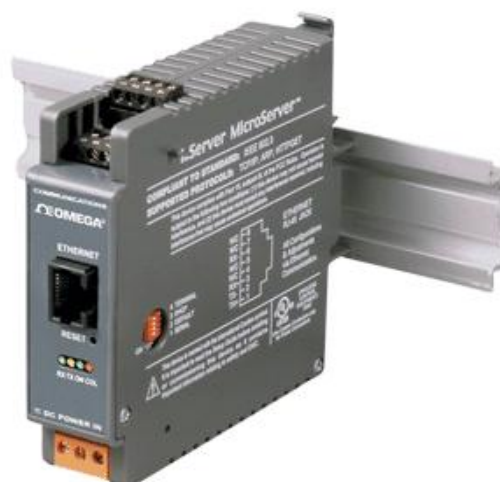
The Omega EIS-2B Microserver was used on this project in order to connect the signal conditioners to the wireless connection.

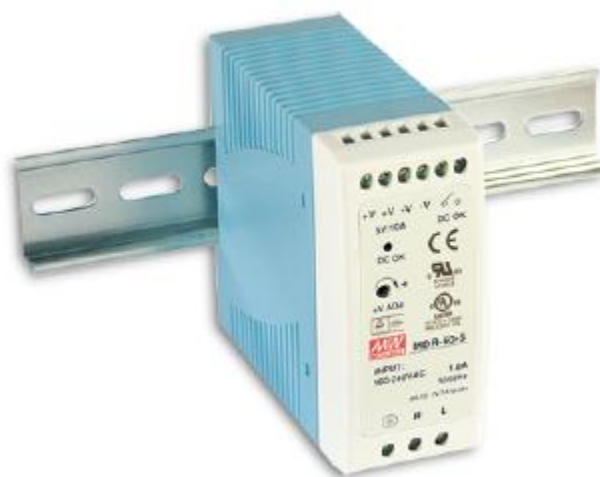
**Figure 17: MDR-60-24 Power Supply**

A Mean Well MDR-60-24 power supply was used to power both of the flame detectors and a Mean Well MDR-10-5 was used to power the relays in both of the flame detectors.

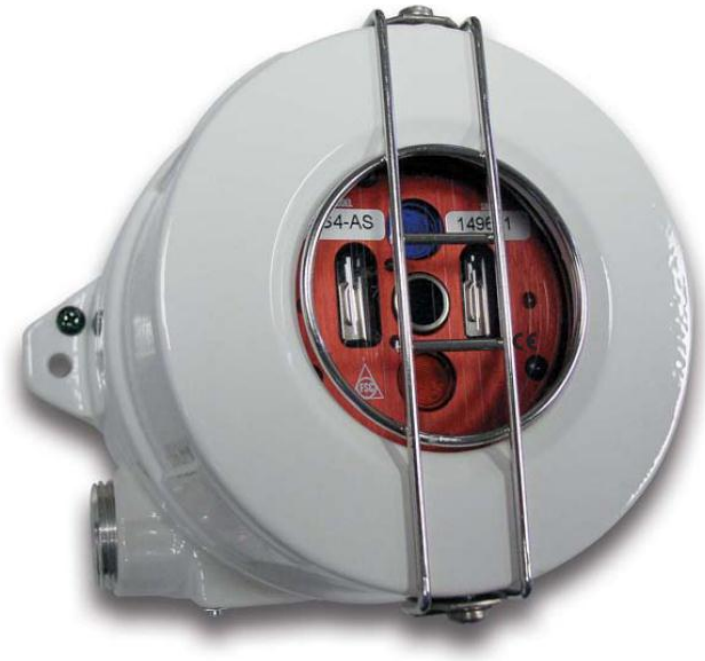
The flame detector decided upon for this project was the SS4-A Multi-Spectrum Electro-Optical Digital Fire Detector from the Fire Sentry Corporation. This camera senses radiant energy in the ultraviolet (UV), visible, and Wide Band Infrared (IR) spectrums within a 120° of vision. The settings for the flame detectors were set at the 50' to 60' range since most of the bridges are roughly 100' to 120' long from opening to opening.

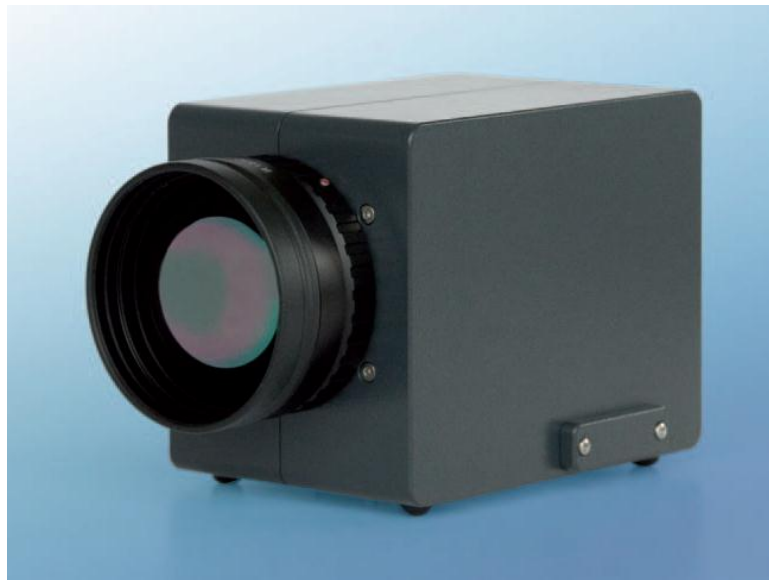
For this project there was only one infrared (IR) camera per bridge that was positioned at a certain distance from one bridge entrance, usually within 50-150 feet to nearest entrance of the bridge. The infrared camera used on all five bridges was the IR-TCM 384 HiRes IR Camera Module from Jenoptik. This camera has the ability to produce thermal images in real time of 384 x 288 pixels. An encasing that was provided by Jenoptik was used in order to protect the camera from the elements as well as individuals who would want to damage the camera with projectiles or through other measures. The enclosure for the IR camera had a glass lens that was coated in germanium for optimum performance.

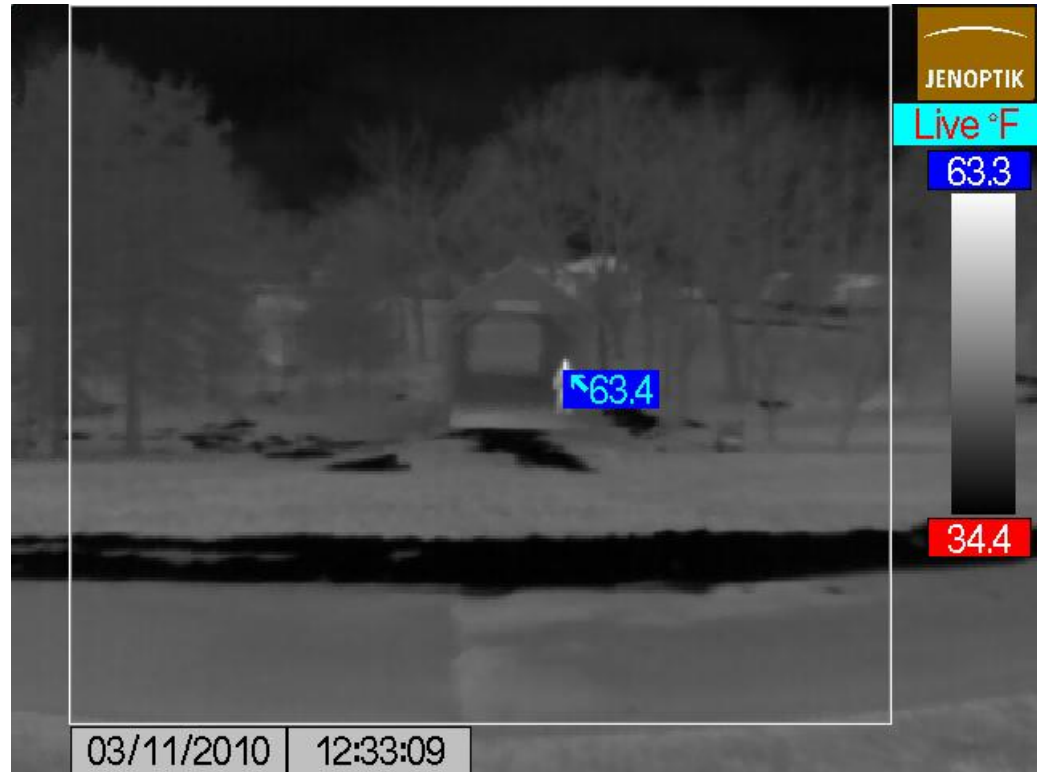
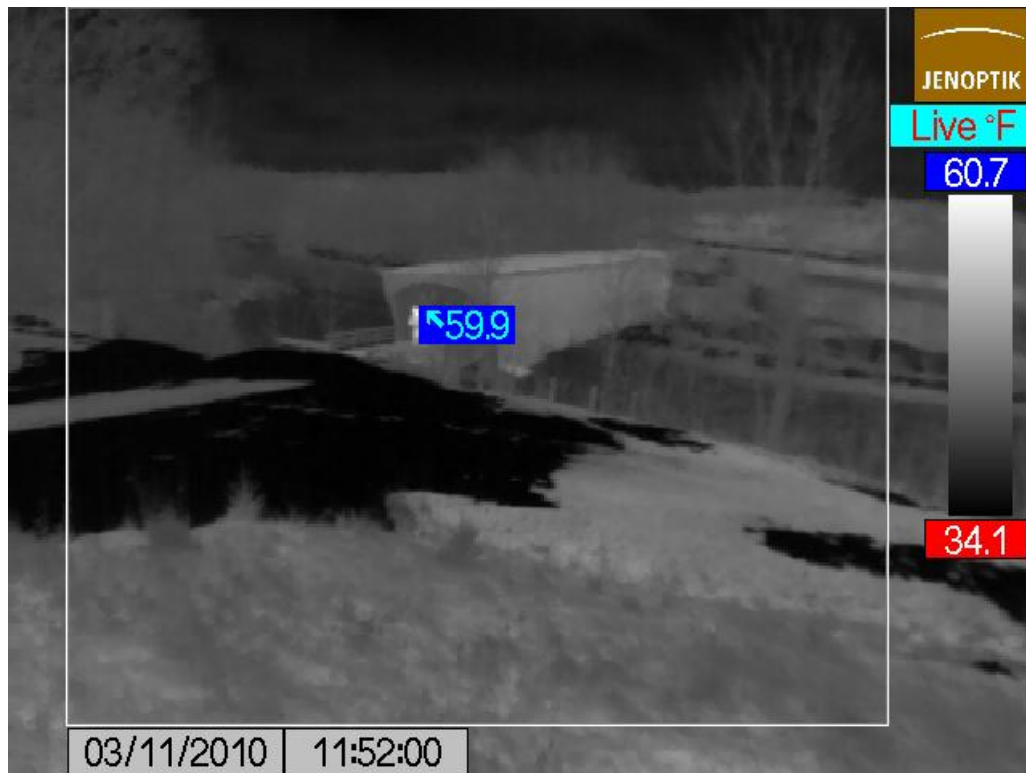
Figure 22 and Figure 23 show the image that the IR camera produces. It produces the date and time as well as the spectrum of temperatures within it's field of view including high and low temperatures. For each of these bridges there is a person standing within the opening of the bridge and the IR camera points out this area of increased temperature when compared to it's surroundings with an arrow and a box with the temperature in it. If these maximum temperatures reach a certain threshold then then IR camera can set off an alarm.

Figure 22: Infrared Camera Image at Cutler-Donahoe Bridge

**Figure 23: Infrared Camera Image at Holliwell Bridge**

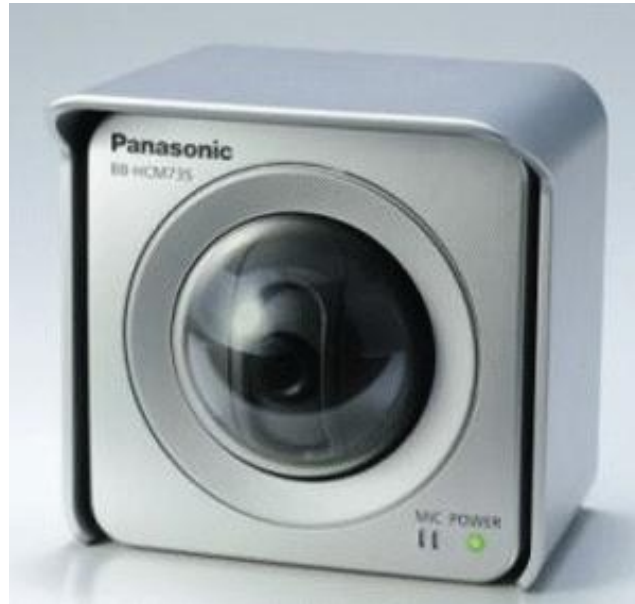
Directly next to the Infrared Camera there was an Optical Camera placed at every bridge. The Optical Camera provided a similar service as the Infrared Camera except instead of providing images in the infrared light range they provided images in the visual light range. These images were also transmitted in real time over the internet. The camera chosen for this project was the Panasonic BB-HCM735 which is designed for outdoor use so no enclosure was required before installation. This camera has the ability to pan and tilt through remote controls that could be controlled via internet connection. Further specifications about this camera can be seen in Figure 80.

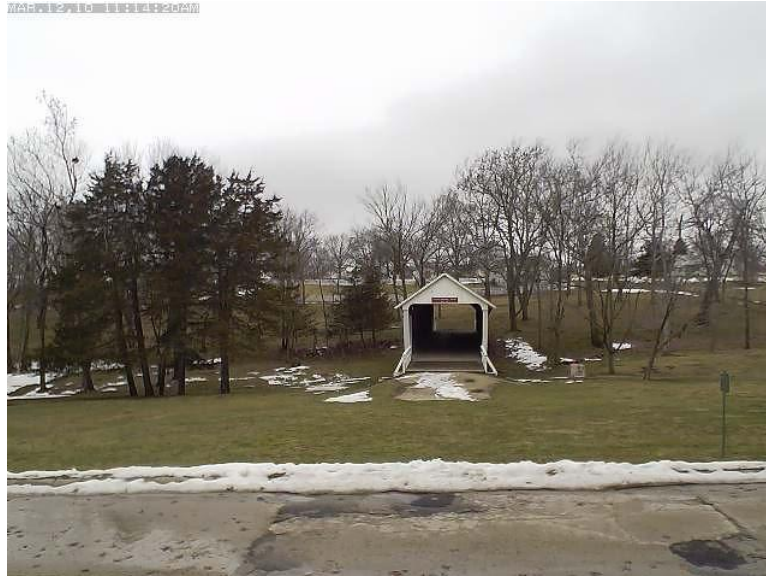
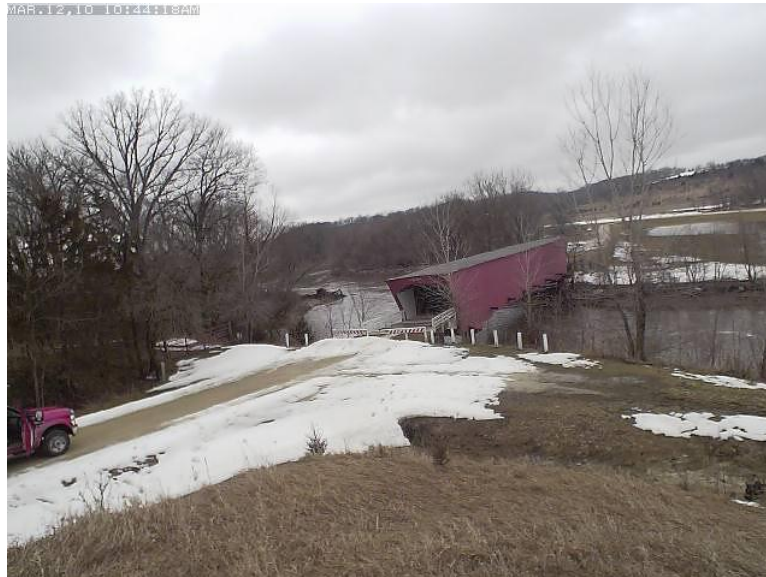
Figure 25 and Figure 26 show the image that the Panasonic optical camera produces. Compared to the IR camera this image is pretty basic and is used for simple surveillance purposes. When an alarm is set through the IR camera of flame detector the optical camera will record video for a specified amount of time and store it for future viewing so personnel can see what caused the alarm to trigger and to have video evidence of any individuals who may be on the bridge during times when the bridge is closed.

**Figure 25: Optical Camera Image at Cutler-Donahoe**

**Figure 26: Optical Camera Image at Holliwell**

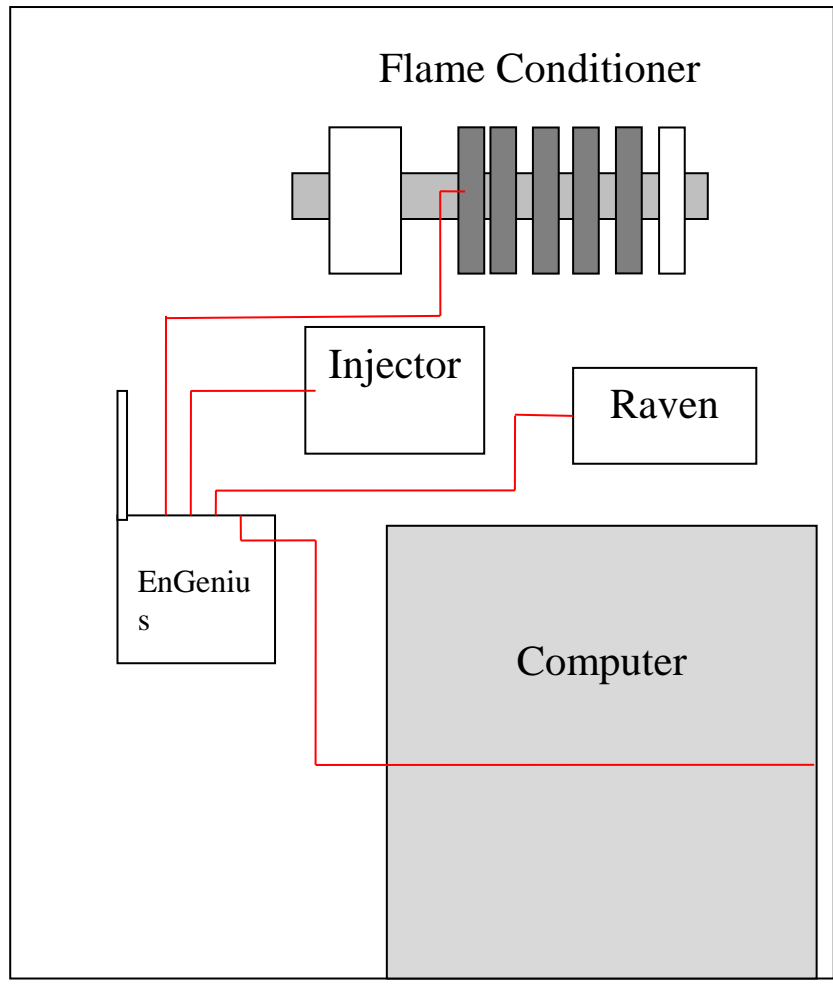
Figure 27: Box Layout for NEMA Enclosure

there would be considerable room for expansion but after placing everything inside the box in the field it proved to have very little extra room with the inclusion of all wires and power supply cords. This can be seen in Figure 28 with the actual in field layout of the NEMA enclosure. The extra box that is located within the enclosure that is not shown in the sketch is a power switch that is used to remotely switch different equipment on and off in case of a malfunction or a false positive.

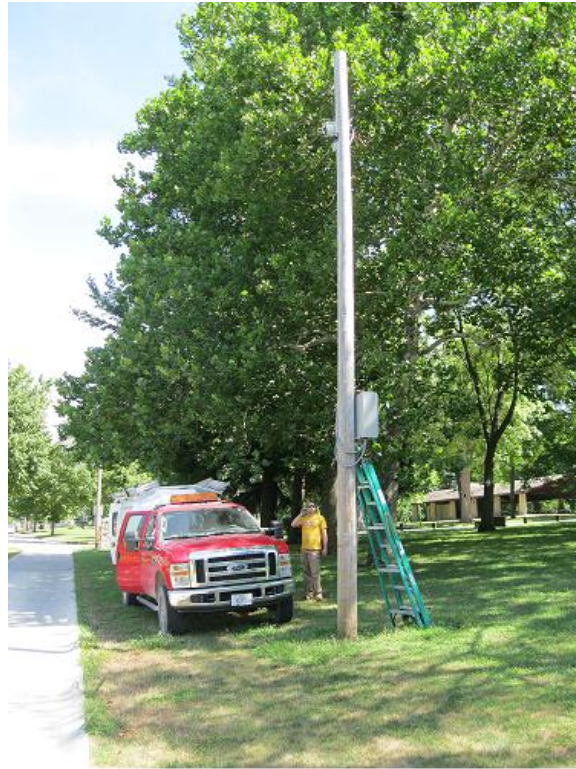
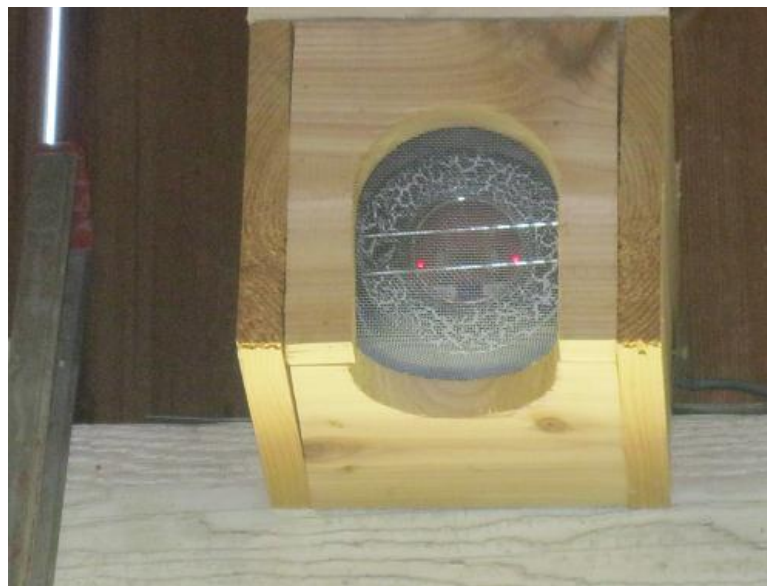
The flame detectors for this particular bridge were required to be placed in the middle of the openings because of the architecture of the bridge. This caused multiple problems since cross members tended to get in the way of a direct line of site for the detectors. Other bridges allowed side mounting of the flame detectors so that cross members and other structural members did not inhibit a direct line of a site and were of optimum efficiency. It is essential when installing all equipment both in the bridge and around the bridge site to balance the aesthetics of the bridge site with the functionality of the equipment.

**Figure 30: Cutler-Donahoe Pole**

**Figure 31: Cutler-Donahoe Flame Detector that is set off**

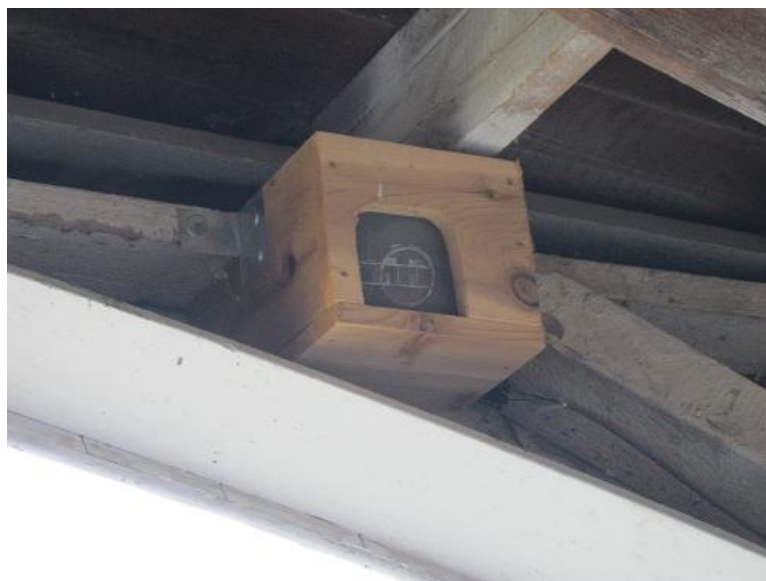
The Hogback Covered Bridge proved to be the most difficult bridge out of the five completed on this project. Due to the isolation of this particular bridge it was equivalent in price to run the electric from the local municipality to the bridge site as it would be to set up a renewable energy system that utilized the solar and wind power in the area. Neither the BEC nor the County of Madison had ever tried to develop such a large, stand alone alternate energy system prior to this project so there were initial uncertainties of such an undertaking. After discussion it was decided to use alternative energy sources with the aid of professionals within the industry of renewable energy. As seen in Figure 32 and Figure 34 it was required to have 3 more NEMA enclosures for the renewable energy equipment and a 60 foot pole to house the solar panel and wind turbine. All of this equipment will be discussed in the following section.

**Figure 32: Hogback Enclosure Set Up**

**Figure 33: Hogback Flame Detector**

**Figure 34: Original Hogback Pole**

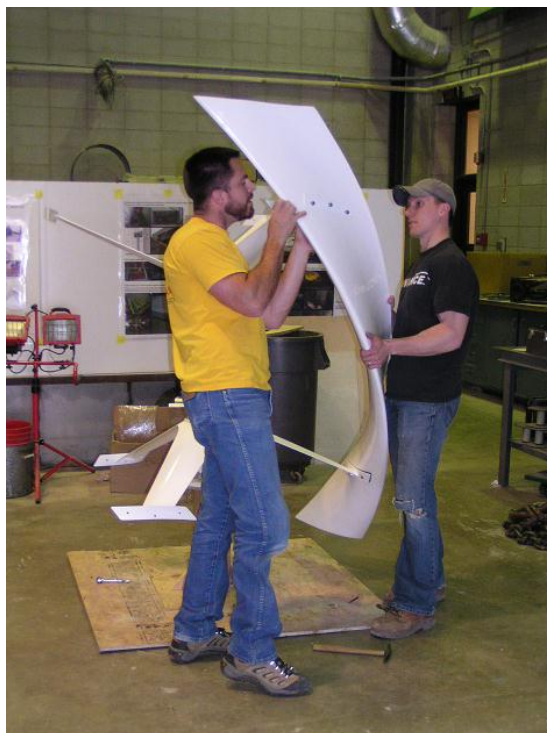
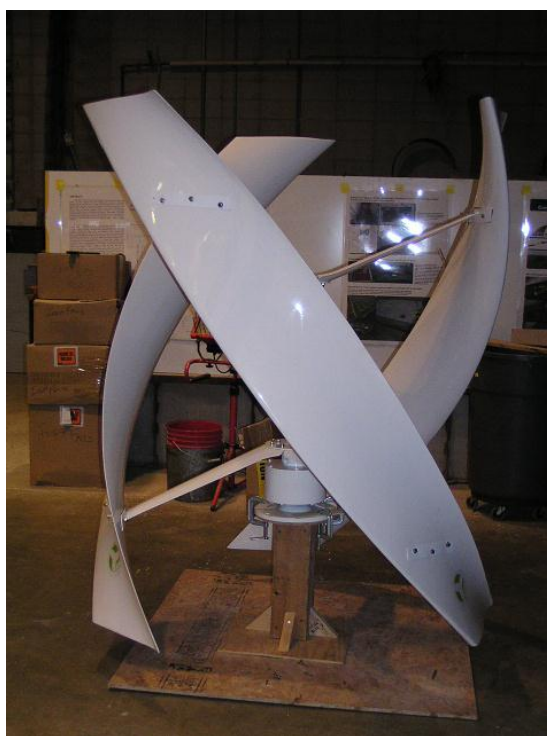
Figure 36 shows the construction of the wind turbine within a laboratory setting for testing of power output at different wind speeds. For a frame of reference the BEC employee in the yellow shirt in Figure 36 is approximately 6 feet tall. The BEC had the unique privilege of having ties with the Aerospace Engineering Department's Wind Tunnels at ISU so laboratory testing was practical in this situation. The testing proved inconsequential since the wind turbine could not fit within the actual wind tunnel and had to be placed in the exhaust section that could only produce wind speeds of roughly 19 miles per hour. Even with the approximate 19 mph winds coming from the wind tunnel we were unsuccessful in getting the wind turbine to 'cut in', or begin spinning from a stop, by itself. If the wind turbine was just lightly nudged with a finger however, the turbine would begin to spin and continue to spin with the wind tunnel on. It is believed that the air flow coming from the wind tunnel exhaust is not an adequate representation of the wind flow in an exterior setting. Figure 37 shows the complete assembly of the wind turbine in the laboratory setting.

**Figure 36: Assembly of 600 watt VAWT**

**Figure 37: Full Assembly of 600 watt VAWT**

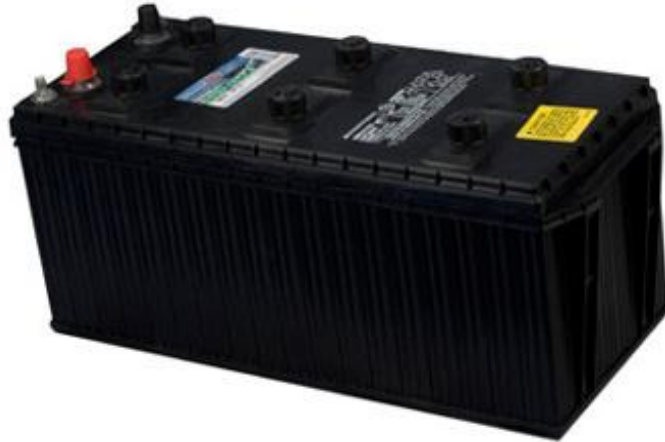
bank could provide power to the security system for up to 32 hours without charge from the wind and solar and with the security system running at 100% usage.

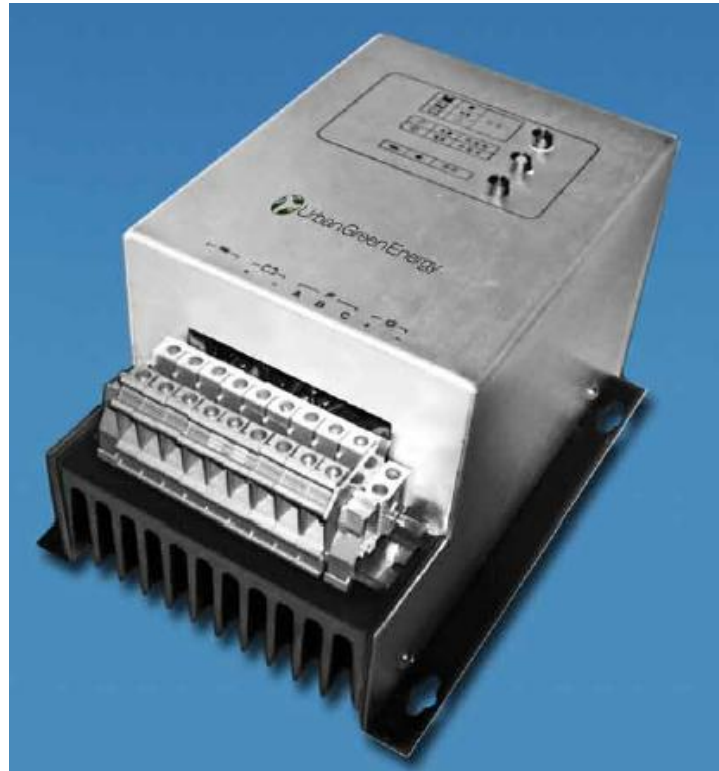
The controller used for this project was a UGE off-grid controller designed specifically for the 600 VAWT. The function of the controller is to take the variable 3-phase AC output from the permanent magnet generator and convert it to a stable 24 volt DC output to charge a battery bank. The controller also manages the turbine so that it performs safely and optimally. Figure 82 and Figure 83 show the specifications and drawings for the off-grid controller used in more detail.

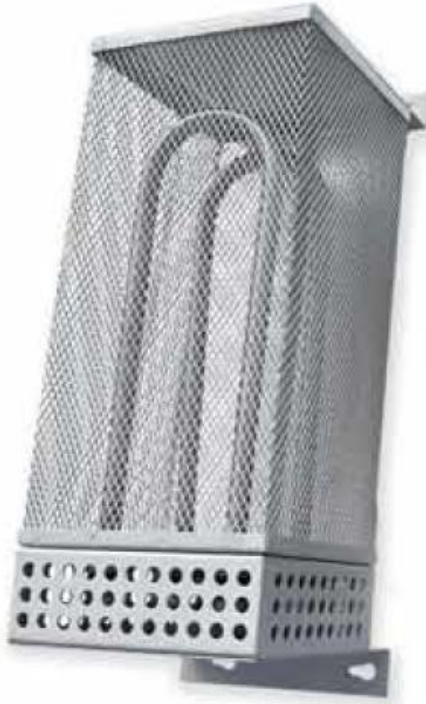
The diversion load is designed specifically to work with the controller for this particular set up. If there is too much charge coming from the wind and solar units at any given time the excess power goes to the diversion load which dissipates the power through the form of heat. This piece of equipment is essential in order to not over charge the system and potentially destroy the controller or batteries.

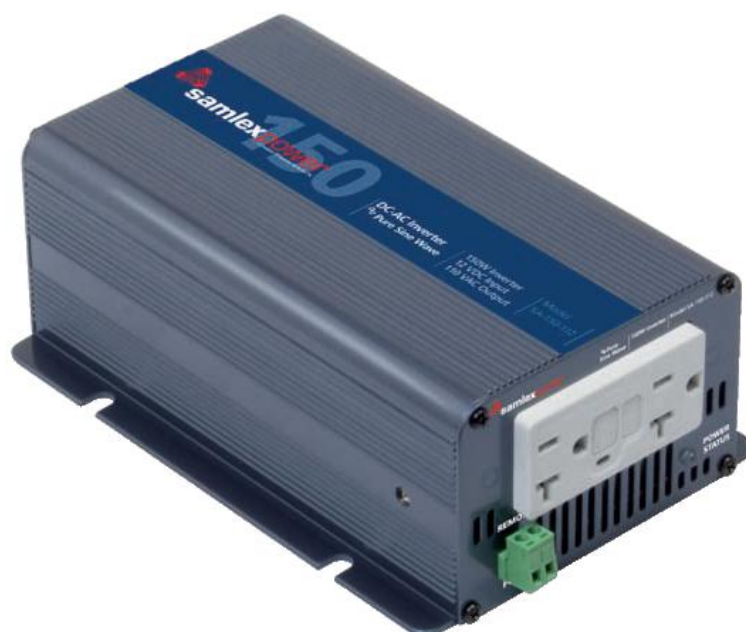
The inverter used for this renewable energy system was the Samplex America 300 watt, 24 volt DC-AC pure sine wave. As mentioned earlier in this report, it is essential that a pure sine wave inverter is used to have an adequate power supply. The efficiency of the inverter was 89% therefore there was an 11% loss between DC to AC which was calculated for in the sizing stages so that the loss did not affect the security system. Figure 84 shows the complete specification sheet for the inverter used as well as the specifications for the 12 volt version.

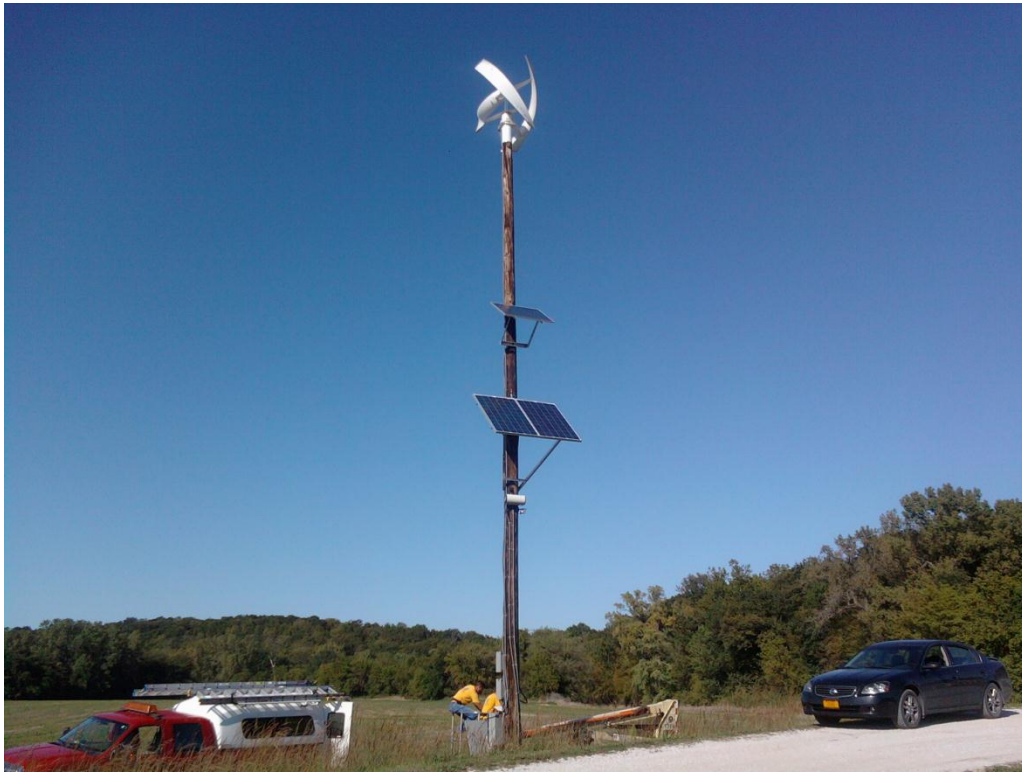
**Figure 43: Modified Renewable Energy System**

After installation of the renewable energy there were multiple problems with the power output of the system. It was found that the system could not support the monitoring system that had been installed for more than four to five days. It was decided to slowly start expanding upon the renewable energy system while trying to decrease the power demand from the monitoring system by turning off certain pieces of equipment during the different times of the day. The first change to the system was the addition of (2) 230 watt Conergy solar panels as well as a Morningstar controller that was used solely for these two solar panels. The specifications for these pieces of equipment can be seen in Figure 85 and Figure 86. Figure 43 shows the modified renewable energy system with the added solar panels. It can be seen from this photo that the extra solar panels are relatively large when compared to the original solar panel but have been successful thus far.

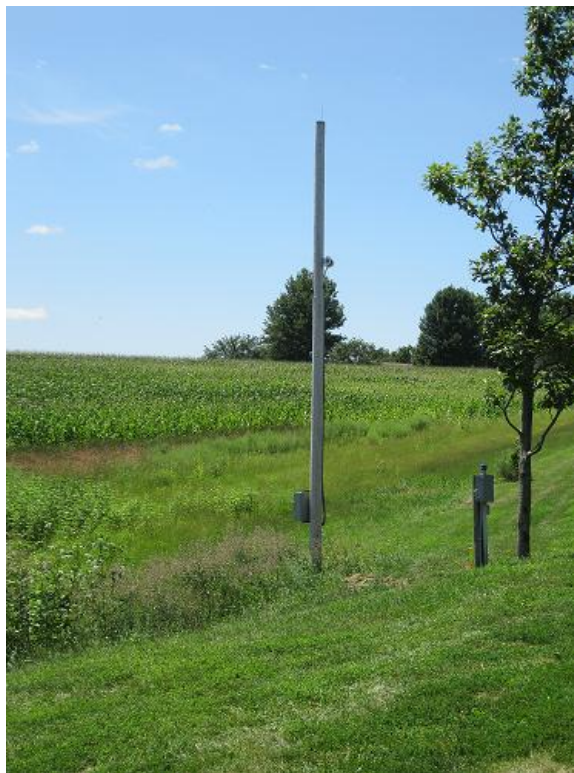
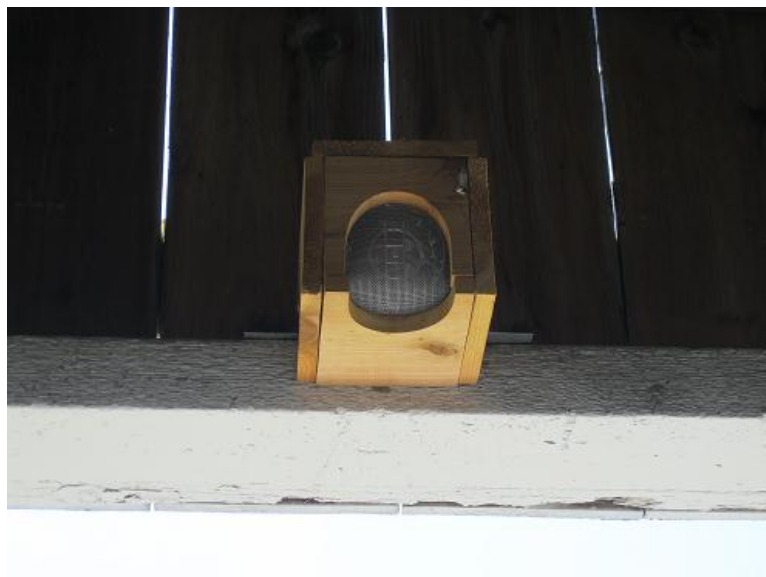
The Imes Bridge used an existing pole that was moved roughly 20 feet from its original position. The NEMA enclosure was placed at chest height which proved to be the most efficient height for protection while still allowing access into the enclosure with ease. Figure 48 shows the flame detector placement which closely resembles the Cutler-Donahoe set up in the middle of the bridge opening. There was existing power for street lamps roughly 50 feet away that was hand trenched to the pole.

**Figure 47: Imes Pole from Bridge**

**Figure 48: Imes Flame Detector**

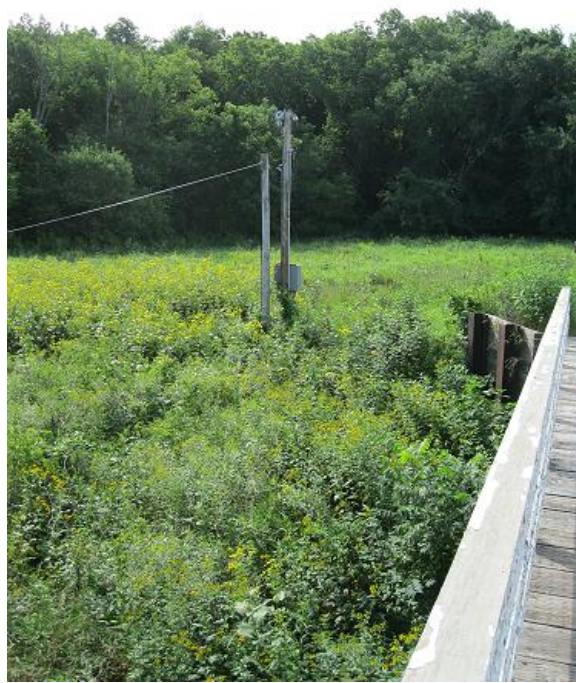
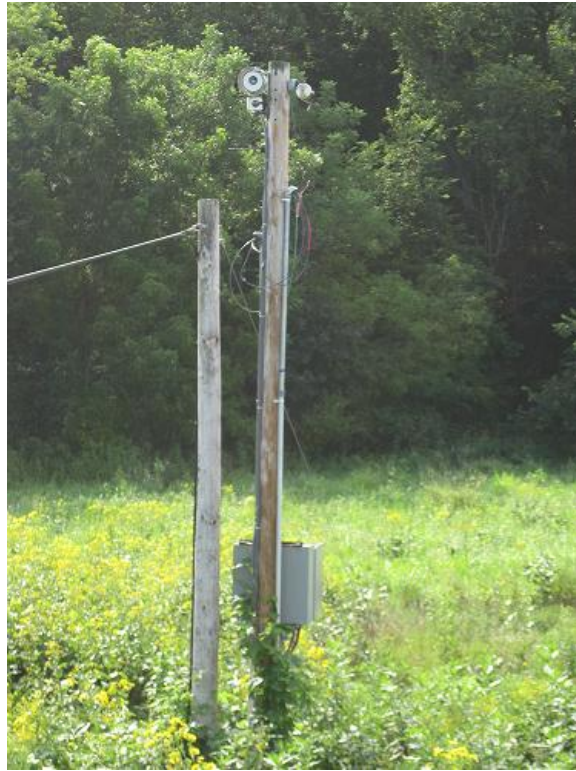
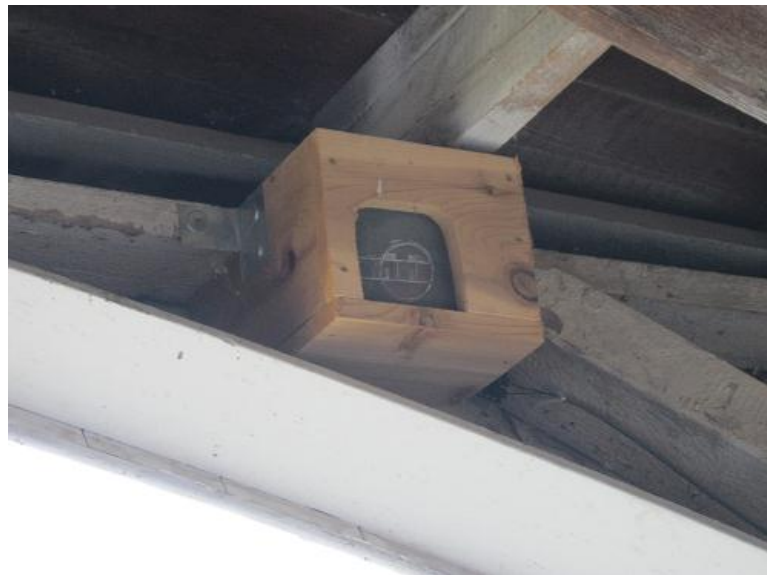
in an optimum position that already had power ran to it from a previous project. This allowed for minimum disturbance with the aesthetic value of the bridge site since very little had to be changed in order to install the security system. Figure 51 shows the positioning of the flame detector which is halfway between the middle of the opening and the side of the bridge. Because of the architecture of the bridge this proved to be the optimum position for the flame detectors with direct line of site to the middle of the bridge.

**Figure 49: Roseman Pole from Bridge**

**Figure 50: Roseman Pole**

**Figure 51: Roseman Flame Detector**

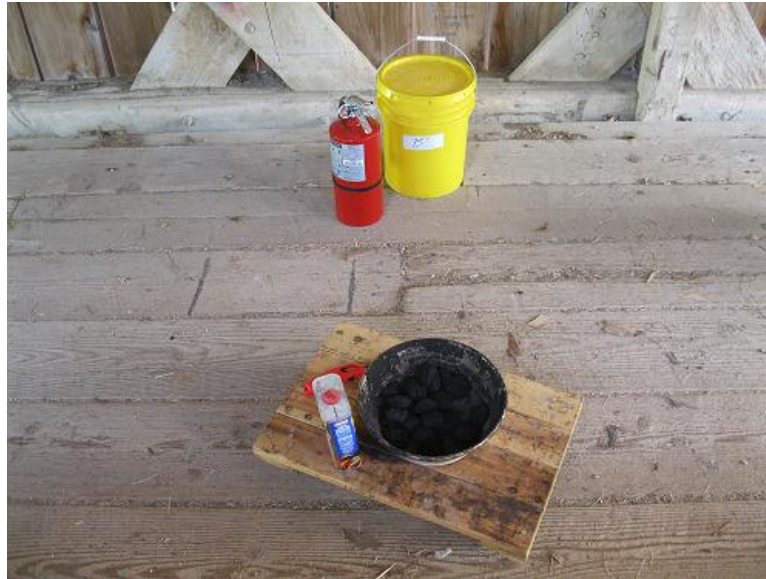
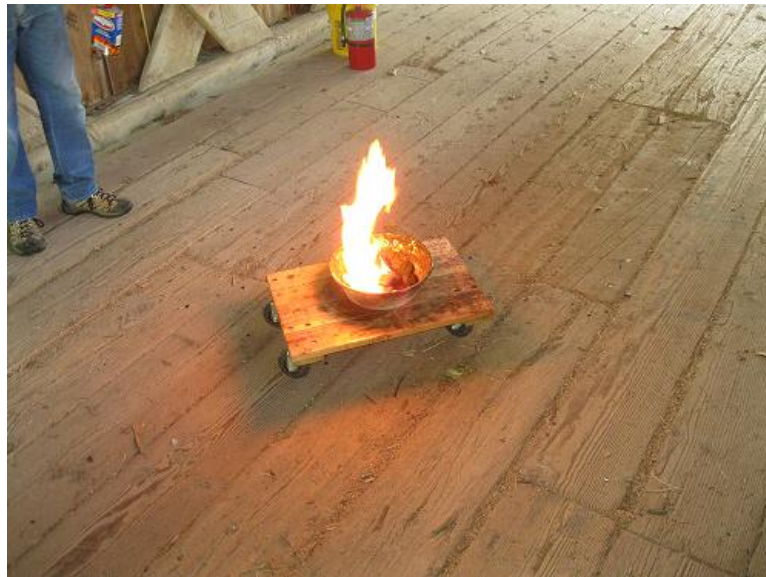
The test started in the middle of the bridge span directly between the two flame detectors on either end. For some of the detectors to be set off the fire had to be pushed roughly 10 feet towards the end of the bridge due to direct line of site limitations to the center of the bridge. There was problems with 4 of the flame detectors and were returned to the manufacturer but they were promptly replaced and in functional order. These problems could have been due to wiring problems inside of the NEME enclosure because of poor wire schematics. It is essential to fully label and follow all wiring diagrams to ensure the safety of all equipment being used with the monitoring system.

**Figure 52: Required Material for Flame Test**

**Figure 53: Flame Test Being Conducted**

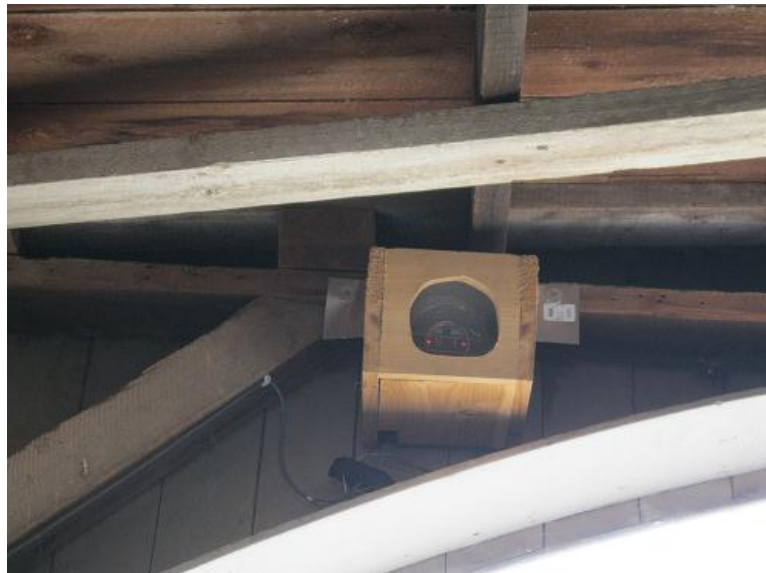
stay on until the system is reset via either internet connection or by simply cycling the power off and on.

**Figure 54: Flame Detector Prior to Alarm**

**Figure 55: Flame Detector after Alarm Set Off**

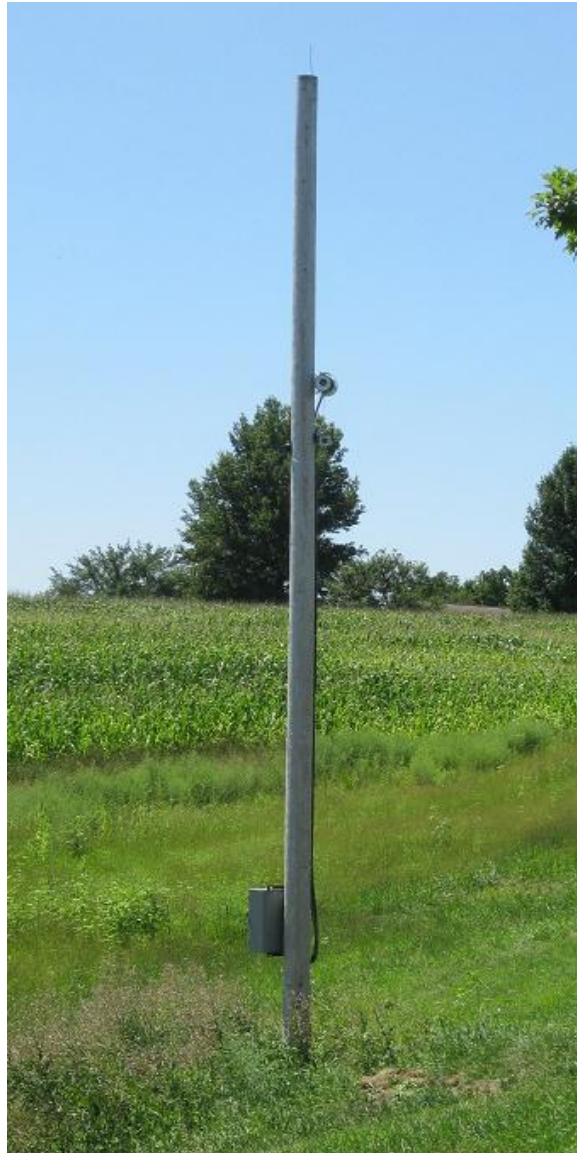
**Figure 65: Complete Pole after Installation**

positioning the lift in the correct spot to get the best possible angle for installation. Since most of the poles were in hard to reach areas it was a very time consuming part of installation. A typical pole can be seen in Figure 65 with both cameras and the antenna located towards the top of the pole and the NEMA enclosure towards the bottom of the pole.

In order to expedite the installation at the bridge site while the lift was still being rented it was decided to do as much of the work in the Iowa State structural laboratory as possible. This included running all necessary wires through the flexible conduit that was to be run between the cameras and the NEMA enclosure as well as placing the IR camera into its enclosure and making sure all camera and antenna components were as weather proof as possible before being sent to the field for installation. Once all of the equipment required for installation was as prepared as possible it was sent to the field along with the rented lift.

Installation included having two design members in the lift to position and install all of the cameras, one member in the NEMA enclosure to cut all flexible conduit to the correct size and make all necessary connections to the equipment inside of the NEMA enclosure, and an IT professional to access the cameras remotely or locally in order to correctly position both cameras and antennas in the best possible location. In order to expedite the process there was one other member that was on the ground in order to assist the members in the lift as well as the member working in the NEMA enclosure. The most difficult part of installation was

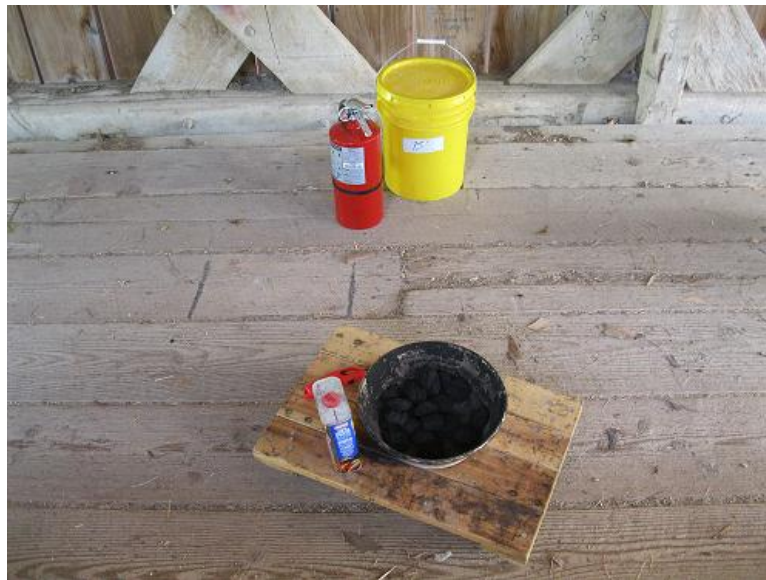
**Figure 68: Required Material for Flame Test**

water and fire extinguishers were close at hand as seen in both Figure 52 and Figure 53. All local authorities, such as police and fire departments, were informed by the design team that open flame tests were being conducted to ensure any alarms or notifications from passer byers would be ignored during the time of testing.

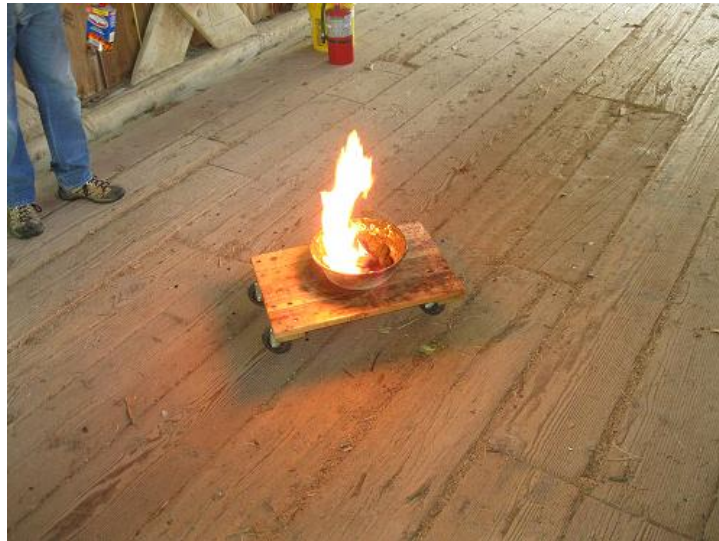
**Figure 69: Flame Test Being Conducted**

At each bridge the test started in the middle of the bridge span directly between the two flame detectors on either end. For some of the detectors to be set off the fire had to be pushed roughly 10 feet towards the end of the bridge due to direct line of site limitations to the center of the bridge. There were problems with 5 of the flame detectors and were returned to the manufacturer but they were promptly replaced and in functional order. These problems could have been due to wiring problems inside of the NEMA enclosure because of poor wire schematics. It is essential to fully label and follow all wiring diagrams to ensure the safety of all equipment being used with the monitoring system.
