# Remote monitoring and security of covered bridges in the United States

A thesis submitted to the graduate faculty  
in partial fulfillment of the requirements for the degree of  
MASTER OF SCIENCE

Major: Civil Engineering (Structural Engineering)

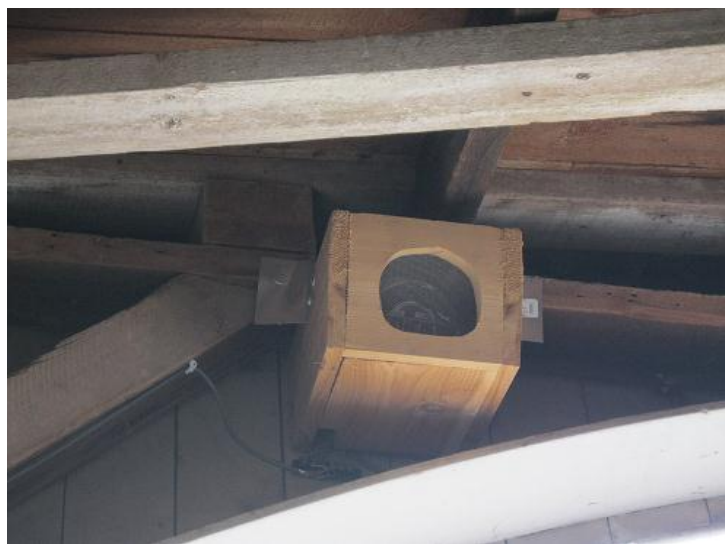
**Figure 70: Flame Detector Prior to Alarm**

The flame detectors were able to visually show that an alarm had been set off through the use of LED lights that could be seen through the wire mesh in the wooden boxes. Figure 54 shows a flame detector that is not set off and in working order. It visually shows that it is monitoring the bridge by blinking the LED lights every 15 seconds. Figure 55 shows a flame detector that was triggered during the fire testing. The red LED lights are constantly on and stay on until the system is reset via either internet connection or by simply cycling the power off and on.

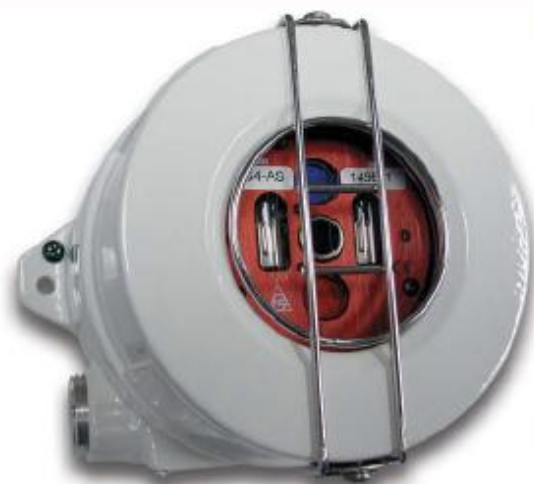
# SS4-A

- Multi-Spectrum™: senses ultraviolet, visible and Wide Band Infrared™
- Built-in Test for optical "through the lens" testing
- False alarm immunity
- Detects hydrocarbon and non-hydrocarbon based fires
- Wide field-of-view and solar-blind
- Adjustable detector sensitivity
- Microprocessor based algorithms: FirePic™, and Tri-Mode Plot™
- Wide temperature range of operation
- Compatible with standard approved fire alarm panels
- Explosion-Proof housing
- Time programmable alarm verification

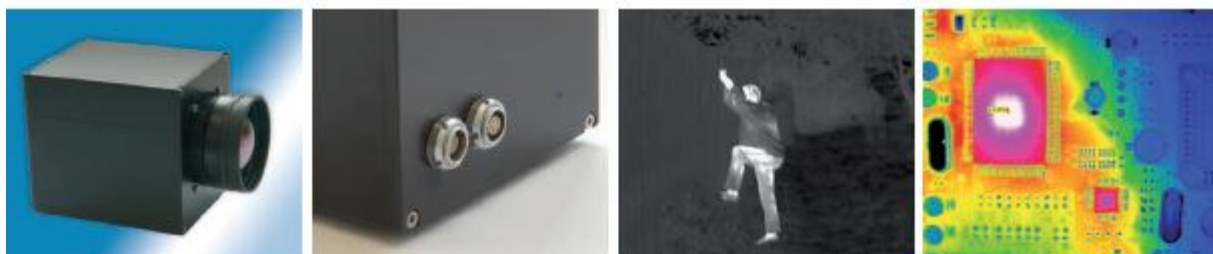
## IR-TCM 384 HiRes IR camera module

Thermal images, 384 x 288 pixel resolution

Whether visualizing or measuring heat distribution charts, the new uncooled OEM IR camera module IR-TCM 384 outputs impressive infrared images of 384 x 288 pixel resolution with a sharpness and distinctness so far unknown at commercial level. What's more, it does so in real-time! If configured with an optional hardware extension for resolution enhancement, it can even produce close to photo-realistic IR pictures with 768 x 576 pixel resolution.

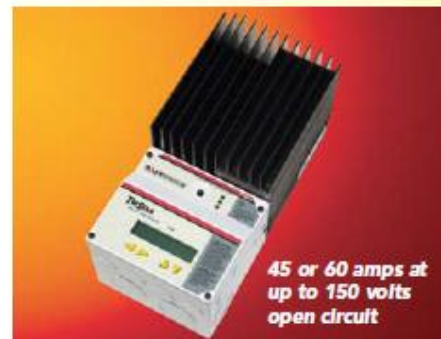
Product shown with optional meter

Morningstar's *TriStar MPPT* solar controller with *TrakStar Technology™* is an advanced maximum power point tracking (MPPT) battery charger for off-grid photovoltaic (PV) systems up to 3kW. The controller provides the industry's highest peak efficiency of 99% and significantly less power loss compared to other MPPT controllers.

The *TriStar MPPT* features a smart tracking algorithm that maximizes the energy harvest from the PV by rapidly finding the solar array peak power point with extremely fast sweeping of the entire I-V curve. This product is the first PV controller to include on-board Ethernet for a fully web-enabled interface and includes up to 200 days of data logging.
