SEISMIC EVALUATION OF HOLLOW CORE PRESTRESSED CONCRETE BRIDGE COLUMN-PILES IN WASHINGTON STATE

A thesis

Master of Science in Civil Engineering

University of Washington

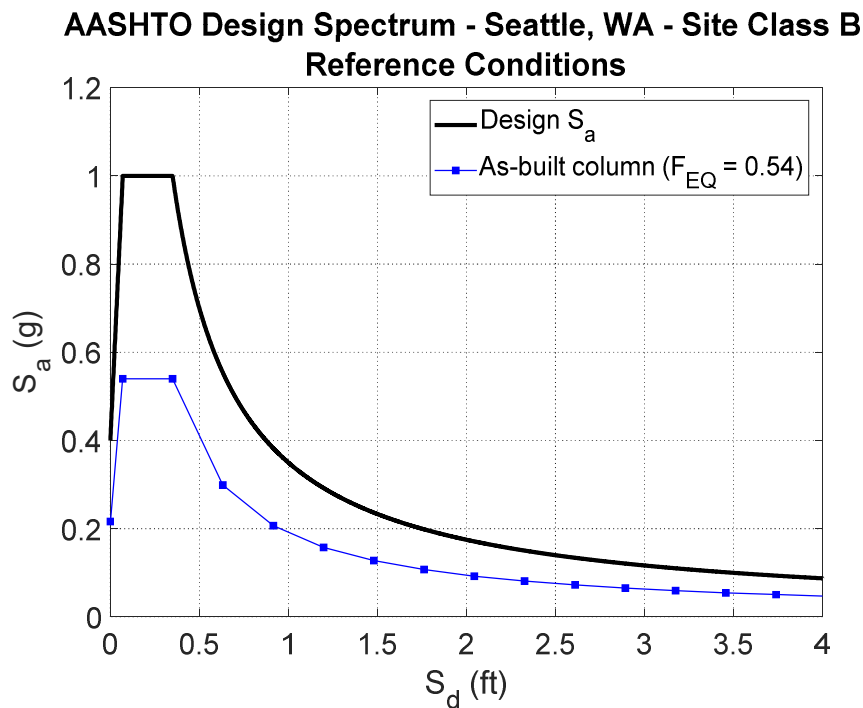
Figure 3-9. Scaled AASHTO Response Spectrum for As-built conditions

Figure 3-9 shows the scaled response spectrum that would be expected to cause failure of the as-built column reference condition. The scale factor indicates that a smaller earthquake, or an earthquake with a smaller return period than the 1000-year design earthquake could cause failure of the existing columns. The failure considered here is at the top of the column, where the plug is present, and not in the hollow region. The column is assumed to be non-ductile, based on the low proportion of spiral steel, in which case it is assumed to fail when it reaches first yield.

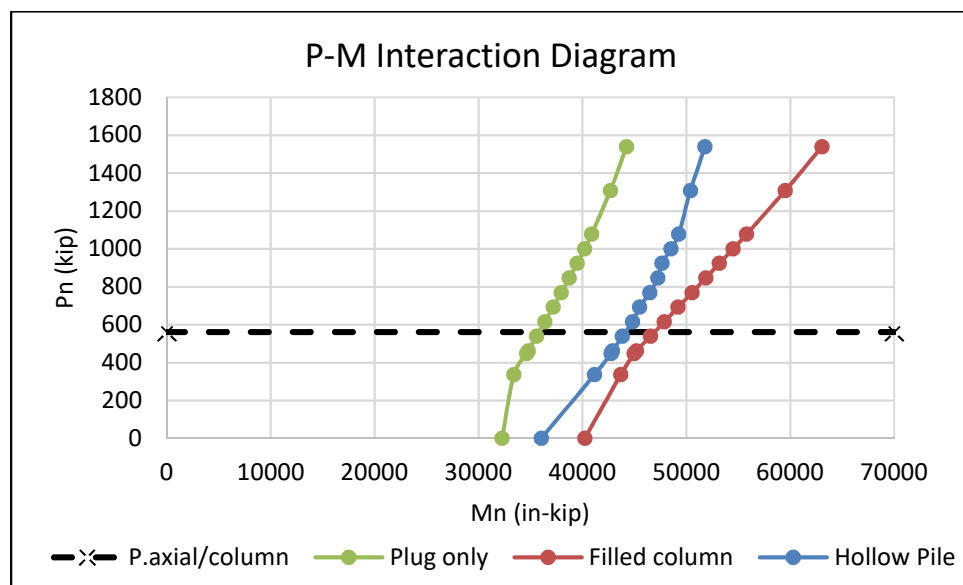
Figure 3-22. P-M Interaction Diagram for the different failure modes

As shown in Figure 3-22, at the expected reference axial load, the moment capacity for all three failure conditions lies on the ascending branch of the interaction diagram. Therefore, a higher vertical stress on the column will also increase its moment capacity. Furthermore, since the slope of the “plug only” interaction is steeper than that of the hollow pile, the DCR of the hollow section at plug yield should remain below 1.0 at higher axial loads, even with the increased moment demand.

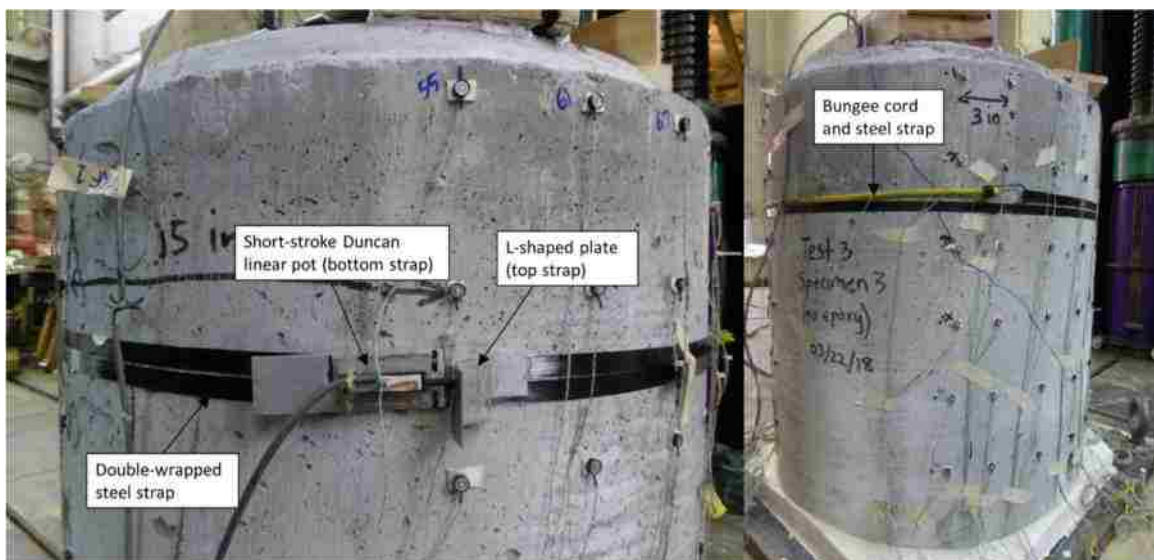
Figure 4-13. Instrumentation design to measure circumferential displacement

To measure the circumferential expansion of the pipe wall, a thin steel strap which was double-wrapped around the perimeter of the pipe and kept tight using a short bungee cord (See Figure 4-13). Relative displacements of the ends of the strap were measured using a short-stroke Duncan potentiometer and L-shaped bracket attached to the strap. This displacement, divided by the pipe circumference, gave the average circumferential strain.

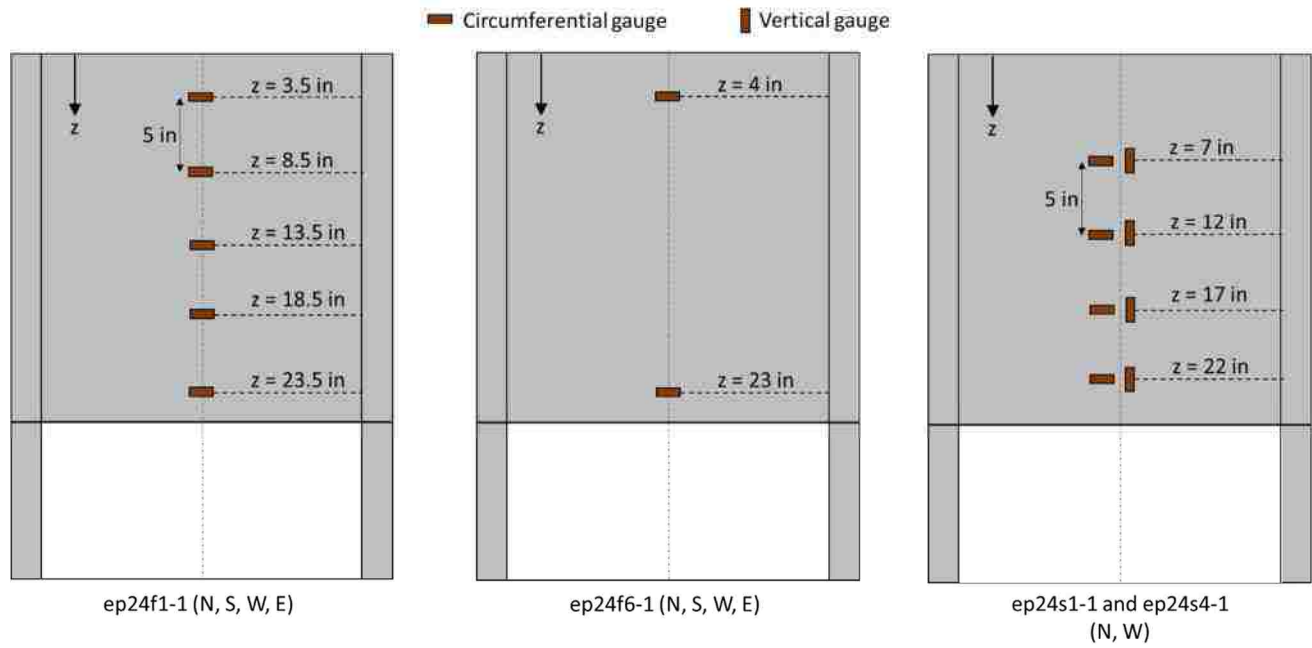
Figure 4-15. Location of strain gauges on jacketed specimens

CFRP specimens, which were tested first, showed that the strains were approximately equal on opposite sides of the specimen so gages were only attached to two faces on the steel-jacketed specimens (See Figure 4-15).

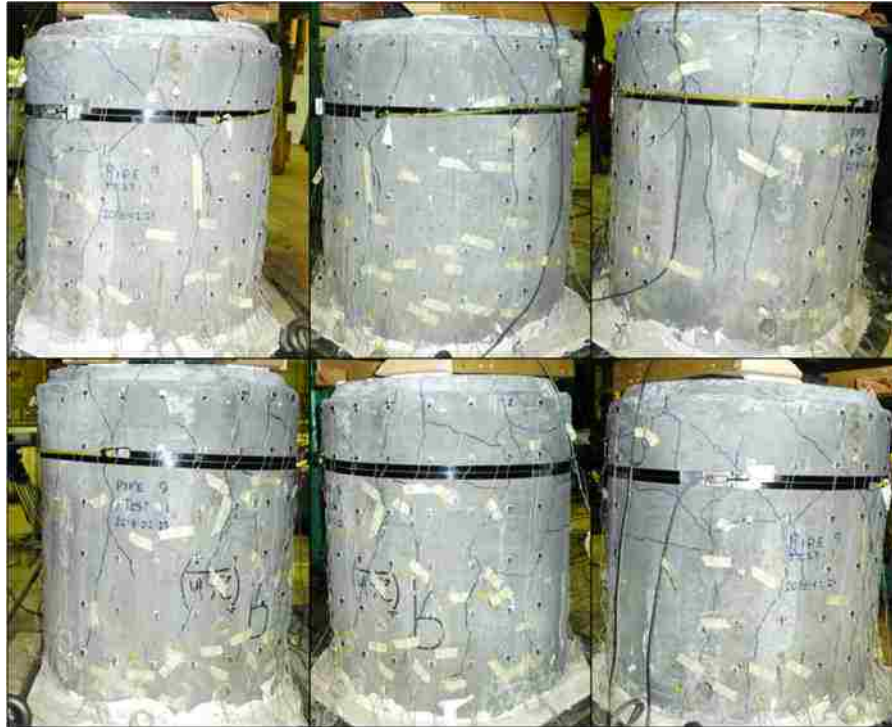
Figure 5-5. Crack formation at peak load for Test ep24-1 (L-R: N-NW-SW; S-SE-NE)

In the sliding region, the failure occurred between the pipe wall and the epoxy, which remained firmly attached to the plug concrete. This was observed for all tests where epoxy mortar was applied.

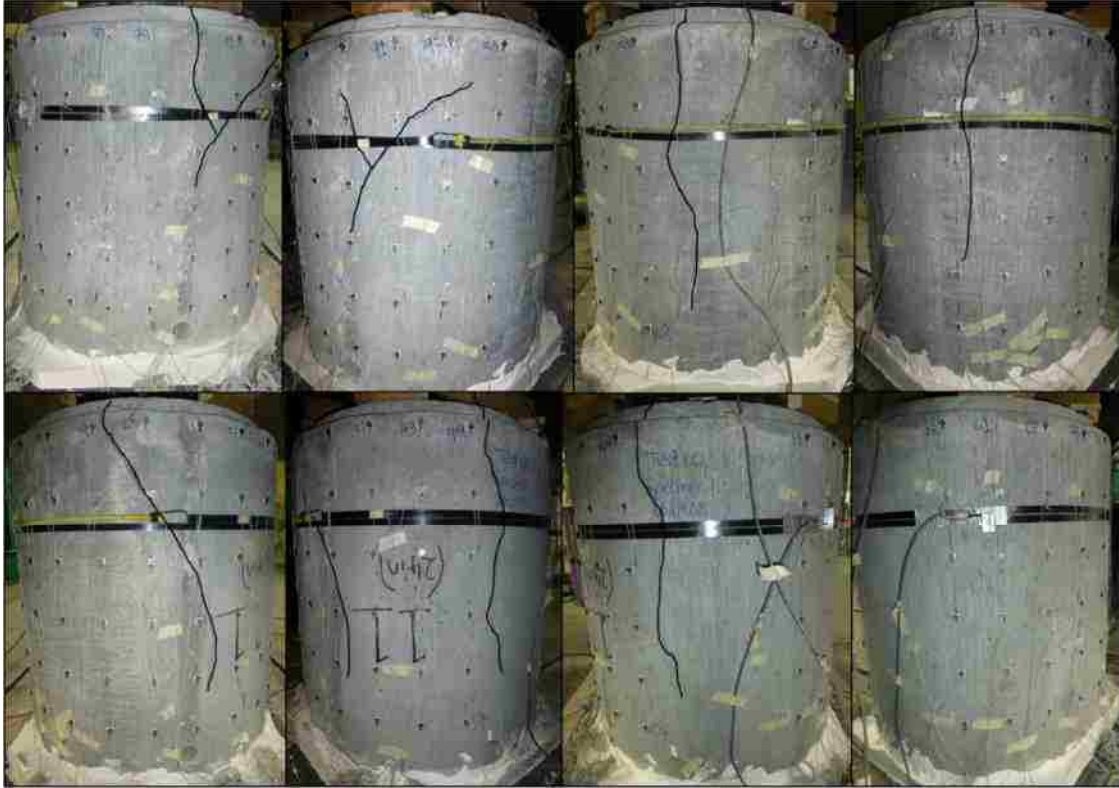
Figure 5-6. Crack formation at peak load for Test ep24-2 (L-R: N-NW-W-SW; S-SE-E-NE)

This test was done as a repeat of the first test that is, keeping all of the variable conditions the same in order to corroborate the results being used for the baseline condition. The peak load for this test was 320 kips, which is approximately 75% of that of test ep24-1, and the number of vertical cracks that formed around the specimen was less than that of the first test. Additionally, there was not a similar cluster of horizontal or diagonal cracks (See Figure 5-6). Unlike test ep21-1, all of the plug displacement was a result of sliding at the interface.

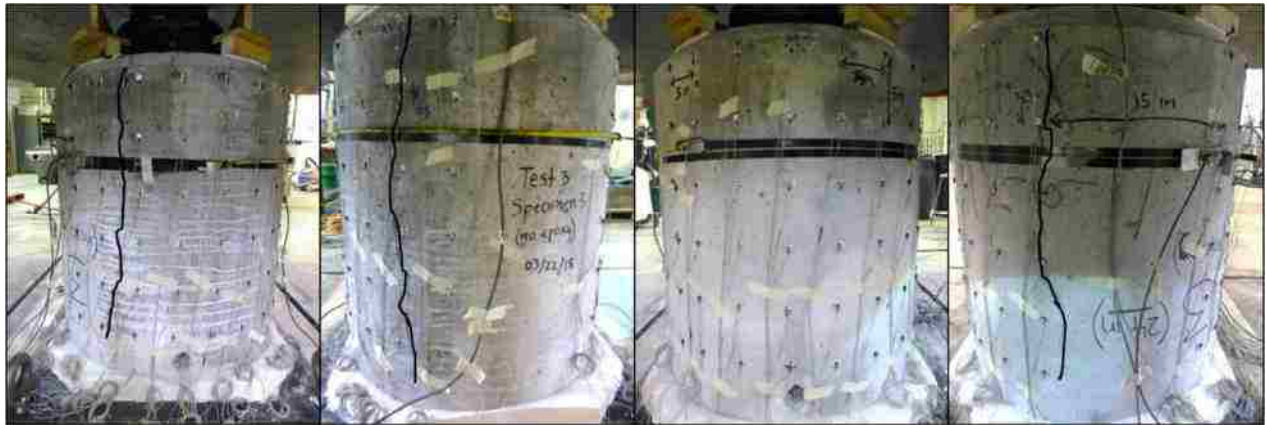
Figure 5-9. Crack formation at peak load for Test ep0-2 (L-R: N-W-S-E)

This was a repeat of the previous test and similar results were observed. The peak load was recorded at 147 kips, less than 10% different from the companion test, and only 3 longitudinal cracks formed at this load (See Figure 5-9). Additionally, the plug displacement was only due to sliding along the interface (See Figure 5-10). At the end of testing some additional cracks had formed except there was no large-scale horizontal crack as in the former test.

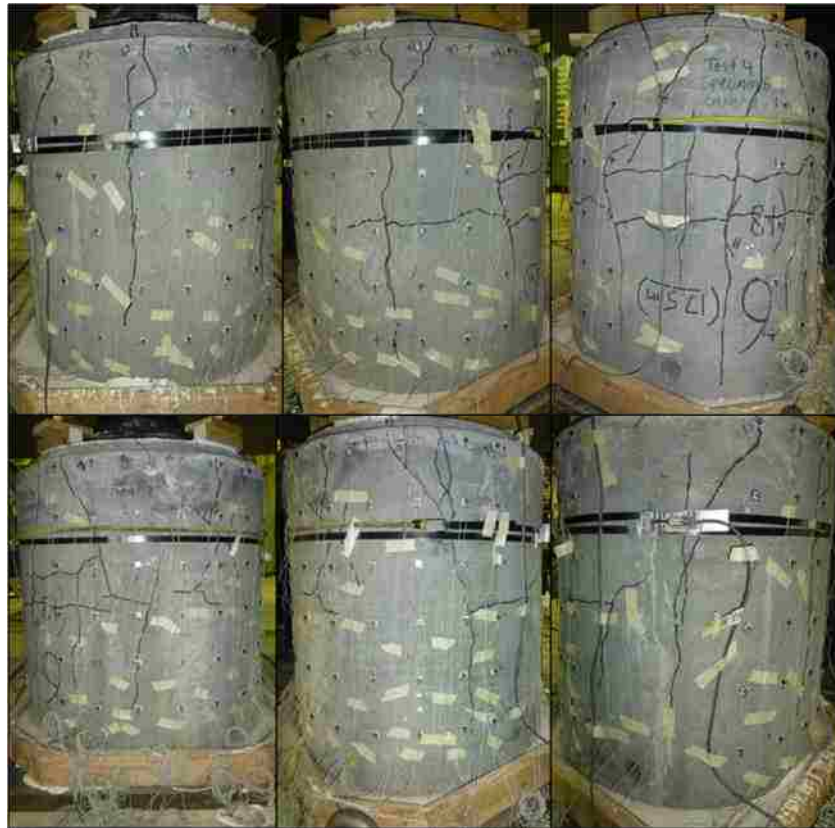
Figure 5-11. Crack formation at end of testing for Test ep18-1 (L-R: N-NW-SW; S-SE-NE)

For this test, the inner plug was cast 18 inches deep instead of 24 inches deep, and the pipe wall was treated with epoxy mortar. The peak load was 364 kips at which point, many longitudinal cracks formed as well as a small number of little horizontal cracks. However, at the end of testing a large horizontal crack that spanned about 75% of the circumference was marked at approximately 18 inches from the top of the specimen (i.e. at the bottom of the plug) (See Figure 5-11).

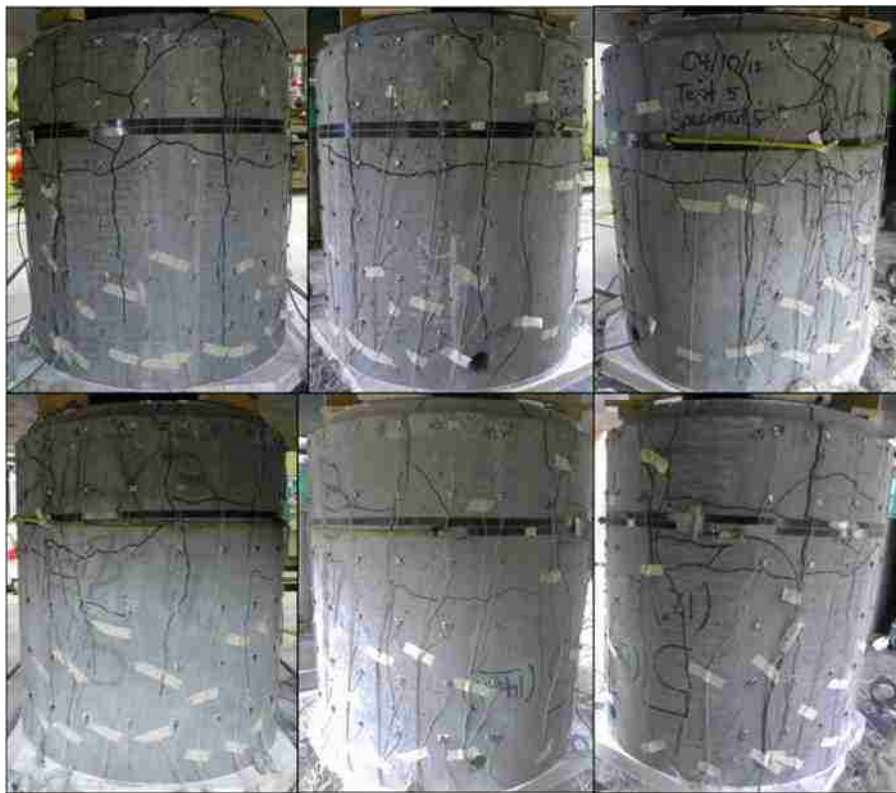
Figure 5-12. Crack formation at end of testing for Test ep14-1 (L-R: N-NW-SW; S-SE-NE)

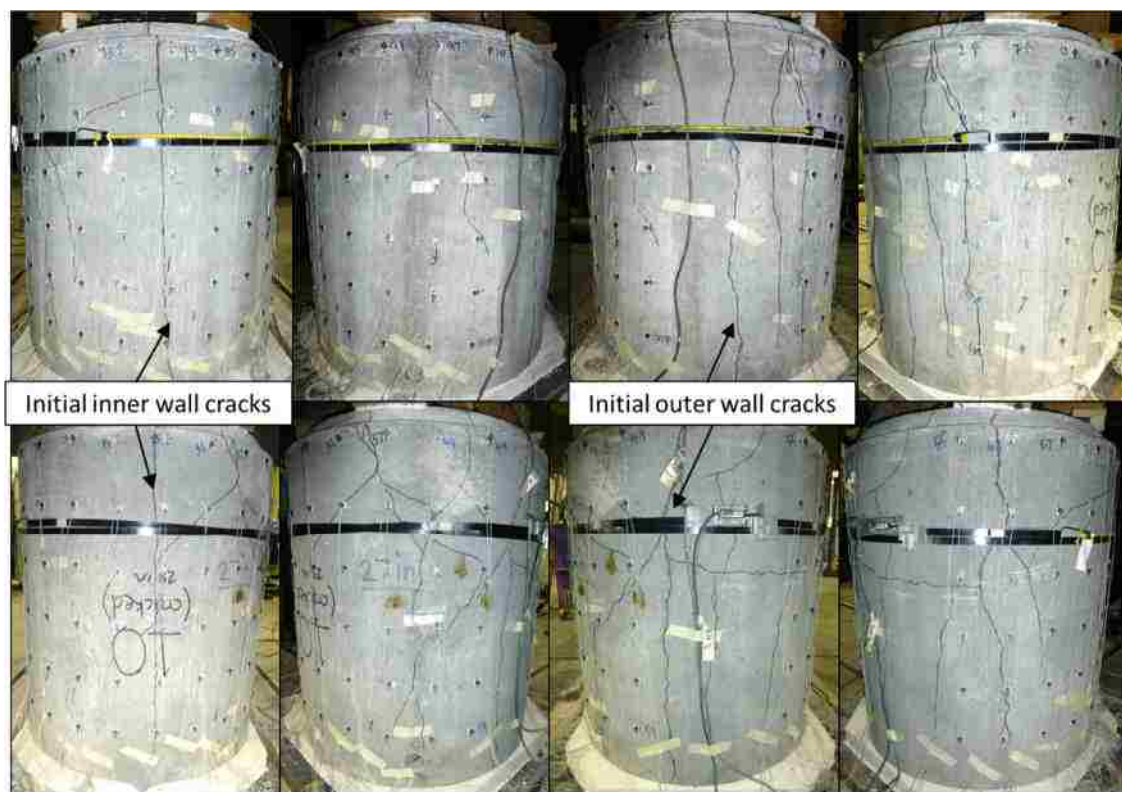
Figure 5-13. Crack Formation at Peak Load for Test 6-ep24-cr (L-R: N-NW-W-SW; S-SE-E-NE)

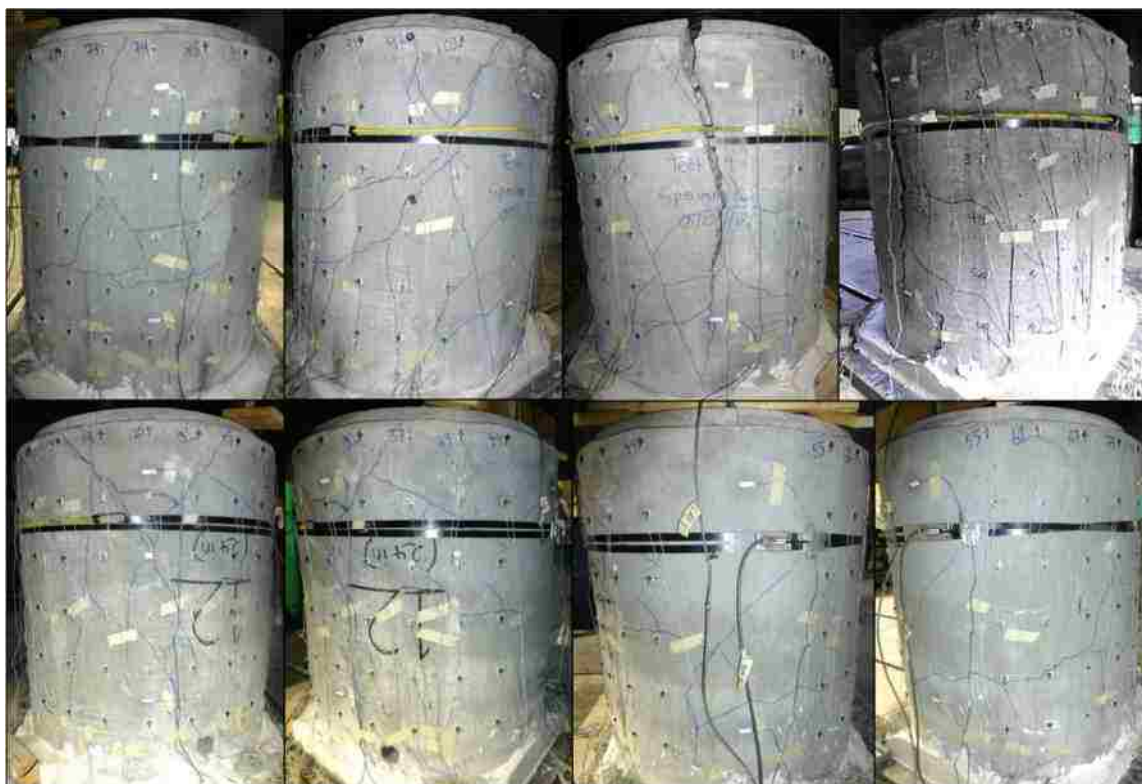
Figure 5-15. Crack formation at Peak Load for Test 9-ep24-ecc showing large crack on west side (L-R: N-NW-W-SW; S-SE-E-NE)

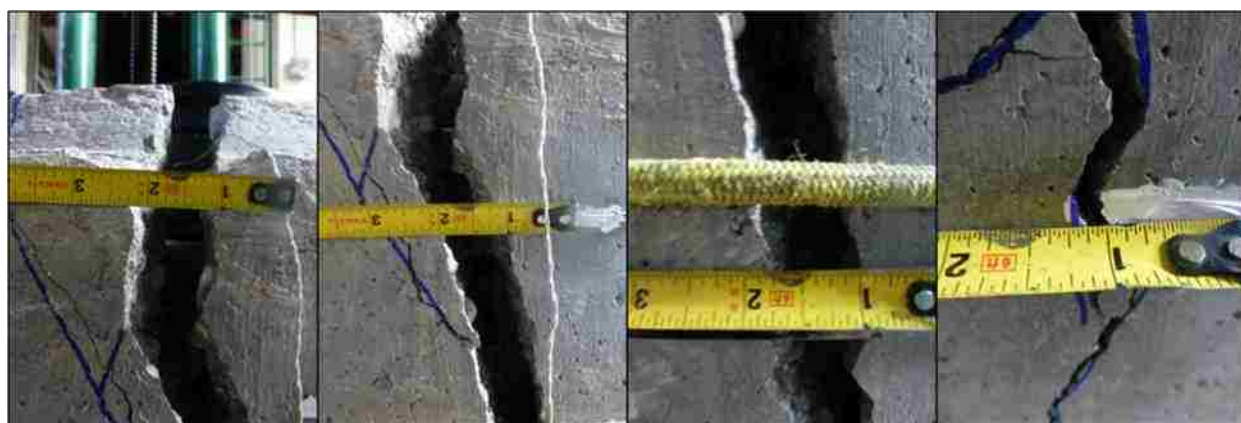
Figure 5-16. Width of large crack on west side of specimen (top to bottom)

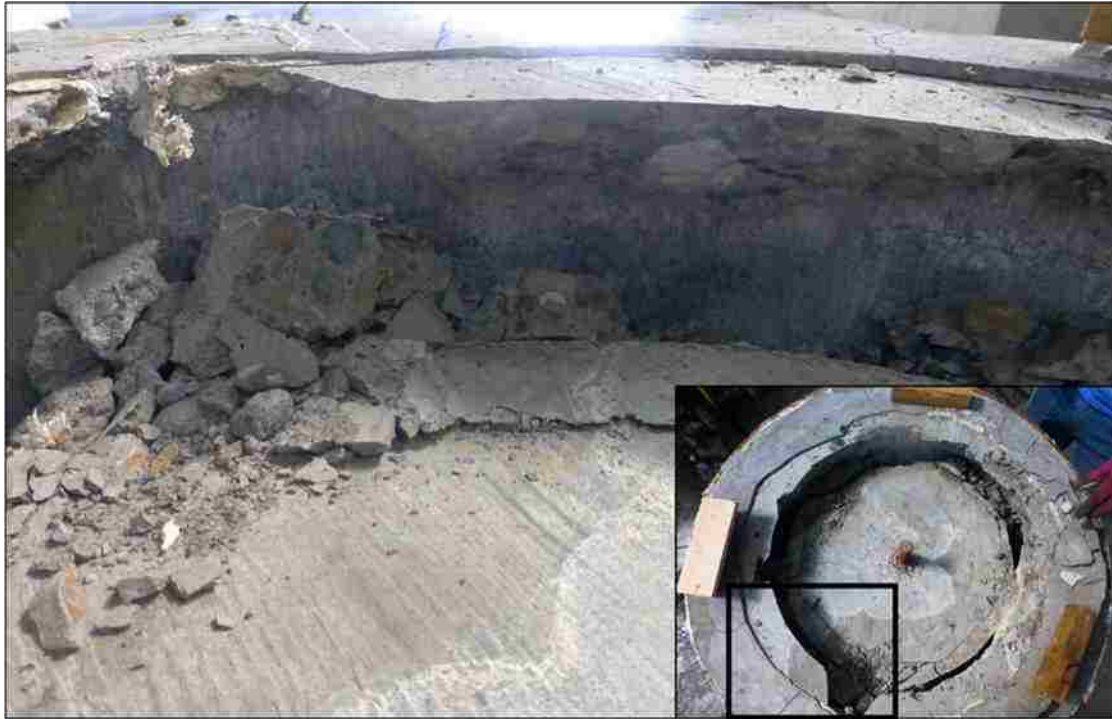
Figure 5-20. Plan View of Test ep24s4-1 at the end of testing showing "punching" displacement of plug

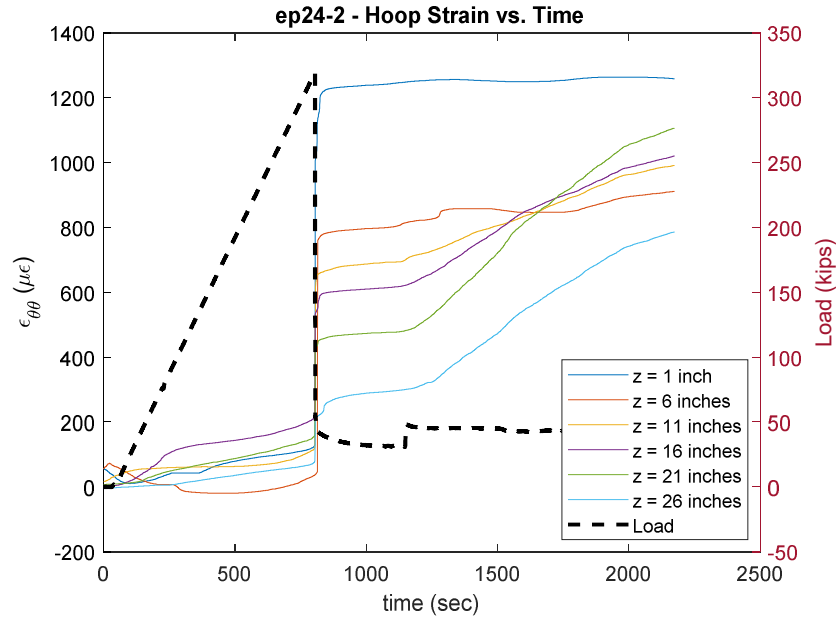
Figure 5-25. Hoop Strain vs. Time, with Axial Load for test ep24-2

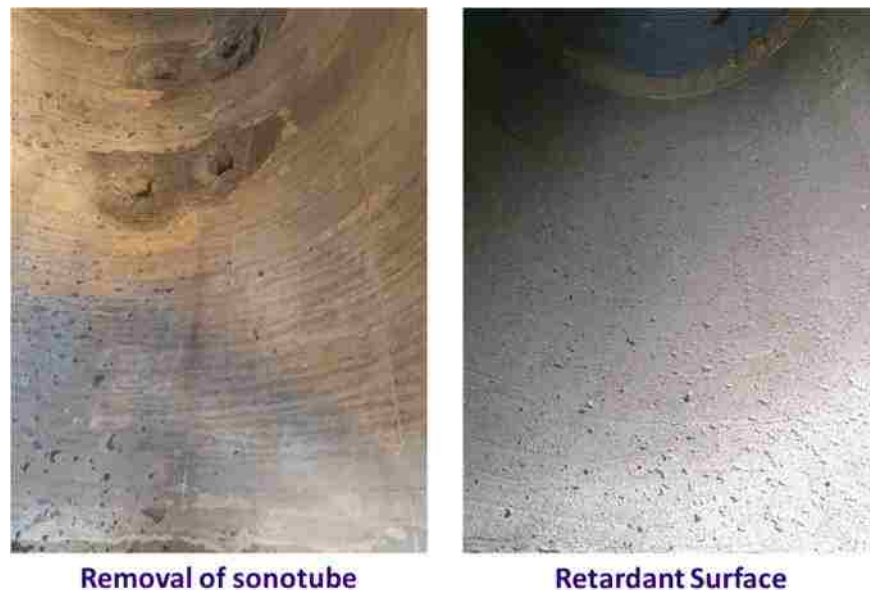
Figure 7-12. Comparison of surface roughness after removal of sonotube, with and without retardant

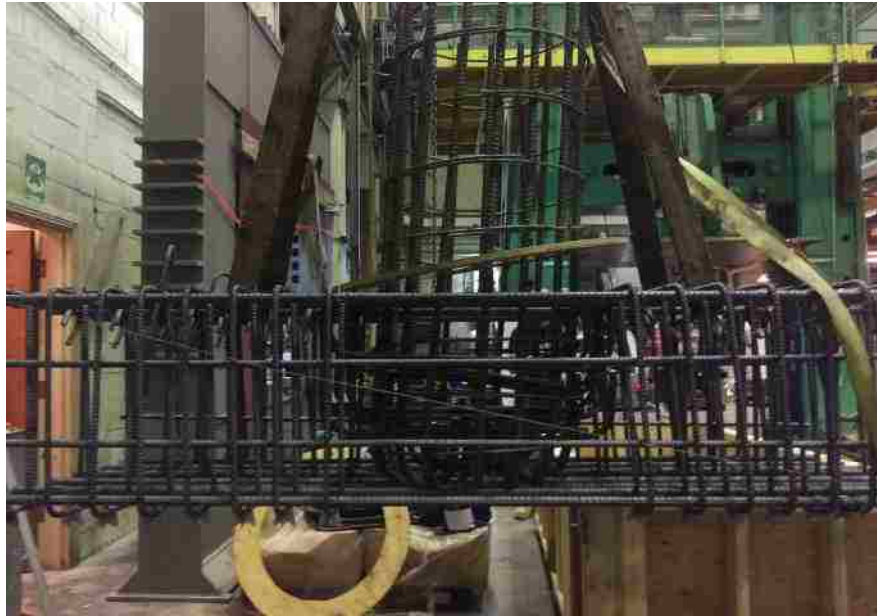
Figure 7-14. Reinforcement cage for cap beam being lifted into formwork for casting

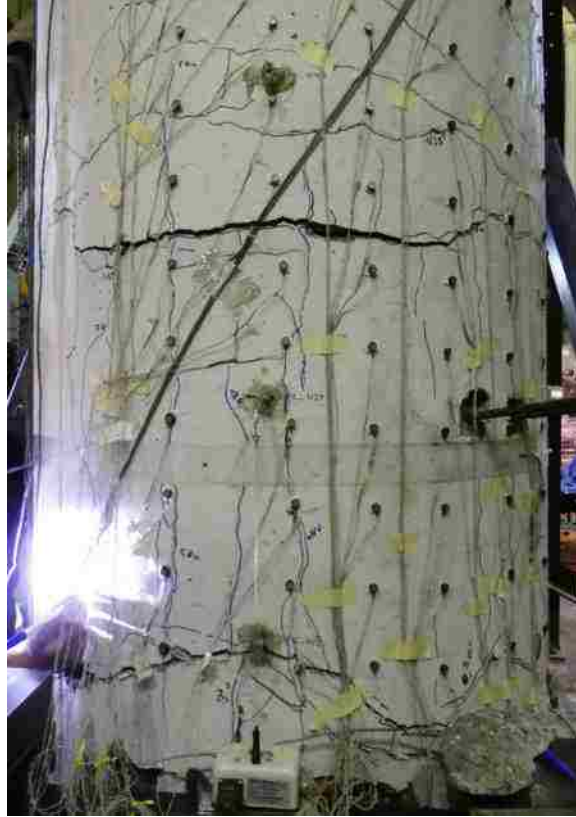
Figure 8-12. Very wide crack on north face, Series 8

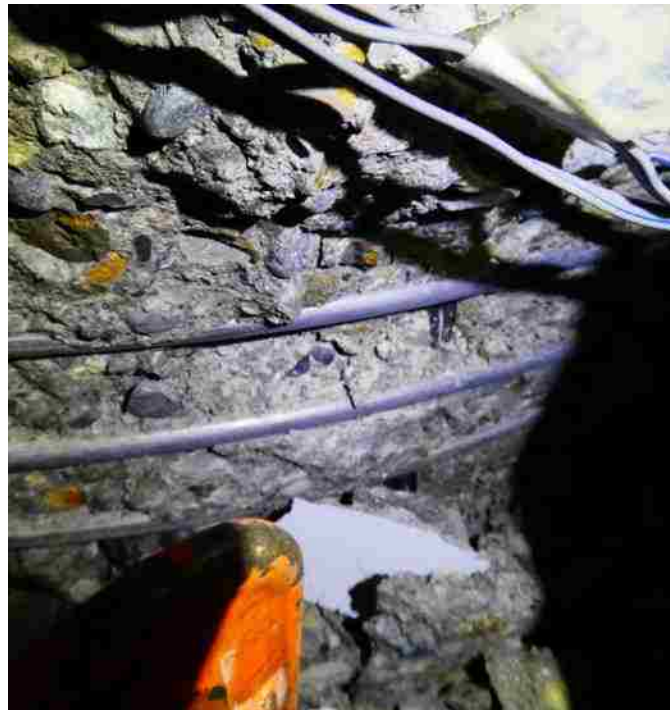
Figure 8-13. Substantial spalling and exposed spiral reinforcement, Series 8

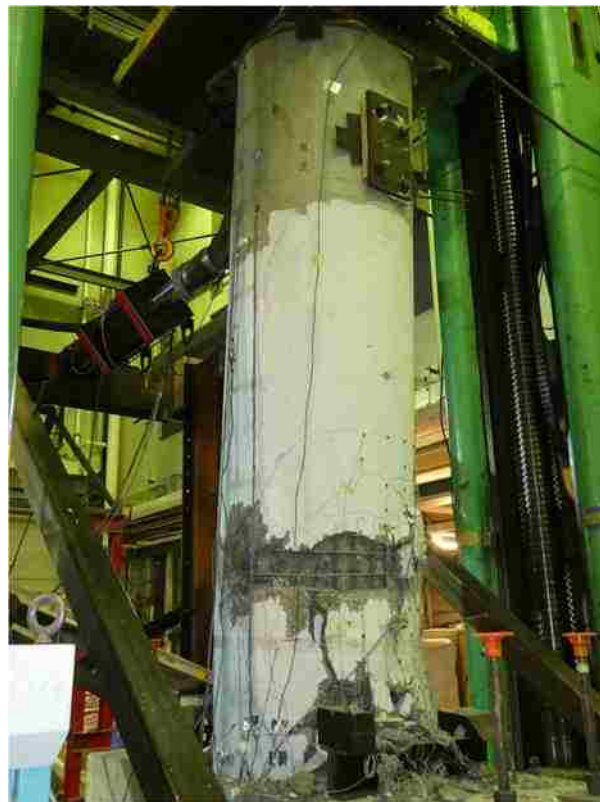
Figure 8-16. Final position of specimen at failure

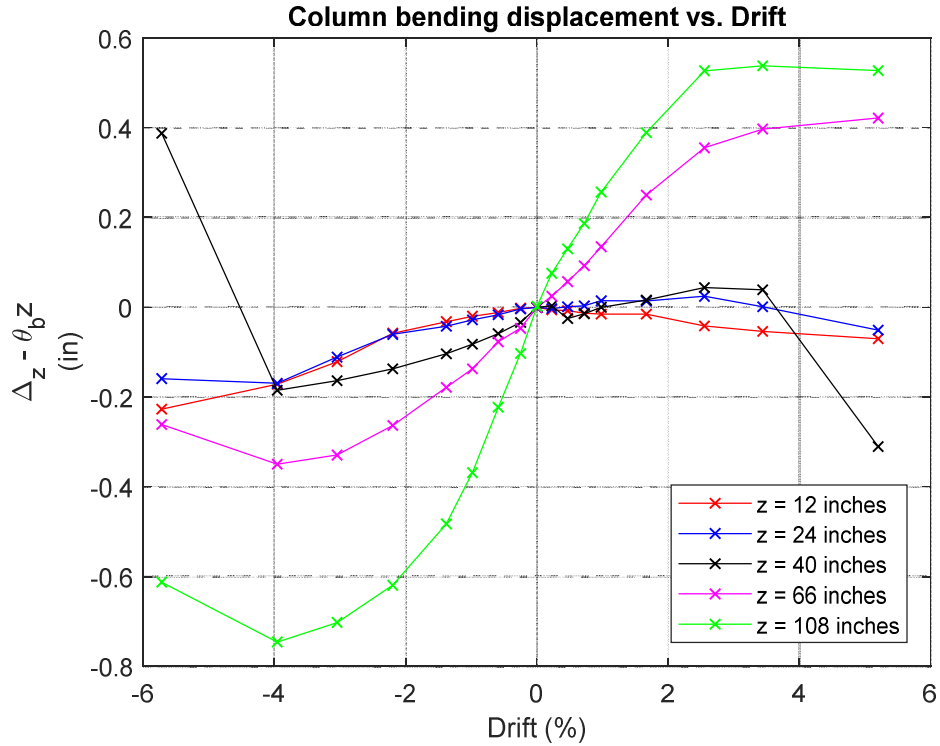
Figure 8-28. Extent of Column Bending Deformation in terms of Local Lateral Displacements

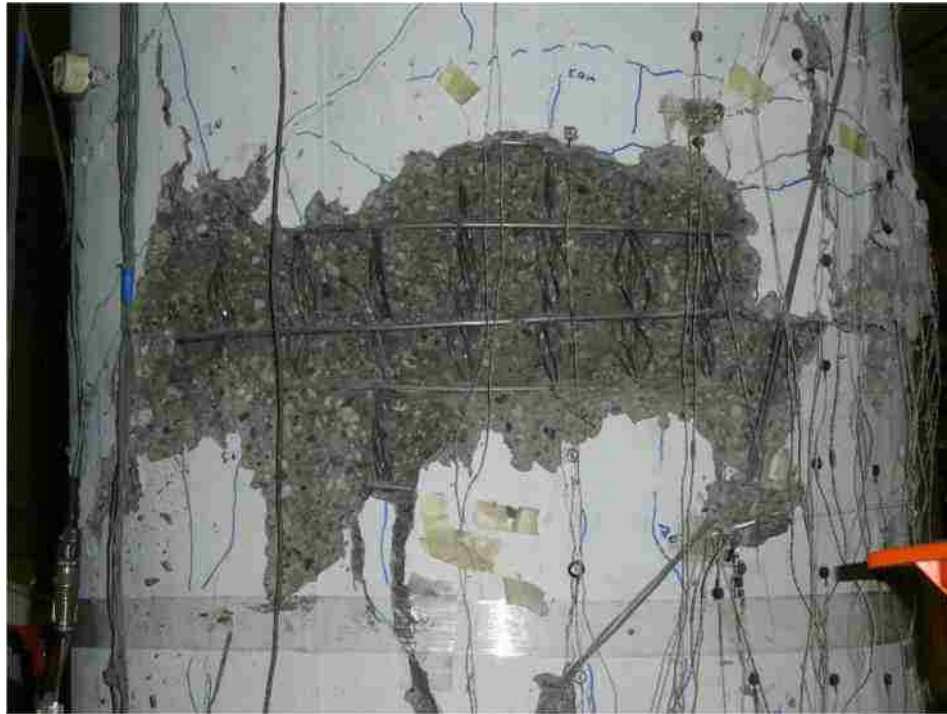
Figure 9-3. "Damaged Area" at end of testing showing concrete spalling, buckled strands and spiral deformation
