Seismic Retrofit of Bridges Supported on Hollow Core Prestressed Concrete Pile-Columns

A thesis

Master of Science in Civil Engineering

University of Washington

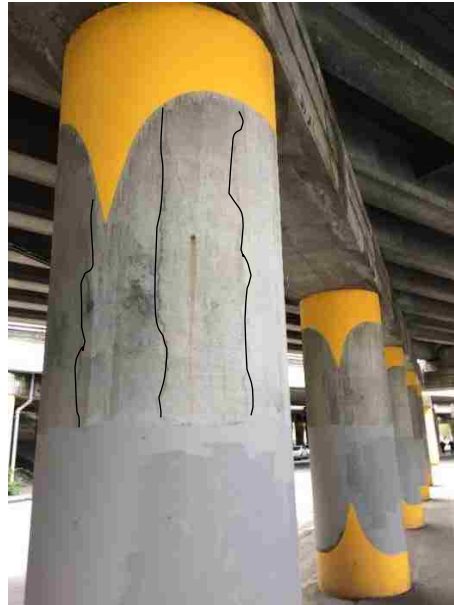
Figure 1-2. Longitudinal cracks on columns of Ravenna Bridge

the first piles were driven (See Figure 1-2). These cracks also aligned well with the three-strand tendons of the column, which were detected using a reinforcement locator, but the precise cause of the cracks is unknown.

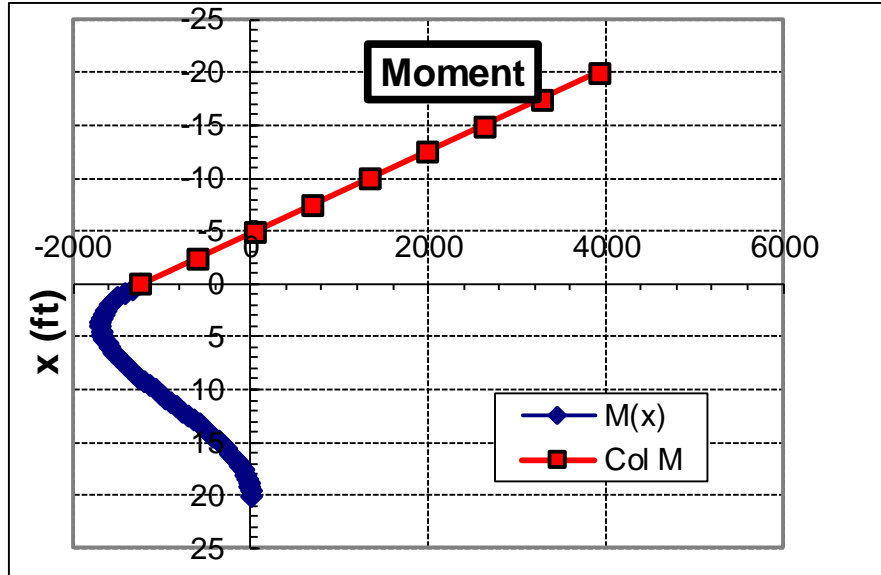
Figure 1-5. Moment demand for as-built conditions

Two locations in the pile-column are particularly susceptible to large moments and were deemed critical by the research team. These are at the cap-beam-column connection and below-grade (See Figure 1-5, grade line is at the x-axis, positive downwards into soil). For elastic response, the above-grade column moments are shown by the red line in Figure 1-5, while the below-grade pile moments are shown in blue and are based on a beam-on-elastic-foundation formulation (Hetényi, 1946). The peak column moment occurs at the cap beam connection and is higher than the peak pile moment, which occurs one to two column diameters below-grade, depending on the soil conditions. The presence of the solid concrete plug at the cap beam connection prevents the inward implosion of the hollow section there under large moments but depending on the length of the plug and the moment gradient along the length of the column, there exists the risk of a hollow section flexural failure just beyond the end of the plug at the sudden change in the column's flexural capacity. The below-grade moment also poses problems as moments high enough to cause potentially non-ductile failure there could be reached after the cap beam connection has yielded. Tests conducted on the as-built specimen and subsequent analysis showed that the more critical component is the cap beam connection. In addition, this location is more practical and convenient for retrofit, and efforts were focused on improving the ductility there by commercially available means.

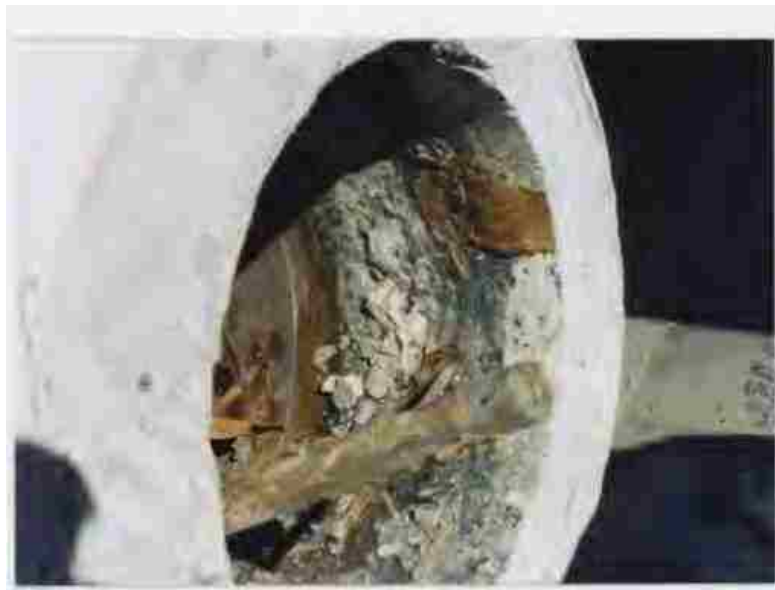
Figure 2-1. Internal spalling at core face of hollow specimen (Fig. 6.1.2., Budek, Benzoni and Priestley, 1997)

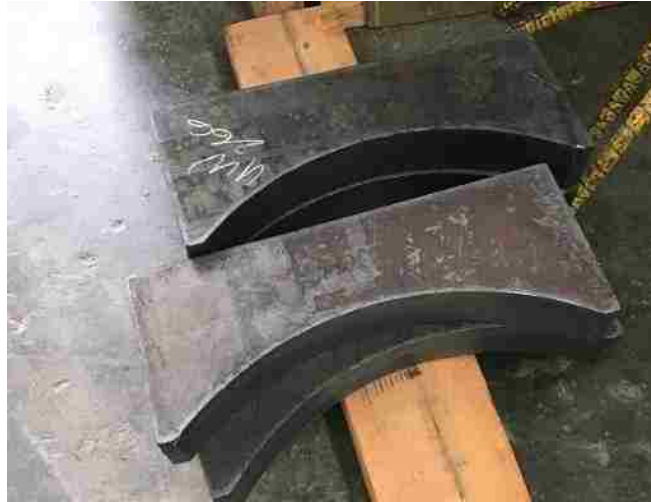
Figure 3-6. Load and support cradles

The two tests to be described in this chapter were chosen by the research team to further understand the behavior, and establish a basis for strength, of the hollow piles in pure bending, as well as combined bending and shear. In order to achieve the desired failure modes while minimizing construction time and resources required, the pile-columns were tested as beams (see Figure 3-4 and Figure 3-5). The support and load cradles were custom made, 4-inch thick steel cradles (see Figure 3-6).

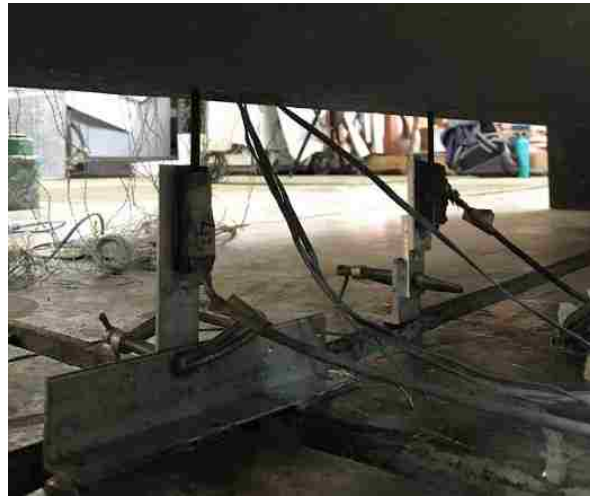
Figure 3-26. Bottom Duncan potentiometers

(Figure 3-27). The displacements measured using the Duncan potentiometers allow for the development of a displacement profile of the specimens under the different loading conditions and determine the rotations along the specimen. The same Duncan potentiometer arrangement was used on both test specimens.

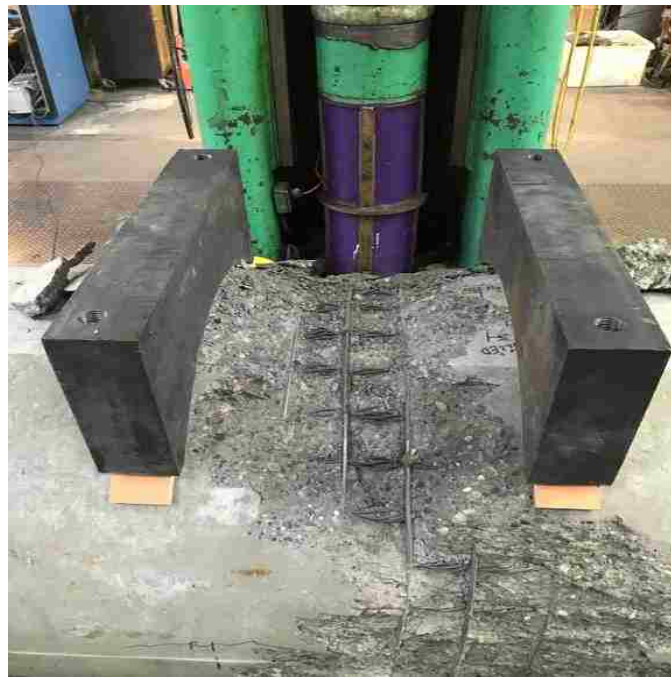
Figure 4-2. Concrete crushing and buckled strands

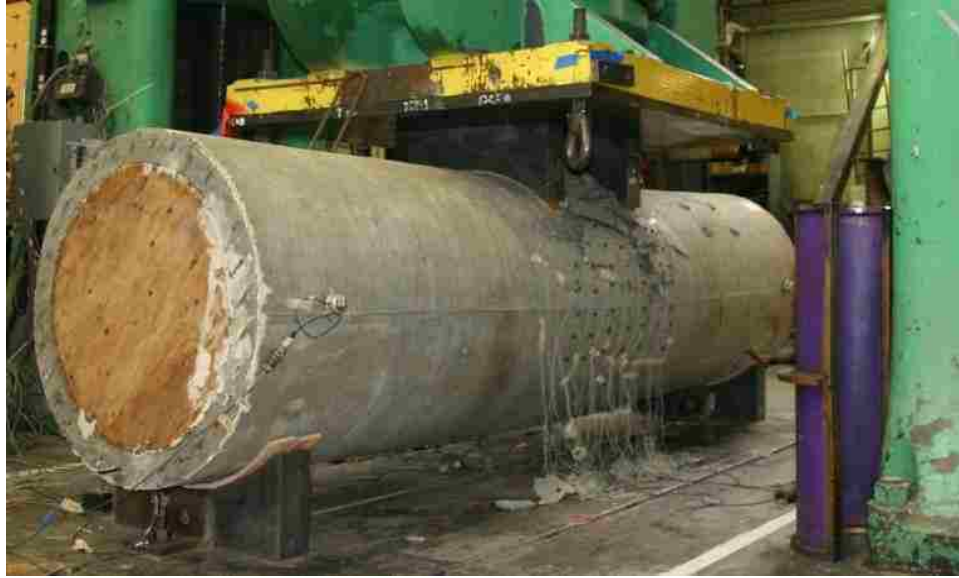
Figure 4-3. Specimen position at failure

Similar behavior was observed on the third cycle, when the specimen was loaded to the same moment demand of the previous cycle (the intention being to give another chance to accurately predict the decompression load, and thus, how much prestressing remained). On the final cycle, a moment demand of 12,761 in-kips was achieved at ultimate failure. During the test there was no visible evidence of premature internal spalling (the primary concern at the start of the research project); however, the internal diaphragms prevented placement of any cameras or sensors inside the specimen to confirm these observations. Ultimate failure occurred due to concrete crushing on the outer face of the wall and subsequent buckling of strands (see Figure 4-2); the specimen position at failure is shown in Figure 4-3.

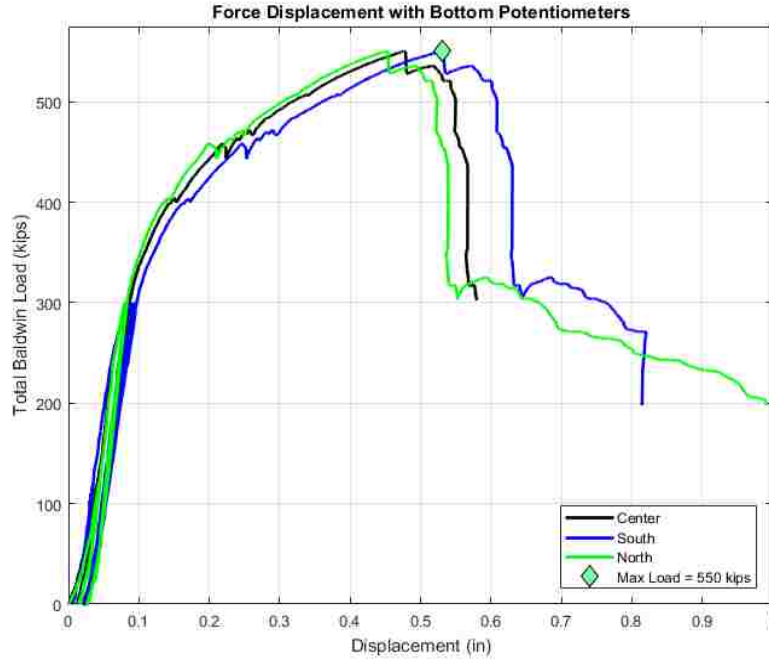
Figure 4-4. Force-displacement curve for all bottom potentiometers

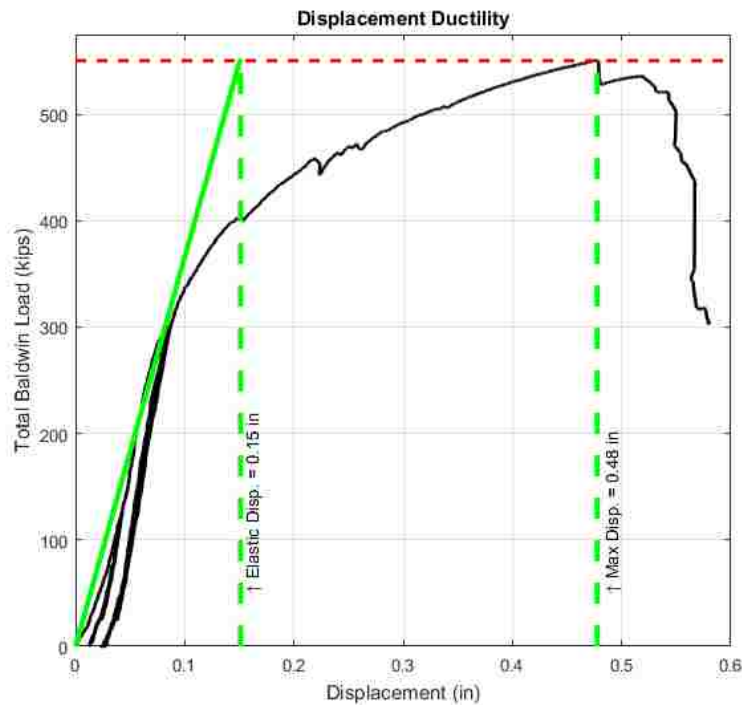
Figure 4-5. Displacement ductility in pure bending

The linear elastic (uncracked) stiffness line was drawn tangent to the measured data, which resulted in an elastic displacement of 0.15 in. The load at peak displacement was 0.48 in, leading to an elastic ductility ratio of 3.2. The slope of this elastic stiffness is lower than the theoretical value (see Appendix C). If the latter were to be used, the elastic ductility ratio would be higher.

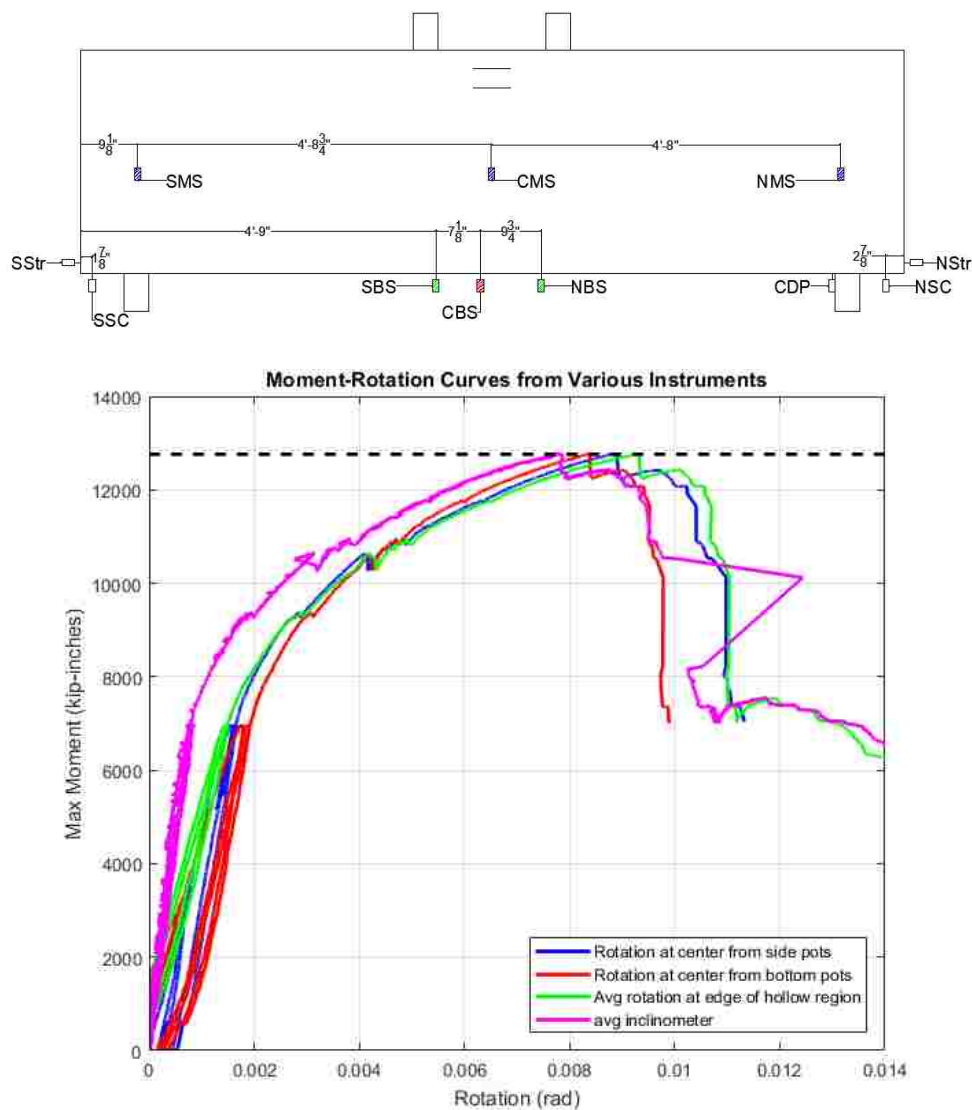
Figure 4-7. Moment-rotation curves all potentiometers and inclinometers

The average rotation measured by the inclinometers was calculated, and was compared to the rotations measured by the potentiometers on both the bottom and side of the specimen (see Figure 4-7). Again, the sketch of the specimen depicts which instruments correspond to which curve. These rotations were either obtained directly (inclinometers) or by dividing the difference between readings of a pair of potentiometers by the distance between them. There was general agreement amongst the various instruments, and the rotation at the edges of the hollow region (green curve) was higher than the rotation at the center of the specimen (red and blue curves). This is typical of the deflected shape of a specimen undergoing pure bending.

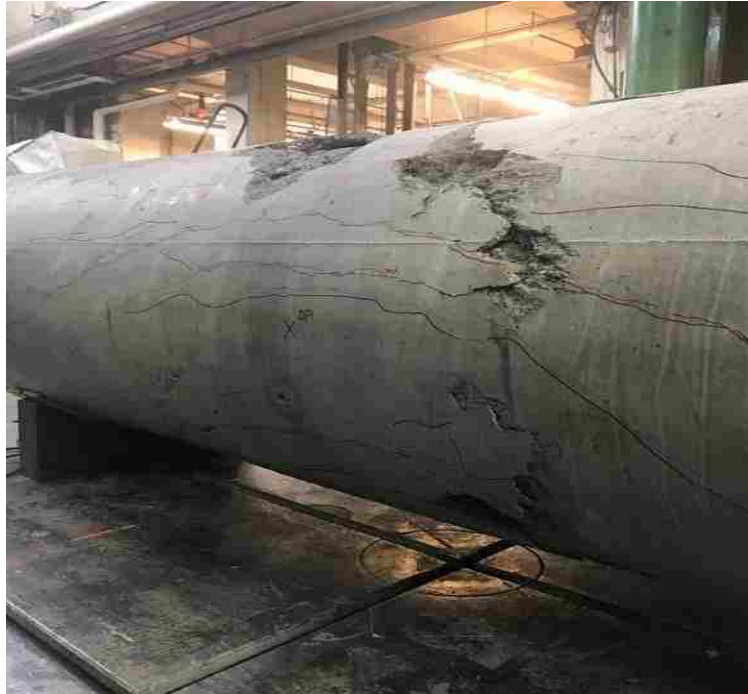
Figure 5-1. Specimen position after failure, note the angle of the cracks

In this section, the observed behavior is discussed. The test protocol described in Table 3-2 was implemented, starting with a cycle to check instruments and check the settlement of the Cotton Duck Padding (CDP). A shear demand of 100 kips was achieved on the first cycle, corresponding to a mid-span deflection of approximately 0.05-inches, and it caused the specimen to crack. This load was smaller than the predicted cracking load. This was attributed to the additional stresses due to bending and prestressing that were not originally accounted for in the cracking load prediction. On the next cycle, a shear demand of approximately 165 kips was achieved, followed by a cycle to failure that achieved a total load of 478 kips (or a shear demand of 239 kips). Figure 5-1 shows the specimen after failure. During the test, progressive cracking occurred in both of the hollow regions. The cracks grew at an incline flatter than 45° (see Figure 5-1). This is consistent with the existence of longitudinal compression from the prestressing.

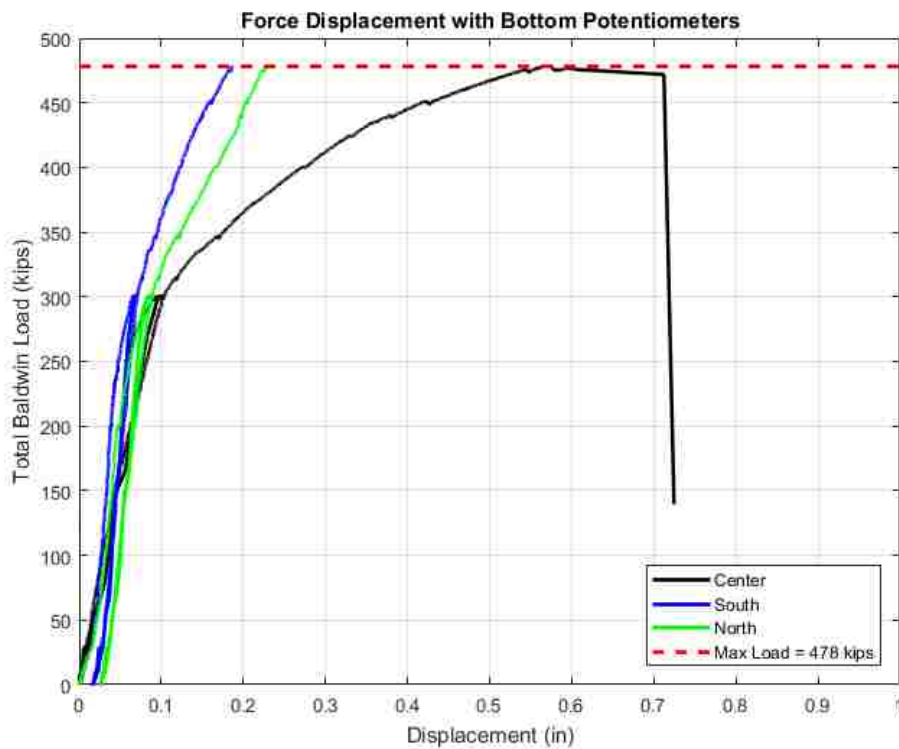
Figure 5-2. Force-displacement curve for all bottom potentiometers

The maximum achieved force was 478 kips, corresponding to 239 kips of shear demand. Figure 5-2 shows the force-displacement curve, as measured by the potentiometers along the bottom of the specimen.

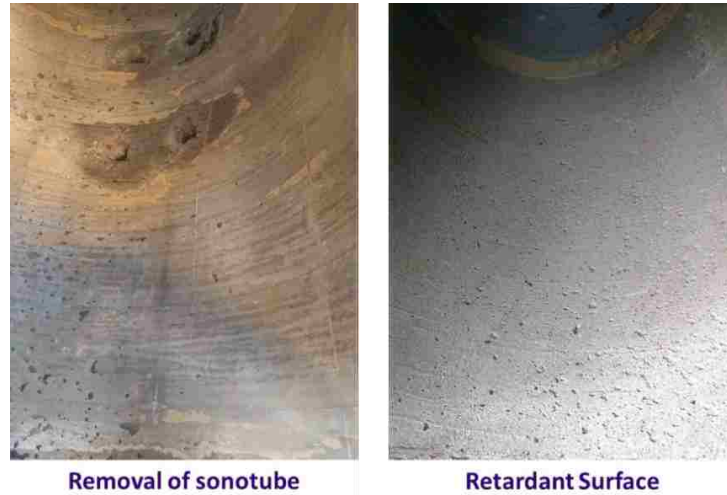
Figure 6-9. Comparison of surface roughness after removal of sonotube, with and without retardant

The precast, prestressed hollow core pile-columns were constructed at Concrete Technology Corporation's facility in Tacoma, Washington. Construction of the specimens was described in Section 3.4. In order to create an inner surface roughness similar to what may have been caused by mandrel-casting used in the past, especially in the region where the plug would be cast, a retarder (Euro-Tard 05) was applied to the surface of the sonotube before casting. When the sonotube was later removed, this gave the inner surface a sandblasted roughness (see Figure 6-9). After the columns were cast in a line, the strands were cut flush when the concrete had obtained a compressive strength of at least 5,000 psi although cylinder tests indicate strengths greater than 6,500 psi in all cases.

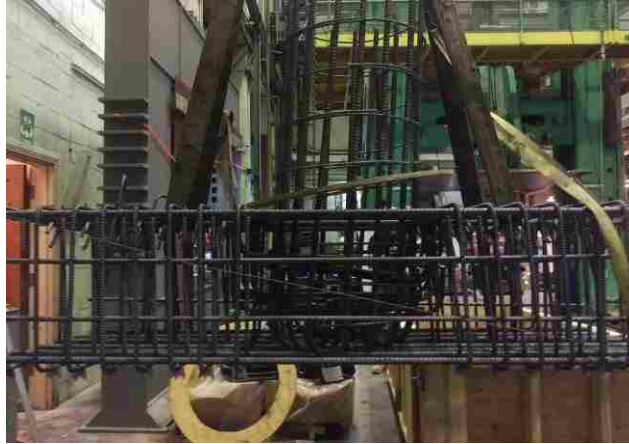
Figure 6-11. Reinforcement cage for cap beam being lifted into formwork for casting

The cap beam reinforcement cage, including the plug reinforcement, was fabricated outside of the formwork and then positioned into the beam form (see Figure 6-11).

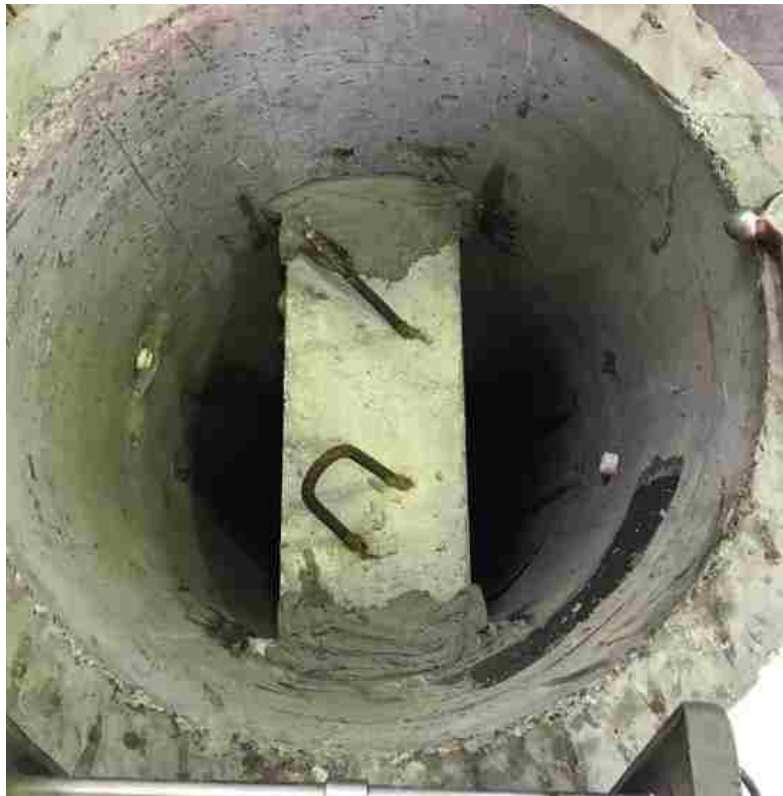
Figure 6-19. Concrete diaphragm to prevent punching shear (temporary wood formwork)

The actuator was connected to the specimen using four 1-inch diameter high-strength steel threaded rods and two steel plates (1 inch thick) with timber and steel shims and thin rubber pads to protect the concrete wall (see Figure 8-4). The timber shims were machined to conform to the outside circumference of the column. On the interior of the specimen, a precast concrete diaphragm was grouted in place between the rods to eliminate the possibility of punching shear through the thin pile-column walls by the applied lateral load (see Figure 6-19).

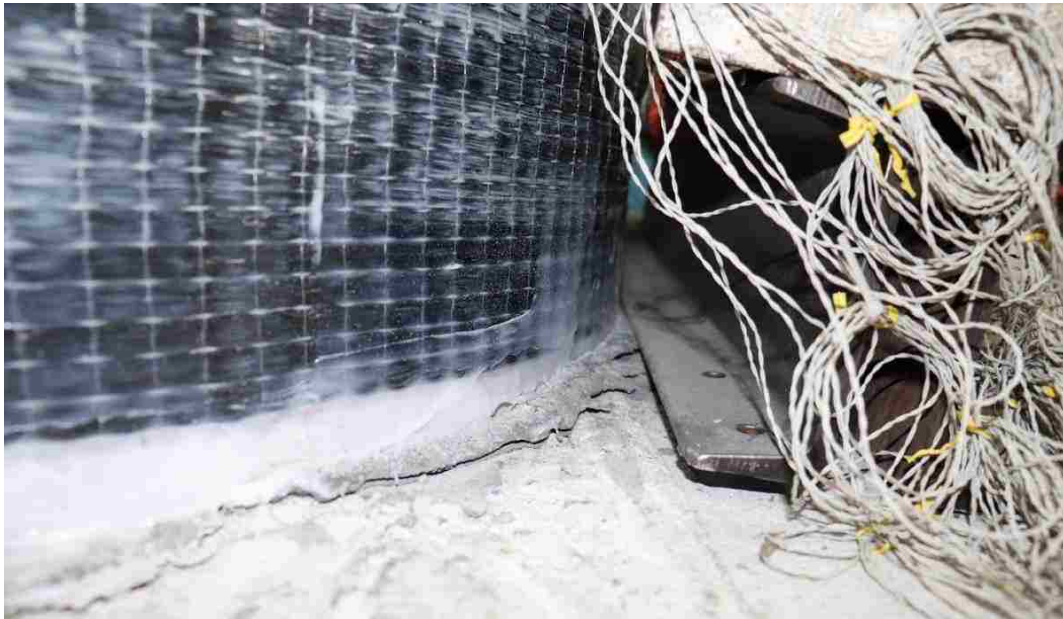
Figure 7-4. Uplift on Cycle 3 of Series 3 (+0.78%, -1.20% drift)

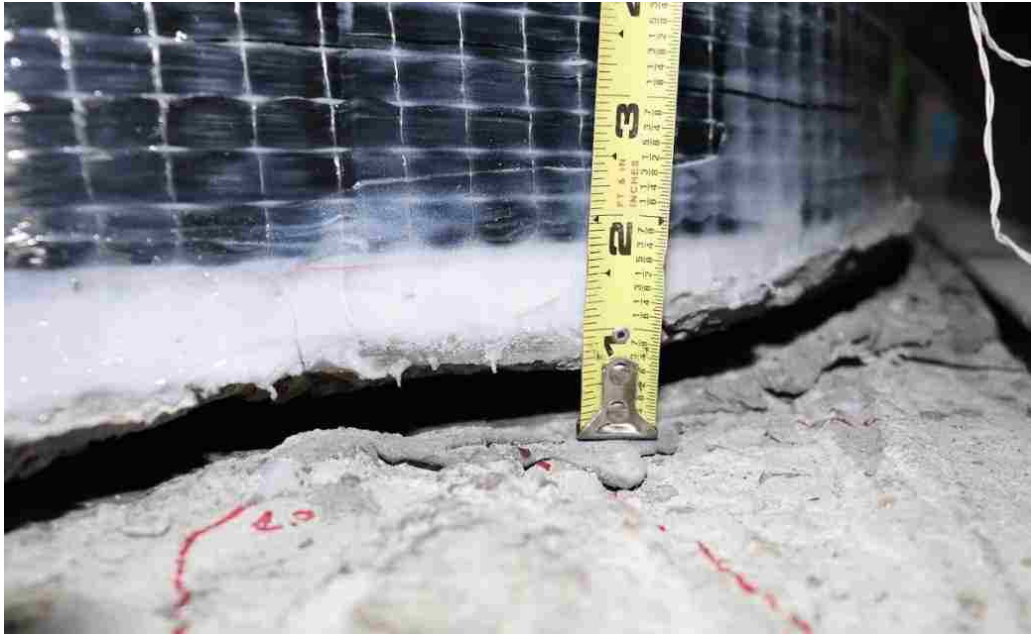
Figure 7-7. Uplift on Cycle 3 of Series 7 (+3.71%, -4.54% drift)

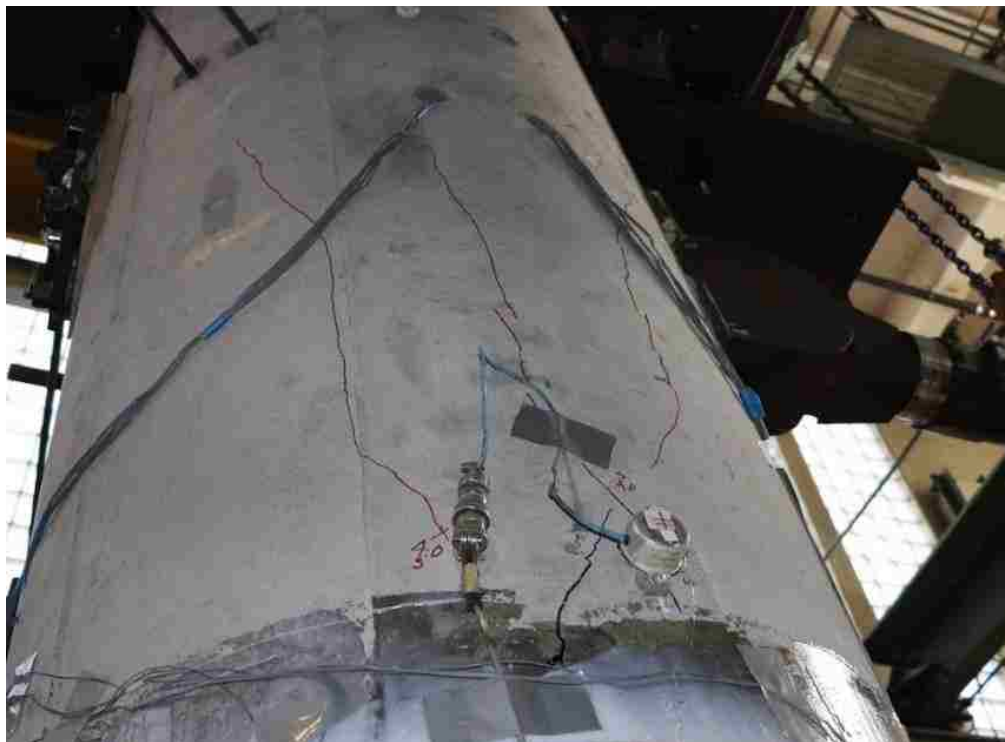
Figure 7-8. Progressive cracking above fiber on Series 8 (+4.71%, -5.49%)

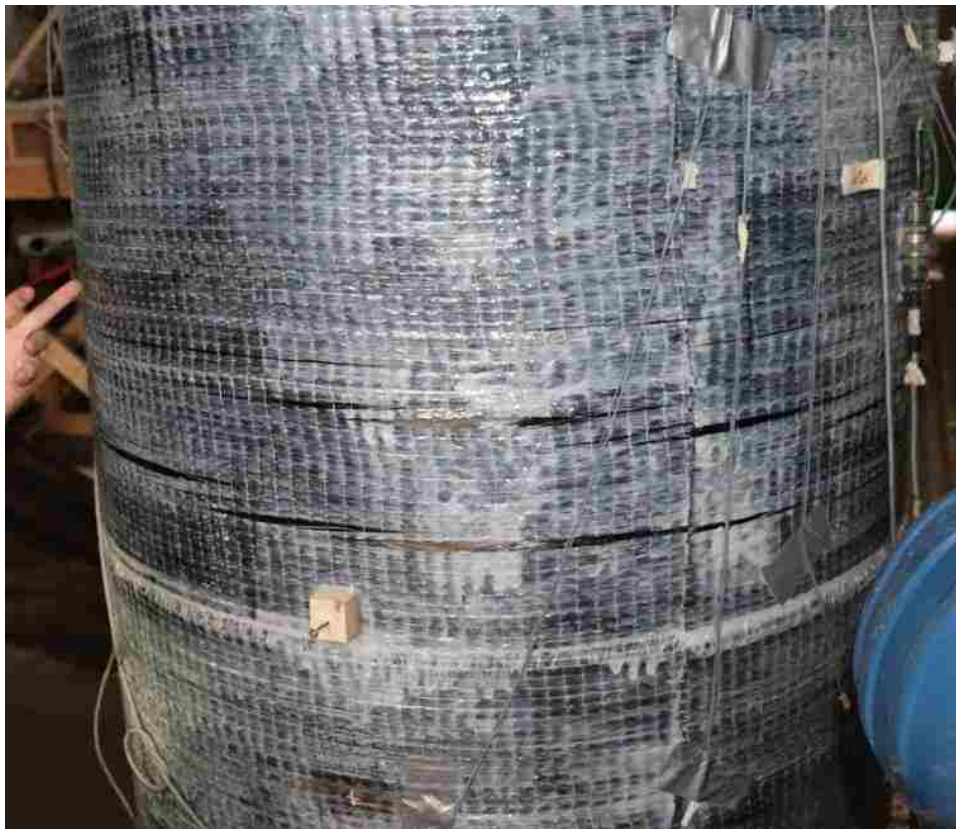
Figure 7-13. Fiber splitting on south face during Series 10

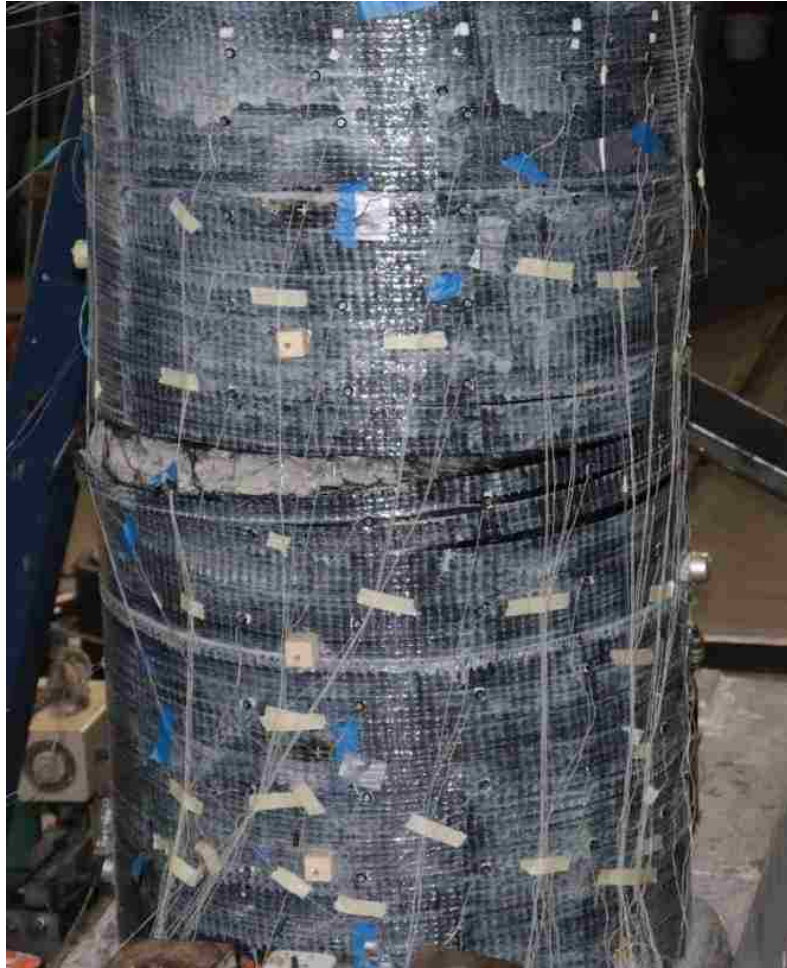
Figure 7-14. Fiber rupture on north face during Series 11

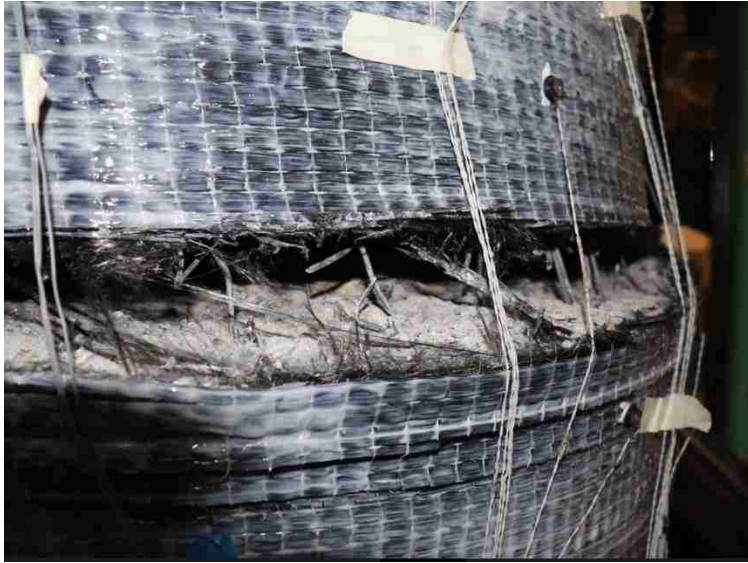
Figure 7-15. Widened fiber split on north face during Series 11

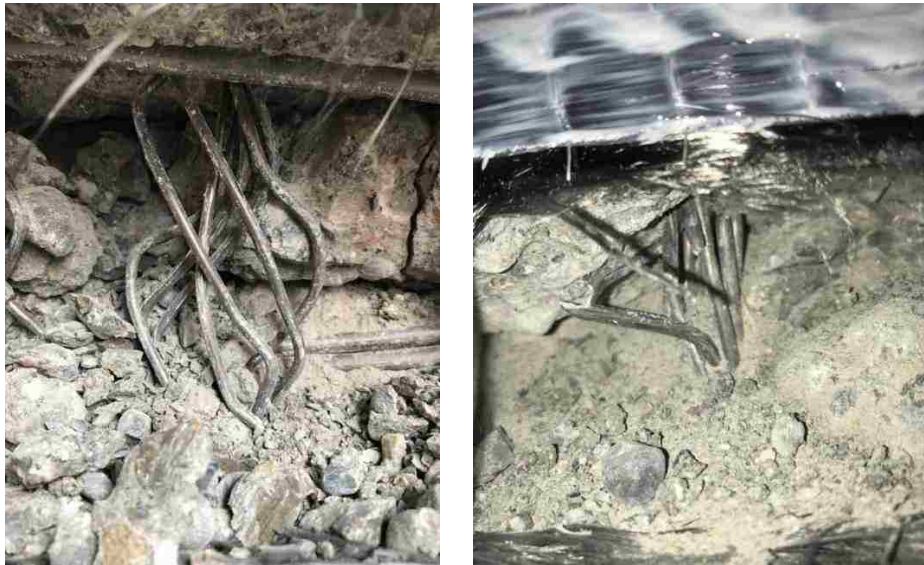
Figure 7-16. Buckled strand (left) and fractured strand (right)

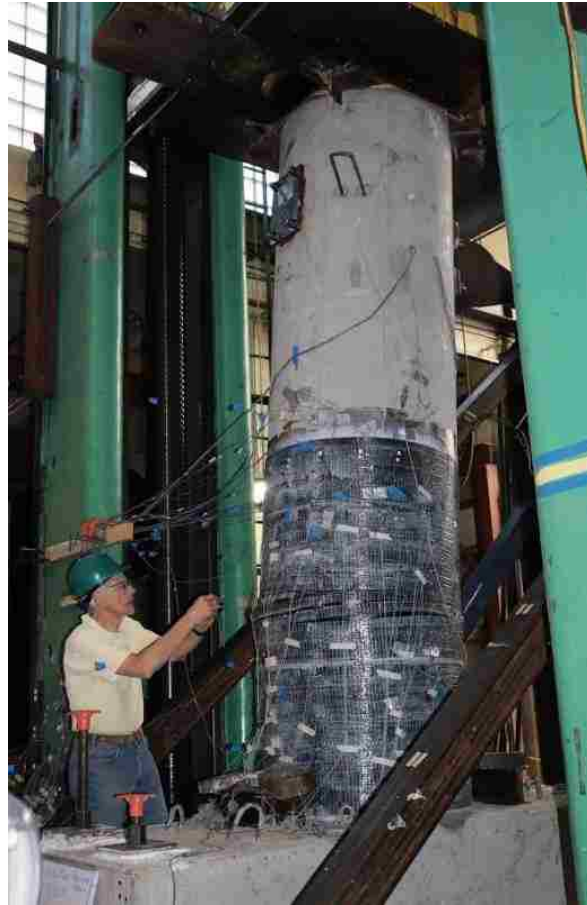
Figure 7-17. Specimen position at +8.09% drift

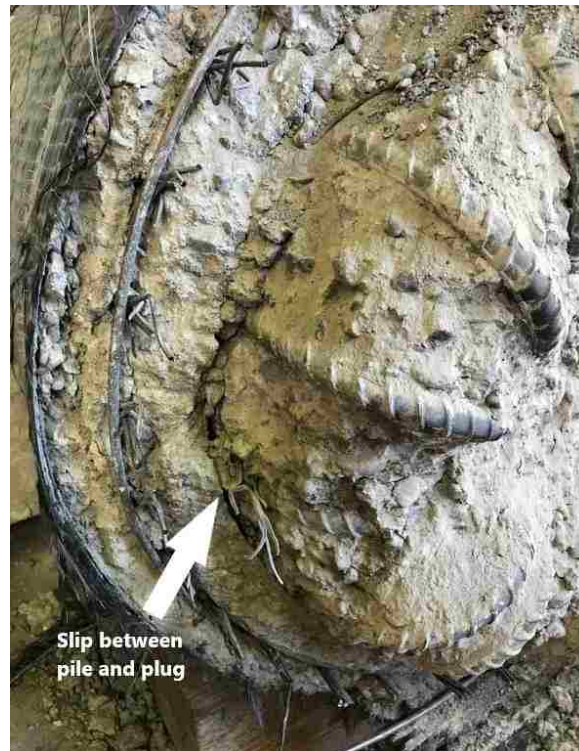
Figure 7-18. Looking down at plug reinforcement after top segment of specimen (portion above the plug in test orientation) had been removed

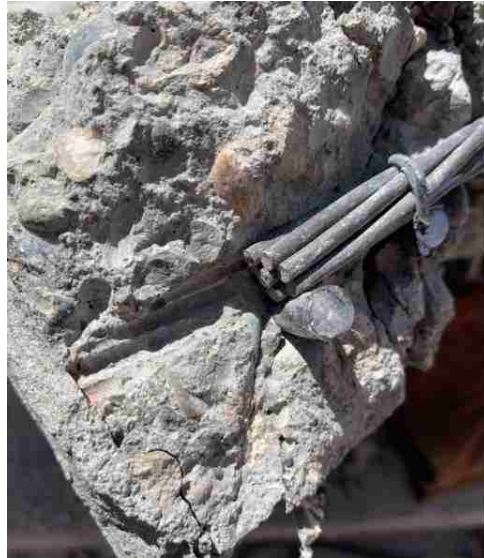
Figure 7-21. Strand slip at the base of the pile-column wall

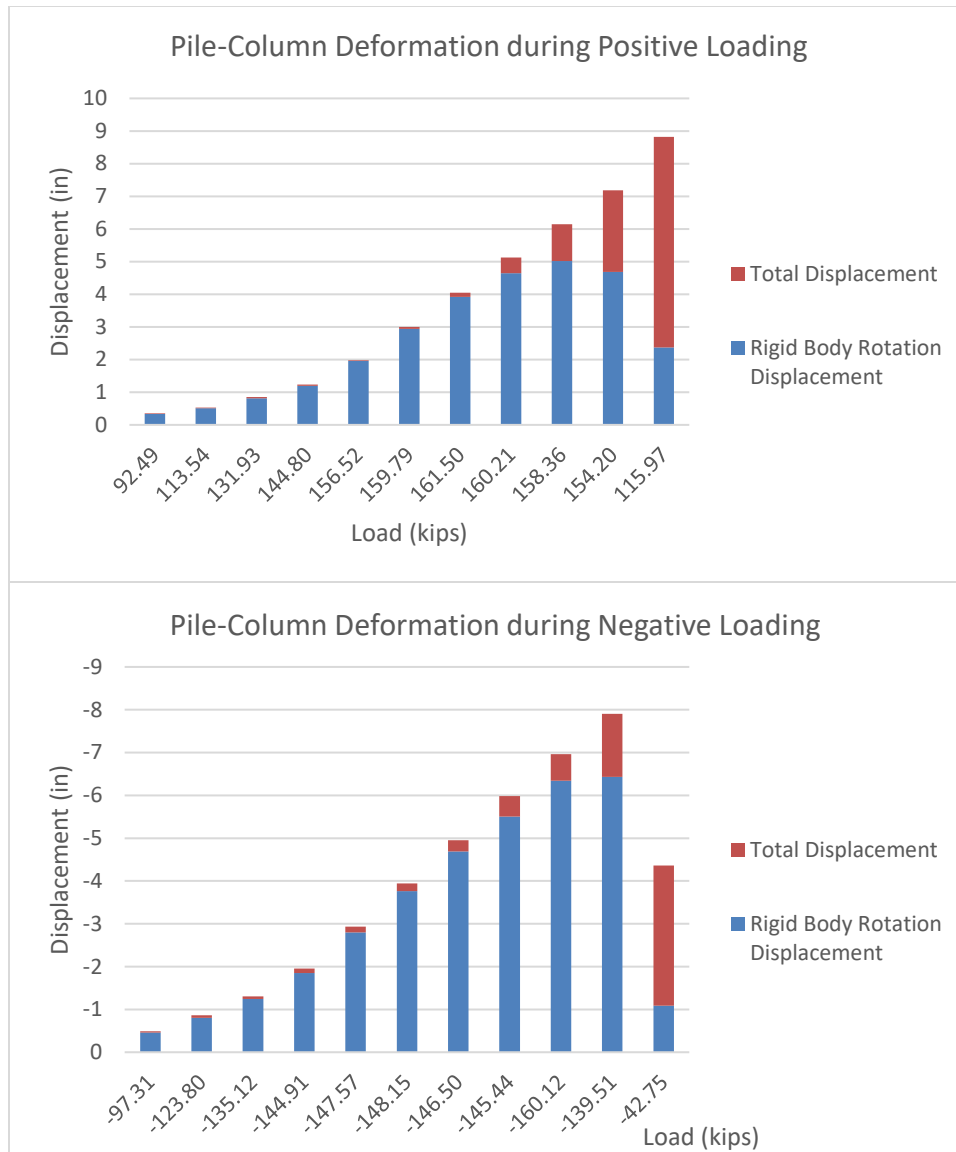
Figure 7-29. Difference between total displacement and rigid body displacement

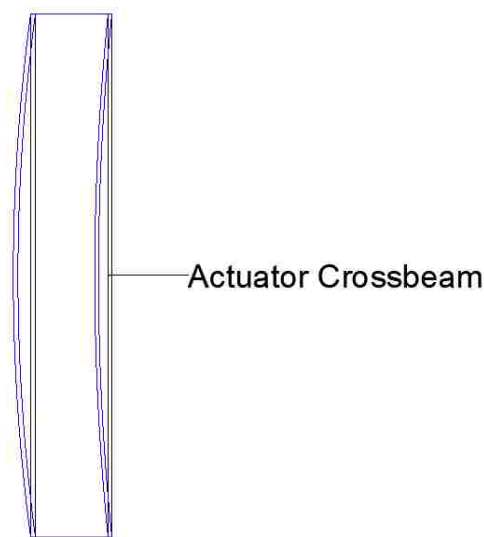
Figure 8-2. Flexing of actuator crossbeam

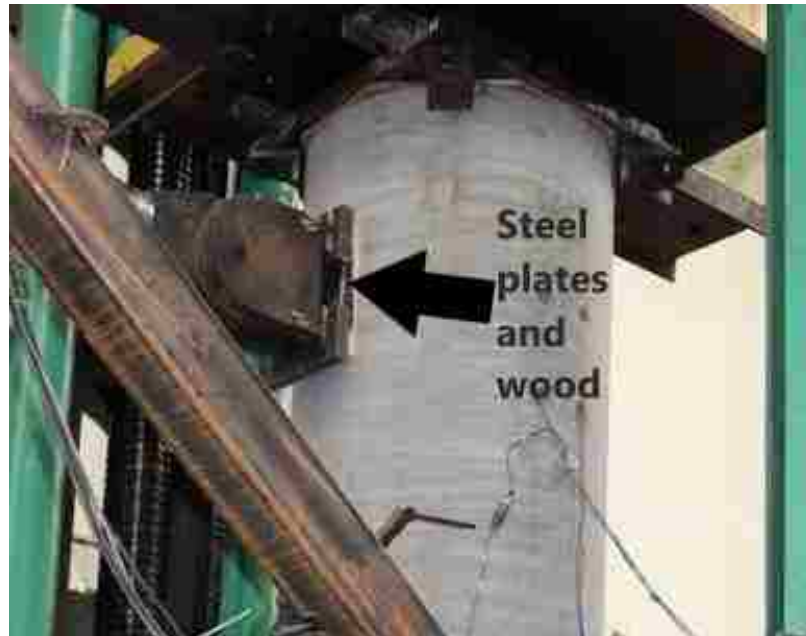
Figure 8-4. Packing underneath actuator connected to specimen

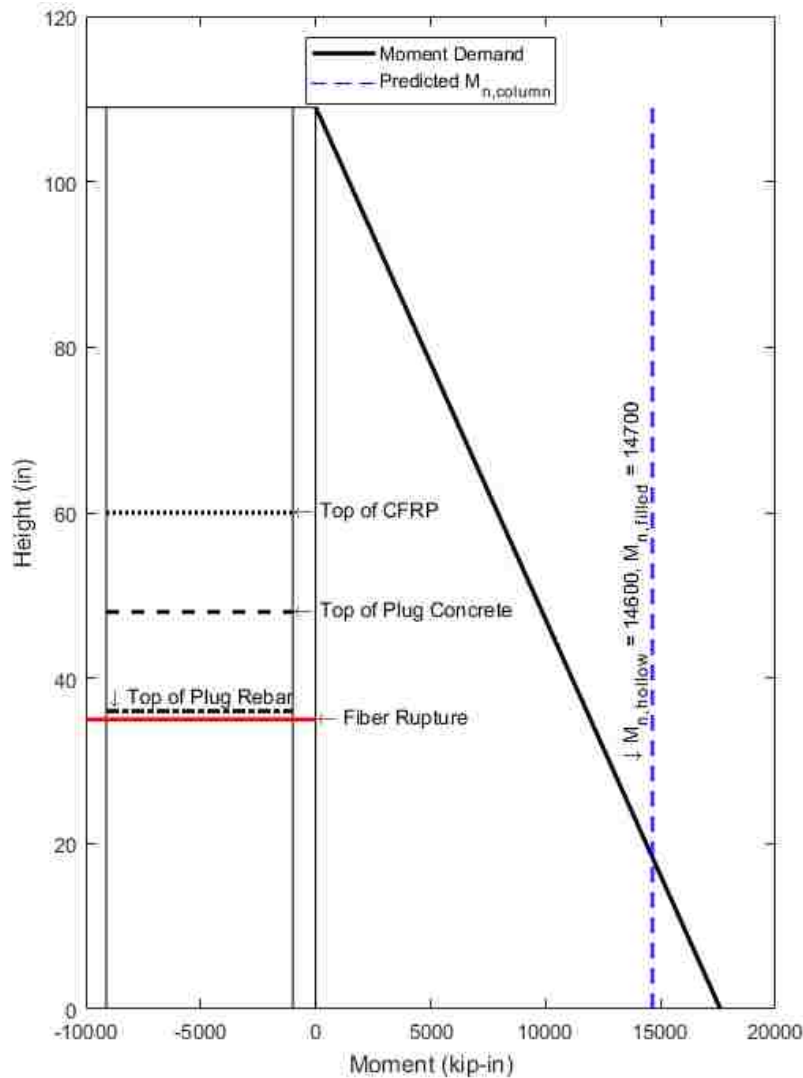
Figure 8-8. Conditions at maximum moment

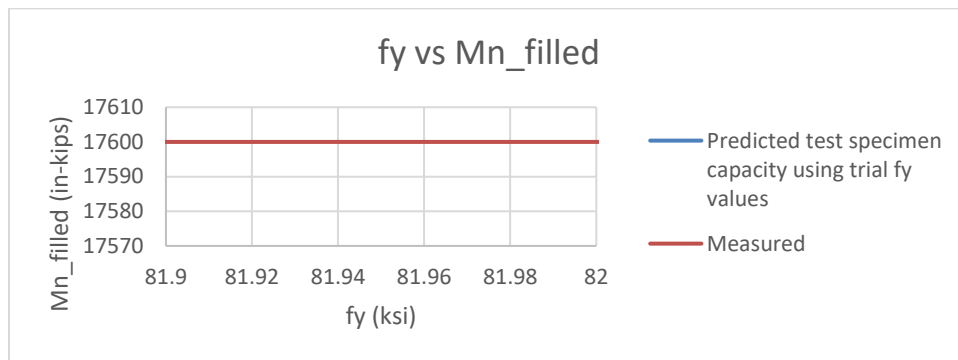
Figure 8-9. Flexural strength of the test specimen filled section as a function of yield stress

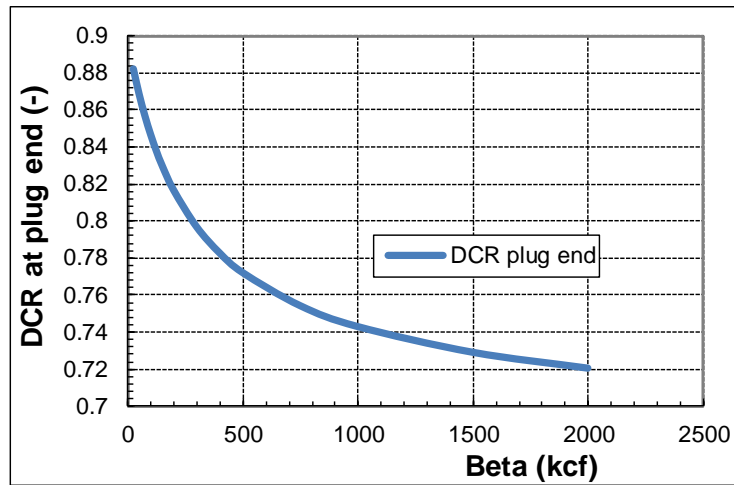
Figure 9-6. Influence of soil stiffness on DCR at bottom of plug.

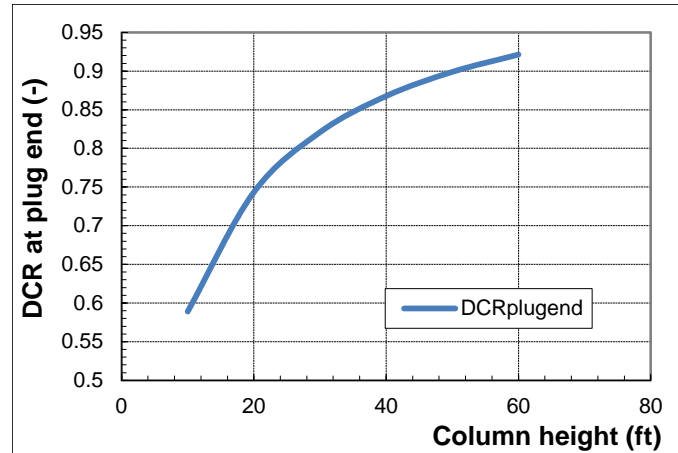
Figure 9-7. Effect of above-grade column height on DCR at the end of the plug.

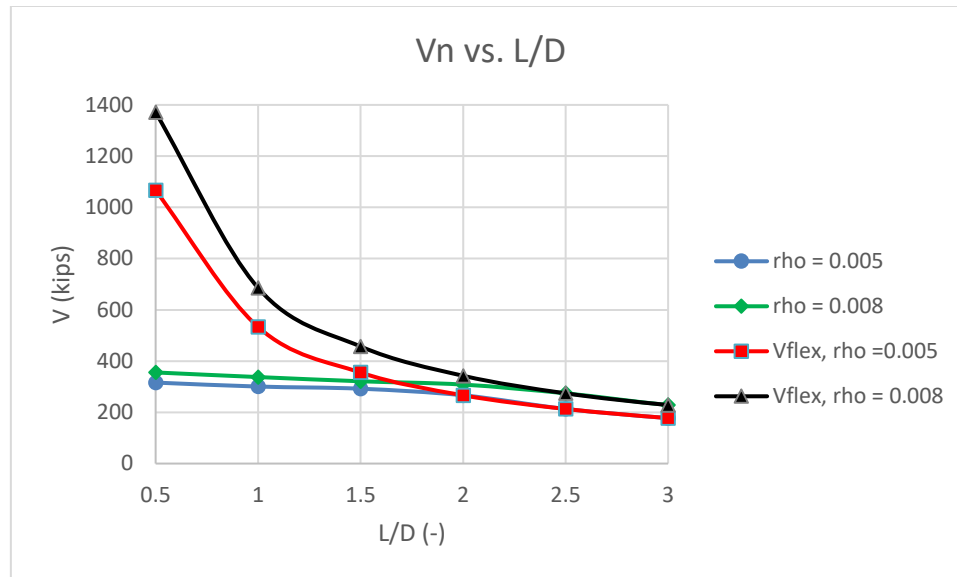
Figure 9-14. Transverse load capacity vs shear span ratio
