Seismic vulnerability assessment of residential buildings using logistic regression and geographic information system (GIS) in Pleret Sub District (Yogyakarta, Indonesia)

Abstract

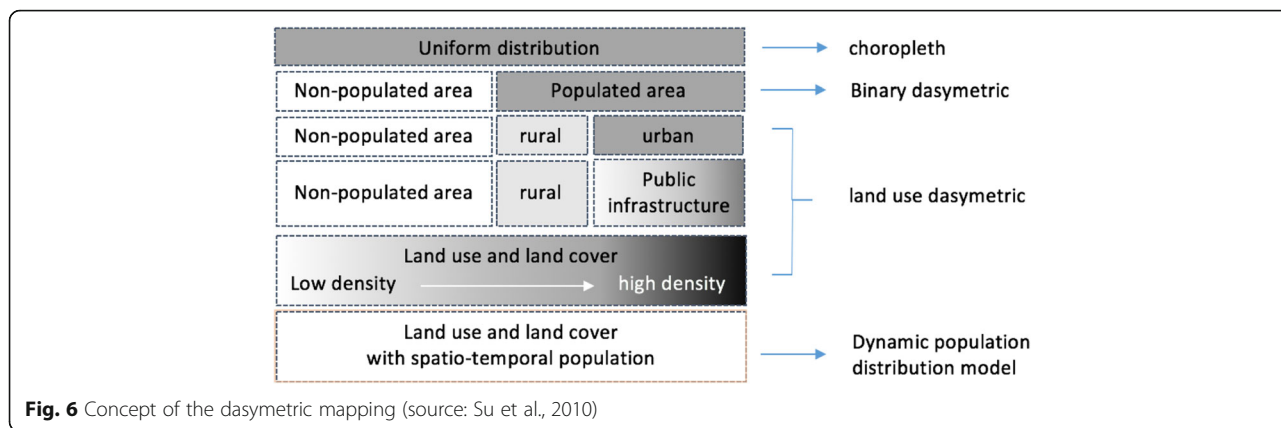
Fig. 6 Concept of the dasymetric mapping (source: Su et al., 2010)

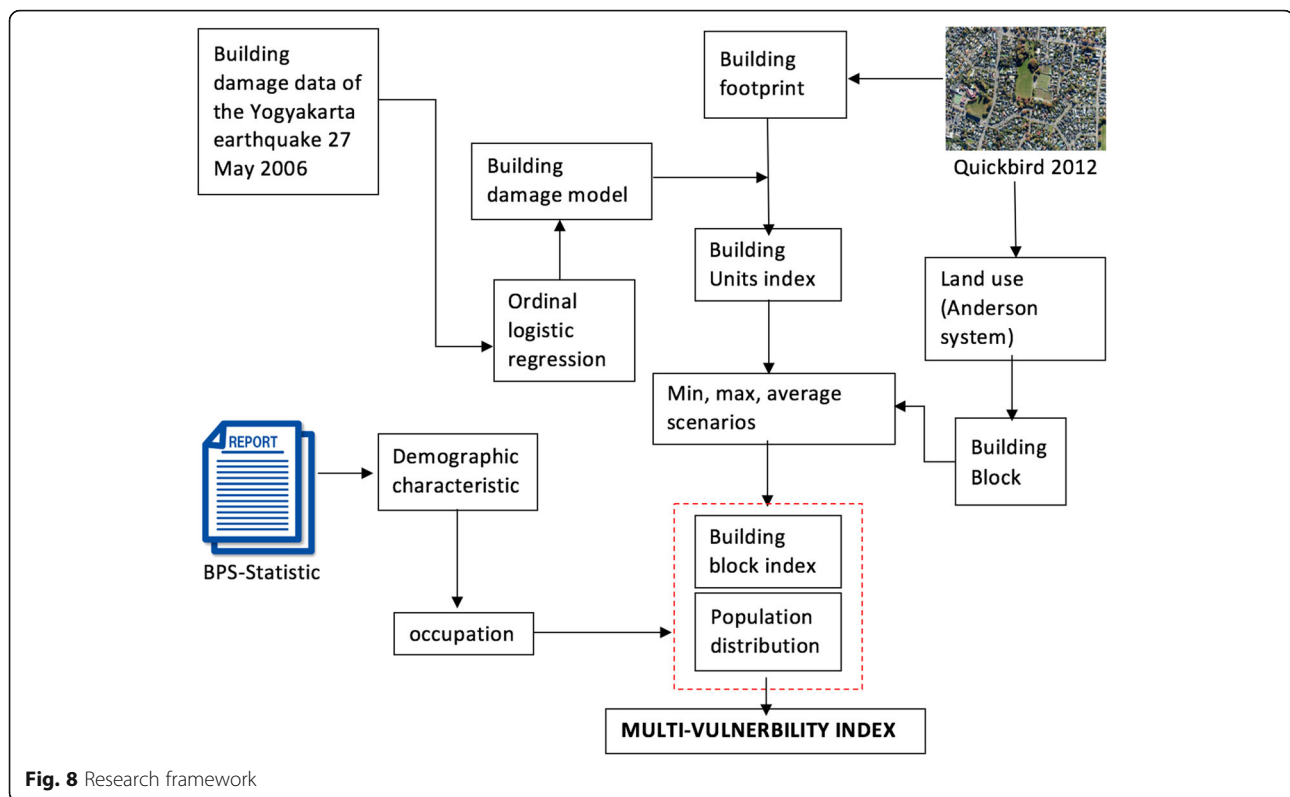
Fig. 8 Research framework

The multi-vulnerability of buildings was determined by adding the building damage category (average scenario) and population distribution class. There are three classes of the numbers of population staying in the particular land use units. Class 1 refers to numbers of population below 100 people, class 2 to numbers of population between 100 and 200 people, and class 3 to numbers of population above 200 people. This classification follows the rule of natural break technique in GIS reclassify tools. The multi-vulnerability value will range between 2 and 6. The values of 2 and 3 are defined as low vulnerability, the value of 3 and 5–6 as medium and high vulnerabilities, respectively. The overall research framework can be seen in the Fig. 8 below.

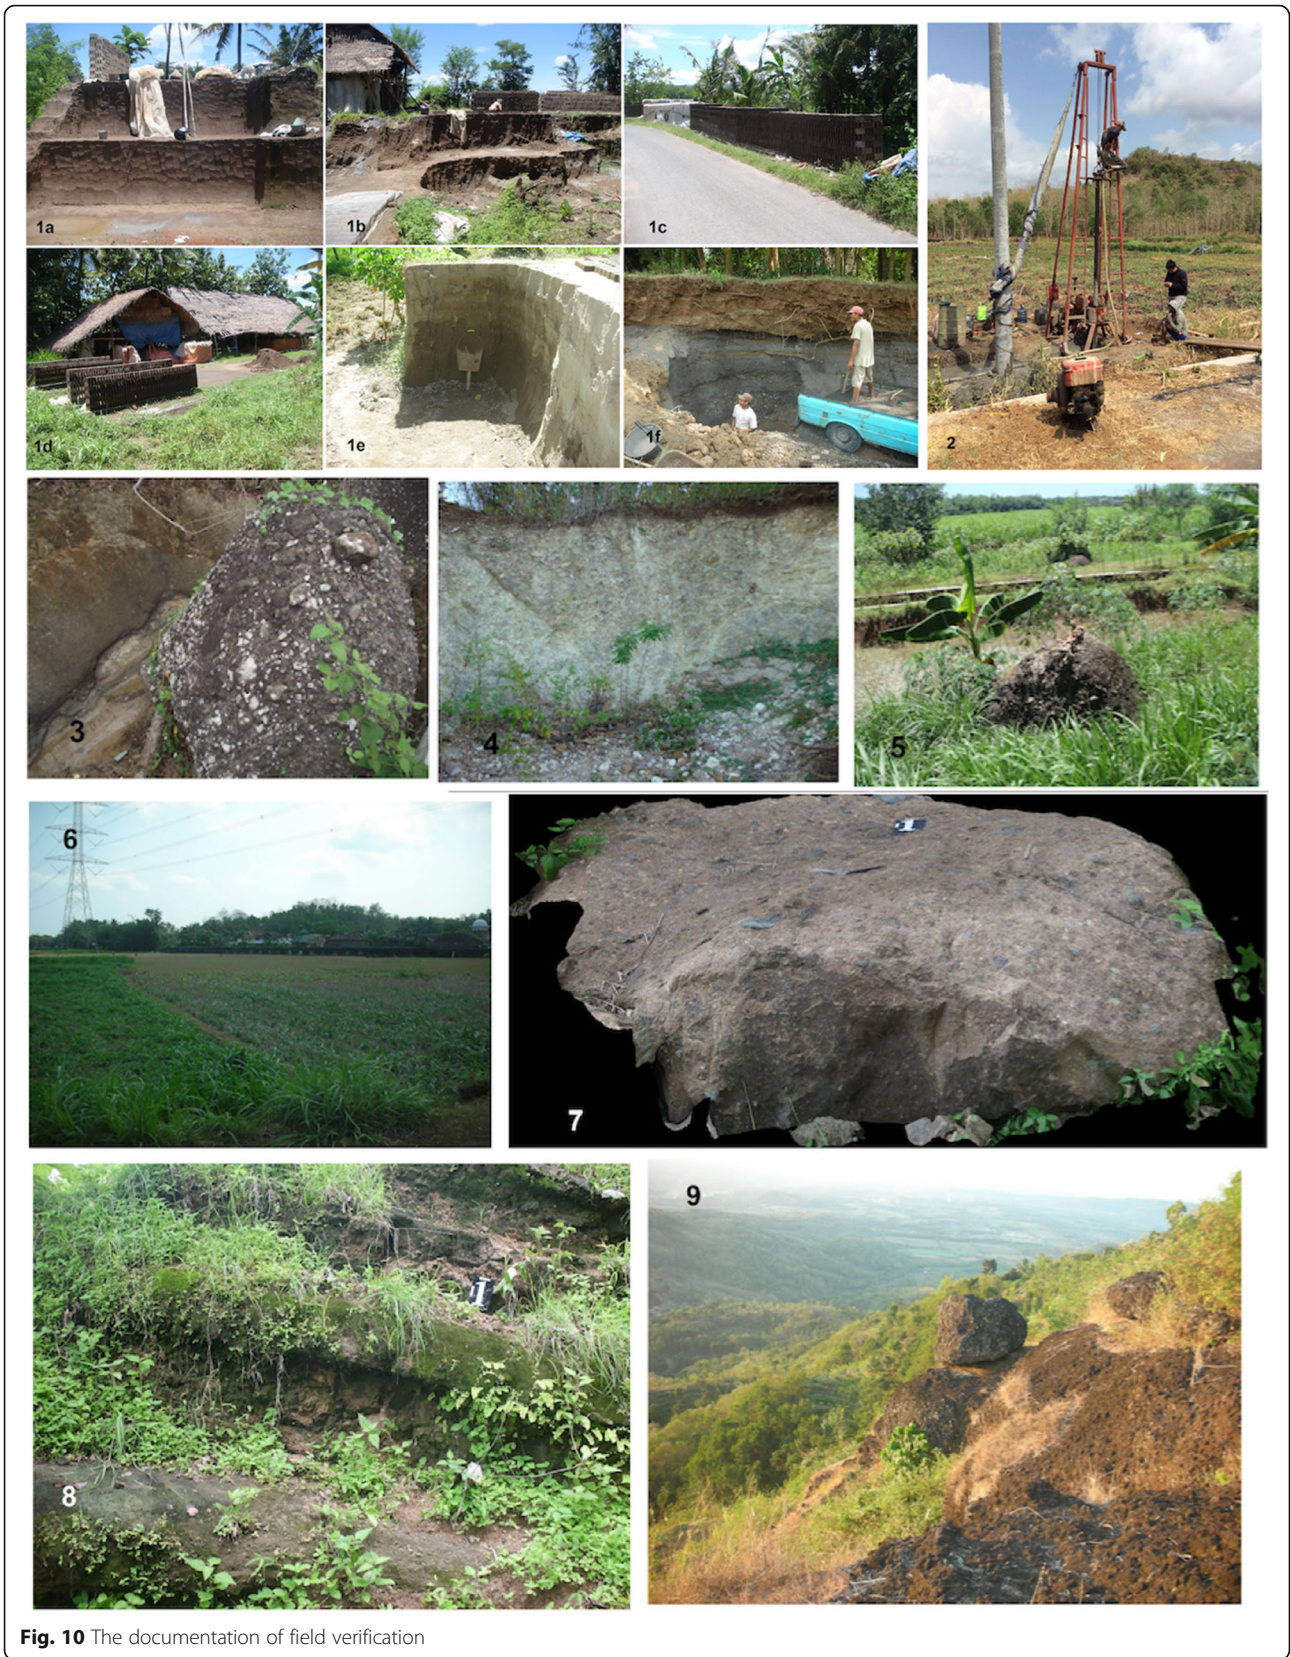
Fig. 10 The documentation of field verification

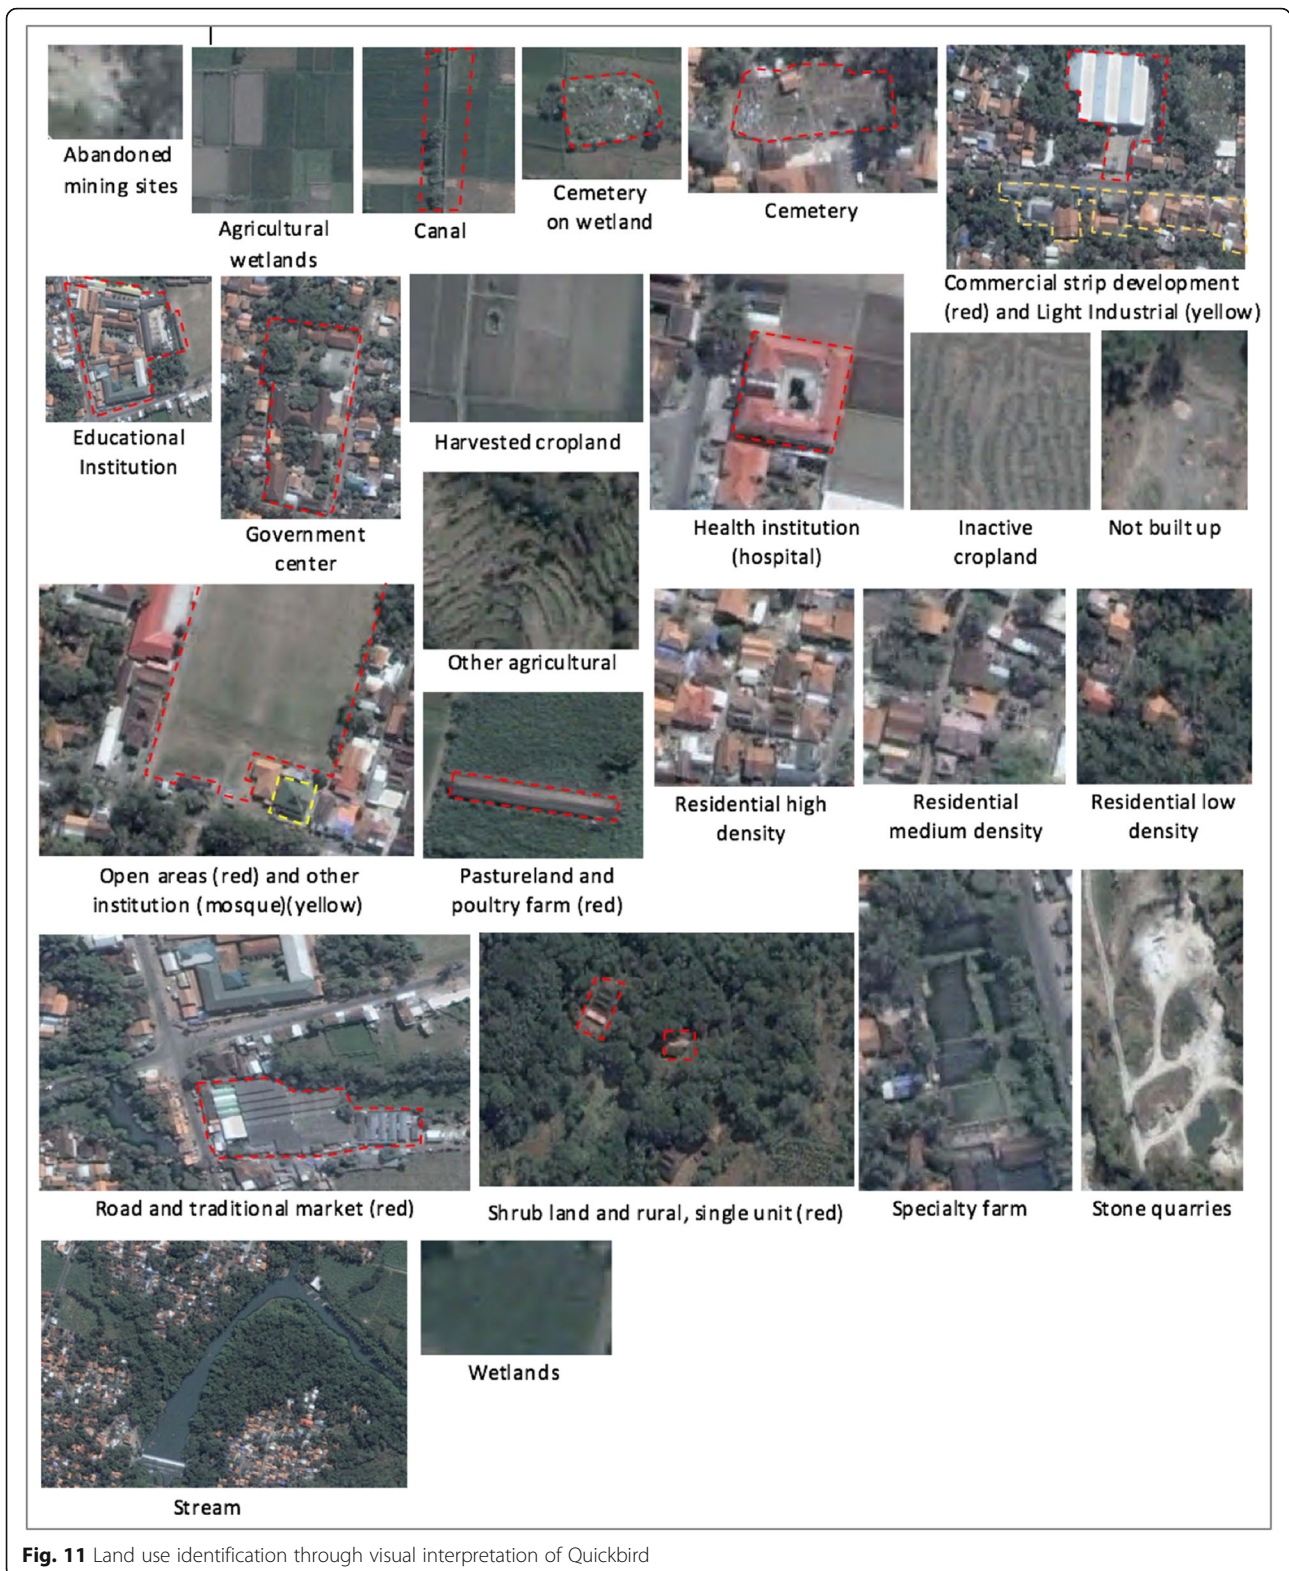
Fig. 11 Land use identification through visual interpretation of Quickbird
