Static evaluation of the out-of-plane behavior of URM infill walls utilizing modern blast retrofit systems

A THESIS

UNIVERSITY OF MISSOURI-ROLLA

MASTER OF SCIENCE IN CIVIL ENGINEERING

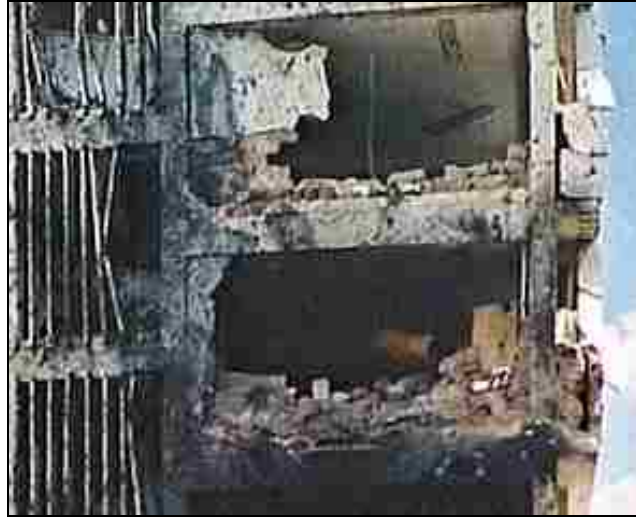
Figure 1.2. Failure of Exterior URM Infill Walls

contributor, and the major threat to the building occupants, is the fragmentation and debris scatter of the building envelope. In 1998, the damage sustained to the U.S. Embassy in Dar El Salaam, Tanzania, as a result of a terrorist attack is an example of such a case when an explosive device did not result in the collapse of the structure; but still resulted in significant damage. The damage to the embassy building is presented in Figure 1.2. Although there were no fatalities as a result of the attack, several injuries and significant damages were attributed to the scatter of debris from the exterior unreinforced masonry (URM) infill wall system (FEMA, 2003).

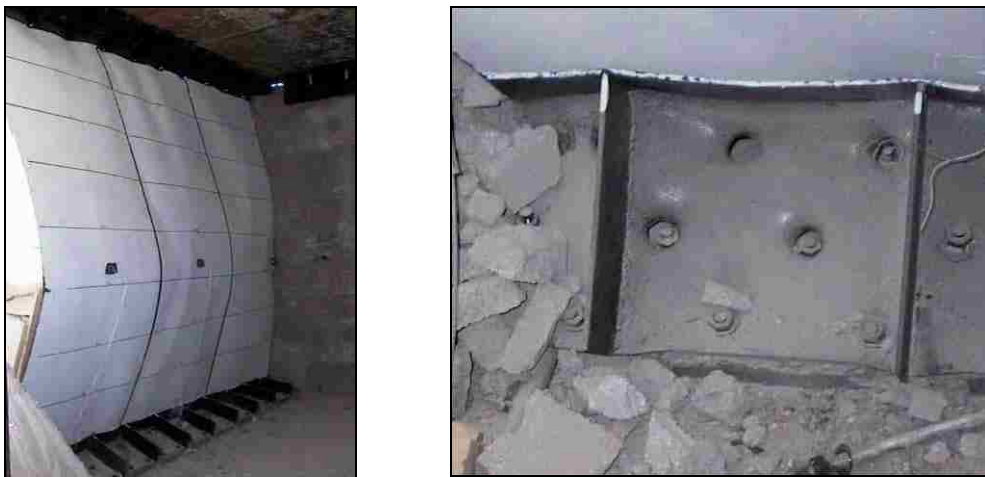
A case study performed by Bogosian and Crawford (2000) presented an aesthetically acceptable, non-intrusive retrofit method to improve the performance of URM wall systems subjected to extreme blast loads. The URM retrofit implemented in this study was designed as a catcher system and consisted of a 1/8in. (3.2mm) thick steel plate spanning from floor to ceiling on the interior face of the wall, high density polyurethane foam, and a stiffened steel anchorage system. This type of steel plate catcher system is highly attractive because the system subtracts little space from the floor plan of the building, and the surface of the steel plate on the interior face of the wall can be easily covered. The retrofit was highly effective in preventing debris and fragmentation from projecting inward into the structure. As a result of the blast, the plate deformed plastically and bent into a membrane to accommodate the impulsive load from the wall debris. The deformation due to the blast load can be seen from the interior face of the strengthened wall and the anchorage system presented in Figure 2.3.

Figure 2.3. Steel Plate Catcher System (Bogosian and Crawford, 2000)

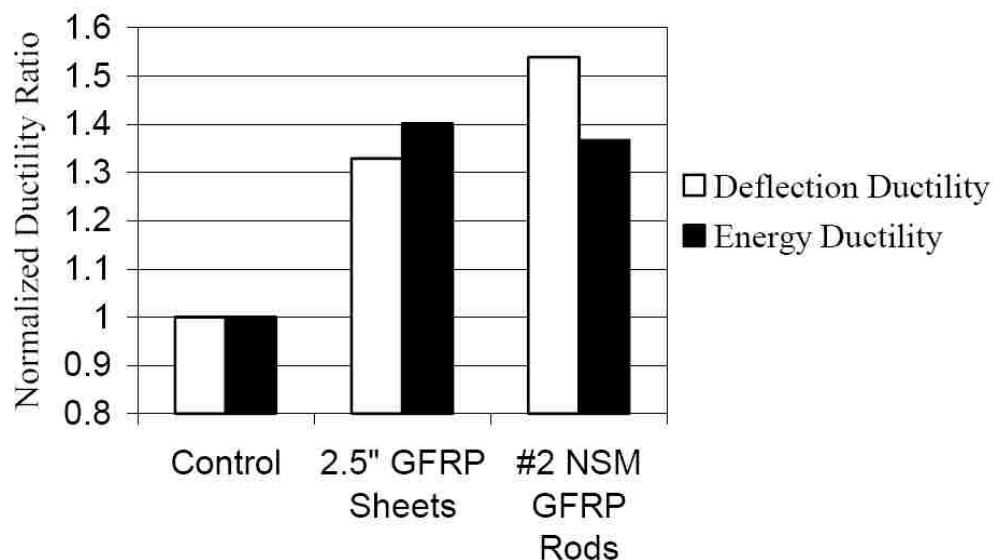
Figure 2.6. Normalized Ductility Results (Carney and Myers, 2003)

Another study carried out at UMR implemented the use of two different FRP retrofit techniques resulting in significant increases in the flexural capacity of partially framed URM infill walls. The walls in this study were tested in the laboratory under static loading using an airbag system. A second phase of study tested strengthened walls in the field under actual blast loads (Carney and Myers, 2003). The walls in this study were restrained between two rigid boundary elements at the upper and lower boundaries of the wall, had a slenderness ratio of 12, and were constructed using CMUs. Due to the low slenderness ratio and the restraint at the member-ends imposed by the surrounding frame, one-way arching action was observed in all of the strengthened and unstrengthened URM walls. The use of both NSM GFRP rods and surface laminate GFRP strips was investigated, and both were found to significantly increase the out-of-plane load carrying capacity as well as the ductility of URM infills. The ductility results from testing have been presented in Figure 2.6.

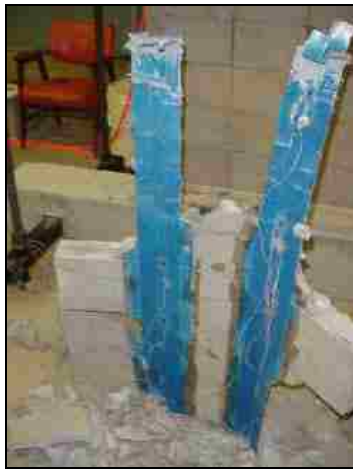
In addition to the increased load carrying capacity and ductility that resulted from the FRP retrofits implemented in this program, the effect of the retrofit schemes on the debris scatter at failure was also investigated. It was also found that the use of the NSM FRP rods resulted in essentially no improvement in the scatter of debris of base masonry material at failure. The use of the FRP surface laminates in this program was found to result in modest improvements in reducing the amount of debris and fragmentation at failure. The failure behavior of each type of retrofitted wall is presented in Figure 2.7.

(a) Surface Laminate Retrofit

(b) NSM Retrofit

Figure 2.7. Debris Scatter of Masonry Substrate Material (Carney and Myers, 2003)

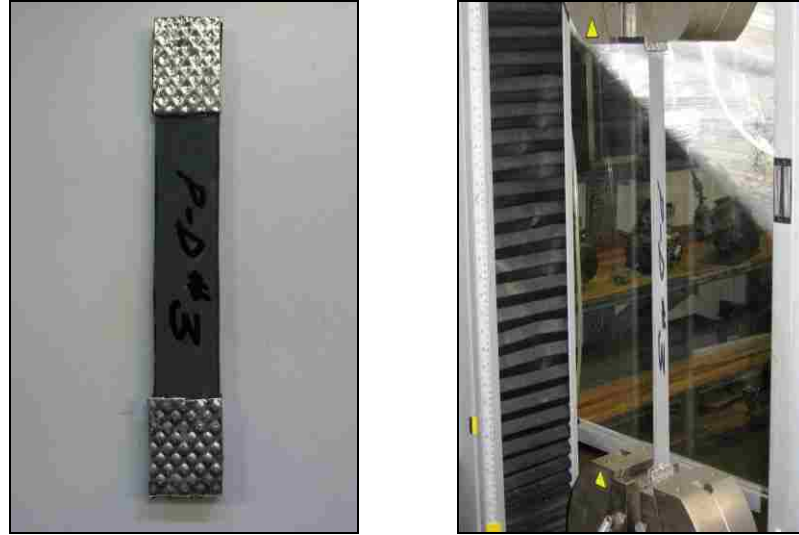
Figure 3.3. Testing of Polyurea Coupon

The coupons were tested at a rate of 0.50in./min (12.7mm/min). The strain data were recorded using a 1in. (25.4mm) extensometer placed at the midpoint of the gage

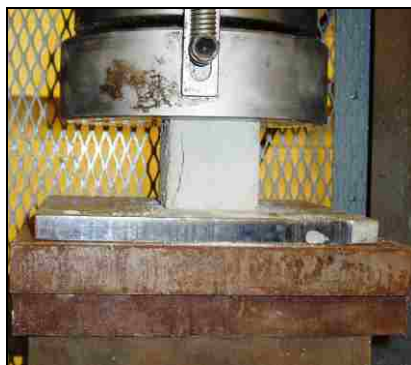
The mortar used for construction of the URM walls was a readily available premixed product classified as Type-S defined by ASTM C270. The compressive strength of the mortar was verified by testing 2in. (50mm) mortar cubes in accordance with ASTM C109. A set of 3 mortar cubes were cast, moist-cured, and tested at 28 days for verification of the mortar type. Additional sets of mortar cubes were prepared and match cured for each URM wall constructed. The match cured mortar cubes were tested at the same time as the wall specimens. The casting and testing of the mortar cubes is illustrated in Figures 3.5 and 3.6, respectively. The results from the cube testing have been summarized in Table 3.6.

Figure 3.6. Mortar Cube Testing

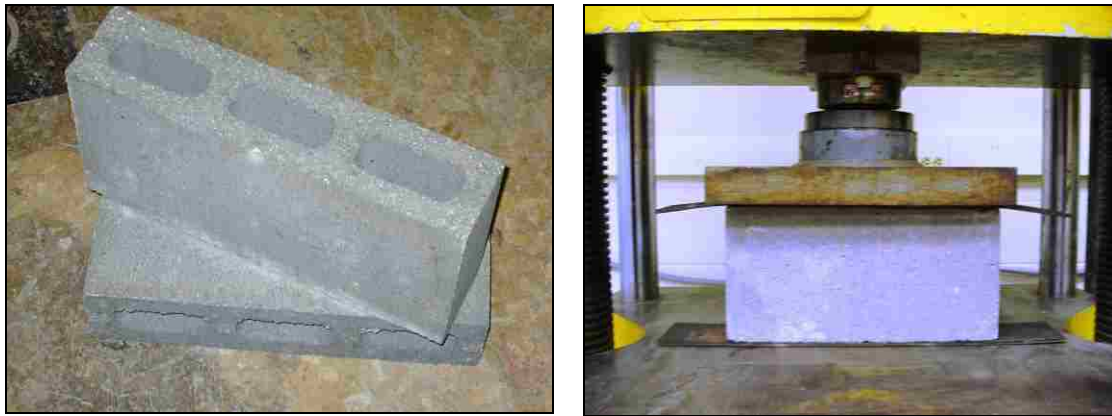
Figure 3.8. Testing of Individual Concrete Masonry Units

was determined by testing full-length uncapped units in accordance with ASTM C140-05a. The gross compressive strength of the CMU units was found to be 1,700psi (11.7MPa), and the net compressive strength was determined to be 2,100psi (14.5MPa). The testing of the individual concrete blocks is illustrated in Figure 3.8.

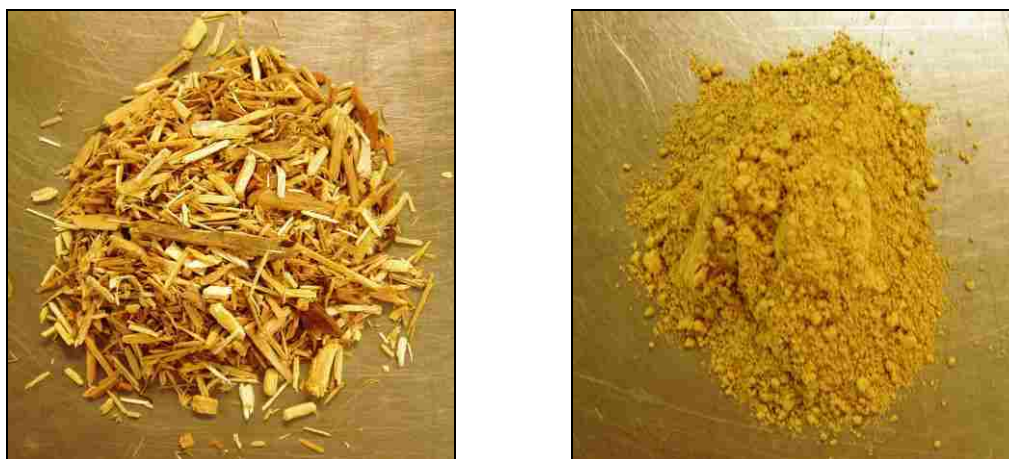
3.4.1.3. Wood-fiber fly ash masonry. The wood-fiber fly ash masonry units (WF-FA) used in this research were made from a composite mixture consisting of primarily white oak wood-fibers and a Class-C fly ash. The raw materials are presented in Figure 3.9.

Figure 3.9. WF-FA Primary Materials

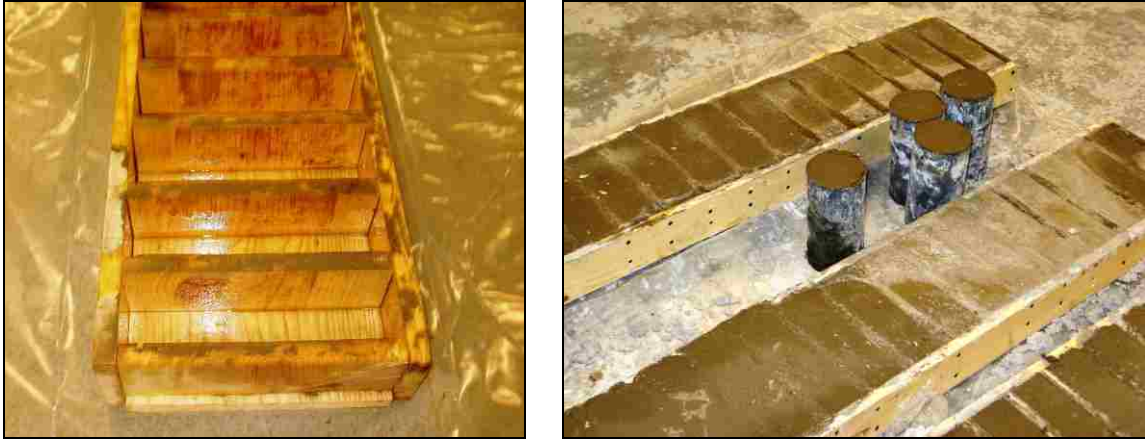
Figure 3.10. WF-FA Material Placement

The WF-FA material was mixed in 2ft³ (0.057m³) batches using a rotating drum mixer with a volumetric capacity of 4ft³ (0.113m³). As shown in Figure 3.10, after adequately mixing, the material was placed into wooden forms, which were subdivided into a series of brick sized units. The material was placed in two layers, and voids were removed by way of rodding the material with a standard tamping rod.

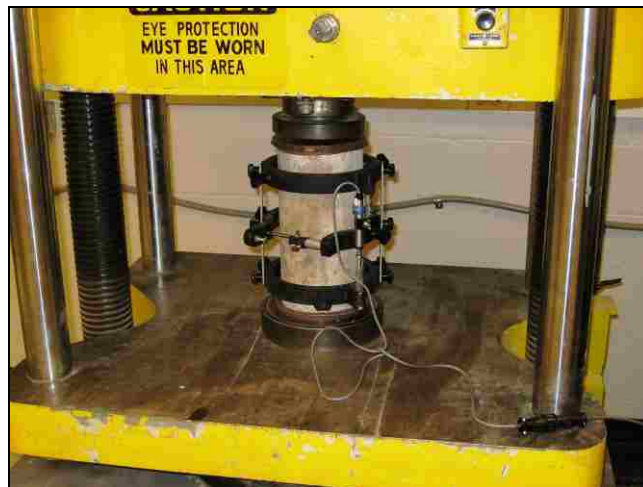
Figure 3.11. WF-FA Compression Testing

compressive strength from each of the batches of material was based solely on cylinder testing and was found to be 450psi (3.1MPa). The stiffness of the material was determined in accordance with the ASTM C469 test method. The 6 x 12in. (152 x 305mm) cylinders were loaded at a rate of 500lb/sec (2.22kN/sec), and longitudinal strain data were acquired using a compressometer. The testing resulted in relatively low stiffness values with an average modulus of elasticity value of 300ksi (2070MPa). The compressive strength testing of the WF-FA material is presented in Figure 3.11.

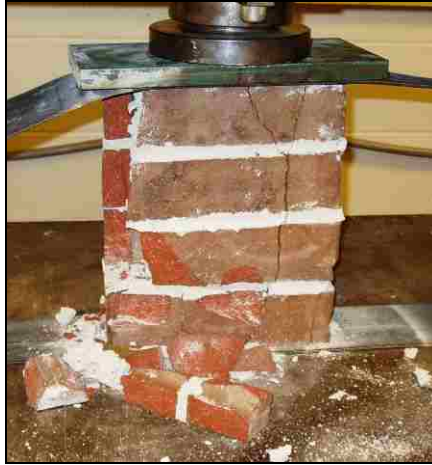
The masonry prisms constructed from the clay units had gross overall dimensions of $2\frac{3}{4} \times 11\frac{1}{2} \times 9\frac{1}{2}$ in. (70x292x241mm). The prisms consisted of four courses of single full-length units. The gross compressive strength of the clay masonry was found to be 1,500psi (10.3MPa) and the net strength was determined to be 1,850psi (12.8MPa). The testing of the clay prisms is illustrated in Figure 3.12.

Figure 3.12. Compression Testing of Clay Prism

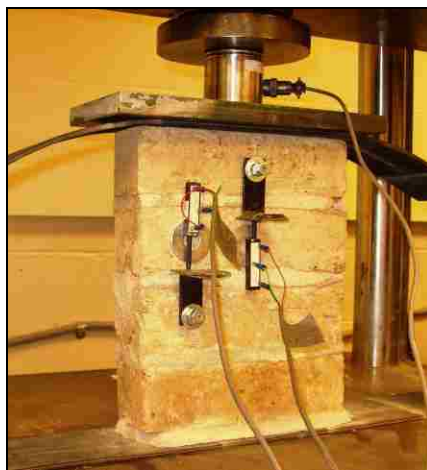
assemblage. The WF-FA prisms had gross overall dimensions of $9\frac{1}{2} \times 2\frac{3}{4} \times 11\frac{1}{2}$ in. (241x70x292mm). The prisms consisted of four courses of single full-length units. In addition to the determination of the compressive strength of the WF-FA prisms, the stiffness of the assemblage was also determined. Testing of the WF-FA prisms is illustrated in Figure 3.13.

Figure 3.13. Compression Testing of WF-FA Prism

During the testing of the WF-FA prisms, the load-deflection behavior was recorded through use of 1 in. (25mm) potentiometers spanning the mortar joints of the prisms. The potentiometers measured displacements from the mid-height locations of the courses immediately above and below the mortar joints. The load data were recorded through use of a 25kip (111kN) load cell. From the data acquired for the WF-FA prism testing, the stress-strain behavior was developed for each of the tests performed. The stress-strain behavior from one of the three WF-FA prism tests is presented in Figure 3.14.

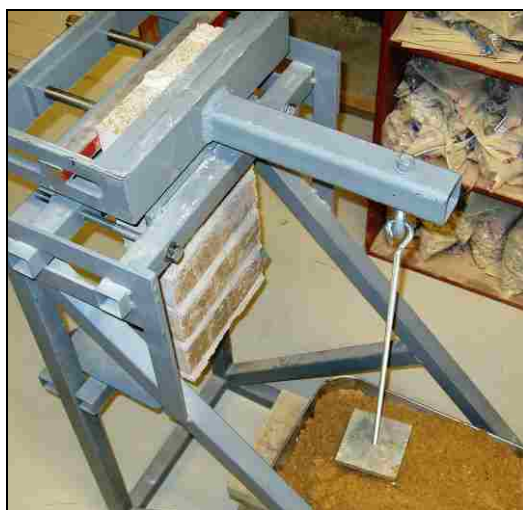
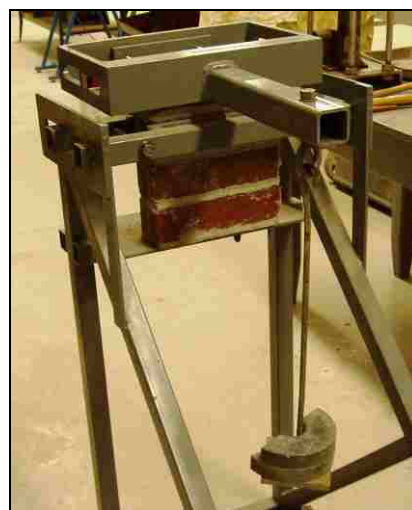
Flexural bond testing was performed on each of the base masonry materials using a bond wrench testing apparatus in accordance with ASTM C1072. A total of eight tests were performed for each type of masonry. The results from the testing showed that the flexural bond strength of un-roughened, smooth faced WF-FA masonry units was approximately half of that determined for traditional masonry units. The masonry flexural bond testing and the apparatus used are illustrated in Figure 3.15. The results from the bond testing have been averaged and are summarized in Table 3.10.

Figure 3.15. Masonry Flexural Bond Test

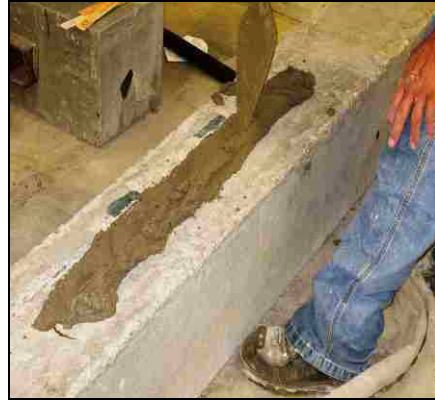
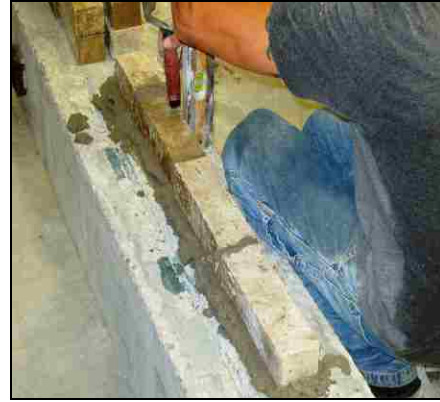
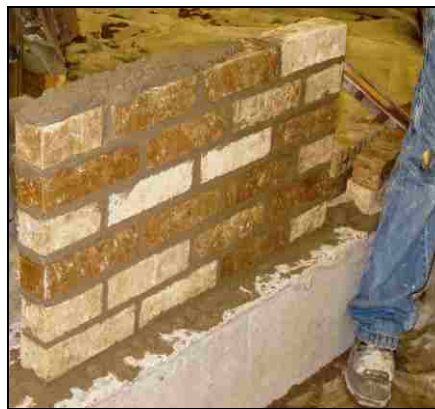
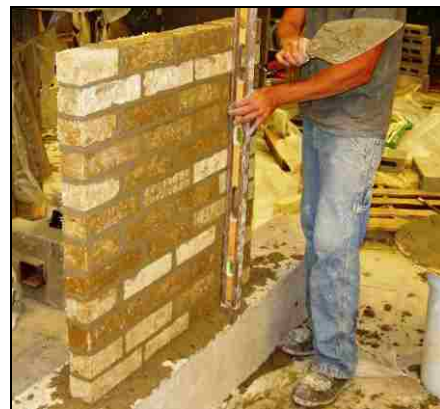
All of the walls in this phase of the program were constructed using a running bond and had an approximate slenderness, or height-to-thickness ratio, equal to 13. The walls were constructed using a Type-S mortar, and mortar joints were finished flush with the surface of the masonry units. The walls were constructed with a uniform width of 36in. (914mm), but varied in height due to the variation in thickness of the masonry units. Walls constructed from the clay brick or WF-FA brick units consisted of 12 courses and were 36in. (914mm) in height. Walls constructed from the CMU block consisted of 6 courses and were 48in. (1219mm) in height. The construction of one of the WF-FA masonry walls from Phase 1 of the experimental program is presented in Figure 5.2.

Figure 5.2. Construction of WF-FA Phase 1 Wall

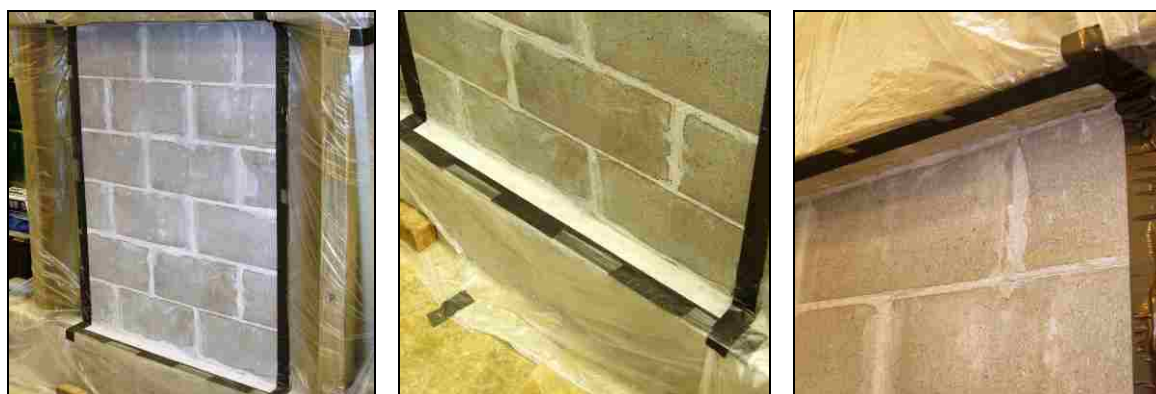
Prior to the application of the strengthening material, the mortar joints of the walls were ground down smooth using a mason's stone, and all dust and debris was removed from the surface of the walls and boundary elements. The walls and surrounding frame elements were taped off, so only the front face of URM wall and a 2in. (51mm) strip on the upper and lower boundary elements would be exposed during the spray-on application of the polyurea elastomer. The overlap of material onto the boundary elements was done in an attempt to provide some level of wall anchorage to the surrounding frame by way of the polyurea. The taped off wall is shown in Figure 5.4.

(a) Face of URM Wall

(b) Lower Boundary Beam

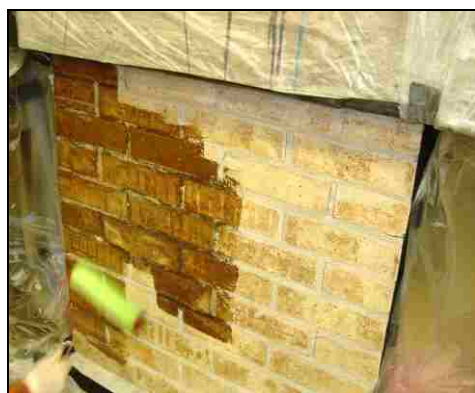
(a) Application of Primer

The application of the primer material and the primed walls are shown in Figure 5.5.

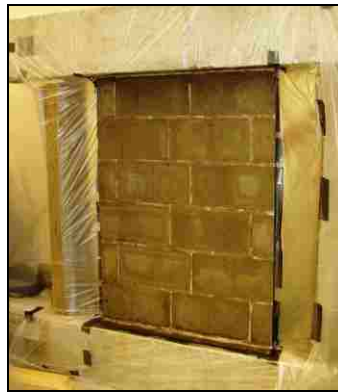
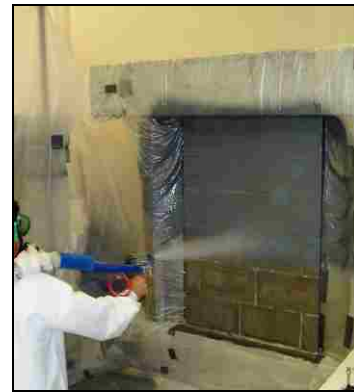
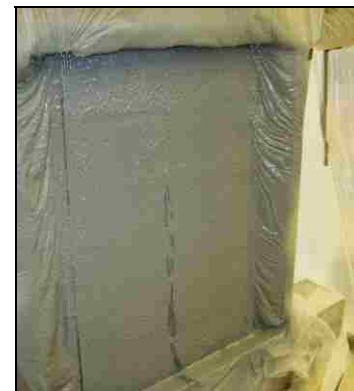
The primer was allowed to cure for approximately one hour prior to spraying the walls with the elastomeric polyurea material. For walls strictly undergoing the polyurea retrofit, a 1/8in. (3.2mm) layer of material was applied to face of the wall as well as to the exposed areas of the surrounding frame. For the walls that were retrofitted with the FRP grid embedded within the polyurea, a thin initial layer of polyurea was sprayed onto the walls prior to the application of the FRP grid. Immediately after the first layer of polyurea was sprayed onto the wall surface, the grid was embedded into the still-soft polyurea material using a heavy roller. The set-time for the polyurea was approximately 10 to 20 seconds; therefore, the application of the grids had to immediately follow the application of the polyurea. For the purpose of applying the FRP grids as quickly as possible, the grids were pre-cut to match the width of the walls but were cut slightly

shorter than the wall height to avoid interference from the frame elements. Finally, a second application of polyurea was sprayed over the FRP until the surface became free of voids, and the FRP was fully embedded within the polyurea. The combination of the FRP and polyurea material resulted in an overall retrofit thickness of approximately 3/8in. (9.5mm). The spraying of the polyurea and the application of the FRP grids is presented in Figure 5.6. Additionally, a schematic of the two retrofit schemes used for the Phase 1 walls has been provided for illustration in Figure 5.7.

Figure 5.6. Strengthening Procedure for Phase 1 Walls

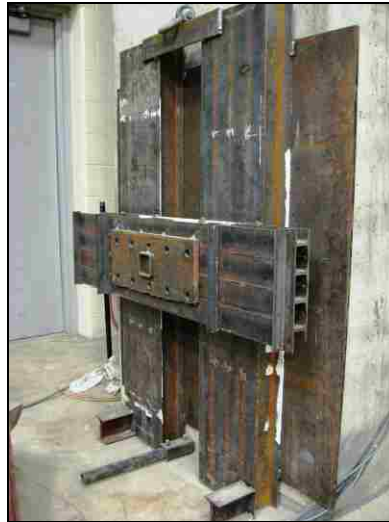
Once the URM wall was in its final position, the lower boundary element was anchored to a concrete strong floor through use of the threaded dywidag rods used in the steel frame assembly. A stiffened 1/2in. (13mm) steel plate was used as the reaction structure for the airbag system. The plate was stiffened using built-up WF-sections oriented in both the horizontal and vertical directions and is presented in Figure 5.8. The steel plate was lifted into position using the overhead crane and was supported at five locations, the four corners, and at center. The center of the plate was supported by an 8 x 8 x 3/8in. (203 x 203 x 10mm) structural steel tube that housed a dywidag rod assembly. The use of the dywidag assembly made the section adjustable in length. The center plate

support reacted directly against a 4ft (1.20m) thick concrete strong wall. The plate supports used at each of the four corners were 6 x 6 x 1/4in. (152 x 152 x 6mm) built-up rectangular sections. These members were shimmed into place using masonry units and steel plates, which also reacted against the concrete strong wall.

Figure 5.8. Stiffened Plate Assembly

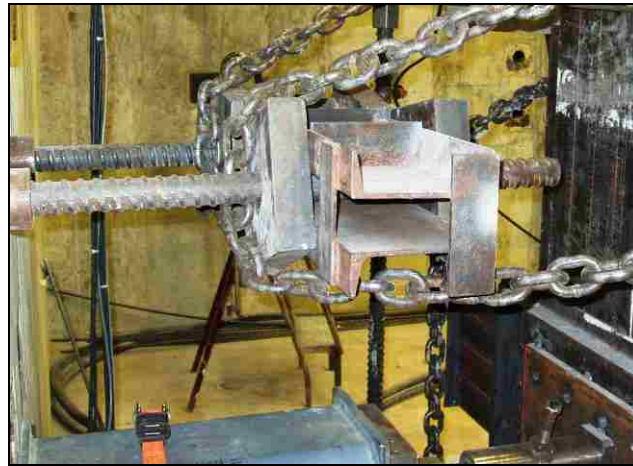
To effectively anchor the upper boundary element, restraints had to be provided in both the vertical and horizontal directions. To prevent vertical translation from occurring, 8 x 8 x 3/8in. (203 x 203 x 10mm) structural steel tubes were attached to the steel frame assembly that was used to position the upper and lower boundary elements. The horizontal translation was limited through the use of a pair of 12kip (53.4kN) capacity chains. One end of the chains was wrapped around the upper boundary element at each side of the URM wall, and the other end of each chain was wrapped around a small steel beam built-up from stiffened C-sections. The steel beam was loosely attached

to a concrete strong wall using a dywidag rod assembly. This method of anchoring the chains allowed for the tension in the chains to be adjusted both prior to and during testing. The reaction system used for the chains is presented in Figure 5.9.

Figure 5.9. Chain Restraint System

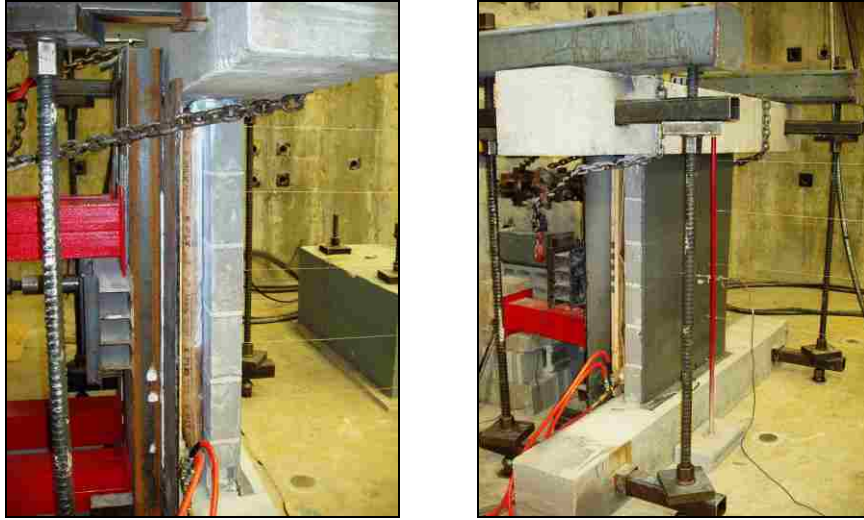
Figure 5.11. Phase 1 Test Setup

assembly, and it resulted in a relatively large coverage area of the URM wall when the airbag was inflated. In most cases, sheets of plywood were used to decrease the space between the reaction plate and the URM walls. The full test setup for the Phase 1 walls is illustrated in Figure 5.10 and Figure 5.11.

For each of the Phase 1 walls, the deflection was measured at five locations along the vertical wall profile using a series of string transducers. The use of string transducers

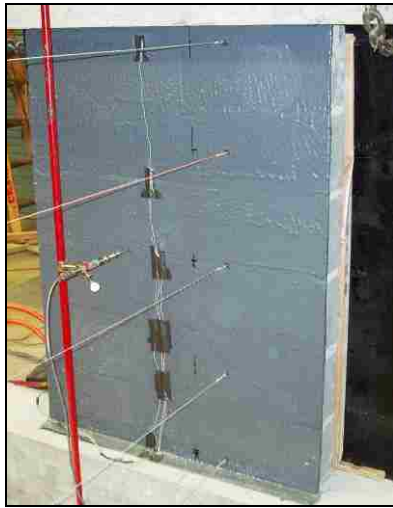
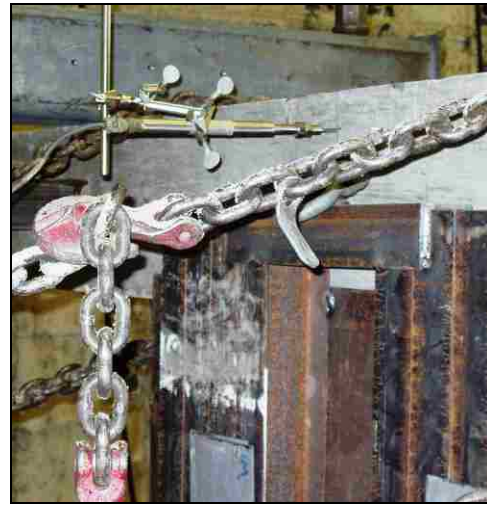
For each of the retrofitted walls, strain gage data were acquired along the vertical profile of the wall at five locations. For the walls strengthened with the GFRP-polyurea system, strain gages were applied directly to the FRP grids prior to embedding them within the polyurea. Walls retrofitted using only polyurea material had strain gages applied directly to the surface of the elastomeric coating. The locations of the string transducers, LVDTs, and the strain gages are presented in Figure 5.12.

Figure 5.12. Phase 1 Instrumentation

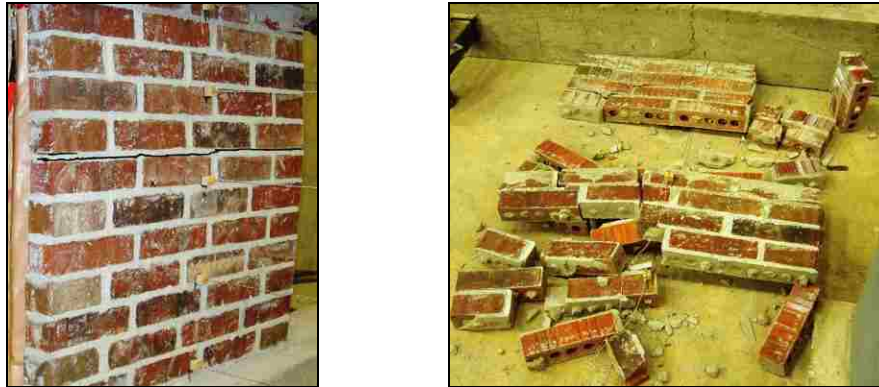
Figure 5.13. Wall P1-1 Failure

5.2.1. Wall P1-1. Wall P1-1 was the clay control specimen. At an applied pressure of 0.8psi (5.5kPa), the first crack was visible on the pressure applied face of the wall in the bed-joint at the lower boundary element location. At a pressure value of 1.9psi (13.1kPa), a major horizontal crack began developing one course above the mid-height location on the exposed face of the wall, and visible rigid body deformation was observed (see Figure 5.13). As the formation of the arch progressed, the mid-height crack grew along the full length of the bed-joint and continued to open. Wall P1-1 reached a peak airbag pressure value of 4.6psi (31.7kPa) at a deflection of 0.62in. (15.7mm) before the behavior of the wall became unstable and the pressure resistance began to drop, as shown in Figure 5.14. Ultimately, the pressure resistance decreased to a value of 3.6psi (24.8kPa), and the wall collapsed. The clay control wall achieved a maximum deflection value of 1.10in. (28.0mm). The debris scatter and poor resistance to fragmentation of the base masonry material can be seen in Figure 5.13b. In examining the masonry units of Wall P1-1, it was found that only minor crushing had occurred in the mortar of the bed-joints at the mid-height and boundary location. The wall ultimately failed due to instability.

(a) Horizontal Crack

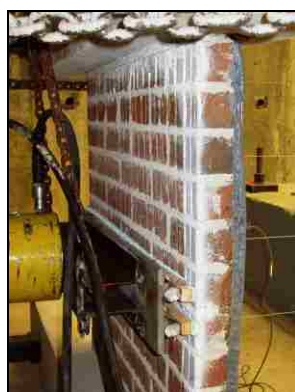
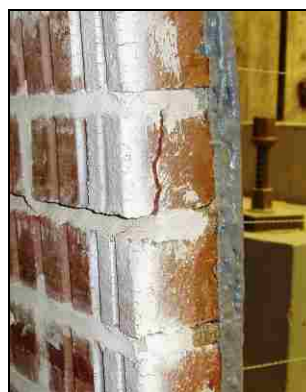
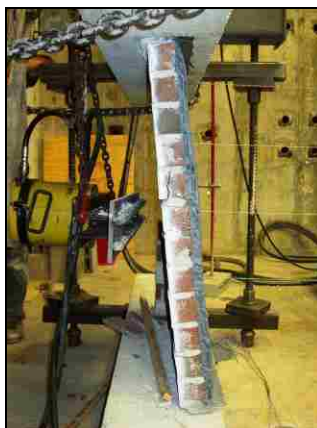
5.2.2. Wall P1-2. This wall was a clay wall specimen strengthened with the GFRP-polyurea retrofit. Due to the stiffness of the masonry and the high level of reinforcement of this specimen, the ultimate capacity of Wall P1-2 was not achievable using the airbag system. Therefore, the wall was initially loaded using an airbag, but upon reaching the capacity of this system, was loaded using a hydraulic jack. The first

cracks in Wall P1-2 occurred at an airbag pressure value of 1.2psi (8.3kPa) and were found to occur in the bed-joint at the location of the upper boundary element. Loading continued until a peak applied pressure value of 23.0psi (158.6kPa) and deflection of 0.55in. (14.0mm) was reached, and the airbag system failed. Up to this point of the test, significant wall sliding was found to occur, and only hair-line cracks at the mid-height location were observed. To load the wall to failure, a line-load across the width of the wall at the mid-height location was applied using a hydraulic jack. The load imposed on the wall from the jack has been expressed as an equivalent uniform face pressure, which would induce the same mid-height moment as that of the force value applied using the jack. The wall reached an equivalent airbag pressure value of 29.5psi (203.4kPa) at a deflection of 0.64in. (12.3mm). At this point, flexural-shear cracks began to form from the point of load application, and the load resistance of the wall began to decrease (see Figure 5.15). Ultimately, the wall failed at an equivalent uniform pressure value of 21.6psi (148.9kPa) and a deflection of 1.12in. (28.5mm). The load resistance behavior of Wall P1-2 expressed as an equivalent uniform pressure is presented in Figure 5.16.

Figure 5.15. Wall P1-2 Failure

Figure 5.15 (continued). Wall P1-2 Failure

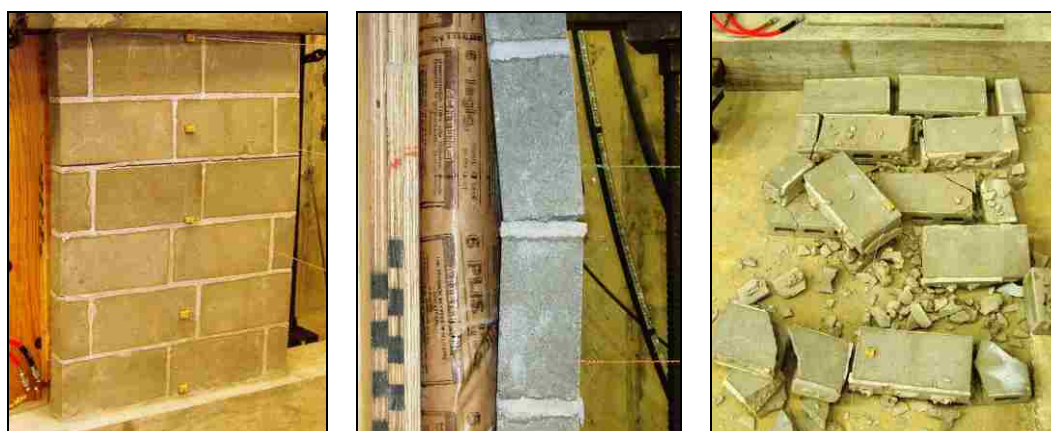
(a) Horizontal Cracking (b) Rigid-Body Behavior (c) Debris Scatter

joint one course above the mid-height location, as illustrated in Figure 5.17. Once the crack developed over the full-width of the bed-joint, the upper and lower segments of the wall began to rotate as rigid elements, and the cracks at the boundary locations and mid-height continued to grow in width. Wall P1-3 reached a peak pressure value of 5.9psi (40.7kPa) at a deflection of 0.75in. (19.1mm). Once reaching the peak pressure value, the mortar from the top bed-joint began to crush, and the load resistance began to decrease as shown in Figure 5.18. The wall collapsed at an applied pressure value of 4.0psi (27.6kPa) and a mid-height deflection value of 1.08in. (27.4mm). As illustrated in Figure 5.17c, the wall had little resistance to fragmentation.

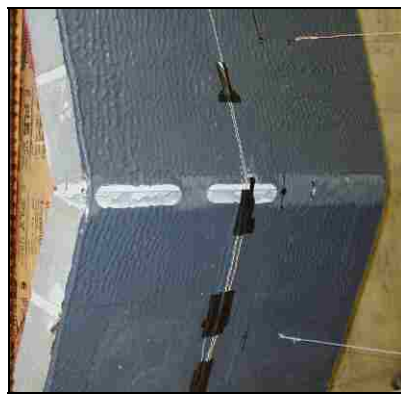
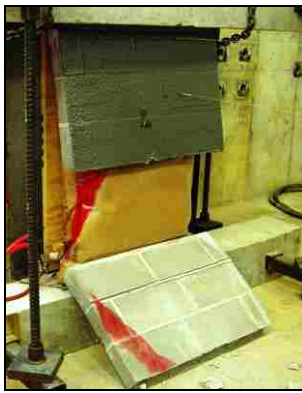
The peak pressure applied to this wall was 8.1psi (55.8kPa), which occurred at a deflection of 0.81in. (20.6mm). Beyond the peak, the load resistance began to decrease, and the upper and lower segments of the wall continued to deform as rigid bodies undergoing very large deflections as shown in Figure 5.19. The reduction in the pressure resistance slowly decreased until a resisting pressure of 1.07psi (7.4kPa) and a deflection of 4.03in. (96.5mm) were reached. The wall maintained this pressure until failure occurred due to rupture of the polyurea at mid-height, as shown in Figure 5.19b. The maximum mid-height deflection achieved by Wall P1-4 was 8.57in. (217.7mm). The load resistance behavior of this wall is presented in Figure 5.20. The failure behavior of the wall is presented in Figure 5.19c, and it can be seen that even after partial collapse of the URM wall, the polyurea remained bonded to the surrounding frame and prevented fragmentation of the base masonry material from occurring.

Figure 5.19. Wall P1-4 Failure

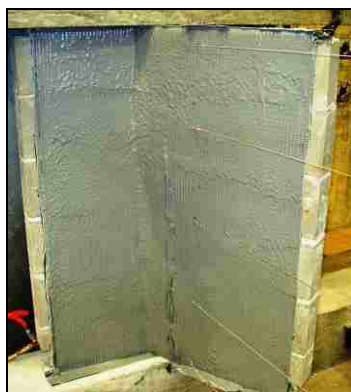
5.2.5. Wall P1-5. This wall was constructed from concrete block and was strengthened using the GFRP-polyurea retrofit. Initially, cracks formed in the bed-joints of the upper and lower boundaries at a value of 1.4psi (9.7kPa). At 13.0psi (89.6kPa), the initiation of debonding of the polyurea material from the surrounding frame elements was observed. The debonding slowly progressed until the overlap of polyurea material fully debonded from the boundary elements on one side of the wall, forcing the wall into a form of negative bending about the vertical axis (see Figure 5.21). The wall failure occurred immediately after the polyurea debonded at an airbag pressure value of 14.3psi (98.6kPa) and a mid-height deflection value of 0.87in. (22.1mm). Prior to failure, no visible horizontal cracks were observed on the exposed face of the wall. Because the wall remained partially bonded to the surrounding frame elements, no fragmentation or debris from the substrate material resulted from the wall failure. Further investigation of the failed wall showed that no crushing had occurred in the CMUs, and only minimal crushing had occurred in the mortar of the bed-joints at the location of the boundary elements. The load-deflection behavior is illustrated in Figure 5.22.

(a) Bending About Vertical Axis

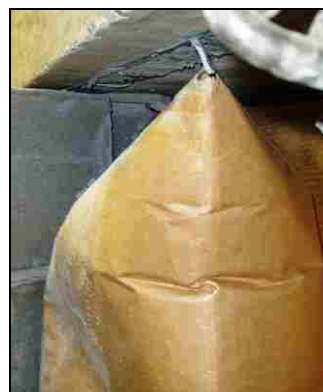
Figure 5.21. Wall P1-5 Failure

(b) Debonding of Polyurea

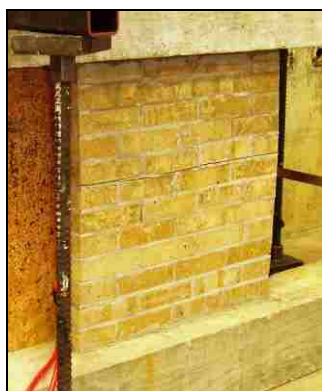
Figure 5.23. Wall P1-6 Failure

(a) Horizontal Cracking

5.2.6. Wall P1-6. Wall P1-6 was a control wall constructed from the WF-FA brick units. This wall cracked in the bed-joints at the boundary element locations almost immediately after loading was initiated. At an applied pressure of 1.6psi (11.0kPa), the first major horizontal crack began developing one course below the mid-height location, on the exposed face of the wall. At 3.5psi (24.1kPa), a second major horizontal crack formed in the bed-joint located one course above the mid-height location. As the test progressed, the horizontal crack below mid-height appeared to stop developing, and the width of the horizontal crack immediately above the mid-height location continued to grow as can be seen in Figure 5.23. The deflected shape of the wall was much less rigid than that of the clay and CMU control wall, and did not demonstrate the formation of a visible arching mechanism. This result can possibly be partially attributed to the poor bond behavior between the mortar and the smooth-faced WF-FA masonry units. Wall P1-6 reached a peak airbag pressure value of 5.2psi (35.9kPa) at a deflection of 0.96in.

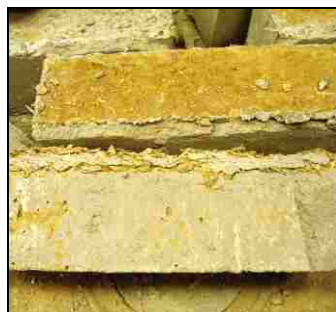
(c) Crushing of WF-FA Brick Units

(24.4mm). After reaching the peak pressure, the wall maintained this resistance value and continued to deform with little decrease in pressure resistance until immediately prior to collapse, as illustrated in Figure 5.24. The maximum value of mid-height deflection obtained by Wall P1-6 was found to be 1.22in. (31.0mm). It can be seen from Figure 5.23b that the wall had no resistance in preventing the debris scatter of the masonry upon failure. From examination of the WF-FA brick units after failure, it was found that crushing had occurred in the units at the mid-height location as well as at the location of the lower boundary element. The damage to the WF-FA brick units due to the crushing at the hinge locations is presented in Figure 5.23c.

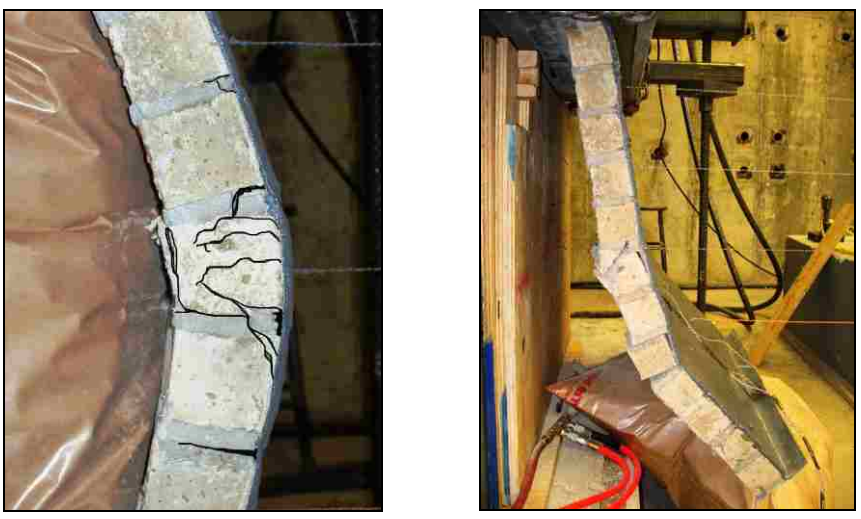
Figure 5.25. Wall P1-7 Failure

as well as the bed-joints (see Figure 5.25). The load resistance remained relatively constant until failure occurred in the polyurea at the location of the lower boundary element. The failure of the wall has been presented in Figure 5.25c, and the load resistance behavior is illustrated in Figure 5.26. The maximum measured mid-height deflection achieved by the wall was 6.90in. (175.3mm).

(a) Deformed Shape

(b) Flexural Cracks in WF-FA

(c) Failure

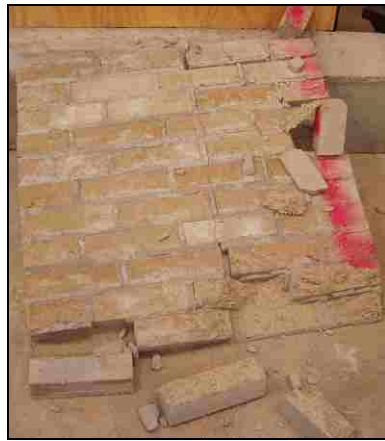
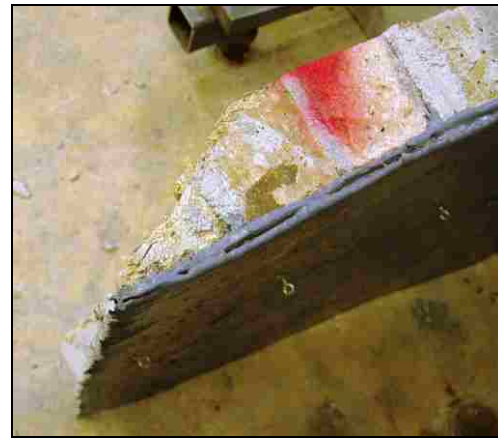
Figure 5.27. Wall P1-8 Failure

further inspection, it was also found that the units at the boundary locations had sustained damage due to a combination of shearing forces and membrane forces (see Figure 5.27b).

(a) Wall Collapse

(b) Damage Sustained to WF-FA Units

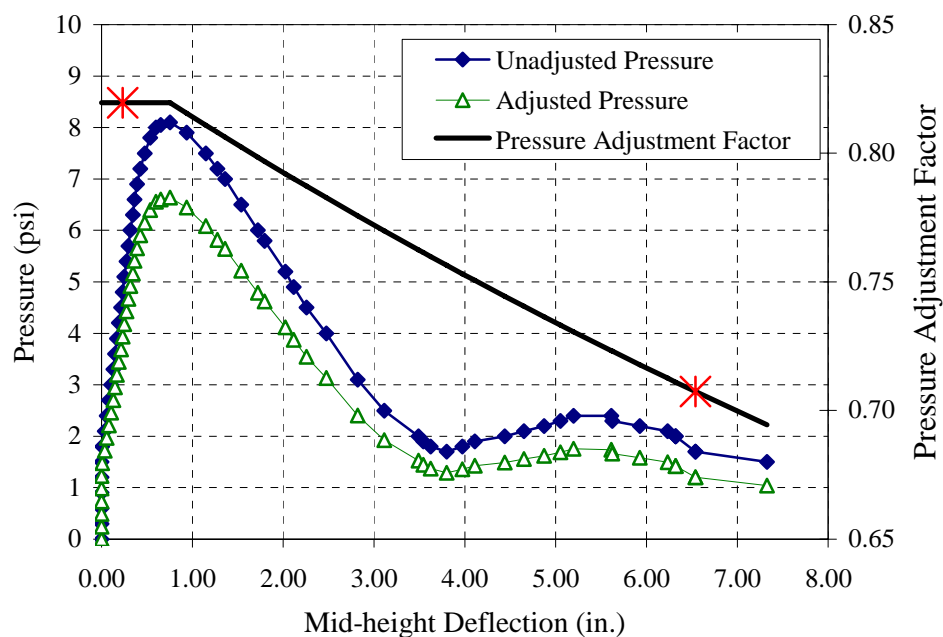
pressure adjustment factor and the load resistance for one of the polyurea retrofitted walls is shown in Figure 5.29.

Note: X denotes the point at which the airbag coverage area was marked

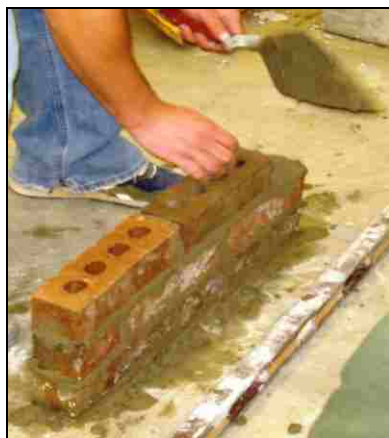
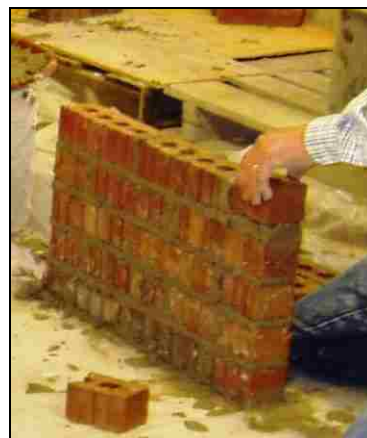
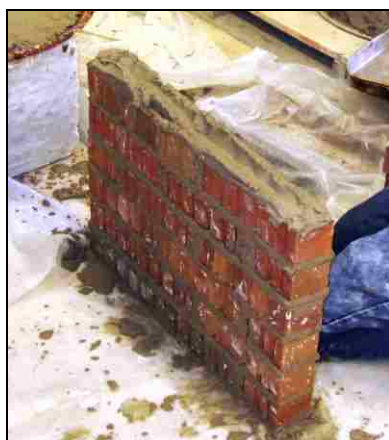
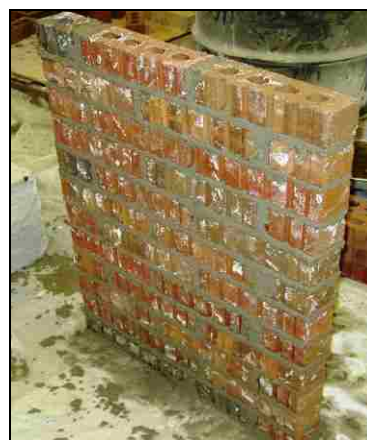
Figure 6.1. Construction of Phase 2 Walls

(a) Quarter Wall

(b) Half-Wall

(c) Bed-Joint Construction

(d) Completed Wall

6.1.1. Wall Construction. The Phase 2 walls were constructed by the same group of masons that built the walls presented in Phase 1 of this study, and they were constructed using techniques similar to those employed for the Phase 1 walls. The Phase 2 walls were built off of a flat concrete surface and were constructed using a running bond with all mortar joints finished flush with the surface of the masonry units. All of the walls had a uniform width of 24in. (610mm). Walls constructed from clay brick units consisted of 12 courses and were 36in. (914mm) in height, and walls constructed from the CMU blocks consisted of 6 courses and were 48in. (1219mm) in height. The construction of one of the Phase 2 clay walls is presented in Figure 6.1. After the completion of wall construction, the Phase 2 walls were allowed to cure for a minimum of 28 days prior to being moved or undergoing external retrofit.

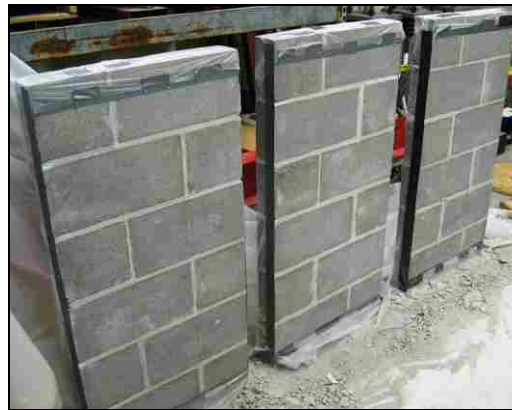
Figure 6.2. Phase 2 URM Walls Prior to Strengthening

Prior to the application of the strengthening materials, the mortar joints of the walls were ground smooth to the face of the masonry units using a mason's stone, and all dust and debris were removed from the surface of the walls. In the case of the URM walls utilizing the unanchored retrofit, the wall edges and support locations of the walls were taped off, so only the free-span of the URM wall was exposed during the spray-on application of the elastomeric polyurea material. For the anchored retrofit, only the edges of the URM walls were taped off. The taped off Phase 2 walls are shown in Figure 6.2.

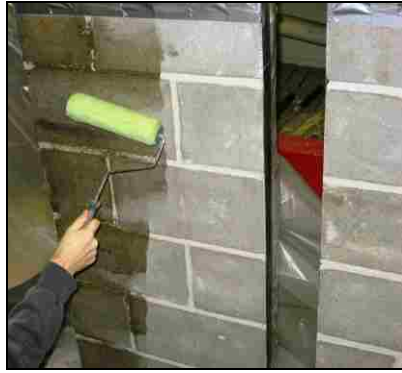
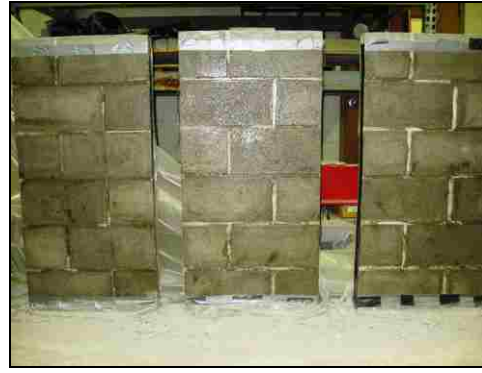
Figure 6.3. Primer Application of Phase 2 Walls

(a) Application of Primer

(b) Primed URM Walls

Prior to spraying the walls with the elastomer, an epoxy-based primer was applied to the exposed surface of the URM walls. The epoxy primer was used to prevent reactions from occurring between the spray-on polyurea material and free moisture

within the base masonry material. The application of the primer and the primed walls are shown in Figure 6.3.

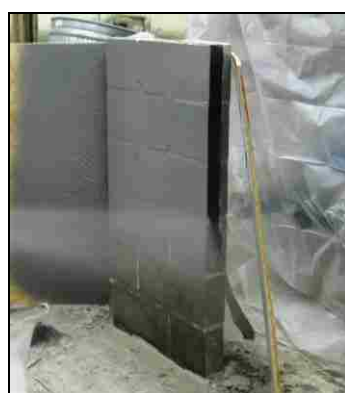
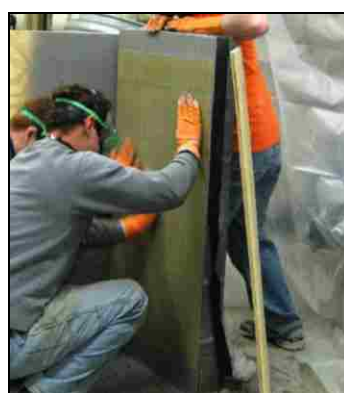
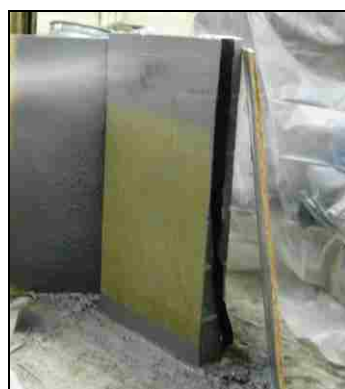
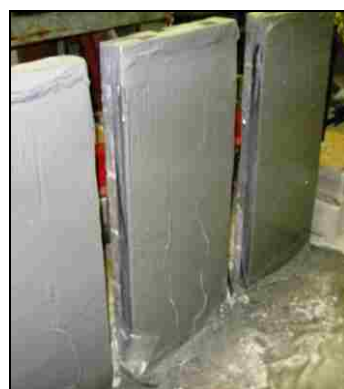
Figure 6.4. Retrofit Application for Phase 2 Walls

(a) Initial Polyurea Layer

(b) Embedding FRP Grid

(c) Secondary Polyurea Layer

(d) Retrofitted URM Walls

The primer was allowed to cure for approximately one hour prior to spraying the URM walls with the elastomeric polyurea material. After the primer had properly cured, a thin initial layer of polyurea was sprayed onto the exposed surfaces of the walls. Immediately after the first layer of polyurea was sprayed onto the wall surface, the FRP grid was embedded into the soft polyurea material. The set-time for the polyurea was approximately 10 to 20 seconds; therefore, the application of the grids had to immediately follow the spray application of the polyurea. For the purpose of applying the FRP grids as quickly as possible, the grids were pre-cut to match the width of the walls and were cut slightly shorter than the free-span length of the walls. After the FRP grid was correctly positioned and embedded within the base layer of polyurea, a second application of polyurea was sprayed over the FRP until the surface was free of voids, and the GFRP grid material was fully embedded. For walls with two layers of grid material,

the second grid was embedded within the second layer of polyurea, and a third polyurea layer was applied to the surface to fully embed the grid and close all voids. The combination of the FRP and polyurea material resulted in an overall retrofit thickness of approximately 3/8in. (9.5mm) for the walls strengthened with a single layer of GFRP, and approximately 1/2in. (12.7mm) for the walls strengthened with two layers of GFRP. The spraying of the polyurea and the application of the GFRP grid are presented in Figure 6.4. Additionally, a schematic illustrating the simulated anchored and non-anchored retrofit schemes used for the walls has been provided in Figure 6.5.

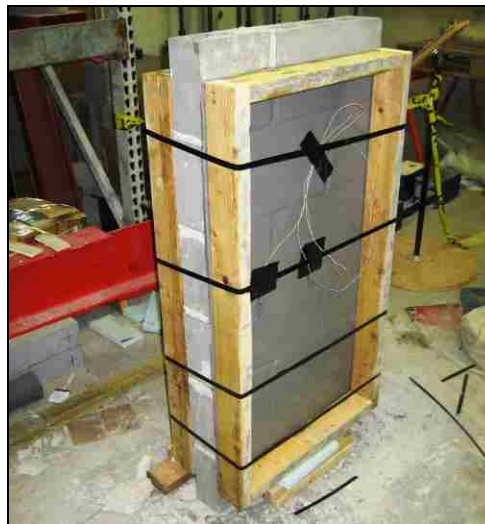
Figure 6.6. Braced URM Wall

6.1.3. Test Setup and Testing Procedure. The wall tests for Phase 2 of the research program were performed in the UMR's Engineering Research Laboratory (ERL). The walls in this phase of the study were loaded horizontally under four-point bending using a 400k (1780kN) capacity Baldwin Universal Testing Machine. The walls were constructed outside of the testing area and were later moved into place with the use of a standard pallet jack. To prevent any damage or cracking from occurring while moving the URM test specimens, the walls were braced using a metal banded wooden frame assembly. Once transported to the test-bed of the testing machine used to load the specimens, the wooden bracing system was removed from the URM walls. The wooden framing that was used to brace the URM walls is shown in Figure 6.6.

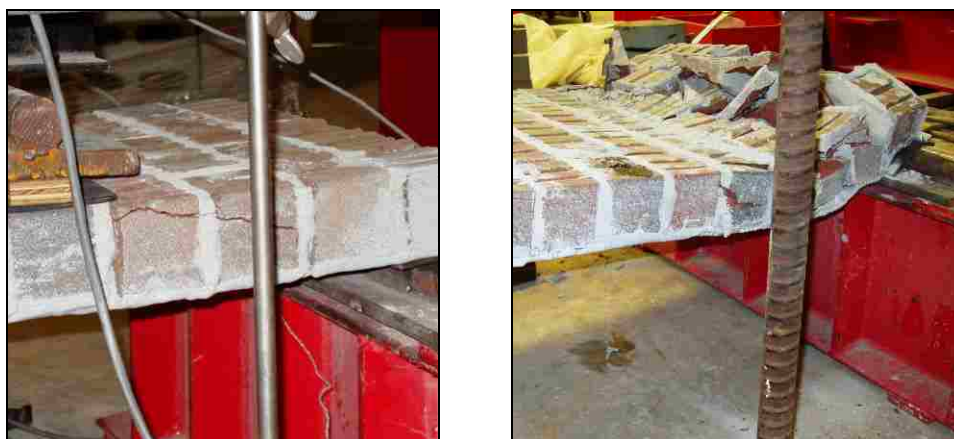
Figure 6.10. Wall P2-1 Failure

(24.9kN) and midspan deflection of 1.63in. (41.4mm). The separation and splitting of the masonry is illustrated in Figure 6.10b. The load-deflection response for Wall P2-1 has been provided in Figure 6.11.

(a) Flexural-Shear Cracking
