Static evaluation of the out-of-plane behavior of URM infill walls utilizing modern blast retrofit systems

A THESIS

UNIVERSITY OF MISSOURI-ROLLA

MASTER OF SCIENCE IN CIVIL ENGINEERING

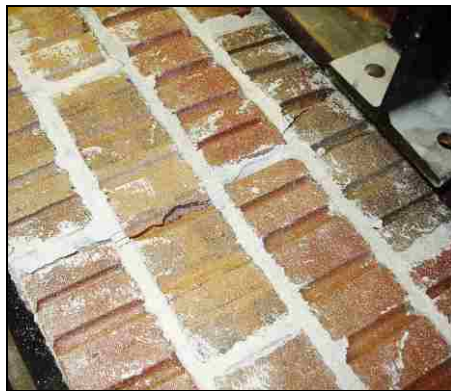
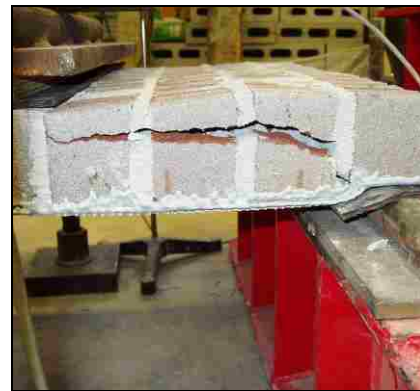
Figure 6.12. Wall P2-2 Failure

6.2.2. Wall P2-2. This wall was the second of two strengthened URM walls constructed from clay brick units. Wall P2-2 was strengthened with two layers of grid material using the GFRP-polyurea retrofit system with polyurea applied to the entire face of the wall to simulate the presence of an anchored retrofit system. The wall behaved similarly to Wall P2-1 in that cracking occurred almost immediately at an applied load value of 0.7k (3.1kN). As testing progressed, flexural cracking was observed in the bed-joints throughout the constant moment region of the wall. At an applied load of 10.9k (48.5kN), the formation of flexural-shear cracks originating from the point of load application were observed. At 12.8k (56.9kN), a major longitudinal crack forming through the shear-span on the compression face of the wall originating from the applied load was observed (see Figure 6.12). The wall reached a peak load resistance value of 15.3k (68.1kN) at a midspan deflection of 0.75in. (19.1mm). The wall failed almost immediately after reaching the peak load resistance (see Figure 6.13) by way of masonry splitting due to the development of flexural-shear cracks as shown in Figure 6.12b.

(a) Longitudinal Cracking

(b) Flexural-Shear Cracking

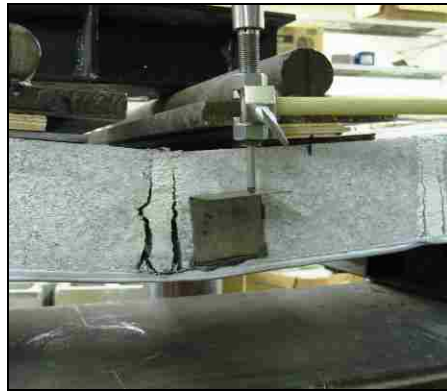
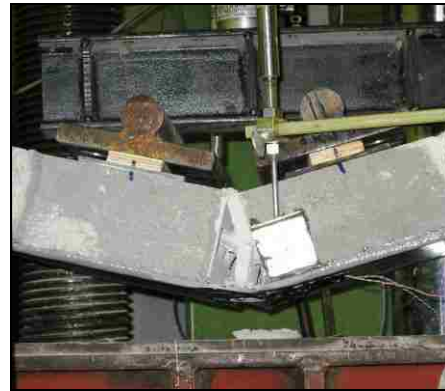
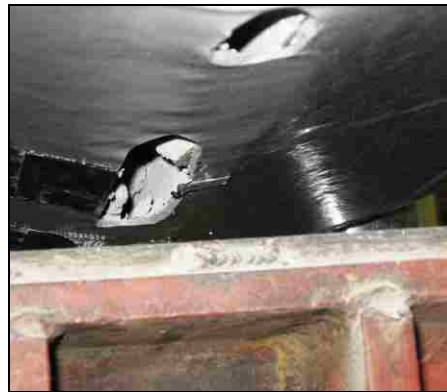
Figure 6.14. Wall P2-3 Failure

the wall began to separate into two segments and displayed rigid body deformation behavior. As the polyurea material continued to rupture, the load resistance of Wall P2-3 slowly decreased, as shown in Figure 6.15. Ultimately, the wall failed due to full rupture of the polyurea material, which occurred at a midspan deflection value of 7.01in. (178.1mm). Upon failure, the wall collapsed and separated into two half-wall segments (see Figure 6.14d).

(a) Midspan Cracking

(b) Growth of Crack Width

(c) Rupture of Polyurea

(d) Wall Collapse

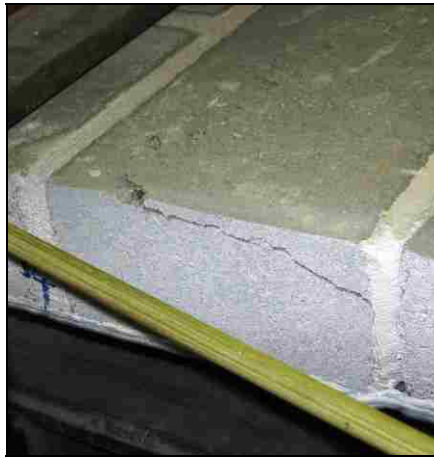
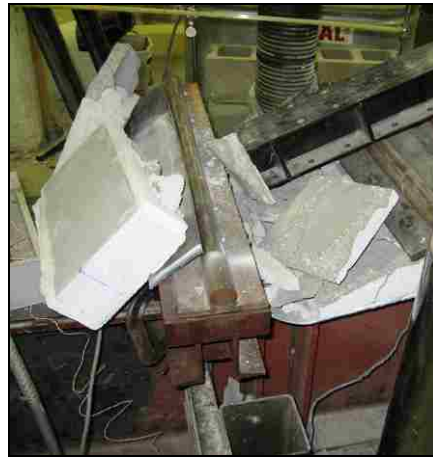
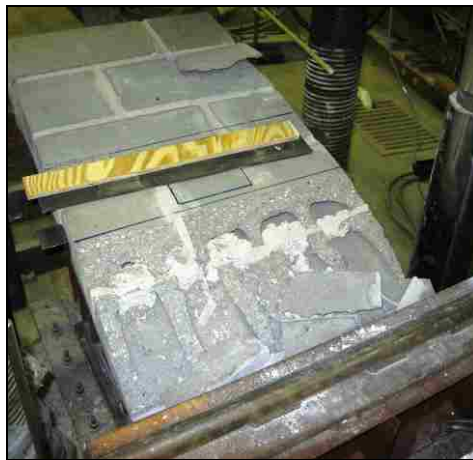
Figure 6.16. Wall P2-4 Failure

(a) Flexural-Shear Cracking

(b) Debonding of Masonry

(c) Fracturing of Masonry

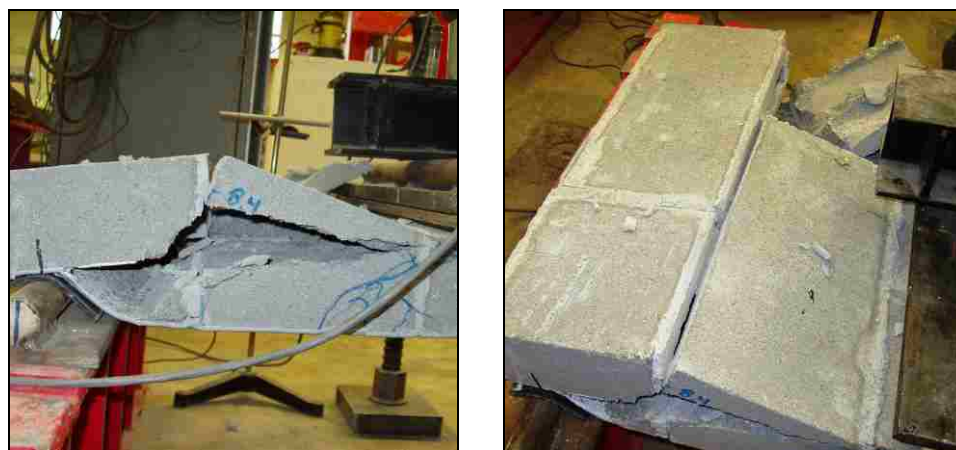
Figure 6.18. Wall P2-5 Failure

(a) Separation from Polyurea

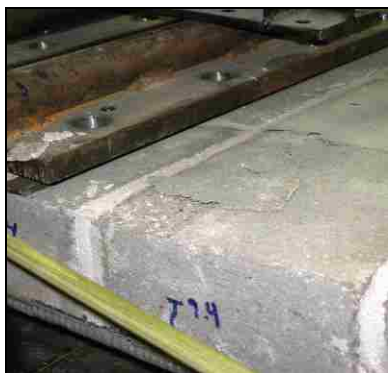
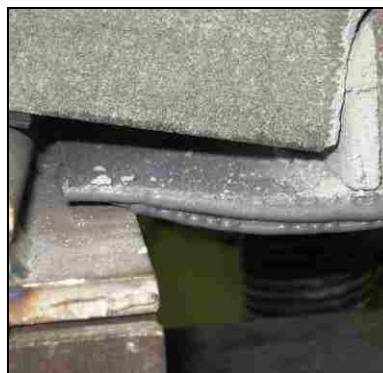
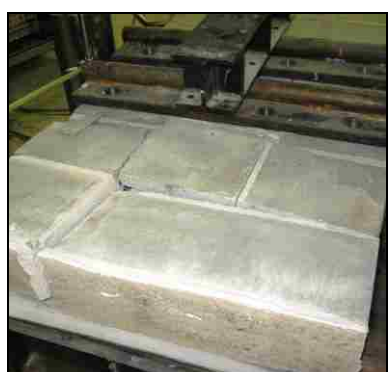
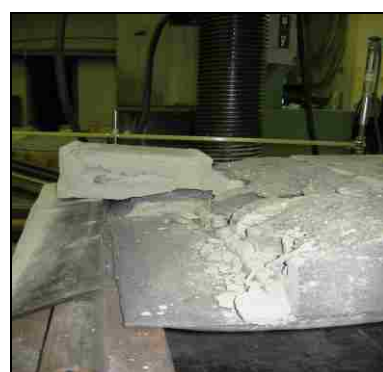
Figure 6.20. Wall P2-6 Failure

(a) Masonry Rupture

(b) Debonding of Polyurea

(c) Separation of Masonry

(d) Wall Failure

6.2.6. Wall P2-6. This wall was constructed from concrete block and was strengthened with the GFRP-polyurea retrofit using two layers of grid material embedded within the polyurea. The retrofit was applied to the free-span of the wall only to avoid interaction between the supports and the strengthening materials. The first flexural cracks were observed in the midspan bed-joint at an applied load of 0.7k (3.1kN). At a load of 4.0k (17.8kN), flexural cracks were observed in the concrete masonry units. As testing progressed, flexural cracks throughout the constant moment region as well as throughout both shear-spans were observed. At an applied load of 7.6k (33.8kN), the formation of the first major flexural-shear cracks were observed. Loading continued until reaching an applied load of 12.0k (53.4kN) and a midspan deflection of 0.54in. (13.7mm). At this point, the first sign of concrete rupture was observed in the masonry units immediately outside of the constant moment region originating from the applied load. The load resistance of the wall decreased significantly as the rupturing of the concrete masonry occurred. The rupturing of the masonry was the result of the flexural-shear cracking and is presented in Figure 6.20. As testing continued, the load resistance increased until the polyurea material debonded from the masonry at the support location (see Figure 6.20b), which occurred at a midspan deflection of 0.74in. (18.8mm). The sudden drop in the load resistance due to the initial rupturing of the masonry is illustrated by the load-deflection behavior presented in Figure 6.21. The figure also shows that the load resistance of Wall P2-6 continued to increase after the formation of the flexural-shear cracking until failure ultimately occurred by way of the debonding of the polyurea material from the base masonry material at the support location.

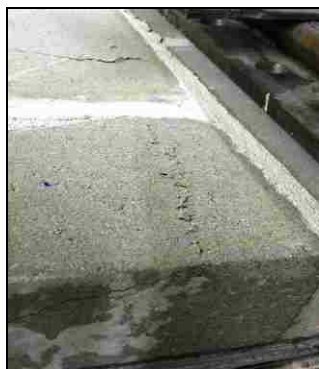
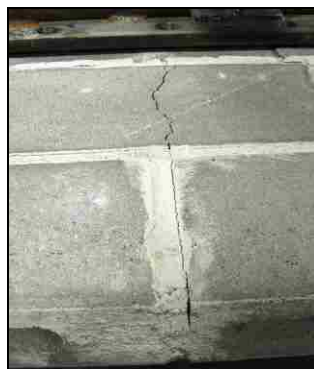
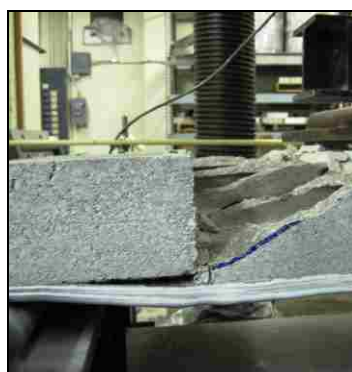
Figure 6.22. Wall P2-7 Failure

(a) Flexural-Shear Cracks

(b) Longitudinal Cracking

(c) Flexural-Shear Failure

6.2.7. Wall P2-7. Wall P2-7 utilized the same strengthening scheme as Wall P2-6, retrofitted with the GFRP-polyurea system using two layers of grid material embedded within the polyurea. Wall P2-7 was also constructed with the use of the simulated retrofit anchor. The behavior of Wall P2-7 was very similar to Wall P2-6. At an applied load of 4.3k (19.1kN), flexural cracks in the masonry units were observed. At an applied load of 7.0k (31.1kN), the first major flexural-shear cracks were observed in the shear-span of the wall. Almost immediately after the onset of flexural-shear cracking, the concrete masonry began to rupture as a result of the splitting action from the flexural-shear (see Figure 6.22a). In addition to the splitting action of the masonry, longitudinal cracking was observed in the shear-span location on the compression face of the wall. At 11.5k (51.2kN), the concrete began to split off from the surface, and the flexural-shear cracks had opened significantly, resulting in a slight decrease in the load resistance. As loading continued, the flexural-shear cracks continued to develop, and the masonry began to split and separate from the polyurea. At a midspan deflection of 0.82in. (20.8mm), the strengthened URM wall achieved its maximum load resistance of 14.1k (62.7kN). Beyond this point, the wall maintained significant resistance until the masonry split as a result of the flexural-shear cracking and ultimately separated away from the polyurea material in the shear-span (see Figure 6.22c). The maximum deflection achieved by Wall P2-7 was 0.94in. (23.9mm). The load-deflection behavior for Wall P2-7 has been presented in Figure 6.23. From the load-deflection behavior the ability of the wall to maintain load resistance even after the formation of the significant flexural-shear cracks can be seen.
