A Survey of Structural Design of Diagnostic X-ray Imaging Facilities and Compliance to Shielding Design Goals in a Limited Resource Setting

Purpose: To survey structural designs of x-ray rooms and compliance to shielding design goals of three x-ray imaging facilities.

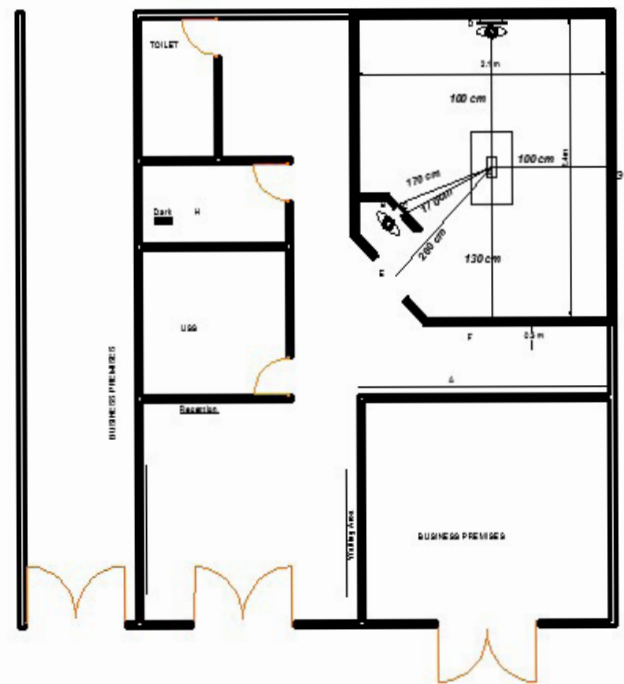
Figure 1. X-ray Room Layout for Center X

Findings from this study indicate that out of the three radiodiagnostic centers studied for structural designs, Center X (Figure 1) had a room dimension of 2.4 m × 2.1 m with a minimum and maximum distance of 100 cm and 280 cm from the x-ray tube to the nearest wall or protective barrier (Tables 1a and 1b). A 2.23 mm lead sheet bonded to plywood was used as the shielding material.

S/N	Point of Measurement	Description	Distance from the source	Measured Exit Dose	Recommended Dose (mSv/wk)
1	Point B	Lead Glass window	170 cm	0.00152± 0.0000	0.1
2	Point C	Control Console	170 cm	0.0014 ± 0.0000	0.1
3	Point H	Darkroom	150 cm	0.00068± 0.0000	0.1

S/N	Point of Measurement	Description	Distance from the source	Measured Exit Dose	Recommended Dose (mSv/wk)
1	Point D	Chest Stand	100 cm	****	0.02
2	Point E	X-ray room door	280 cm	0.00056± 0.0000	0.02
3	Point F	Wall 1	130 cm	0.0176± 0.0009	0.02
4	Point G	Wall 2	100 cm	0.0076± 0.0004	0.02
5	Point I	Patient Waiting Areas	30 cm	0.00066± 0.0000	0.02

In this study, the distance from the x-ray tube to the chest stand in one of the centers was found to be 100 cm, which is less than the recommended distance for a standard chest x-ray of 140-200 cm (11). This implies that chest x-rays done at this distance may not reflect the true anatomical geometry of the patient's chest, since the source to image distance is not optimized. The radiation protection implication of this

finding is that the intensity of the radiation reaching this wall will be high, hence additional shielding may be required. This finding is just one among many issues that go unnoticed in limited-resource settings.

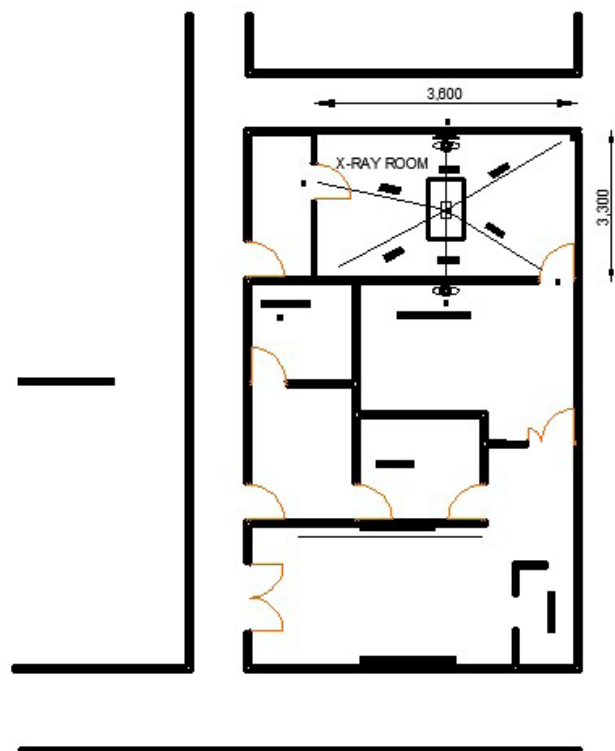
Figure 2. X-ray Room Layout for Center Y

Center Y (Figure 2) had an x-ray room dimension of 3.6 m × 3.3 m with a minimum and maximum distance of 140 cm and 310

cm from the x-ray tube to the nearest wall or protective barrier (Table 2a and 2b). Barium plaster with an unquantifiable thickness was used as the shielding material.

S/N	Point of Measurement	Description	Distance from the source	Measured Exit Dose	Recommended Dose (mSv/wk)
1.	Point B	Control console	180 cm	0.00496±0.0002	0.1
2.	Point G	Darkroom	30 cm	0.00208±0.0001	0.1

S/N	Point of Measurement	Description	Distance from the source	Measured Exit Dose	Recommended Dose (mSv/wk)
1.	Point C	Primary wall	310 cm	0.428±0.0214	0.02
2.	Point D	Secondary wall	200 cm	0.02416±0.0012	0.02
	Point E	X-ray room Door1	180 cm	0.01012±0.0005	0.02
3.	Point F	X-ray room Door2	140 cm	0.32144±0.0161	0.02
4.	Point H	Reception	30 cm	0.00064±0.0000	0.02

Findings of measured radiation doses transmitted through barriers showed that two of the three centers studied were in compliance with the recommendations of the shielding design goals. Only Center Y recorded doses above the recommended design dose limits at some locations, as shown in Tables 2a and 2b. While the measured exit dose for controlled areas in Center Y was below the recommended limit, high measured values above the recommended shielding design goal were observed at two locations for uncontrolled areas; Point C (Primary wall behind the chest stand), and Point F (x-ray room door 2). Possible factors influencing the high measured radiation exposure levels at these points could be inadequate shielding and room dimensions not being optimized. It was further observed that barium plaster was used in this center for shielding, but barium is less efficient than lead in terms of shielding efficacy (9). The doors were not adequately lead-lined, which accounted for the high x-ray beam transmission. The radiation protection implication of this finding is that passersby and patients could be subjected to unnecessary radiation exposure in these areas.
