# Studying the Construction of Floor Mosaics in the Roman Villa of Pisões (Portugal) Using Noninvasive Methods: High-Resolution 3D GPR and Photogrammetry

**Keywords:** subsurface detection; GPR and photogrammetry UAV; Roman mosaic structure; noninvasive archaeological inspection

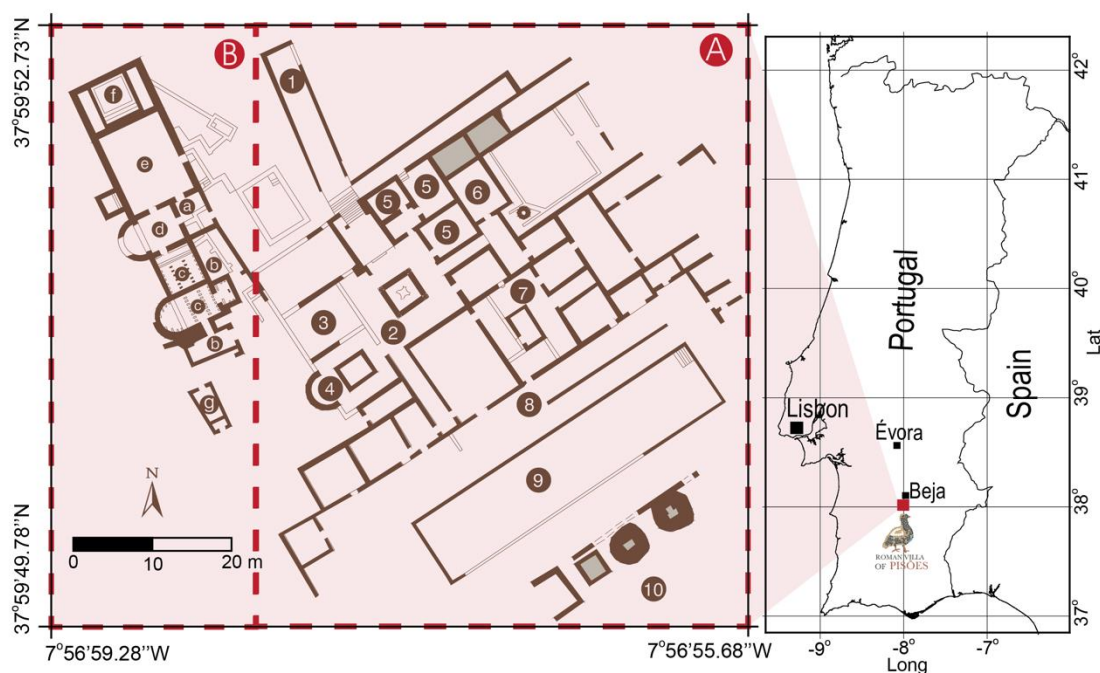
**Figure 1.** Localization of the Roman Villa of Pisões in Portugal map, and the plan view of the *pars urbana* with the (A) residential area and (B) thermal baths. 1. North entrance corridor, where the studied mosaics are located; 2. columned atrium; 3. reception room (*tablinium*); 4. dining room (*triclinium*); 5. bedrooms; 6. larder and kitchen; 7. former atrium with square basin for rainwater (*implivium*); 8. south porticoe; 9. swimming pool (*natatio*); and 10. mausoleums. In the baths: a. Dressing room (*apodyterium*); b. furnace (*prae-furnium*); c. hot water room (*caldarium*); d. warm room (*tepidarium*); e. cooling room (*frigidarium*); f. swimming pool (*natatio*); and g. latrines.

The Roman Villa of Pisões (Figure 1) is located 10 km south of Beja (Portugal). This villa was discovered accidentally in 1967 and is considered by the academic and scientific community to be a heritage site of the greatest cultural relevance and was classified as a property of public interest in

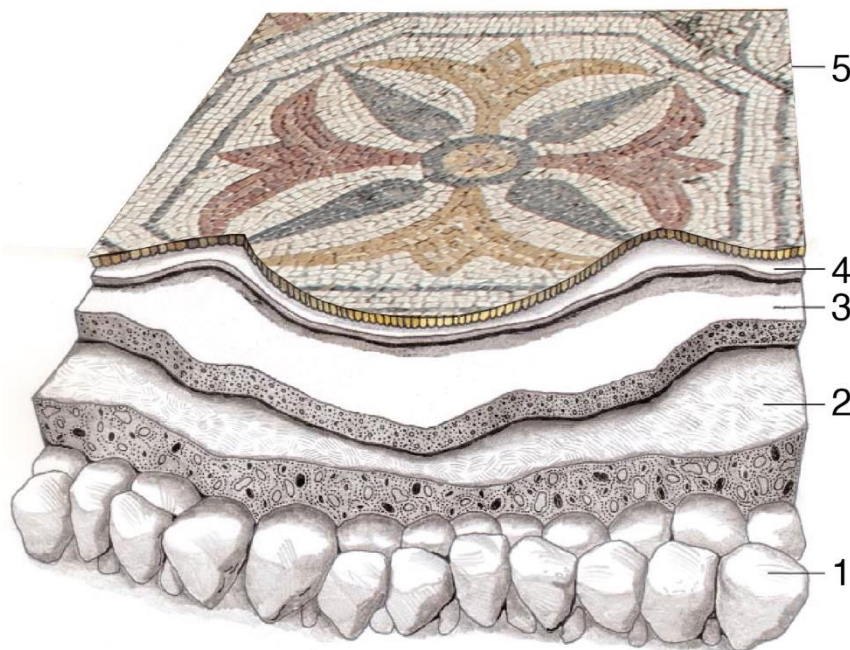
**Figure 2.** Stratigraphy of a Roman mosaic floor according to Vitruvius's description. The scheme is adapted from the Getty Conservation Institute and the Israel Antiquities Authorities and shows a fragment of the studied mosaic. 1. *Statumen*—First preparatory layer of large stones; 2. *Rudus*—mortar layer of gravel to level the floor; 3. *Nucleus*—impermeable mortar layer of powdered pottery and lime to protect the mosaic surface from the soil water (humidity); 4. *Bedding*—thin mortar layer, rich in lime, applied fresh in small regular portions where the mosaic designs were marked, and the *tesserae* were inserted before the mortar dried; and 5. *Tessellatum*—surface of the mosaic composed of *tesserae* and mortar with the bedding composition filling the interstices between *tesserae*.

Architecture of Vitruvius, *De Architectura*, written in the 1st century B.C. and translated into nearly all languages [20]; the author documents the techniques used for the preparation of mosaic pavements, highlights the impermeability issue of the mosaic in terms of functionality, and supplies the ideal method to ensure impermeability. Summarizing Vitruvius's rules, the floor mosaic foundation should be manufactured with the following stratigraphy (Figure 2):

- (1) The first layer, called *statumen*, is made of stones approximately 12 cm thick “each of which is not less than a handful”, laid vertically on the ground, without mortar between the stones, which gives stability to the pavement and favors the flow of infiltrated waters.

- (2) The second layer, called *rudus*, is spread over the *statumen* and consists of a mortar of sand and gravel (three quarters) mixed with lime (a fourth part). This layer is rammed by means of wooden stamps until a unified level is formed, which is then left to dry. The thickness of this layer is at least 22 cm.

- (3) The third layer, called the *nucleus*, is a ceramic mortar that is 11–15 cm thick, made of powdered pottery and lime in proportions of three to one, respectively, and this mortar is spread over the *rudus* and allowed to dry. This layer is the hardest and most impermeable of the three layers. The purpose of this layer was to allow drainage of surface waters.

- (4) On top of the *nucleus*, a bedding layer of mortar very rich in lime is thinly applied in small sections over the *nucleus*. This thin layer is applied according to the forecast of the working day and fresh enough to mark the reference points of the drawing (*sinopia*) or geometric or figurative design. *Tesserae* are inserted in this layer before the mortar dries.

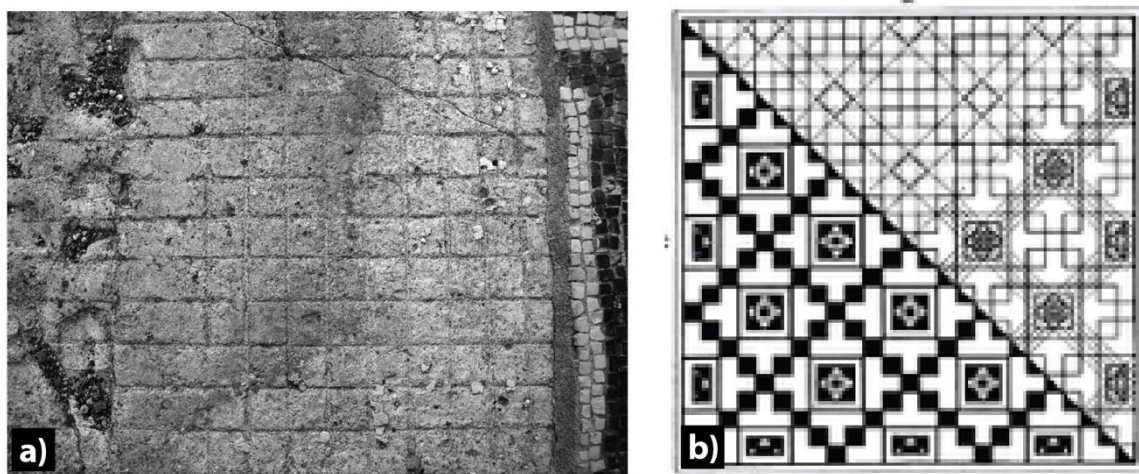
**Figure 3.** (a) View of the sinopia of a mosaic belonging to the domus of [21], from Pompeii. (b) Scheme of mosaic construction based on the sinopia, from [22].

The tesserae were placed according to previously defined patterns, figurative or geometric, and were drawn through incisions in the bedding mortar; some of the imprints were captured under some mosaics (Figure 3a). These geometrically etched guides, called sinopia, were made with simple instruments that formed part of the common masonry tools: Rulers, calipers, compasses, nails, and ropes. Once the general pattern was established (Figure 3b), the specific drawings were painted with chalk or charcoal, whereas for the repetitive motifs that formed part of the decoration of borders and edges, templates could be used.

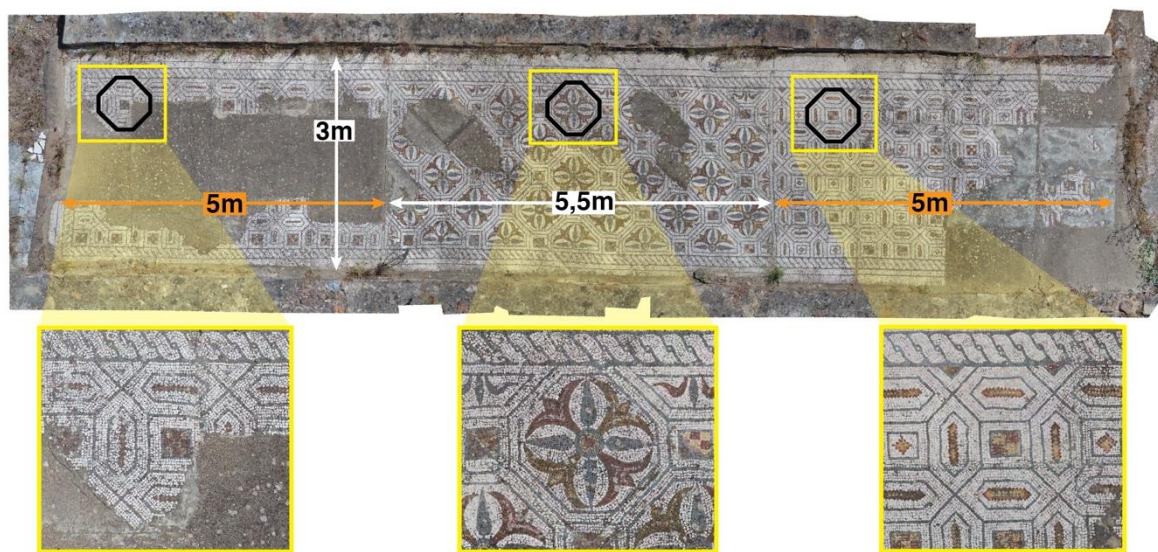
**Figure 4.** Photogrammetric orthomosaic of the entire studied roman mosaic (top), where the large octagons that define the geometry of the background pattern are shown. The bottom panels show a zoom in of the geometric compositions that fill the inner three sections of the mosaic.

The mosaic is formed by a decorative geometric composition of large octagons (Figure 4), outlined with a black filet over a white background. Three distinctive geometric compositions fill the inner octagons. At the ends of the corridor, there are defined panels (5 m in length each) formed by colored squares and diamonds on the same white background, and this pattern is repeated in all octagons; in the central zone (5.5 m), the octagons are filled with rosettes that are the same colors as the ends panels, creating a beautiful decorative effect. The composition is completely enveloped by a simple guilloche border produced with a double row of gray tesserae over the same white background [18]. The same constituent elements and forms are found in the two mosaic fragments of Merida [25], which leads to the assumption that the same model was used for the mosaics at both sites.

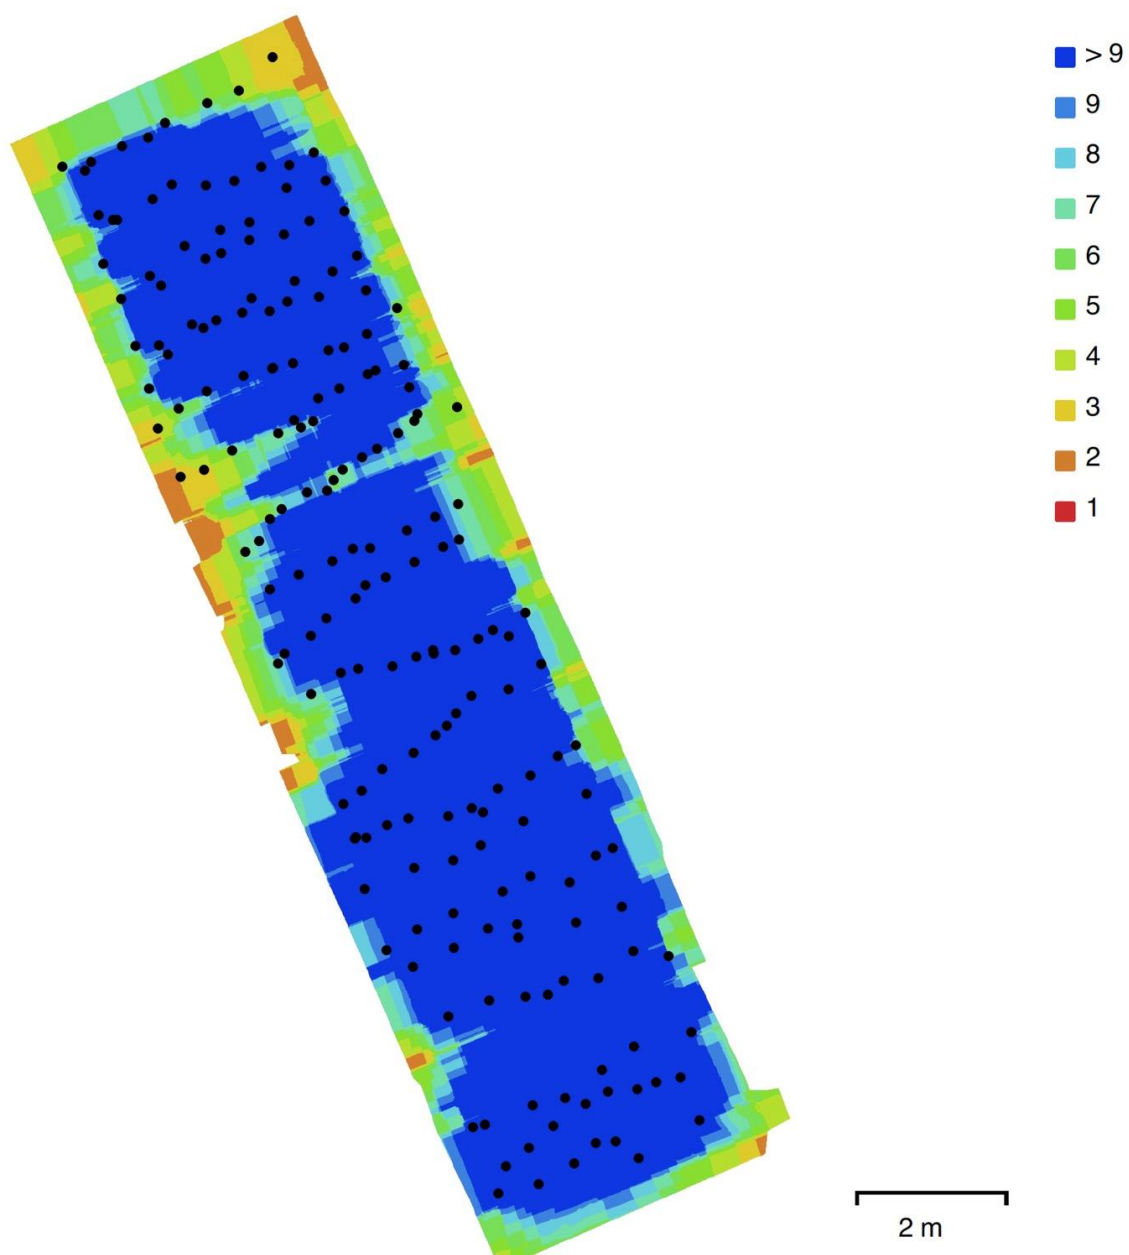
**Figure 5.** Camera locations (black dots) and image overlap. Colors represent the number of photos where each point appears.

In total, 191 pictures were taken, covering 69.9 m<sup>2</sup> of area. A battery exchange was necessary to complete all the surveyed area using this technique. Figure 5 shows the position of each camera as well as the amount of overlap obtained.

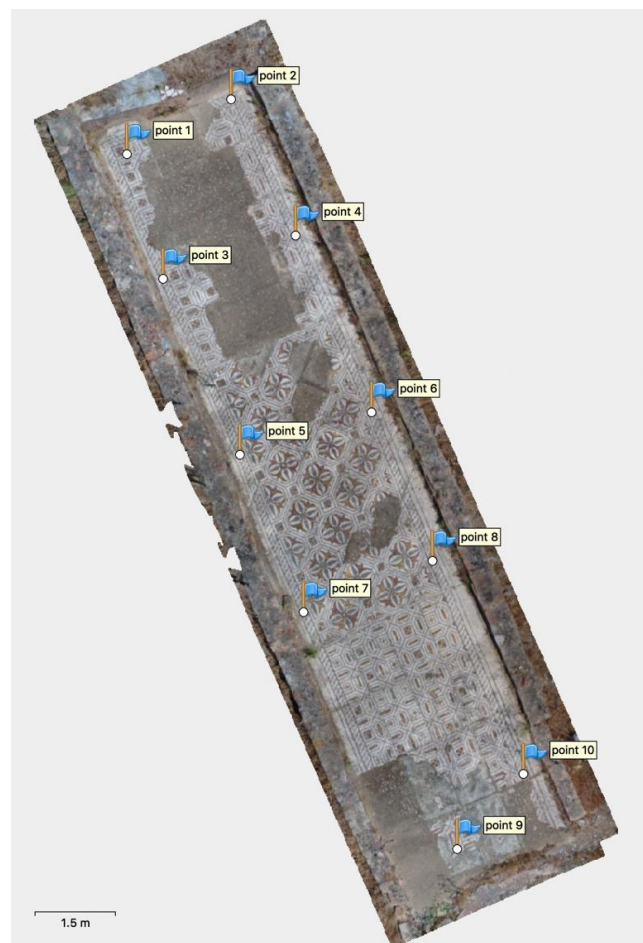
**Figure 6.** Position of the ten ground control points used to geometrically correct the unmanned aerial vehicle (UAV) mosaic survey.

To perform the data processing, the first step was the photo alignment. The highest accuracy was used as well as the generic preselection and reference preselection parameters. In the advanced parameters, the key point limit was set to 60,000 and the tie point limit was set to 4000. Masks were used to exclude areas in the images where the UAV's shadow was present. Adaptive camera model fitting was also used. After this step, points with a reprojection error bigger than 0.50 were excluded from the sparse point cloud. In total 4305 points were excluded and 102,222 were maintained. After this step, a dense cloud with medium quality and a mesh was built, only to help in the placement of GCP's because they were, this way, placed automatically in each photo. To ensure the geometrical accuracy and georeferencing of the photogrammetry products, ten GCP's, which were mostly distinguishable features of the mosaic pattern, were used in the processing chain. The positions of these GCP's relative to the surveyed area are illustrated in Figure 6. The measurement of GCP coordinates was performed using a differential Spectra Precision Epoch 50 GNSS system. The average easting, northing, and altitude errors of the collected coordinates were 0.001 m, 0.002 m, and 0.010 m respectively. After the point cloud optimization, the resulting average errors were: 0.003686 m East; 0.002260 m North; 0.00988 m Altitude. The total RMS error was 0.004435 m and 0.415 pixels. The coordinate system used was PT-TM06/ETRS 89 (EPSG: 3763) which is the official coordinate reference system in Portugal mainland.

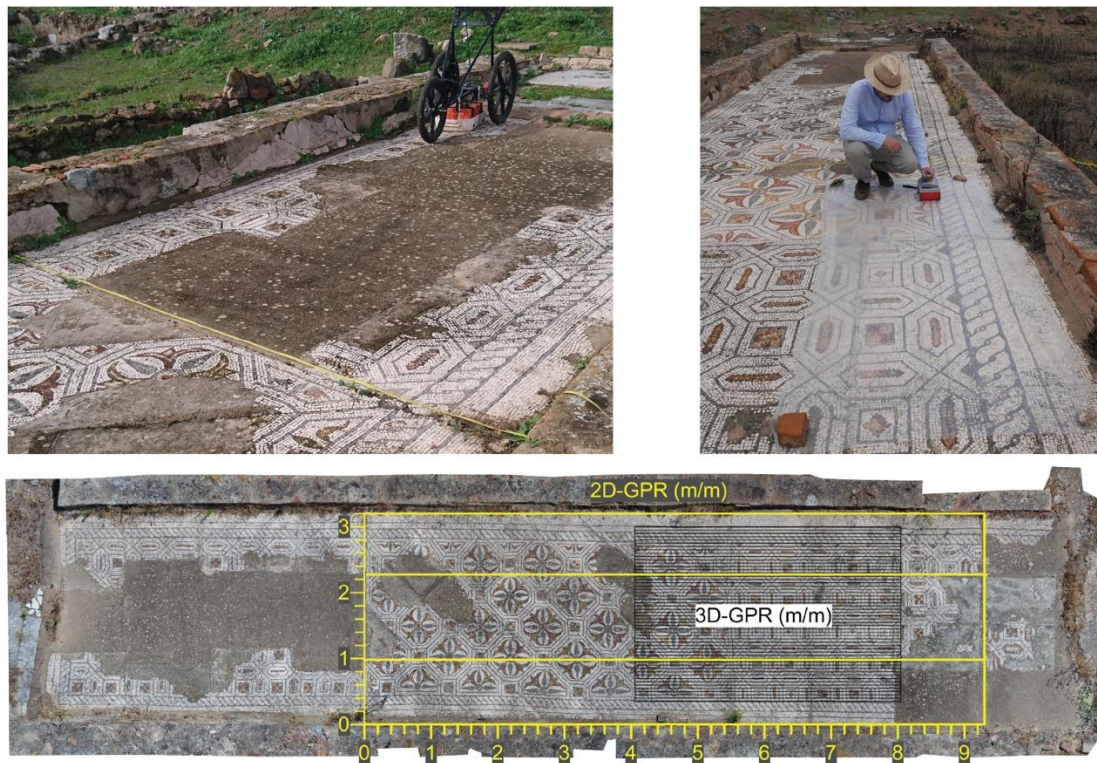
**Figure 7.** The upper left image shows the 400 MHz antenna, which was used in this study to generally inspect below the mosaic. In the upper right image shows the 1600 MHz antenna, which was used to conduct a detailed 3D inspection of the mosaic. The lower image corresponds to the orthomosaic of the corridor where the inspected rectangles were placed; in yellow, the area of the 2D ground penetrating radar (GPR) profiles; and in black, the 3D-GPR area with parallel profiles spaced 0.05 m apart.

The selected mosaic portion has been recognized on two sensor resolution scales; first, a 2D-GPR survey was carried out using a 400 MHz antenna (yellow rectangle in Figure 7, lower image). These profiles were placed every 50 cm (approx.) along the width of the mosaic, and their lengths exceeded the dimensions of the study area in order to obtain a general vertical inner view. Second, we used a 1600 MHz antenna to conduct a 3D-GPR survey based on parallel profiles spaced 0.05 m apart (black rectangle in Figure 7, lower image) to obtain detailed volumetric images of the mosaic. The most significant acquisition parameters for both surveys are presented in Table 1.

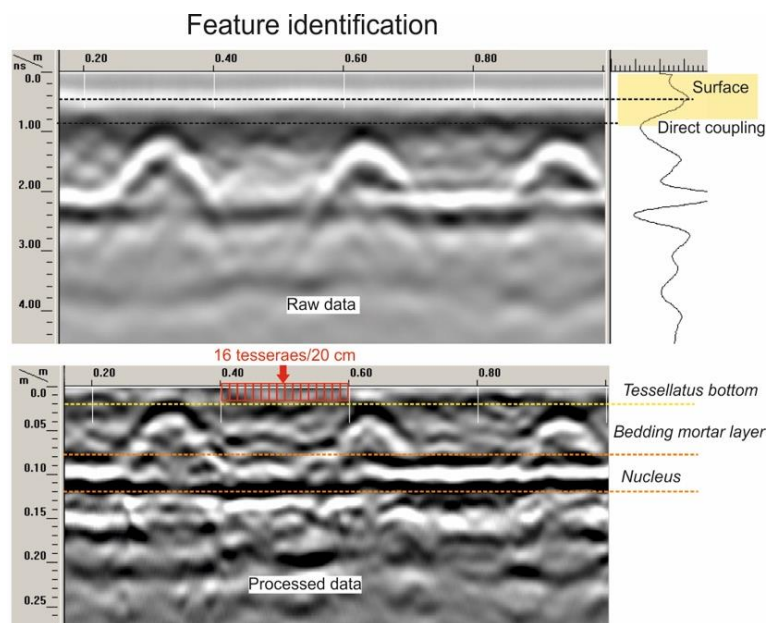
**Figure 8.** Fragments of acquired radargrams over the mosaic with the 1600 MHz antenna; the fragments contain the main identifiable features. The upper radargram is raw data, and the lower radargram is the same processed data, where we note that the 16 tesserae of the chain represented by the red grid, which fill 20 cm on average, are not detected. The three hyperbolas are caused by the sinopia main furrows.

If we assume an average velocity of 0.128 m/ns for the mosaic and 1600 MHz of central frequency, we have a limit of 2 cm for longitudinal resolution and 2–4 cm for lateral resolution at depths between 1 cm and 4 cm, respectively. This explains why the tesserae cannot be detected from data acquired with the 1600 MHz antenna, as shown in Figure 8.

These resolution limits can be reduced slightly in the data processing by applying a spike deconvolution [29]. In Figure 8, we compared the raw radargram with the processed radargram, observing a significant increase in resolution.

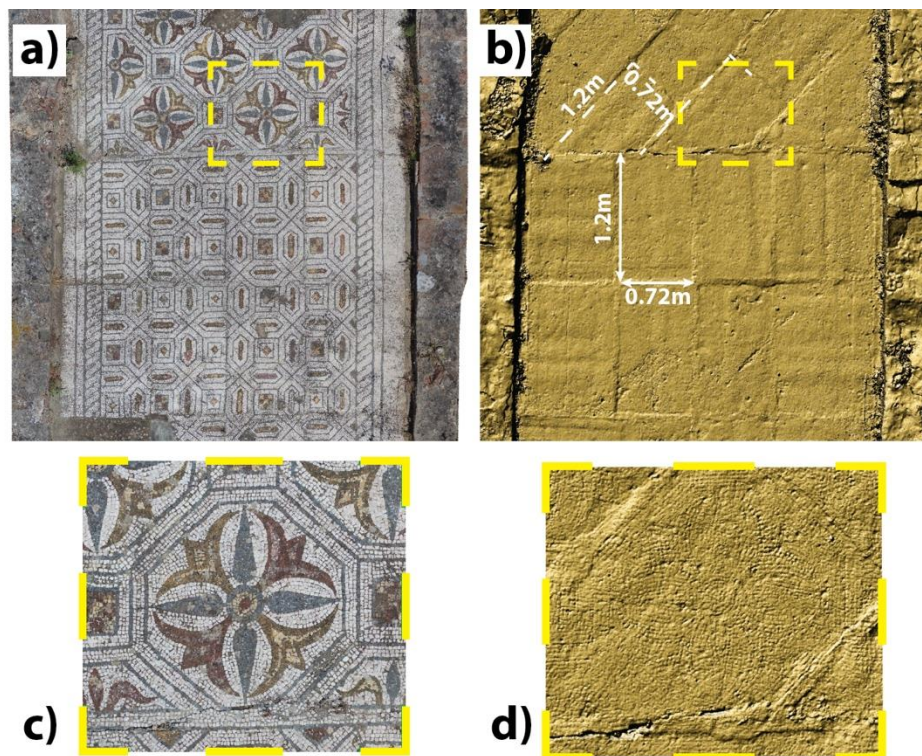
**Figure 10.** (a) Fragment of the obtained photogrammetric orthomosaic from the studied floor mosaic. (b) Fragment of the digital surface model (DSM) in the same area where the boundaries between the bedding mortar sections of different work planning units were perceived and measured. (c) Detail of the green detached square found in (a). (d) Detail of the green detached square found in (b).

The orthomosaic (Figure 10a) consists of approximately 1 giga square pixel with a 0.5 mm ground sampling distance (GSD). It is a resolution that allowed each tesserae (of  $1 \text{ cm}^2$ ) be defined of approximately 400 pixels. Figure 10b shows a grid of rectangular mesh of  $1.2 \text{ m} \times 0.72 \text{ m}$  oriented in two directions: (i) Along the corridor direction in the bottom sector, where the octagonal pattern is filled by squares and diamonds and (ii) oriented  $45^\circ$  with respect to the corridor direction in the upper sector, where the octagonal pattern is filled with rosettes.

The orthomosaic resolution allows a detailed inspection of the mosaic surface. The gigapixel digital surface model (Figure 10b) accurately captured the surface relief of the mosaic, where subtle changes, not perceptible with the naked eye in the field or in the orthomosaic, could be noticed on the DSM. For example, the relief that defines the grid in Figure 10b is in the order of 1.9 mm and was interpreted as the boundaries of the bedding mortar sections, corresponding to different work units, which dried up in different time windows.

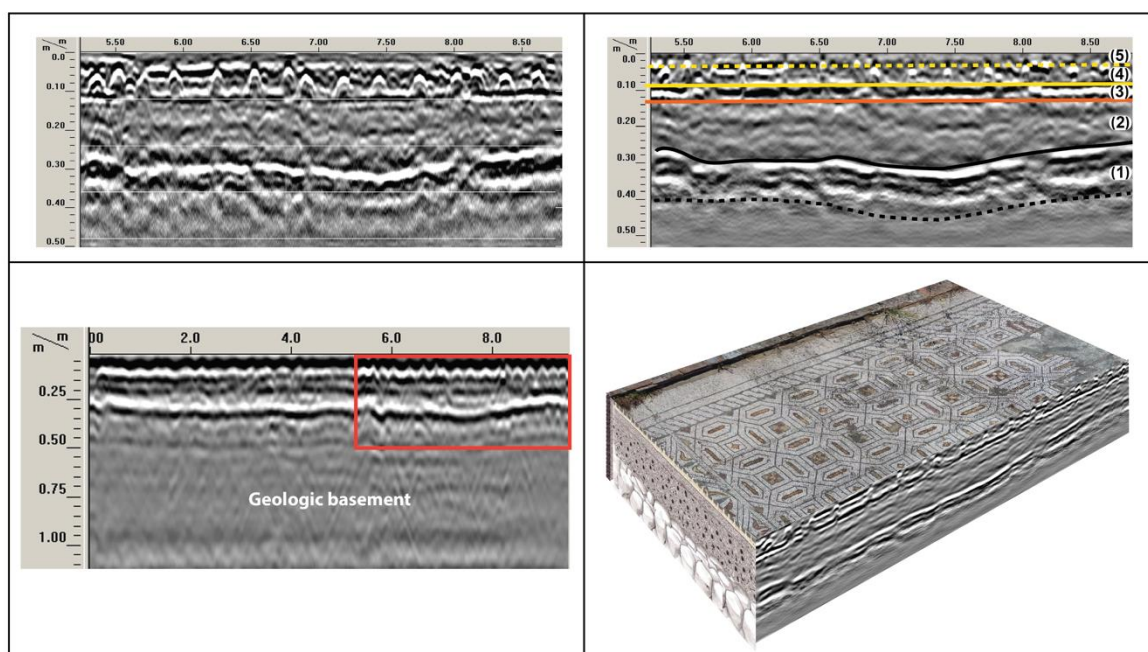
**Figure 11.** Top images show a 2D-GPR profile acquired with a 1600 MHz antenna, and the processing flow that was applied to this profile, as represented in Table 2. The right radargram differs from the left radargram because a Kirchhoff migration has also been applied. In both radargrams, we can distinguish all mosaic units (see the main text). The bottom left image is a raw 2D-GPR profile acquired with a 400 MHz antenna. The profile shows a general vertical stratigraphy view of the mosaic over the geologic bed. The red target indicates the location of the 1600 MHz 2D-GPR profile shown in the upper panel. The bottom right image is a general interpretation view of the main inner structure of the mosaic.

Figure 11 shows a portion of the raw 2D-GPR of the 400 MHz profile (lower left image) and two 2D-GPRs of 1600 MHz processed radargrams (upper images), which are coincident with the upper 2D-GPR profile (red rectangle). The right 1600 MHz radargram has been processed with the same flow, but a Kirchhoff migration has also been applied (marked step in Table 2).

The GPR images in Figure 11 show the main stratigraphic parts of the mosaic, which suggest that one could attempt a 3D inspection to analyze the conservation aspects (humidity, internal fractures, etc.) to make some preservation determinations. The top two layers of Figure 11 (up to 4 cm depth) are more special because they contain information about the artistic construction of the mosaic, and these layers can reveal interesting aspects from the patterns that help to further the knowledge of the mosaic. Thus, the radargrams and lower image in Figure 11 allowed us to establish the first interpretations of the mosaic stratigraphy: (1) the statumen basement layer is between 32 cm and 42 cm depths (on average), and this layer is characterized by a strong reflector at the top followed by a bed of coarse gravels that were well identified on the radargrams; (2) the rudus is a homogeneous layer with hardly any reflections, placed between 12 cm and 32 cm depths; (3) the nucleus, which is characterized by a double strong reflector, is located between 8–12 cm; and for (4) and (5), we could distinguish the

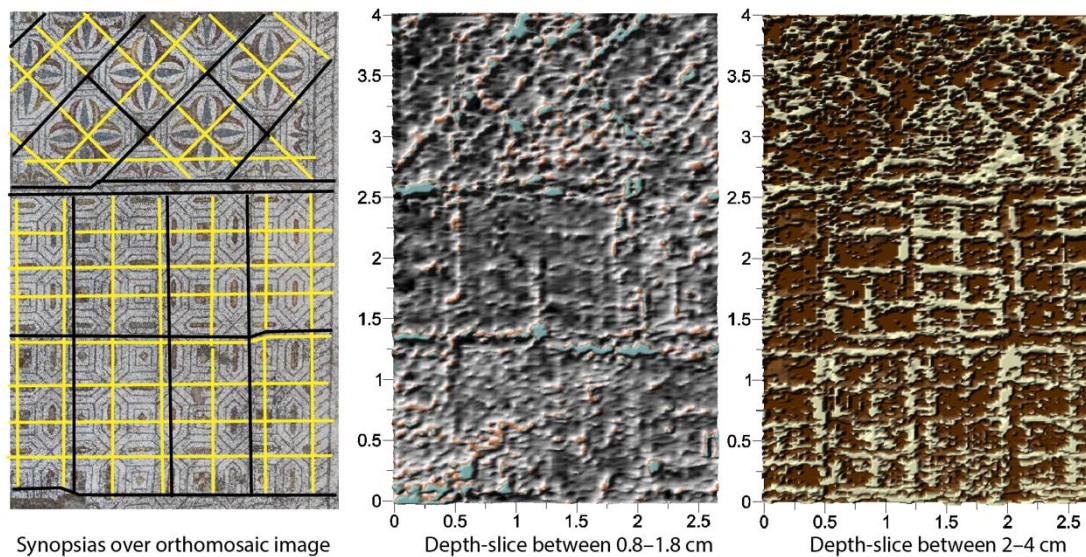
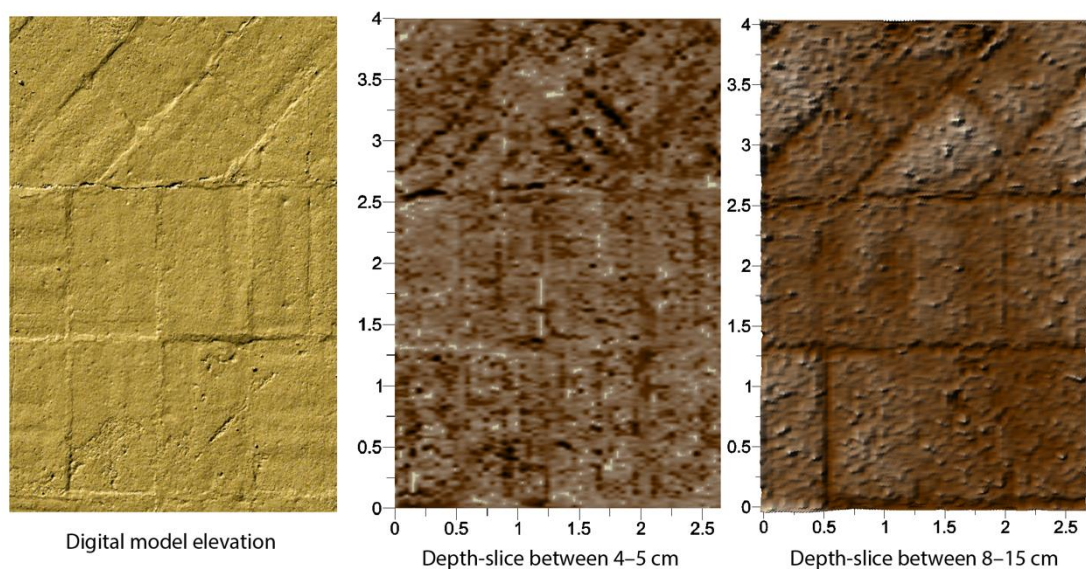
**Figure 12.** Upper images are the orthophoto (left) and two horizontal depth slices in the 3D-GPR model. Through the reflectors, we can infer the main sinopia of the Roman floor mosaic that is placed over the orthomosaic image (see discussion). Lower images are the digital surface model (DSM, left) and two horizontal depth slices cutting the nucleus: The first one is near the top of the nucleus, and the second integrates 7 cm of the nucleus body. Finally, the reflectivity correlates very well with the DSM model.

The first results of the 3D-GPR survey are shown in Figure 12, where the most significant detected levels up to the base of the nucleus are presented. From left to right, the two left images correspond to the photogrammetry: The one on the upper left is the orthomosaic and the bottom left is the DSM. The remaining images are horizontal cuts (depth slices) of the 3D-GPR model from the surface up to 15 cm depth, which contain the most reflective elements within this depth range [25]. The upper GPR slices in Figure 12 (0.8–1.8 cm and 2–4 cm) correspond to the distribution of the significant reflective elements in the bedding layer of the roman mosaic, which contains the tesserae. The black lines over the orthomosaic represent the interface between the blocks detected in DSM and the yellow lines are secondary guides corresponding to reflective elements detected on the GPR 3D slices up to 4 cm.

The lower GPR images in Figure 12 are the depth slice that correspond to the thin bedding layer of mortar (between 4–6 cm) just above the nucleus, where the sinopia are vanishing, and the slice that corresponds to the nucleus layer (between 8–15 cm).

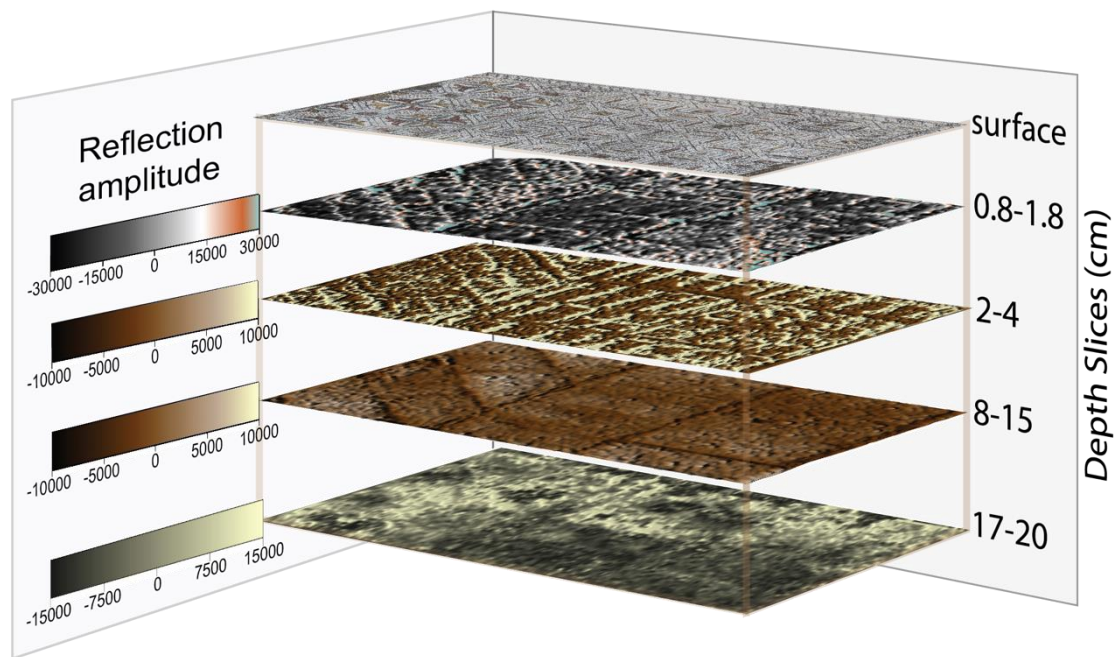
**Figure 13.** Summary of the most significant levels detected in the 3D-GPR survey, collected with a 1600 MHz antenna. The color scales correspond to the amplitude of the reflections.

Figure 13 summarizes the detected levels up to the bottom of the rudus so that we have a complete study and documentation of the beautiful mosaic surface and its internal architecture.

As expected from the previous considerations about the resolution and features identification from GPR data, the first considered layer in the 3D GPR model (between 0.8–1.8 cm, Figure 12) was a “diffuse” image that contained the base of the tesserae (bottom of layer 5 of Vitruvius description) and a part of the mortar that filled the interstices between the tesserae and fixed them. At the following level, represented in Figure 12 (between 2–4 cm depths), a set of geometric reflectors were detected, from whose arrangement the basic sinopia marked in the mosaic construction was inferred. The black lines drawn on the top left image of Figure 10 mark the main blocks detected in DSM and the attenuate segments in 2–4 cm depth-slice; while the yellow lines are the secondary guides that only detect a reflector segments in 2–4 cm depth slice. In the section of the floral motifs, the element that articulated the drawing was a mesh formed by squares with 36 cm sides that were arranged at 45° with respect to the direction of the corridor. For the section of geometric motifs, the basic element was a rectangular mesh with cells of 37 cm × 29 cm parallel to the corridor. The reflections that correspond to the nucleus layer (8–15 cm in Figure 12) correlate perfectly with the DSM, suggesting that in this mosaic, the nucleus was built with rectangular pieces of 1.2 m × 0.72 m distributed parallel, and at 45°, with respect to the corridor direction. Below the nucleus layer, the reflections in the rudus did not present significant distributions, except changes in signal amplitude that could be associated with areas of higher humidity, as mentioned in the previous section. Figure 11 is a summary of the detected levels up to the bottom of the rudus.
