The Impact of Free Radical Stabilization Techniques on In Vivo Property Changes in Highly Cross-Linked Polyethylene Acetabular Liners

Michael M. Decker ., *The University of Western Ontario*

A thesis submitted in partial fulfillment of the requirements for the Master of Science degree in Surgery

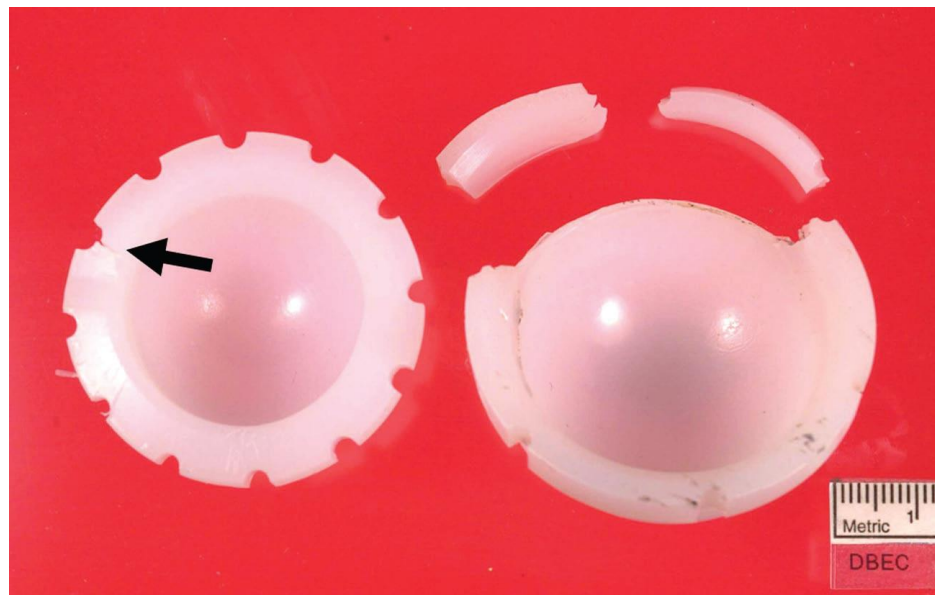
Figure 1-8 - Example of a failed HXLPE acetabular liner at the rim of the implant (permissions from Tower SS. Rim Cracking of the Cross-Linked Longevity Polyethylene Acetabular Liner After Total Hip Arthroplasty. J Bone Joint Surg Am. 2007;89(10):2212. doi:10.2106/JBJS.F.00758)

liners, HXLPE has proven to be successful in terms of wear and osteolysis (30–37) . However, mechanical properties of the implant are compromised at the expense of improved wear properties, specifically fatigue crack propagation resistance (29,38–40). Irradiation used to create polyethylene cross-linking leads to the formation of free radicals (44). These free radicals can react with oxygen species *in vivo*, leading to polymer chain scission, recrystallization and ultimately increased brittleness (42–46). To stabilize these free radicals, implant manufacturers utilize thermal treatments such as remelting above or annealing below the material melting point. Remelting more effectively removes free radicals at the expense of mechanical properties, where annealing less effectively removes free radicals but maintains mechanical properties (50). Furthermore, certain manufacturers utilize irradiation for implant sterilization, which can reintroduce or increase free radicals in the finished implant. Recent reports of mechanical failure of certain HXLPE acetabular liners at the rim of the implant (51–58) have raised concerns about the possibility of decreased mechanical properties on the longevity of these bearing surfaces (figure 1-8).

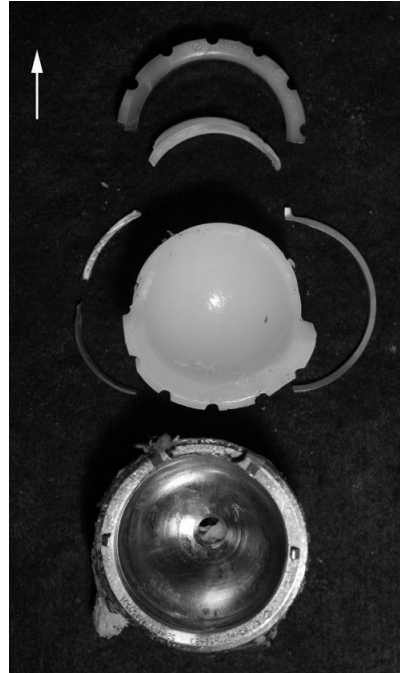
Figure 2-4 - Example of a retrieved fractured remelted HXLPE liner at the implant rim. (Permissions from Moore KD, Beck PR, Petersen DW, Cuckler JM, Lemons JE, Eberhardt AW. Early Failure of a Cross-Linked Polyethylene Acetabular Liner: A Case Report. J Bone Joint Surg Am. 2008;90(11):2499-2504. doi:10.2106/JBJS.G.01304)

Tower *et al* (26) reported on the mechanical failure of four remelted liners from a single manufacturer after *in vivo* times ranging from 7 to 27 months. In all cases, acetabular components were malpositioned vertically. Analysis of the failed implants exposed severe cracking or failure was at the rim with damage evident at the superior aspect where the polyethylene engages the locking mechanism. Cracking was found to begin at the outer edge of the implant and propagate towards the articular surface. Polyethylene thickness at the site of crack propagation was less than 4mm for each implant. Mechanical properties were nearly identical to control samples, though lower than non-crosslinked reference polyethylene. Moore *et al* (27) and Waewsawangwong and Goodman (28) reported on a mechanical failure in a remelted HXLPE liner with a similar fracture pattern with polyethylene thickness in no greater than 3.3mm at the site of rim fracture. Ast *et al* (29) reported on a single case of a retrieved, fractured remelted HXLPE liner in a vertically oriented acetabular component with polyethylene thickness of 2.2mm at the site of rim fracture. In this study, a review of 74 FDA reported cases of liner fracture in remelted HXLPE implants from the same manufacturer was performed. Average *in vivo* time was 27 months. The majority of cases revealed fracture at the implant rim, with polyethylene thickness ≤ 3.7 mm in 61 of 72 cases and ≤ 4.7 mm in 70 of 72 cases.

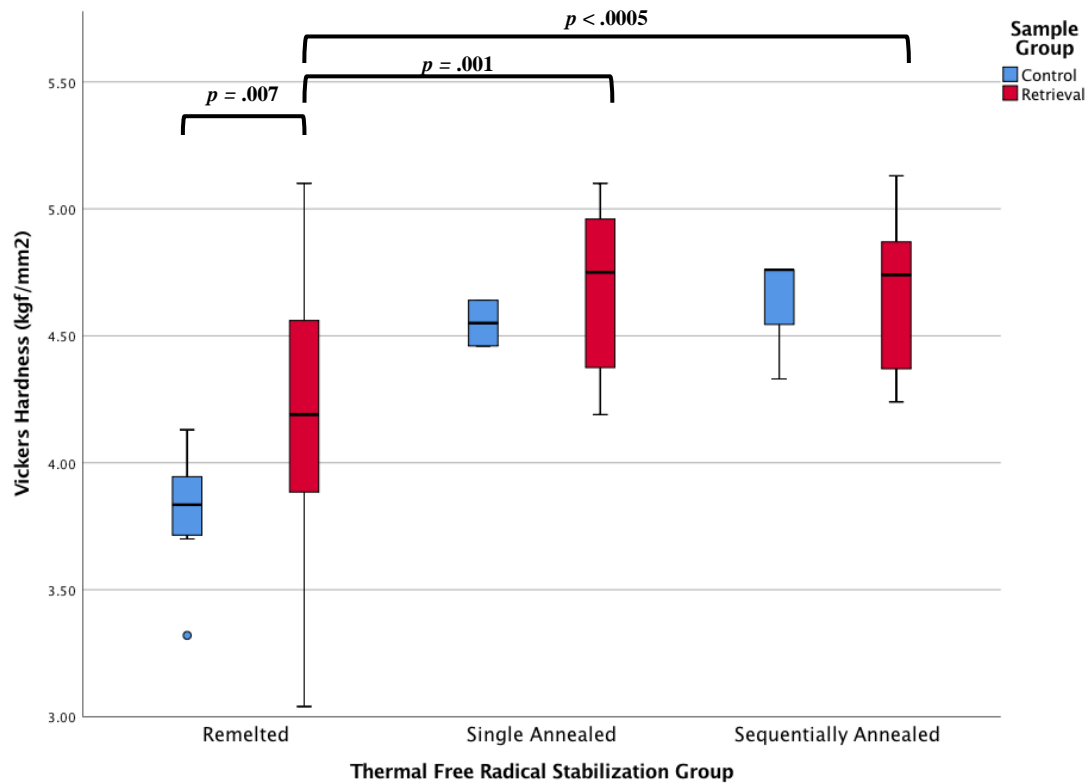
Figure 5-4 - Comparison of hardness values for control and retrieved liner rims grouped according to their thermal stabilization. Note that statistically significant differences were found in Vickers hardness between retrieved remelted liner rims compared to both single and sequentially annealed liner rims, as well as between remelted control and retrieved liner rims.

Hardness of retrieval liners was compared to control liners for changes in hardness from baseline properties (figure 5-4). For remelted liners, there was a statistically significant increase in hardness from control to retrieved liners by 0.40 kgf/mm^2 (95% CI 0.14 – 0.68, $p=.007$). One statistical outlier was noted in the remelted control liner group. However, the statistical significance of the difference between the remelted control and retrieval groups remained when both the outlier was excluded and when nonparametric analysis was performed. No hardness difference was seen between control and retrieved single annealed or sequentially annealed liners.

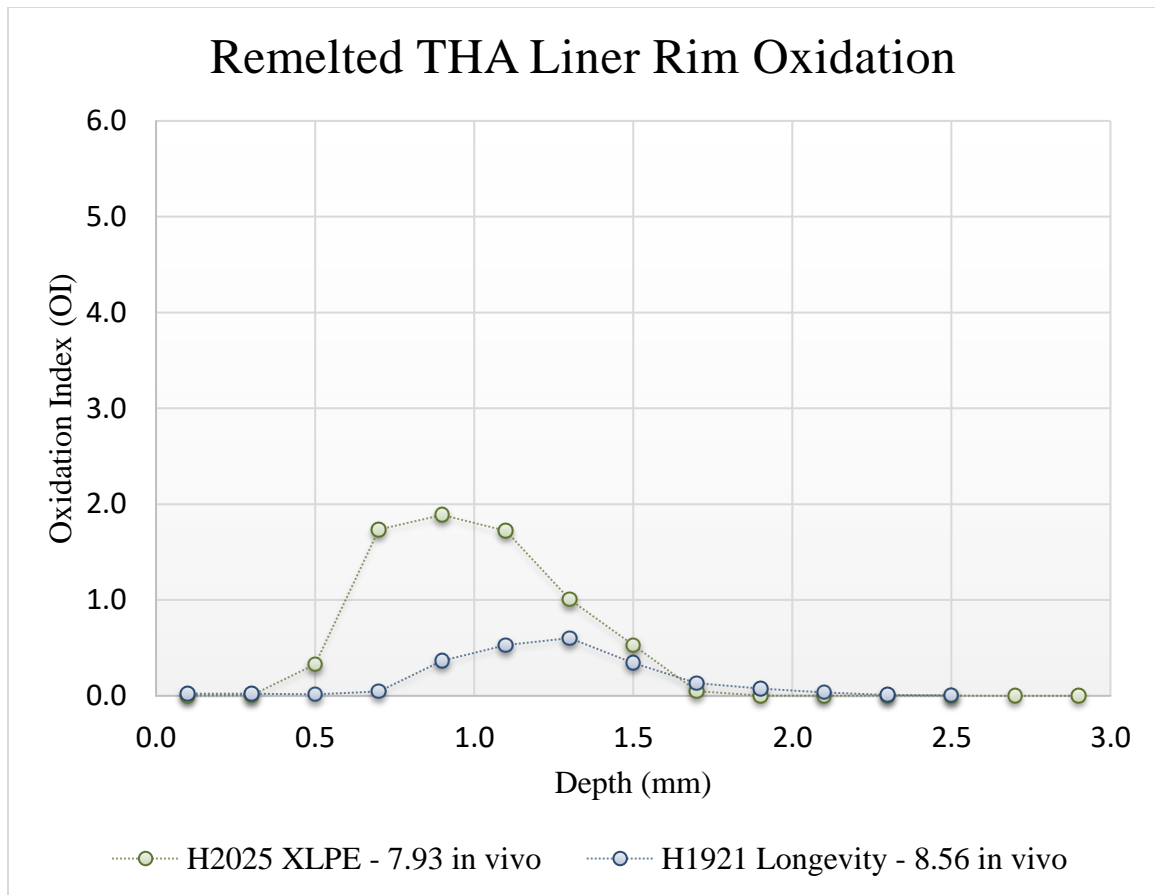
Figure 6-3 - Oxidation Indices of remelted liner rims with detectable oxidation. Note that all remelted control liners and remaining remelted retrieved liners demonstrated $OI < 0.1$ throughout the rim

Rim oxidation as a product of depth in retrieved THA liners with detectable oxidation ($OI>0.1$) is presented in figures 6-3 through 6-5. Average maximum rim oxidation for retrieved and control liners is presented in table 6-3. Rim oxidation occurred in the subsurface region when present. Representative optical images of liners with evidence of oxidation from each thermal stabilization group is provided in figure 6-6, demonstrating characteristic white bands in the subsurface region of the oxidized rim.

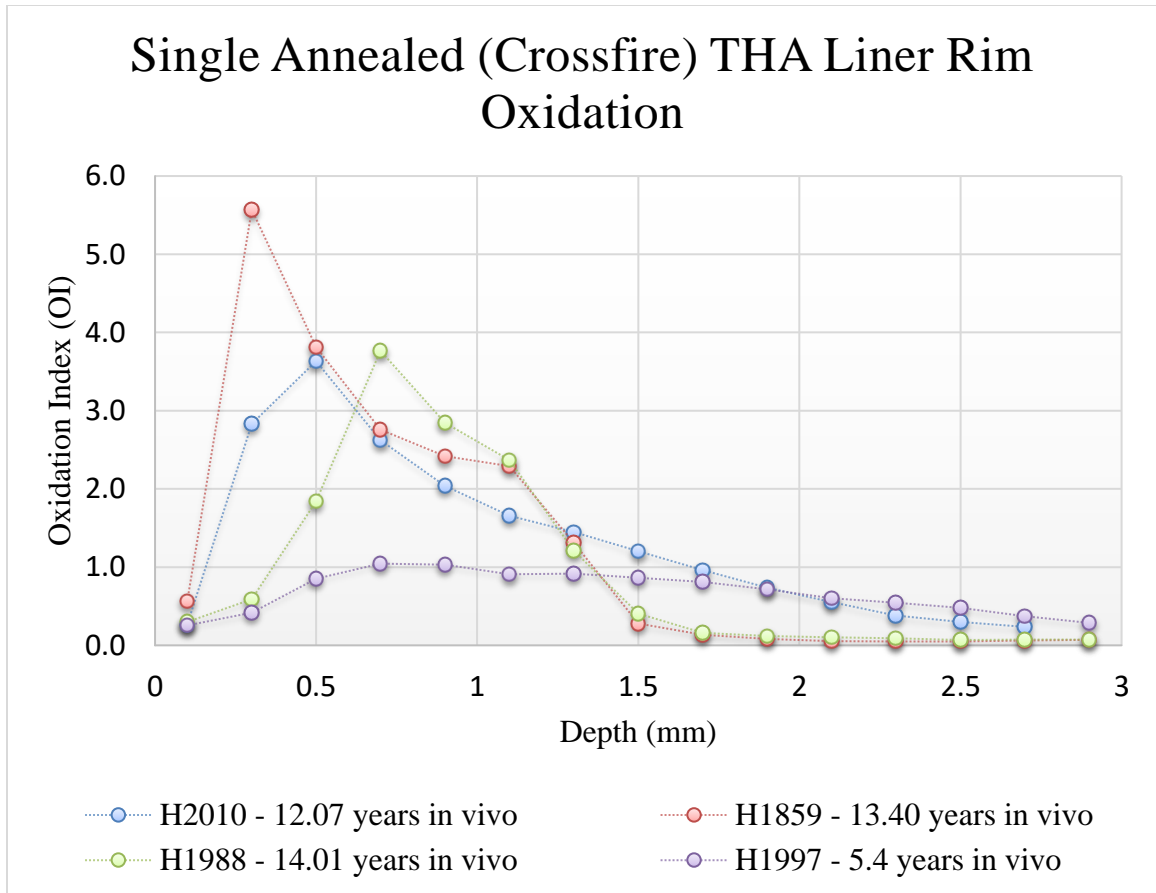
Figure 6-4 - Oxidation Indices of single annealed retrieved and control liner rims. All samples, including the control liner, had a rim OI > 0.1

All retrieved single annealed liners (4/4) demonstrated significant rim oxidation ($OI_{\max} > 1$), with oxidation levels ranging from 1.04 – 5.07. The control single annealed liner demonstrated detectable but low rim oxidation ($OI_{\max} = 0.2$). There was a positive correlation between maximum rim oxidation and *in vivo* time ($\rho = .90, p = .037$).

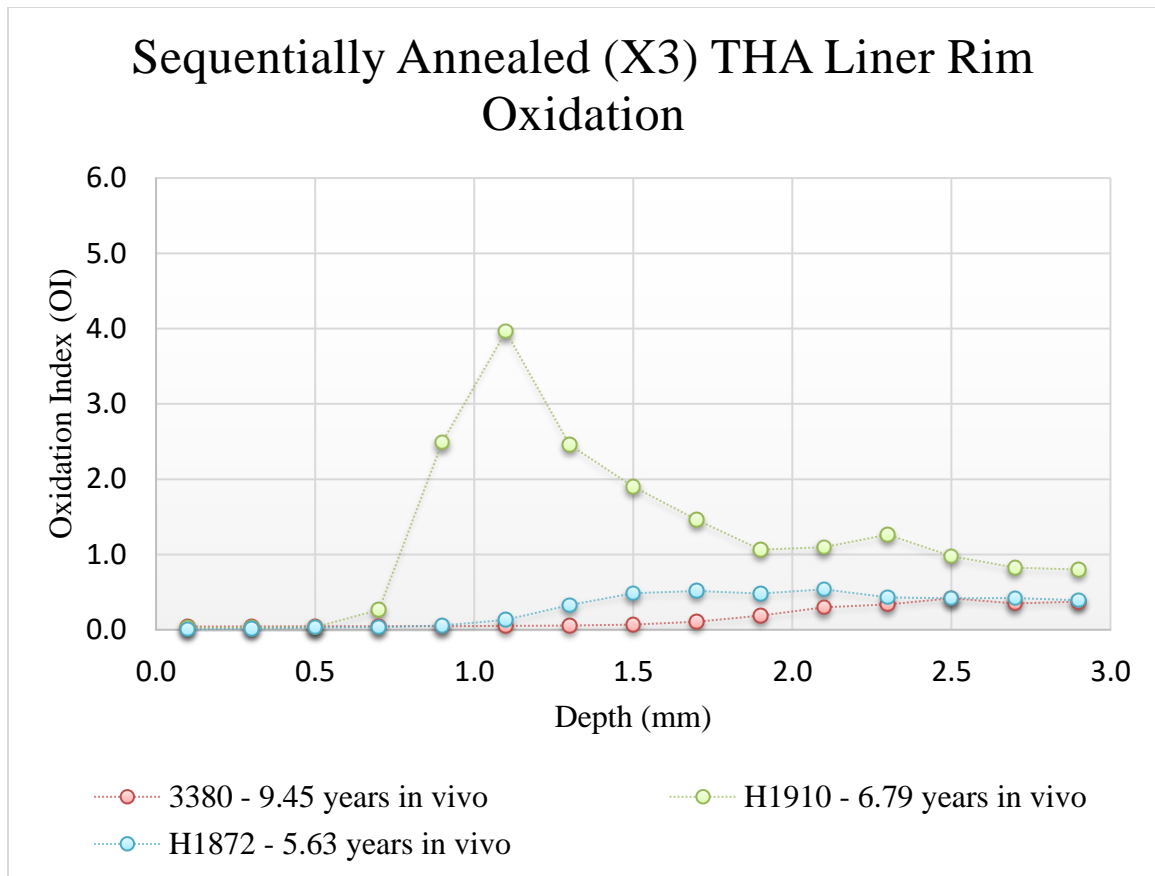
Figure 6-5 - Oxidation Indices of sequentially annealed liner rims with detectable oxidation. The control liner demonstrated low but detectable oxidation

Seventy-five percent (3/4) of retrieved sequentially annealed liners demonstrated detectable levels of rim oxidation, with one liner with *in vivo* time of 6.79 years demonstrating significant oxidation ($OI_{max} = 3.96$). All liners with evidence of oxidation also had oxidation beyond the subsurface region into the implant bulk. The control sequentially annealed liner demonstrated detectable but low rim oxidation ($OI_{max} = 0.10$). There was no correlation between maximum rim oxidation and *in vivo* time.
