The effect of mica on the aging of asphalt binder

**EFFECT OF MICA ON ASPHALT
BINDER AGING BEHAVIOR**

THESIS

Master of Science

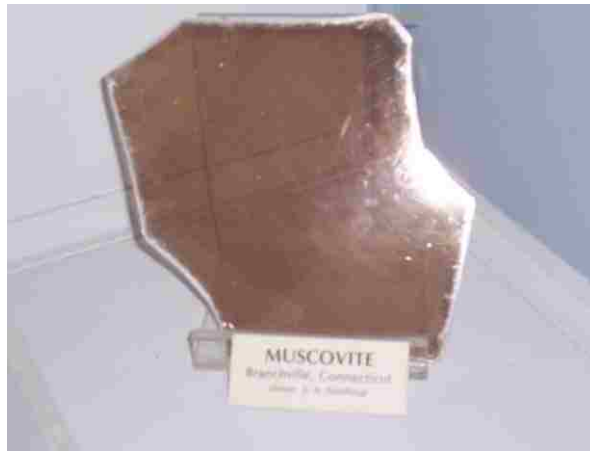
Figure 2.1. Specimen of muscovite (Courtesy University of New Mexico Earth and Planetary Sciences Geology Museum)

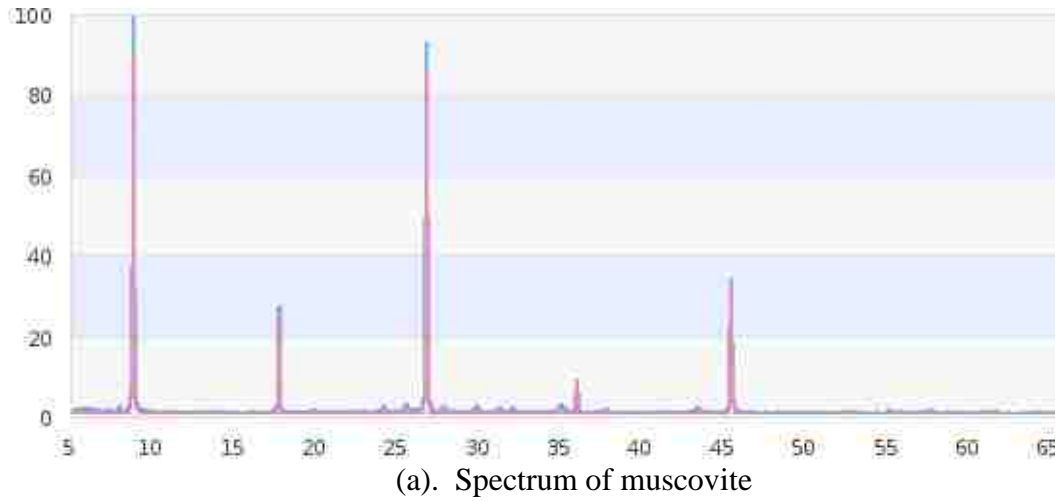
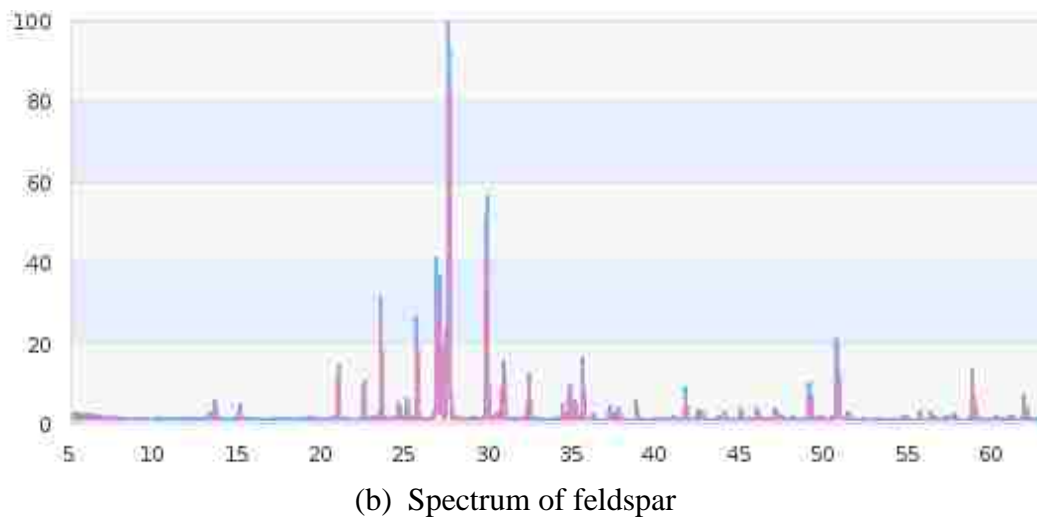
Figure 2.6. XRD Spectra for comparison (mindat.org)

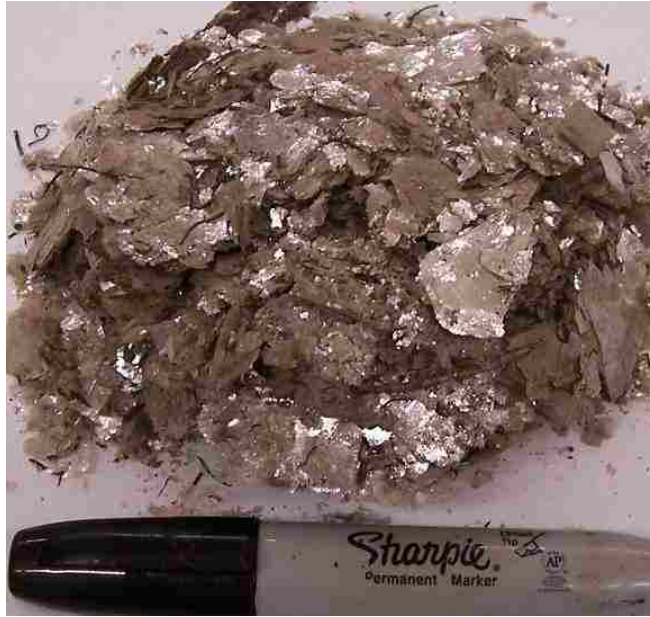
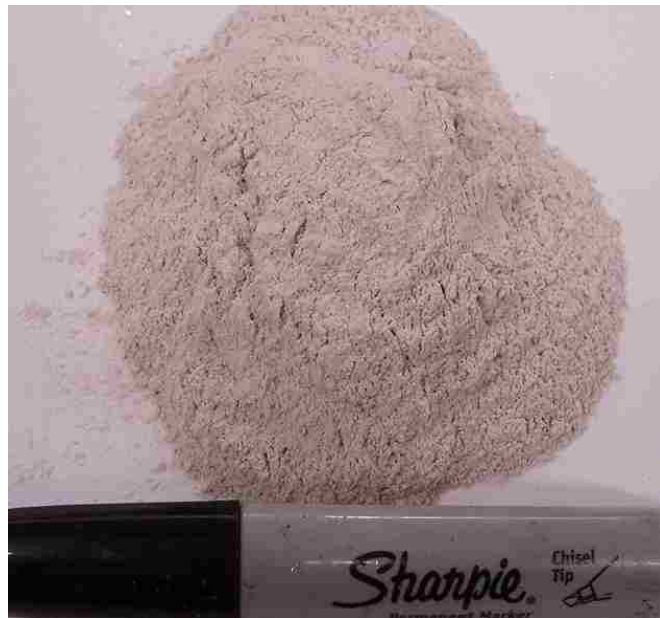
(a) In its natural state as found in wilderness.

(b) After cleaning, grinding and passing #200 sieve

Figure 3.2: Mica

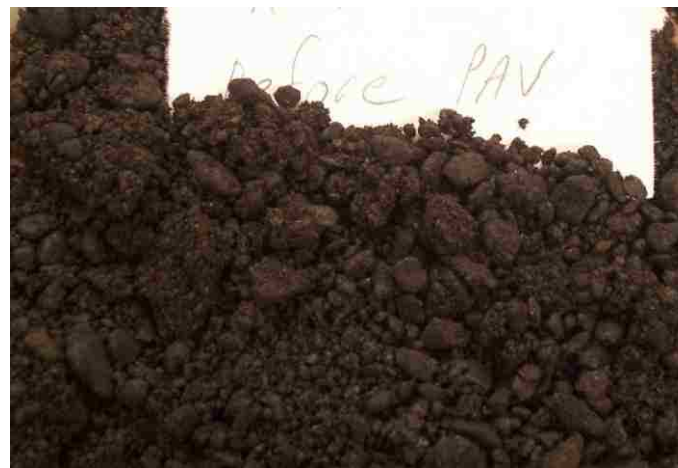
(c) Filler is 10% mica

Figure 3.4: Mastic made with 21% unmodified binder, after RTFO

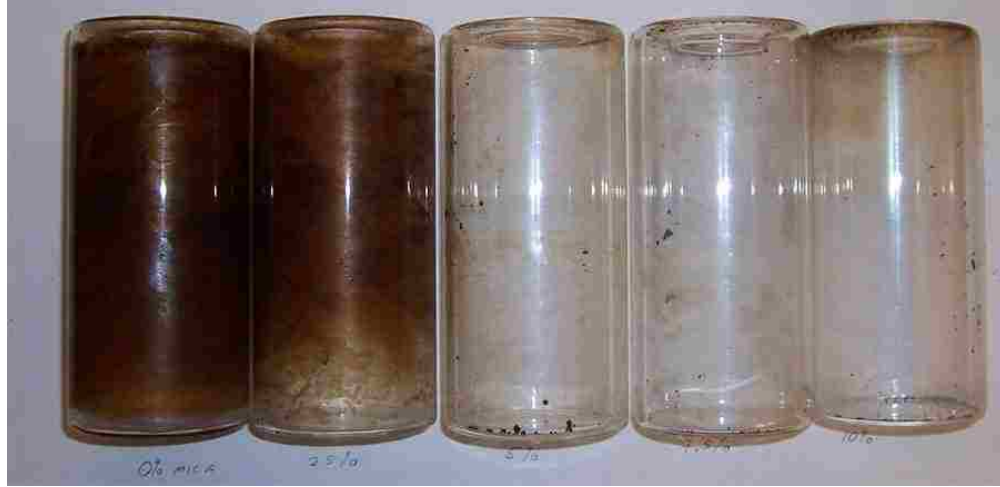
Figure 3.5: RTFO jars from unmodified binder mastic mixes, arranged from 0% to 10% mica

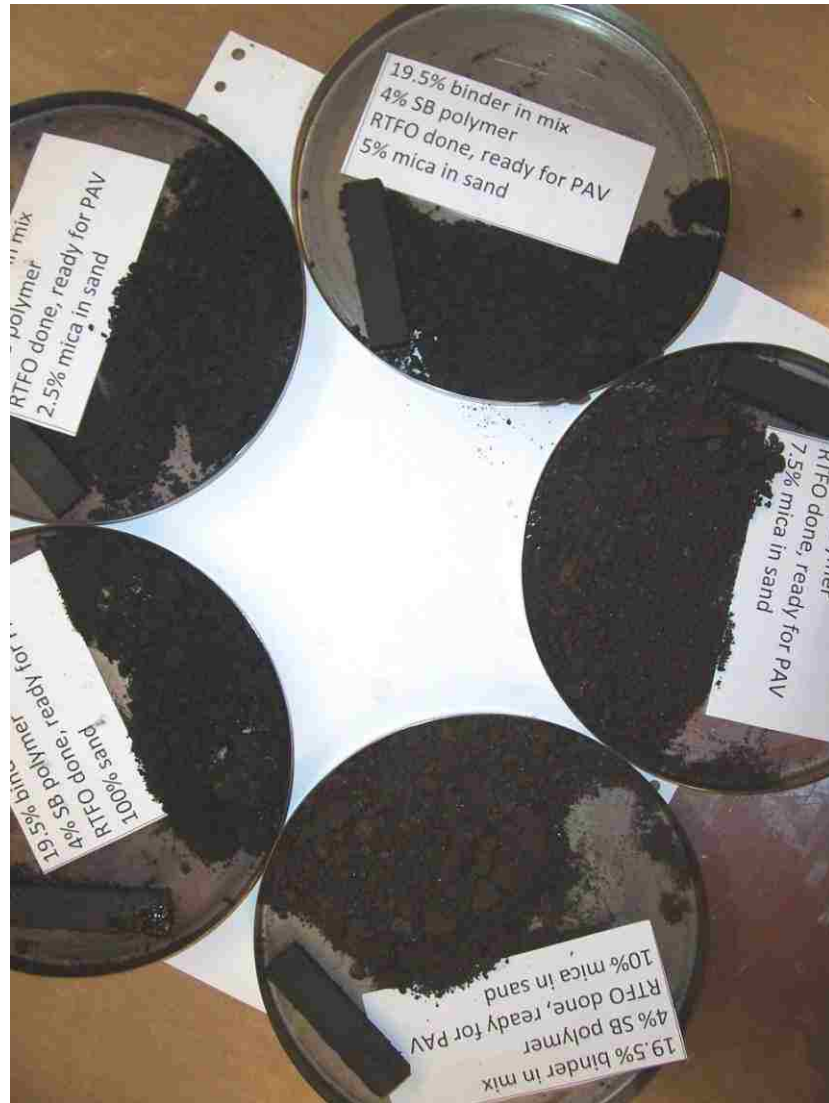
Figure 3.6: SB4% modified mastics, post-RTFO

The percentage of binder was reduced for the SB4% modified mastics. The first attempt used 19% binder, but that proved to be inadequate even for the 100% fines sample, so the final mix had 19.5% binder. After RTFO, it was evident that the 0 and 2.5% samples were rich enough for easy handling, but the 5, 7.5 and 10% samples were quite dry. All five mixes are shown in Figure 3.6 where the 0% mica mix is obviously deep black and sticking together while the 10% mica mix is brown and granular. The RTFO jars were all clean after the cycle was run because these mastics left no residue. While dry, these samples were considered to be adequately useable.

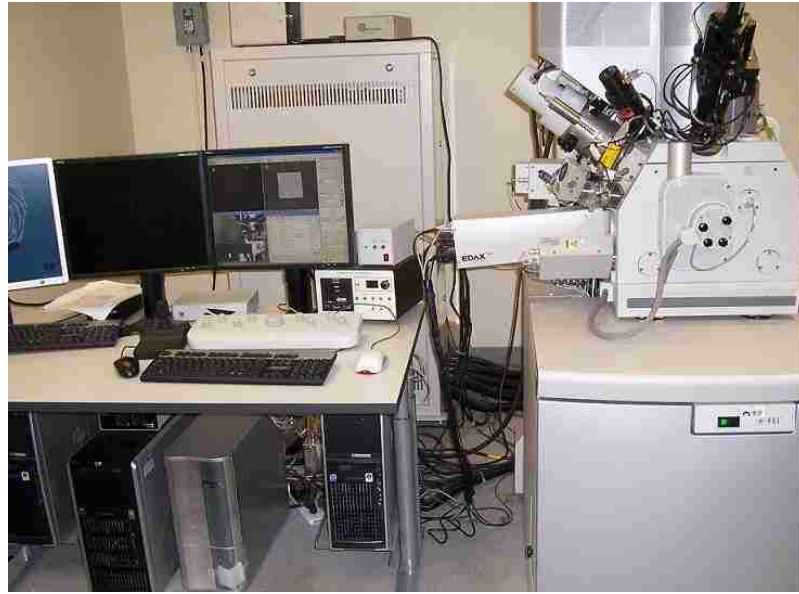
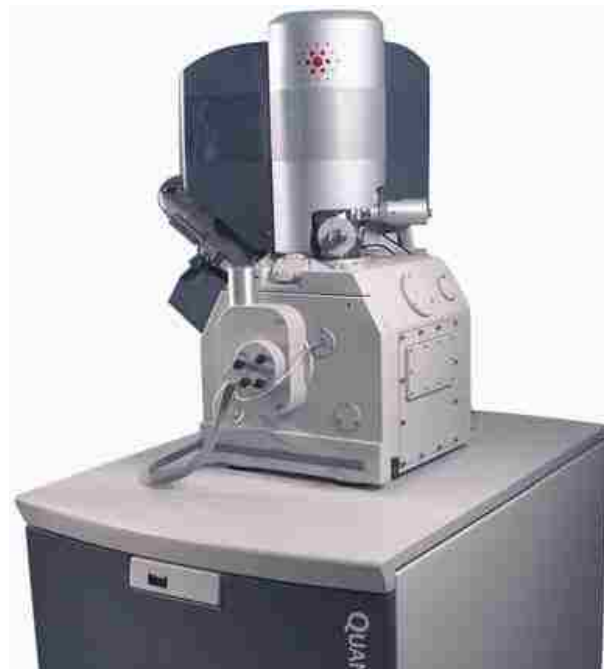
(a) As configured at the University of New Mexico

(b) With no extraneous equipment attached

Figure 3.10: SEM Quanta 3D FEG SEM/FIB machine

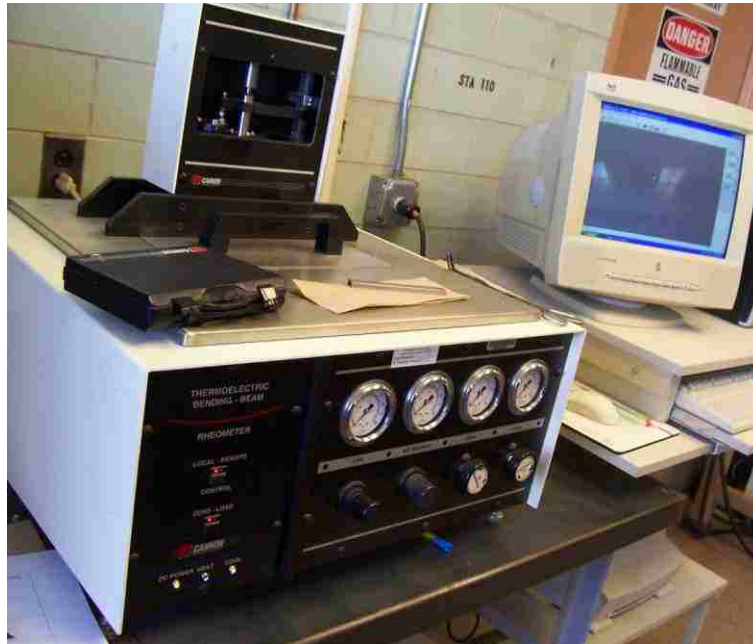
(a) BBR as configured at the New Mexico DOT asphalt test laboratory in Santa Fe, NM

Figure 3.15: Bending Beam Rheometer

The Bending Beam Rheometer (BBR) has been used for several decades to test asphalt binders at low temperatures to determine their susceptibility to thermal cracking. This type of cracking occurs on roadways as the asphalt pavement shrinks in cold temperatures (Roberts et al. 1991). It may happen in one cycle down to an extremely cold temperature or after several cycles of heating and cooling to more moderate temperatures. AASHTO Test T 313-08 describes the detail of the test precisely.

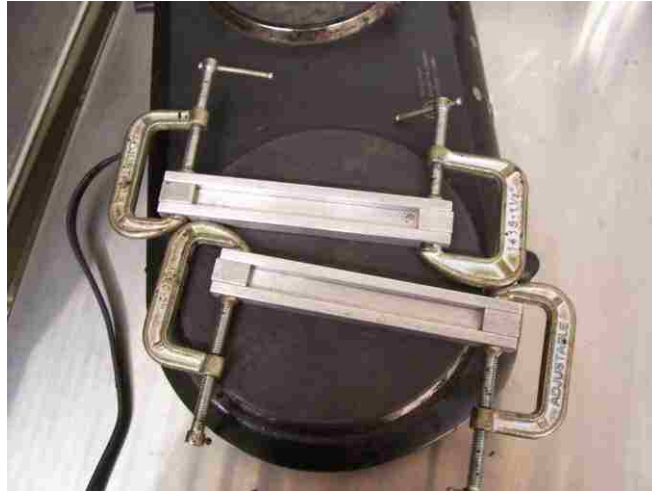
Figure 3.16: BBR sample molds

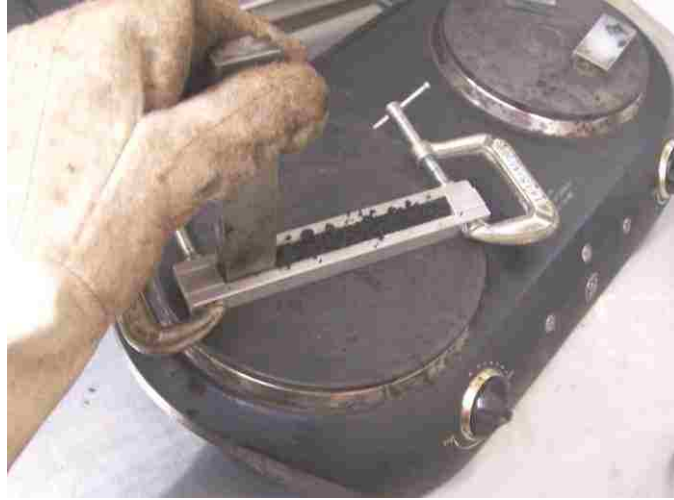
Figure 3.17: Compaction of mastic into mold

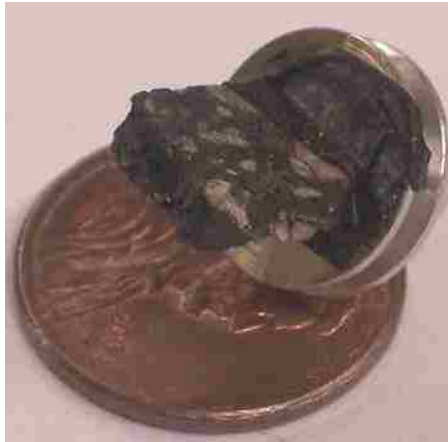
(a): Sample on SEM stub

(b): SEM image of mica in AC

(c): SEM image of AC showing cracked mica

Figure 4.1: Original AC sample

The original motivation for this study came from an SEM image of a random piece of commercial asphalt concrete (AC) that showed several pieces of uncoated mica in the mastic. Figure 4.1(a) shows this piece of AC after it was broken and mounted on an SEM stub for viewing. A penny is included in the photo for scale. Note that, while the sample is over a centimeter tall, the only part viewed in the SEM is the broken face, which is a much smaller area. Figure 4.1(b) shows the SEM image of one piece of mica about 50 micrometers wide that was found in the original sample. Figure 4.1(c) shows a much wider SEM image, nearly a half centimeter, of another area on the sample in which two large areas of mica can be seen. These images raised the question, “How does mica contribute to the mechanical properties of and wear and tear of asphalt on pavement?” In the next sections, the results of the SEM study will be explained.

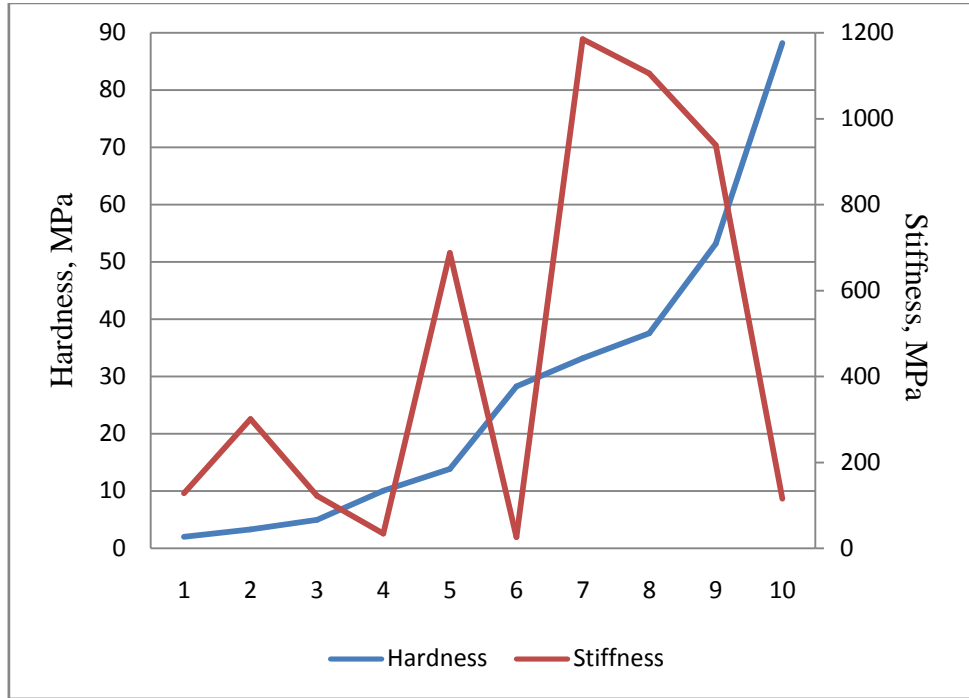
Figure 6.6: Stiffness and Hardness compared to each other, 10% mica mastic, RTFO
