# The effectiveness of Iowa's automated red light running enforcement programs

A thesis submitted to the graduate faculty  
in partial fulfillment of the requirements for the degree of  
MASTER OF SCIENCE

Major: Civil Engineering (Transportation Engineering)

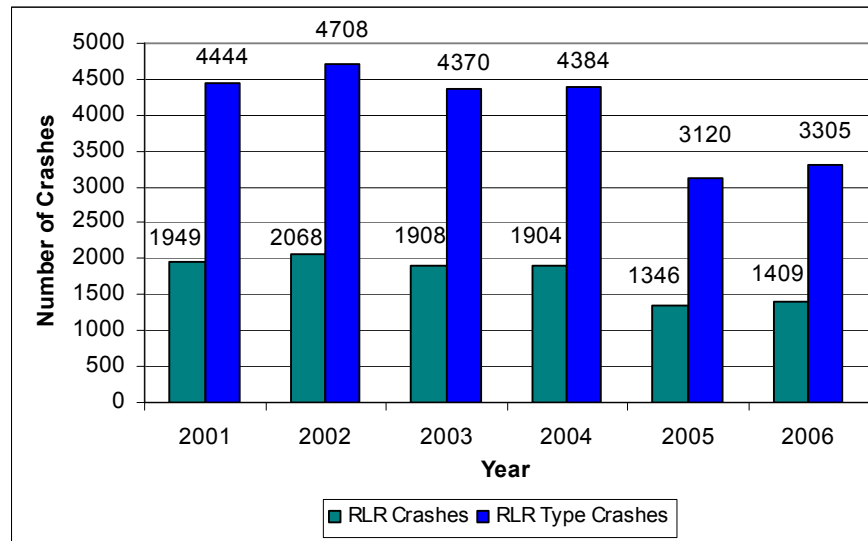
Figure 1. RLR and RLR type crashes in Iowa from 2001 to 2006.

The number of RLR crashes for each year from 2001 to 2006 and the number RLR type crashes for each year from 2001 to 2006 are shown in Figure 1. As indicated, from 1,290 to 1,994 RLR crashes per year occur. This resulted in an annual average of 1,764 RLR crashes. RLR type crashes range from 3,120 to 4,708 with an annual average of 4,055 crashes. Additionally, an annual average of 68 fatal and major injury RLR crashes and 123 fatal or major injury RLR type crashes occurred.

An average of 8,162 total crashes occurred at signalized intersections in Iowa per year. RLR crashes account for 21.6% of all crashes at signalized intersections and RLR type crashes account for 49.7% of all signalized intersection crashes annually. Additionally, RLR crashes account for 35.0% of the fatal and major injury crashes at signalized intersections and RLR type crashes account for 63.6% of fatal and major injury crashes at signalized intersections.

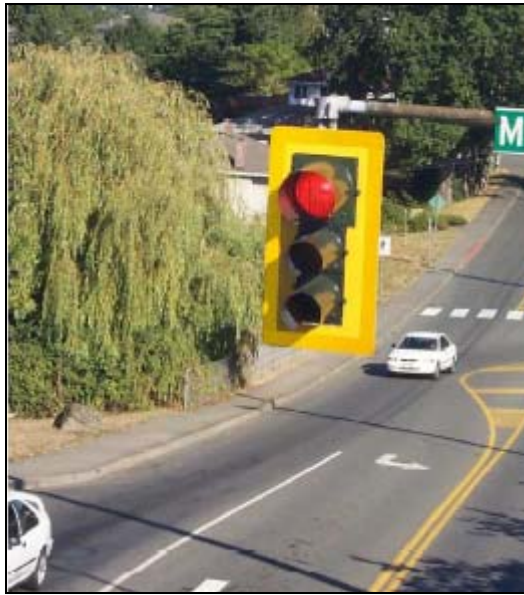
Figure 2. Signal with high intensity yellow retroreflective tape on backplate (23).

In 1998, a research study conducted in British Columbia, Canada by Miska, de Leur, and Sayed investigated the effects of installing yellow reflective tape on the edge of the backplates to combat various claims of not being able to visually see the traffic signals at studied intersection. As shown below in Figure 1, a 75mm reflective 3M tape border was installed on single heads of six traffic signals at six intersections. The cost of installation was minimal at \$35 per signal and around \$420 per intersections. Miska, de Leur, and Sayed concluded that the numbers of claims were reduced up to 60% (23, 24).

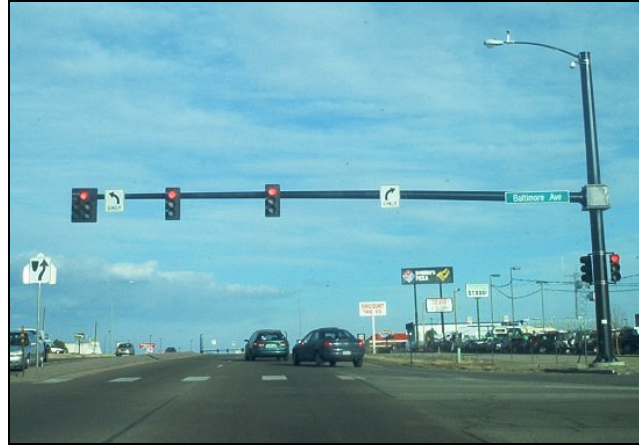
Figure 3. CDOT specified high-speed intersection traffic signal (25).

- **Placement:** Although the MUTCD does not specify or require that the traffic signals be over each lane and be attached to a pole, studies in Iowa and Missouri have shown 32 and 25 percent reductions in crashes at intersections with traffic signals attached to mast and poles (16). An FHWA report states that traffic signals located above each lane overcome three important obstacles that median or roadside traffic signals have: (1) they generally do not provide good conspicuity, (2) mounting locations may not provide a display with clear meaning and (3) motorists' line-of-sight blockage to the signal head due to other vehicles, particularly trucks, in the traffic stream (16). Shown below in Figure 3 is a typical high speed intersection in Colorado where 12" diameter traffic signal heads are located over each travel lane. Also note the 8" diameter

pole mounted signal head to aid vehicles that cannot see the overhead traffic signals due to blockage from trucks or other large vehicles.

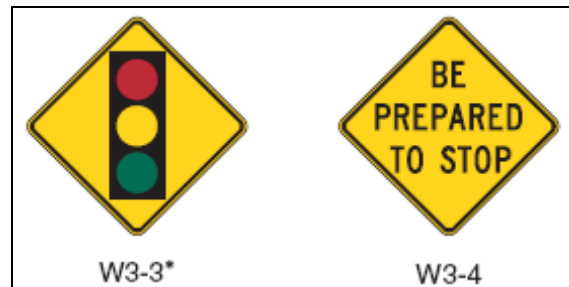
One of the most commonly used countermeasures to warn drivers of an approaching intersection are advance warning signage, as shown in Figure 4. The sign on the left, a W3-3, is typical in urban areas where advance warning may sometimes be needed in heavy congestion. Secondly, these signs can be accompanied by flashing warning lights or flags attached to the sign. In a study conducted by Polanis, it was found the W3-3 warning signs reduced right-angle crashes by 44 percent at signalized intersections (21).

Figure 4. Advance intersection warning signs (12).

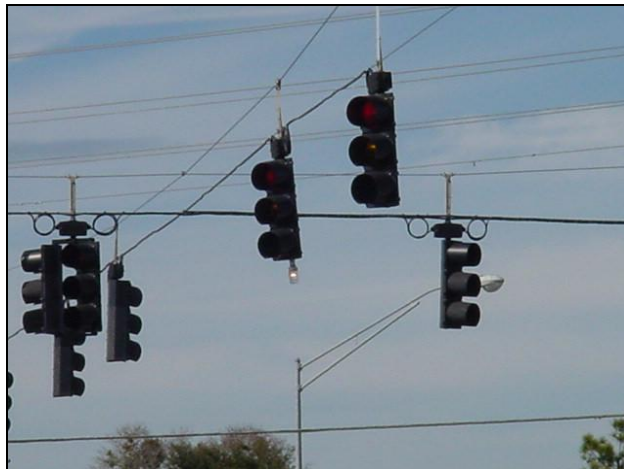
“Rat Boxes”, “White Light Enforcement”, or also referred to as “The Tattler” are a form of enforcement that are simple and cost effective and can be integrated into an existing traffic signal system. Constructed for about \$100, a rat box consists of a small LED or incandescent light that is placed on the backside or underneath a traffic signal as shown in Figure 5. Once the approach traffic signal turns red, the light will activate and will turn off during the green and yellow interval. The system is designed so that a single police officer can sit downstream of the intersection and catch RLR violators while watching each approach stop bar when its designated traffic signal turns red and the rat box illuminates.

Figure 5. White enforcement light in Hillsborough County, Florida (28).

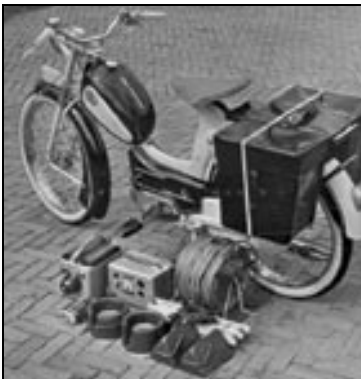
Figure 6. First mobile Gatsometer (31).

Maurice Gatsonides' first invention to capture drivers was the speed camera system, shown in Figure 6. First tested in 1958, it later proved to be the most reliable in the industry. Comprised of a moped, camera, two road tubes, and a mechanical stopwatch, the system was moved easily to different intersections or road segments depending on the client's need. The original intent of this system was to develop a technology to show Gatsonides his speed as his car raced around a corner using the pneumatic road tubes. After the photo camera was activated by a human, a fast speed study was performed by a mechanical stopwatch, which used the pulses from the road tubes at intersections. Gatsometer's second breakthrough product is shown in Figure 7, which were the first speed flash camera invented in 1971, using radar technology to capture RLR and speeding violators. Later, this same technology would be implemented into a camera system that would capture vehicles running a red light based on its approach speed. Gatsometer has been a leader in the RLR camera technology, having made great progress in automated enforcement including mobile cameras, hidden camera technologies, toll booth enforcement, and cameras to capture the driver's face as shown in Figure 8 and Figure 9.

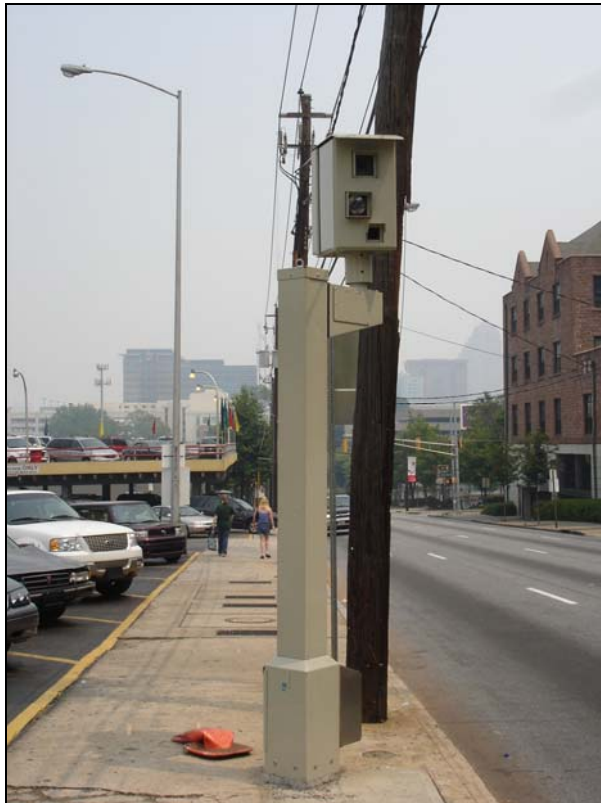
Figure 10. Gatso RLR camera system (Atlanta, GA).

RLR cameras are located typically in weatherproof, vandalism-protected metal boxes. Placed close to the intersection on hinged poles or fixed onto a traffic signal structure, these boxes are mounted 10-15 feet in the air as shown in Figure 10. Other RLR camera systems are integrated into the existing traffic signal hardware as shown in Figure 11. The red light camera system is typically connected both to the traffic signal controller and to dedicated inductive loops in the pavement at or before the stop bars or to the auto scopes at the intersection. Although many traffic equipment vendors claim one automated enforcement camera system can monitor four lanes of traffic, studies performed in New York City have shown accurate photography can only

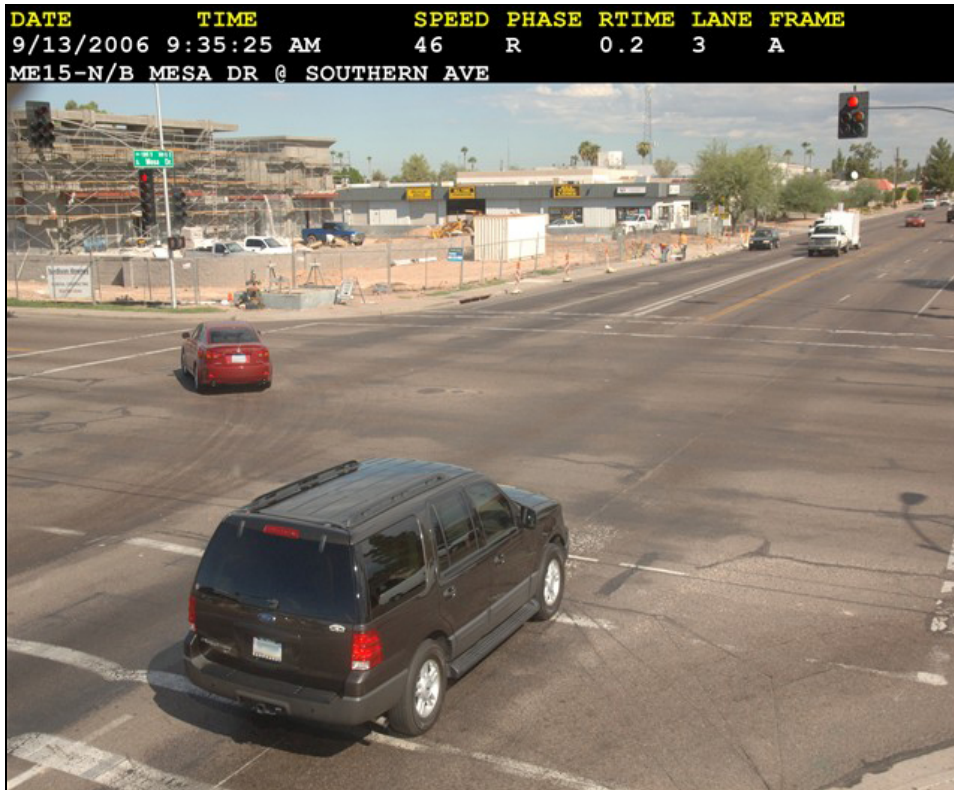
Figure 12. First picture taken by an automated RLR enforcement camera (Mesa, AZ).

Figure 12 shows the sport utility vehicle (SUV) has clearly passed the stop bar and is currently proceeding through the crosswalk. The black bar at the top of the photo displays current information about the picture frame. The date, time, and location are current to the image. The recorded speed is shown at 46 mph, and the current signal phase is "R" or red. RTIME, short for "red time," is shown as 0.2 or two-tenths seconds after the traffic signal had turned red. Also shown is the lane number; this number tells which lane the offending vehicle is in. Typically the lanes are counted from the inside out in one direction if more than one camera is present. Lastly, the frame tells the reader which picture is being shown; for example frame A equals picture 1, while frame B equals picture 2.

When a traffic signal switches to a red phase, the automated enforcement system is activated, and the camera is ready to take a picture. Violating vehicles will cross a trigger mechanism, which could include road tubes, inductive loop sensors, piezoelectric strips (pressure sensors), radar, or lasers. A minimum time period and preset speed limit are built into the trigger mechanism, allowing the system to differentiate between vehicles attempting to make a stop, turn, or run through the intersection. This grace period is typically 3/10 of a second with a typical minimum speed limit of 15-20 mph (34). A second photo of the violating vehicle is taken seconds after the first photo showing the traffic signal color and offending vehicle in the middle of the intersection. In some cases, a third photograph is taken to capture the offending vehicle's license plate. Two pictures taken from the Mesa, Arizona red light automated enforcement system are shown in Figure 12 and Figure 13. These two pictures were originally taken in high resolution color, but were rendered to a lower resolution for the reproduction in this report. The City of Mesa, Arizona uses advanced digital camera systems, which are estimated to have over a 10 mega pixels resolution with zoom capabilities to identify humans in the car and license plate numbers. The magnified pictures are not presented in this report for legal reasons.

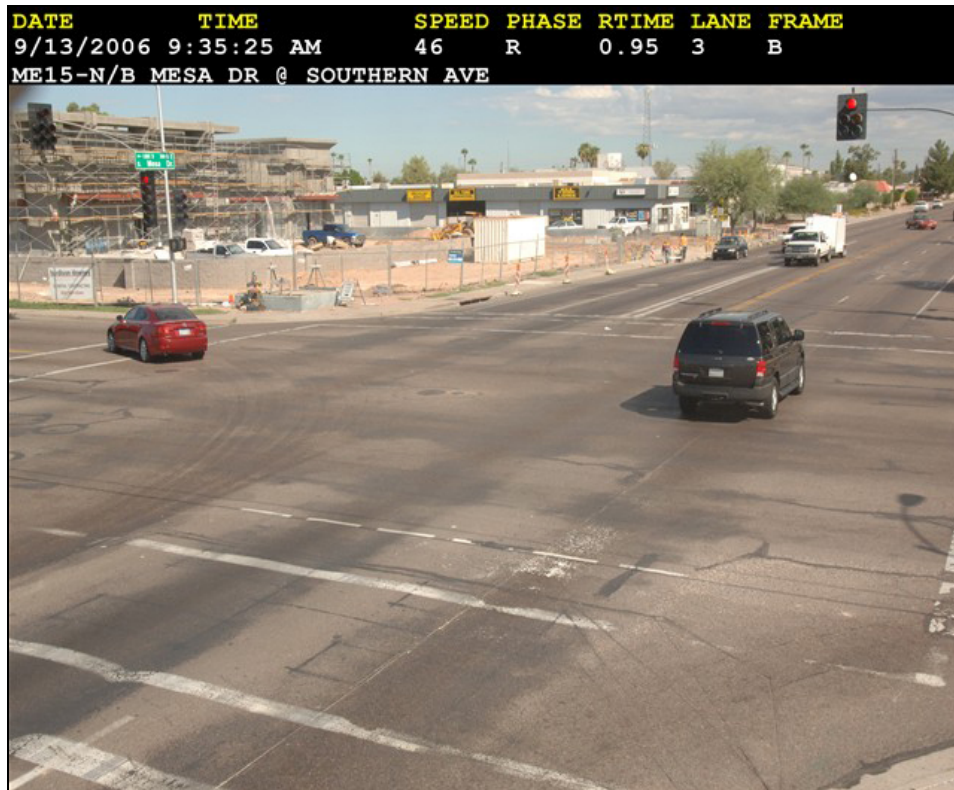
Figure 13. Second picture taken by an automated RLR enforcement camera (Mesa, AZ).

Figure 13 is the second photo taken by the Mesa, Arizona red light enforcement system, showing the SUV clearly inside the intersection. As shown in the photo's black box at the top, much of the information has remained constant except the time and the red time, which is currently at 0.95 seconds. By viewing both Figures 6 and 7, a Mesa, Arizona police officer can conclude that the SUV entered the intersection illegally 0.2 seconds after the traffic signal had turned red.

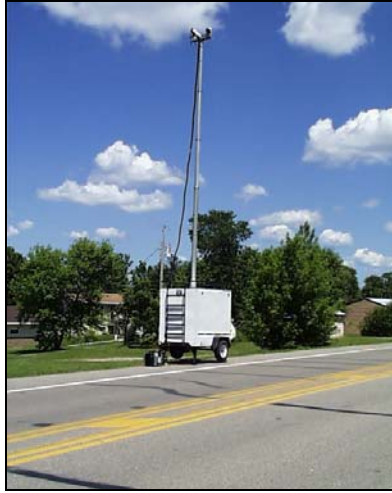
Autoscope technology was first introduced in the early 1970’s by University of Minnesota researchers as proposed video technology to study traffic flow, automatic surveillance, incident management, and signal control (55). Mass production of Autoscope technology started as a joint venture between the University of Minnesota and Econolite Control products in 1984, and advanced software packages were created as a computer overlay program to video taken in the field to evaluate speed, counts, and even operate traffic signal at intersections (55). In a violation study performed by Kamyab and McDonald in 2000, two methods of video recording were tested, including a trailer-mounted Autoscope and a wireless Autoscope system. As shown below in Figure 14, two Autoscope cameras were mounted on a 35 foot pneumatic mast pole and were connected to recording devices located inside the trailer (4j).

Figure 14. Mobile Autoscope trailer (CTRE, Iowa State University).

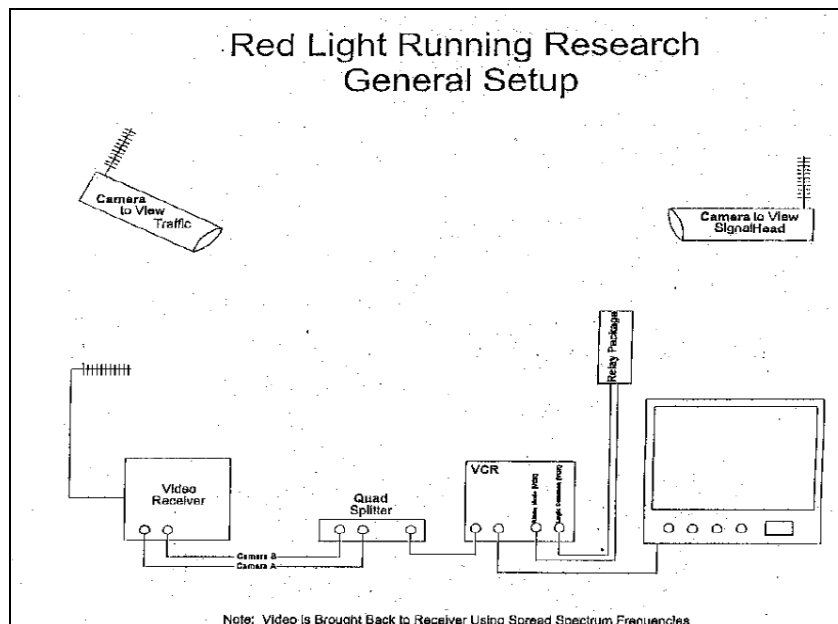
The second method used by Kamyab and McDonald included unattended wireless Autoscoptes that recorded both the traffic signal and approach leg of the intersection. Two cameras were installed at intersections; of interest, one camera monitored the approach traffic signal, and the other camera watched the approaching stop bar from the front. As shown in Figure 15, both cameras used spread spectrum frequencies to transmit video signals to a receiver, and a quad splitter projected both camera images on the same screen. The VCR used in the study was wired to the traffic signal cabinet and started recording when the traffic signal turned yellow, and paused when the green phase started (4j).

Figure 15. Wireless Autoscope system (4j).

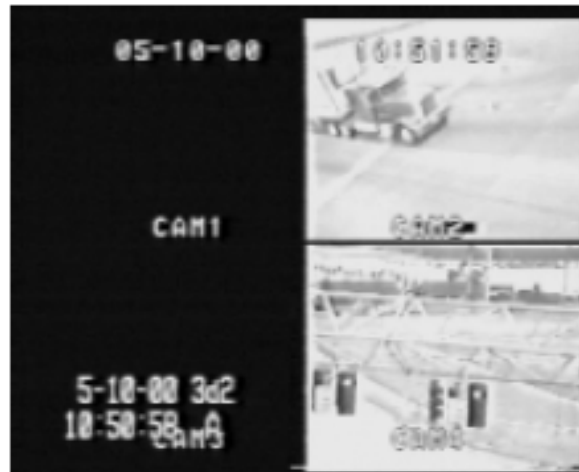
The Direct Monitoring Method is considered the most precise evaluation method available, but can be time-consuming and mistakes can be easily made by the evaluator depending on his or her judgment of a violation (57). Shown below in Figure 16, from the Center for Transportation Research and Education at Iowa State University, a split screen was used to record RLR violations. The top picture shows a truck crossing the stop bar while the traffic signal shown below the picture is red. The research team recorded the time movement of each violation (4j).

Figure 16. Direct monitoring combined camera view (CTRE, Iowa State University).

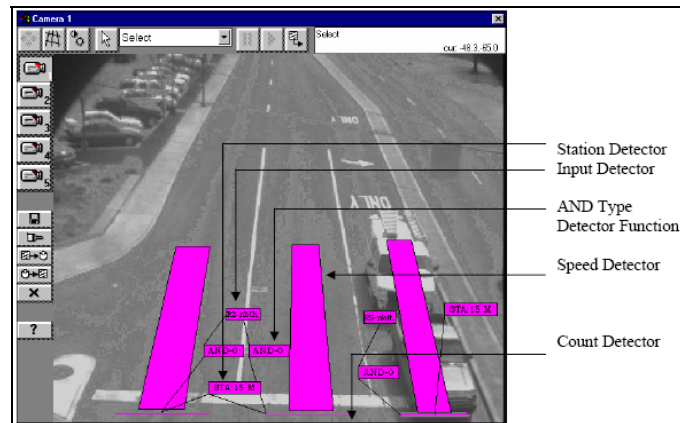
The machine-aided monitoring method’s objective is to reduce the time needed to evaluate an approach with the sacrifice of minimal errors in the evaluation (57). As shown below in Figure 17, Purdue University researchers used Autoscope software to detected RLR vehicles at a single intersection approach while determining entering vehicle counts and approaching vehicle speeds. Tarko et al. concluded that all violations occurred during the first 2 seconds of the red phase. Although this method proved to save considerable time extracting violations, it was determined that the video data needed to be screened a second time to verify that the software captured the violations (57).

Figure 17. RLR Autoscope computer program approach overlay (57).

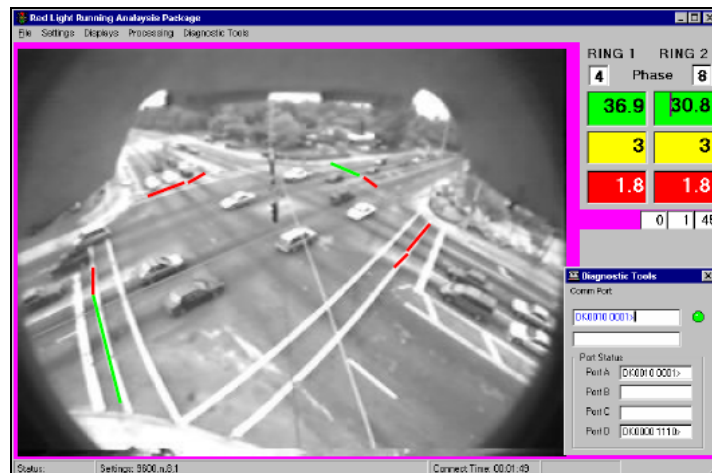
Figure 18. RLRAP monitoring an intersection (58).

In a research project conducted by Washburn and Courage at the University of Florida, a third method to evaluate RLR violators was created. Red Light Running Analysis Package (RLRAP) was developed to enable users to monitor two items simultaneously, vehicles entering the intersection and the current signal status, displayed using colors while only using one video feed of the entire intersection as shown in Figure 18.

Although the RLRAP software package does not include a counting program similar to that used in the Purdue study, the goal of this project was to measure the accuracy of phase timing measurements and the repeatability of those measurements over multiple playbacks of the videotape (58).

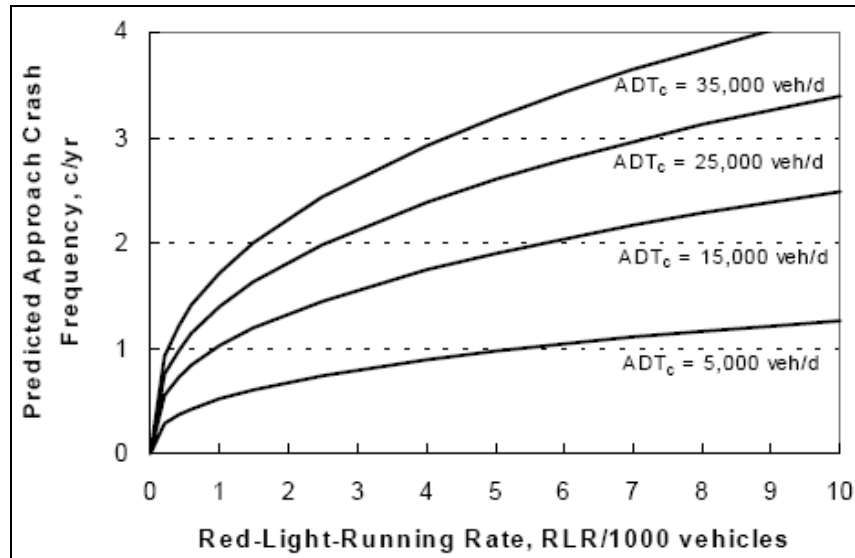
$C_1$  in the above equation is the predicted annual crash frequency rate (crashes per year, right-angle plus left-turn) for a typical intersection approach. The studied intersections approach term (ADT) was not used in the final model calculation because its regression coefficient ( $b_1$ ) was close to zero (2). It was also found that the variable  $b_3$ , which is associated with RLR rate, had a large standard deviation in the model.

Figure 19. Predicted effect of RLR on intersection crash frequency (17).

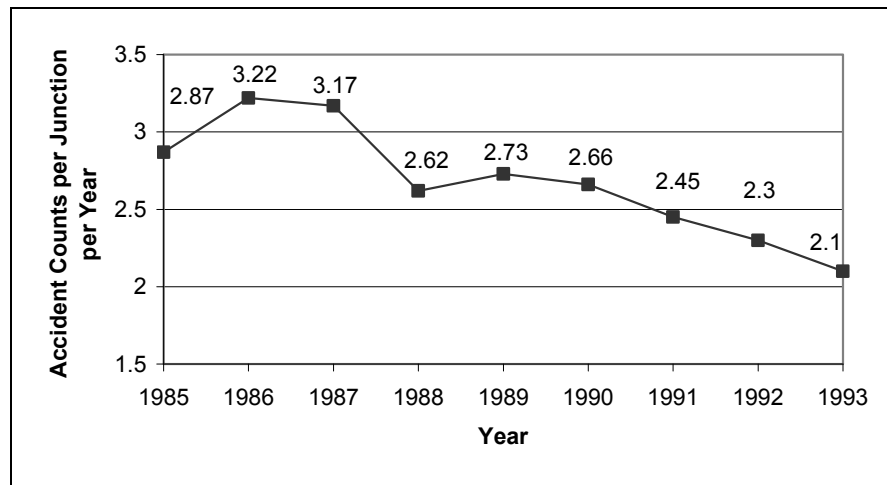
Figure 20. Average annual accident counts at Singapore camera enforced junctions (49, 51h).

One of the most congested cities in the world, Singapore has one of the most extensive RLR camera enforcement programs dating back to 1986. It was reported in 1997 by Ng et al. that one in five intersections was enforced by one to three cameras (51h). Ng et al. conducted two research studies a period, of nine years. The first study was to evaluate and review the crash trends for 125 intersections over the period. The results of this study are shown in Figure 20 (49). As shown, there has been a significant decline in annual accident counts per junction after the installation of the red light camera systems in 1986. Ng et al. also notes in the research report that this decline happened even with a 22 percent vehicle growth rate and generally flat crash trends among the signalized intersections (51h).

Although Ng et al. had a strong case in having control sites, research has shown that Ng et al. did not fully account or adjust for possible regression to the mean, because the comparison intersections had different volumes and were located far away from the intersections with cameras (51h).

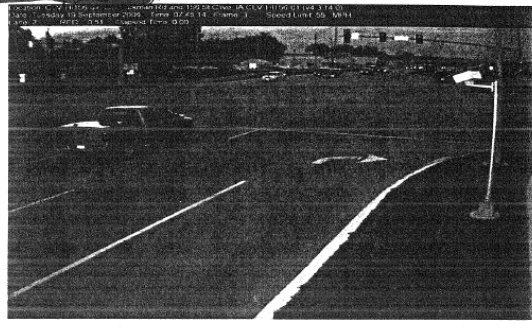
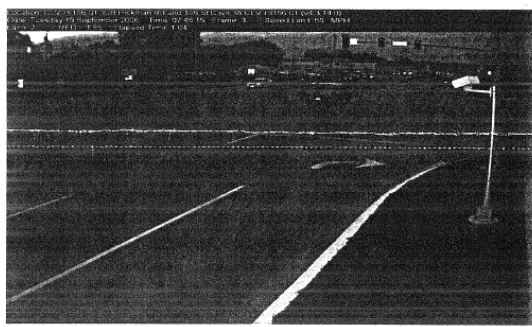
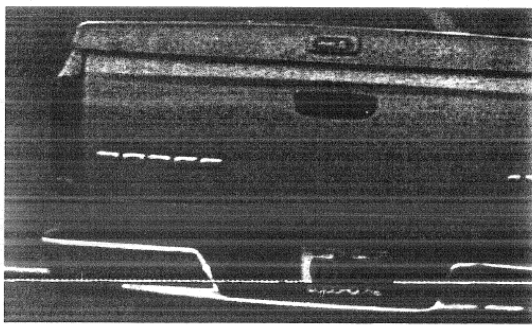
Three images are taken of the potential violator: 1) an image which shows the vehicle behind the stop bar with a red traffic indication shown in the background which indicates that the vehicle crossed into the intersection after the red indication was given, 2) a high resolution image of the license plate, and 3) an image of the vehicle in the intersection (the system uses images 1 and 3 to determine speed and time elapsed since the

vehicle crossed into the intersection). Figure 22 shows how these photos are used in a mailed citation from Redflex. The Clive RLR camera system also incorporates a continuous video system. When a potential violation occurs, the cameras fire a sequence of six seconds of live video which is converted by Redflex to a 12 second video by way of an file unzipping process to accompany the violation images. If a person receiving a ticket wishes to dispute the ticket they are able to go to the Clive Police Department and view the 12 second video and the three official images. The City indicated that in most cases after people view the video it is pretty clear that they ran the red light and they end up not disputing the ticket. The video can also be accessed as evidence. All images are stored on a local system hard drive and are later transmitted to Redflex via a dedicated T1 phone line.

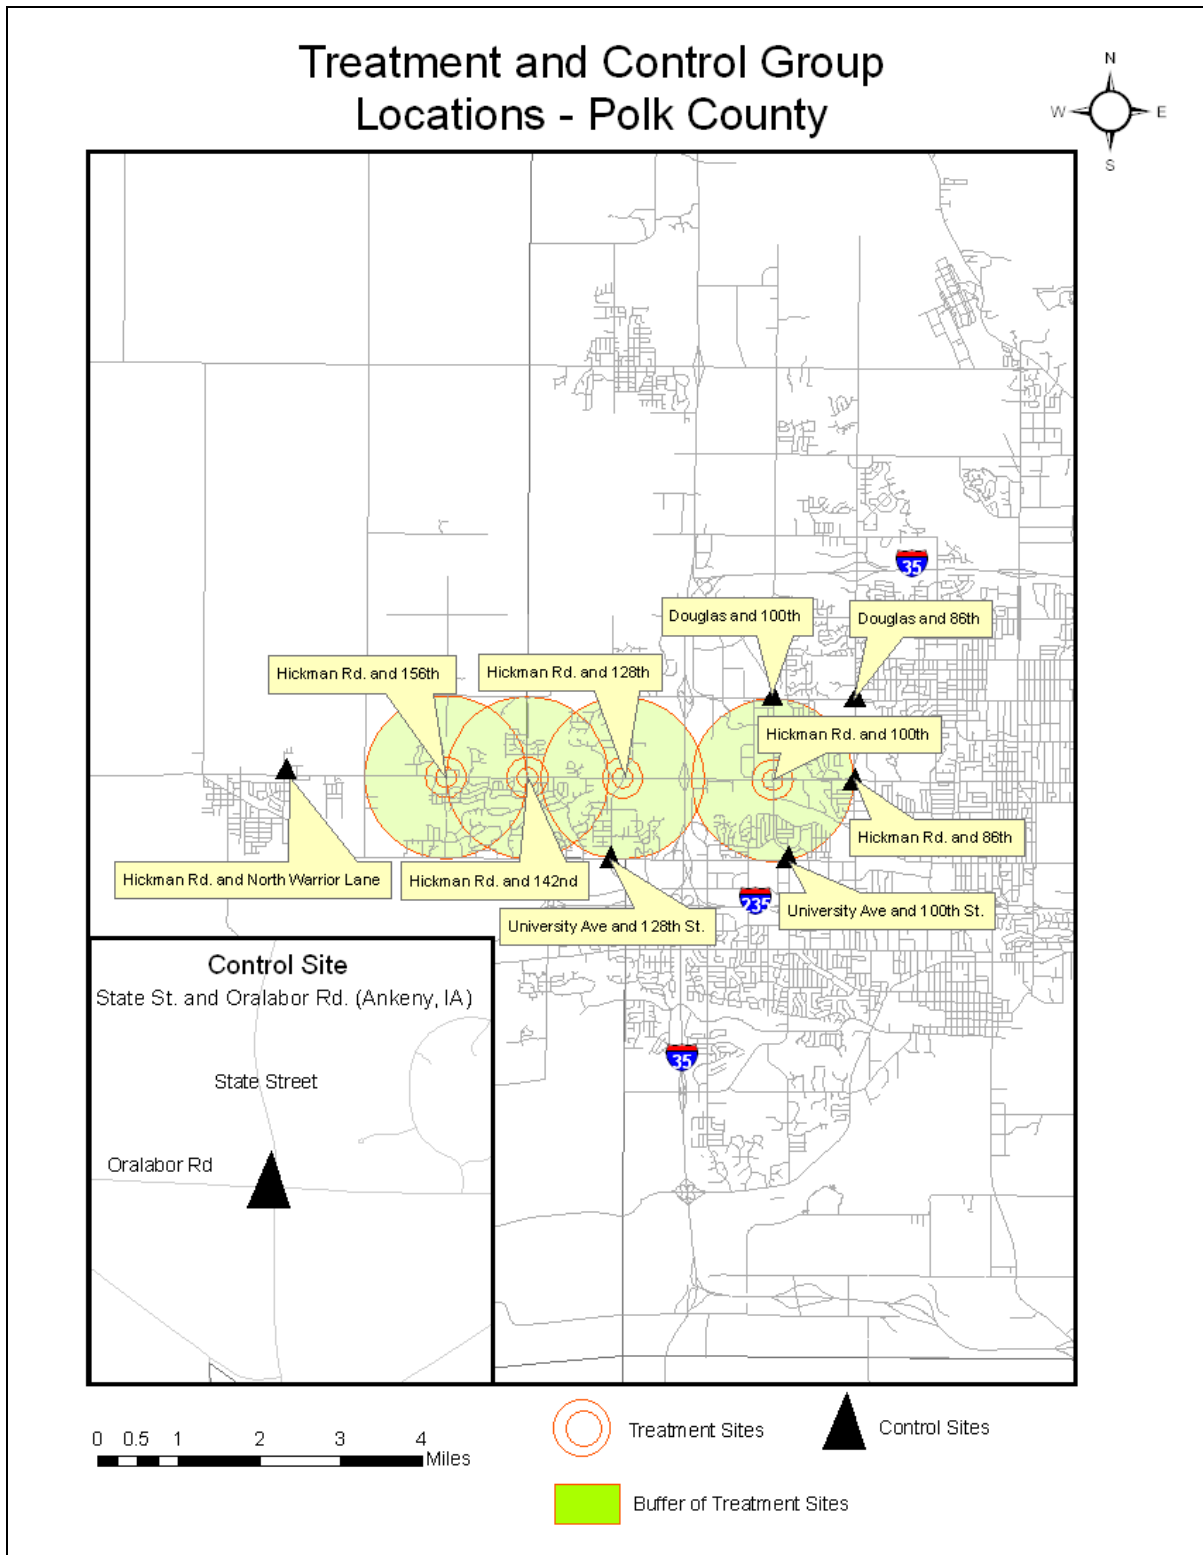
Figure 26. Violation Study Intersections with Buffer Zones.

Details about each of the selected intersections and approaches are shown in the following pages. Approach and aerial images were acquired from local GIS departments and field images were taken during data collection. At each intersection, it was noted what businesses were surrounding the area and if the pedestrian count was high. Other important information collected included peak hour volumes for each turning movement, signal timing for left turning and through movements, and identifying if a lane had a dedicated movement or if it shared a movement (e.g. a through and right turning movement for one lane, this would be specified as “shrd” in the table). The approach speed limit was also recorded as each approach had a different posted speed limit. The last aspect recorded was whether the intersection were actuated, pre-timed, or in coordination with nearby intersections. Actuated means the traffic signal will change for a maximum time if a vehicle is detected by either video or an inductive loop.

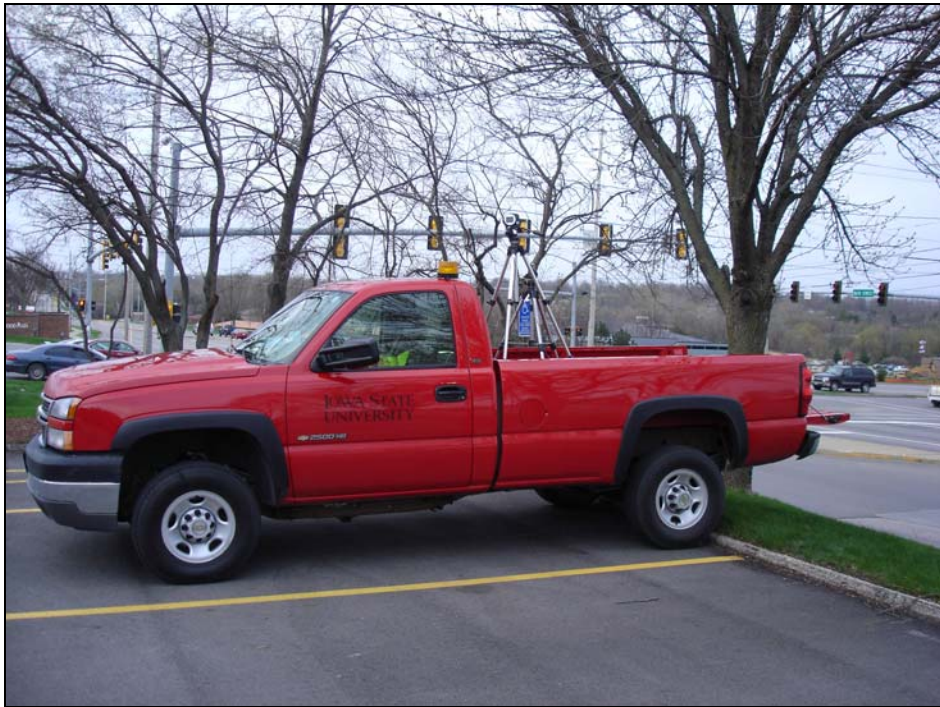
Video was taken using two DVD-R digital cameras mounted on two tripods in the bed of an Iowa State University pickup truck as shown in Figure 45.

*Figure 45. Collecting data at 86th Street and Douglas Avenue.*

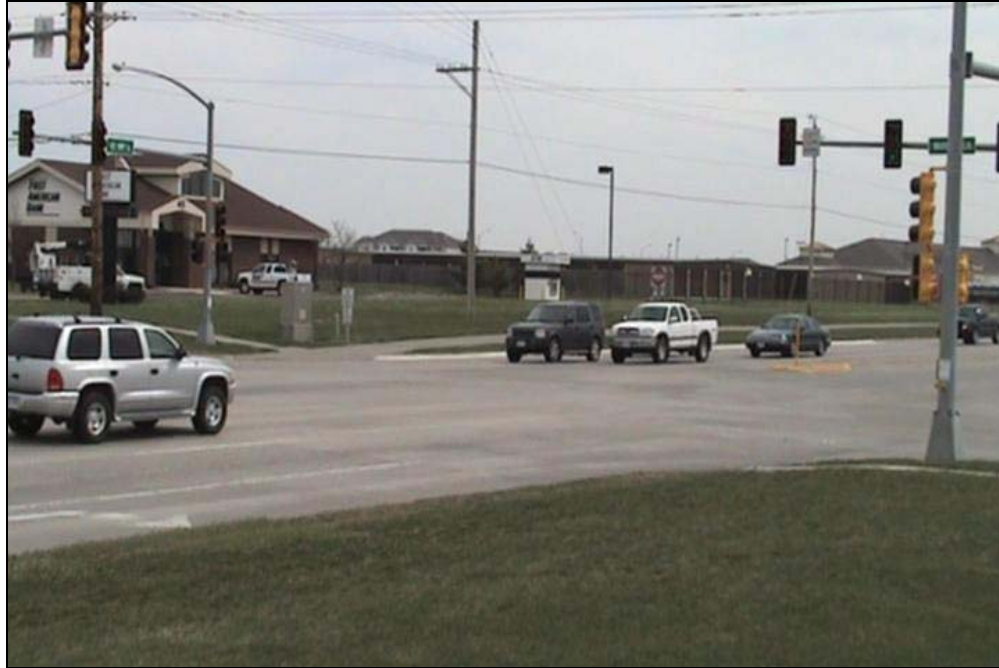
DVDs were viewed using the computer program Power DVD where zoom and frame-by-frame capabilities could be used to determine if a red light running violation occurred. Although the frame-by-frame feature added a more exact way to measure car position in relevance to the yellow and red light, some experimental error was expected. Shown in Figure 46 is a frame of the DVD video of the recorded intersection.

*Figure 46. Captured video of N. Warrior Lane and Hickman Road.*

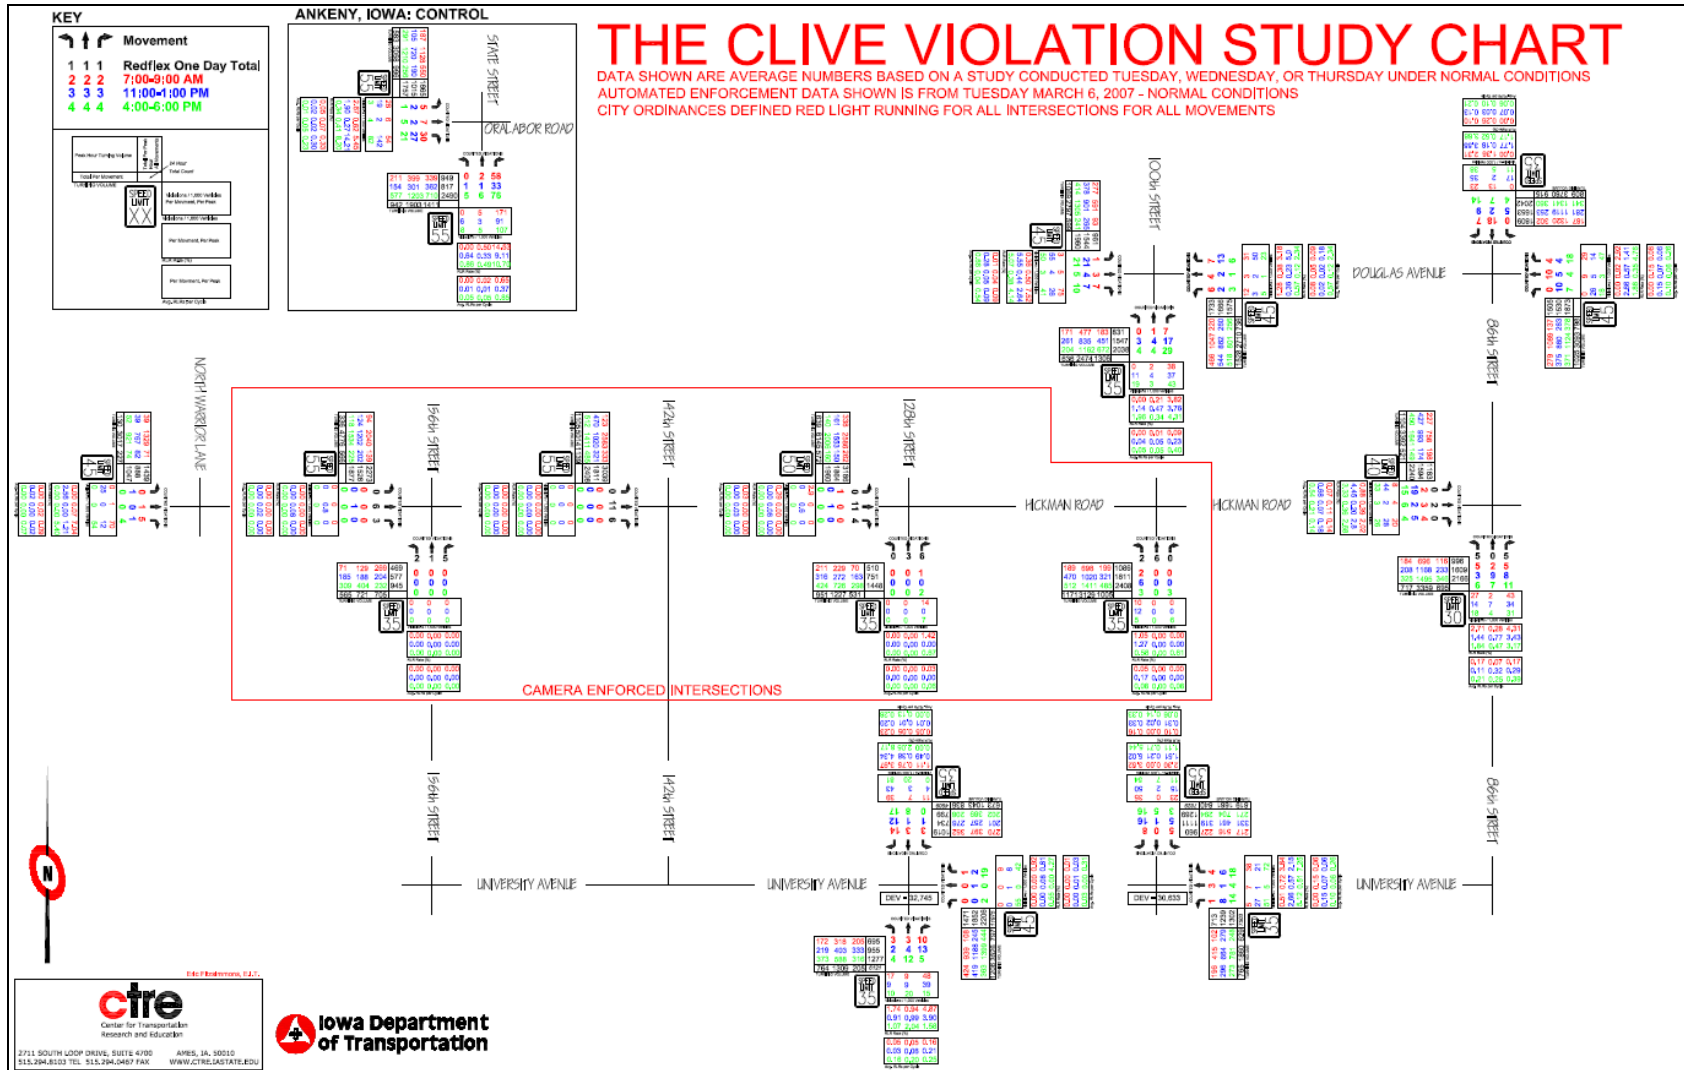
In addition to performing a study looking solely into violations at camera enforced intersections and control intersections, the research team was interested as to what kind of data was behind each violation at the camera enforced intersections. Along with the actual violation count for the entire enforcement period, day of the week data were also obtained from the Clive police records via Redflex as to what day of the week violations occurred the most. A common misconception by many media outlets is that RLR occurs most frequently on the weekends when drivers are away from the office; however, contrary to this theory, RLR studies have concluded that RLR violations occur most frequently during the working days of the week when traffic volumes are higher and schedules are tighter. Using RLR data obtained from the Clive Police Department, TABLE 43 lists the total number of violations for the entire enforcement period per day of the week and the rank of each day depending on this value for all of the intersections in Clive with RLR cameras.

Figure 47. Violation study map and results per intersection.

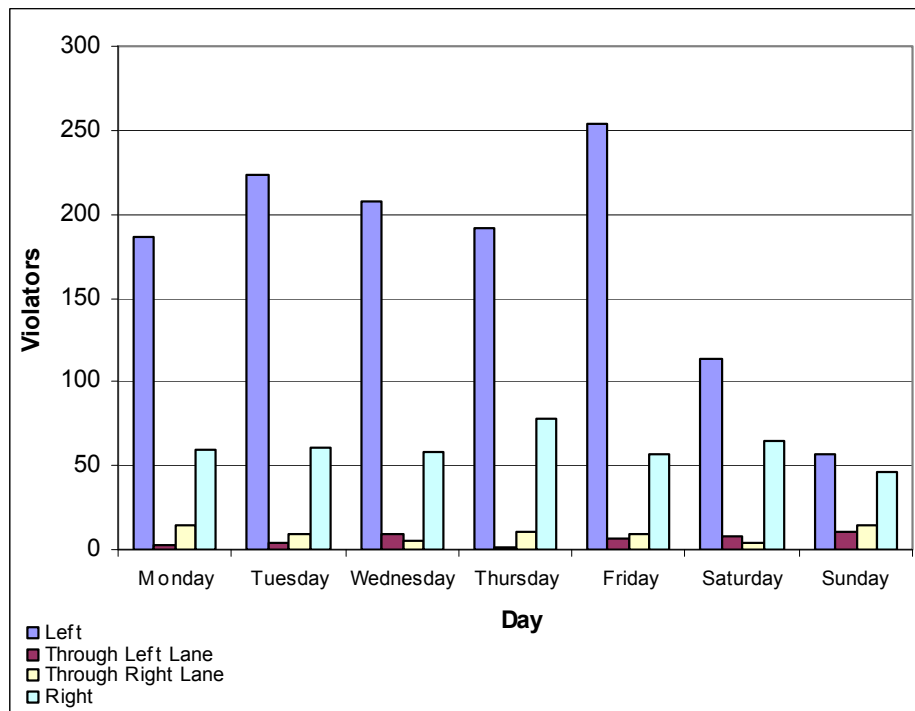
Figure 49 illustrates the number of violators per day of the week for the northbound approach at the intersection of 100<sup>th</sup> Street and Hickman Road. As shown, the left turn movement had the highest number of violators each day of the week with the highest number of violations occurring on Friday. The number of through movement violations stayed consistent throughout the week, the right turning movement had its highest number of violations on Thursday.

Figure 49. Total violations per day of the week at 100th St. northbound and Hickman Rd.

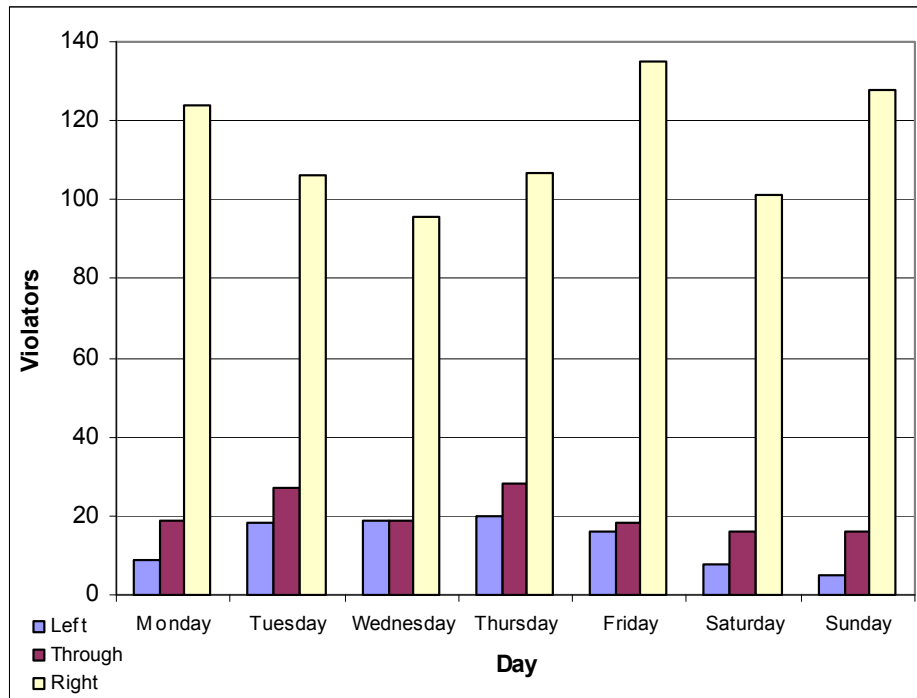
As shown in Figure 50, the northbound approach at the intersection of 128<sup>th</sup> Street and Hickman Road had its highest violation total on Friday. Also, Figure 50 illustrates that the right turning movement had the highest number of violation each day of the week.

Figure 50. Total violations per day of the week per lane at 128th St. northbound and Hickman Rd.

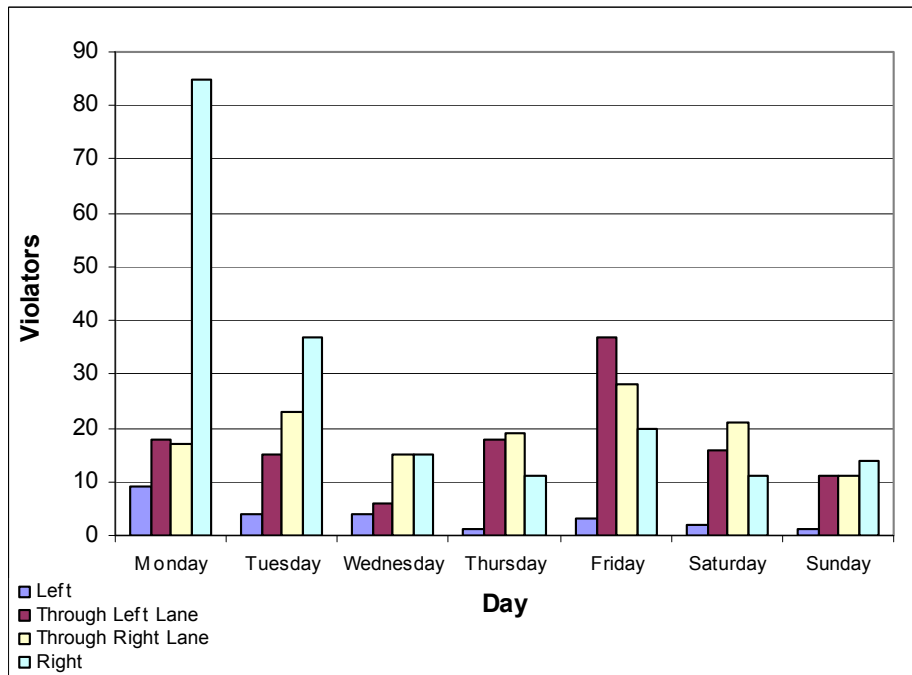
As shown in Figure 54 and listed in TABLE 43, the eastbound approach at the intersection of 156<sup>th</sup> Street and Hickman Road had the highest total number of violations on Monday, as the right turning movement on Monday was extremely high compared to the through and left turning movements for the entire week. The through movement had the highest number of violations on Friday, while the left turning movement had its highest number of violators on Monday.

Figure 54. Total violations per day of the week per lane at 156th St. eastbound and Hickman Rd.

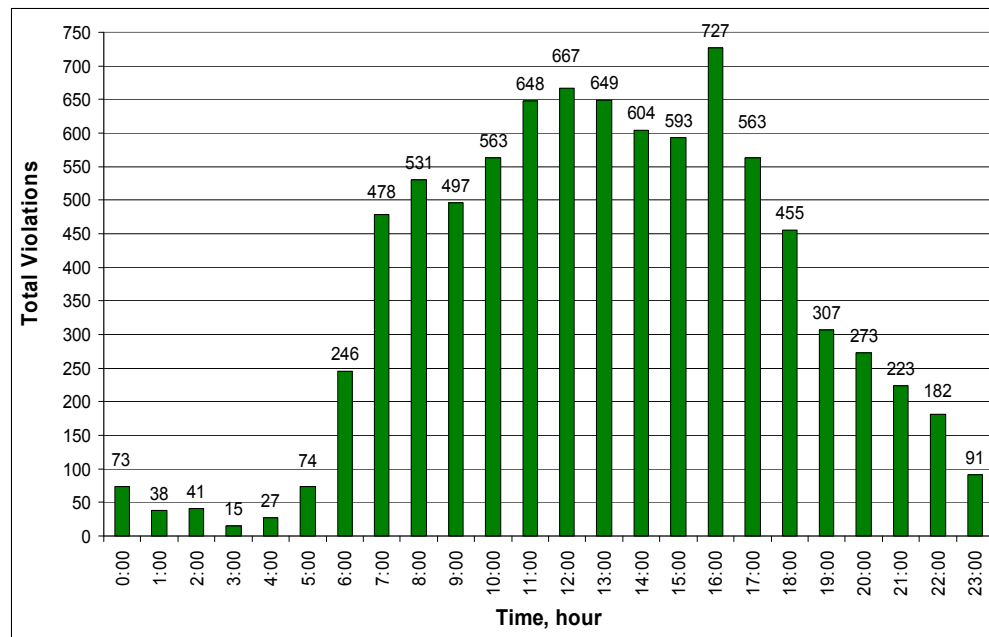
congestion (13). Using the collected data from each camera enforced approach in Clive, the total number of violations per movement was summed and plotted for each hour of the day, and is illustrated in Figure 55.

Figure 55. Total RLR violations in Clive by hour of the day, all intersections combined.

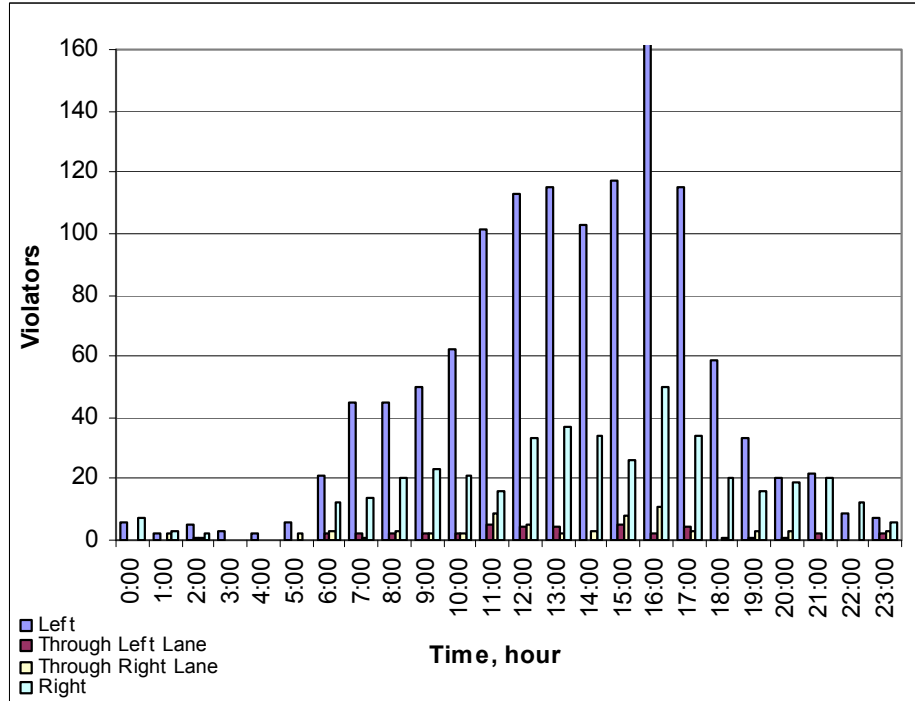
Figure 57 illustrates the total number of violations per hour of day for each northbound movement at 100<sup>th</sup> Street and Hickman Road. As shown, the left lane had the highest number of violations from 6:00 AM to 9:00 PM. Due to surrounding businesses and location of this camera, it is believed that most of the vehicles running the left turn were either commercial vehicles or private vehicles heading towards Interstate 80, located west (left turning movement) of 100<sup>th</sup> Street and Hickman Road. The right turning movement had the second highest number of violators and its trend follows closely that of the left turning movement at a lower number of total violations.

Figure 57. Total violations at northbound 100th Street and Hickman Road over a 24 hour period.

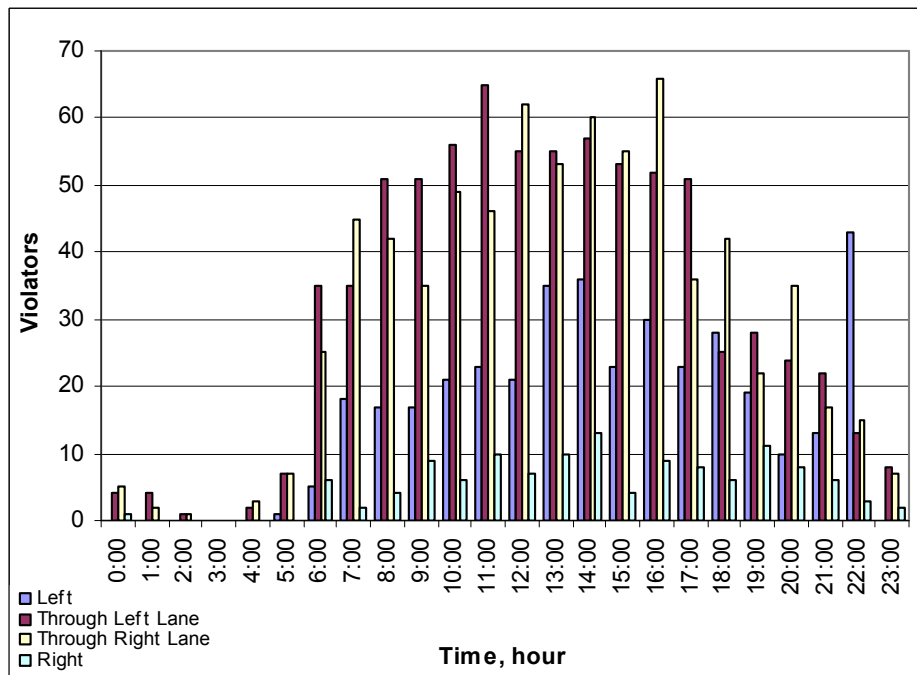
Figure 59. Total violations at eastbound 128th Street and Hickman Road over a 24 hour period.

Figure 59 illustrates the total number of violations per hour of day for each eastbound movement at 128<sup>th</sup> Street and Hickman Road. As shown, the majority of the RLR violations happened between 6:00 AM and 11:00 PM, with both through movements having the highest number of violations. Also shown, the left turning movement had an unusually high number of violations at 10:00 to 11:00 PM compared to the trend of all other movements.

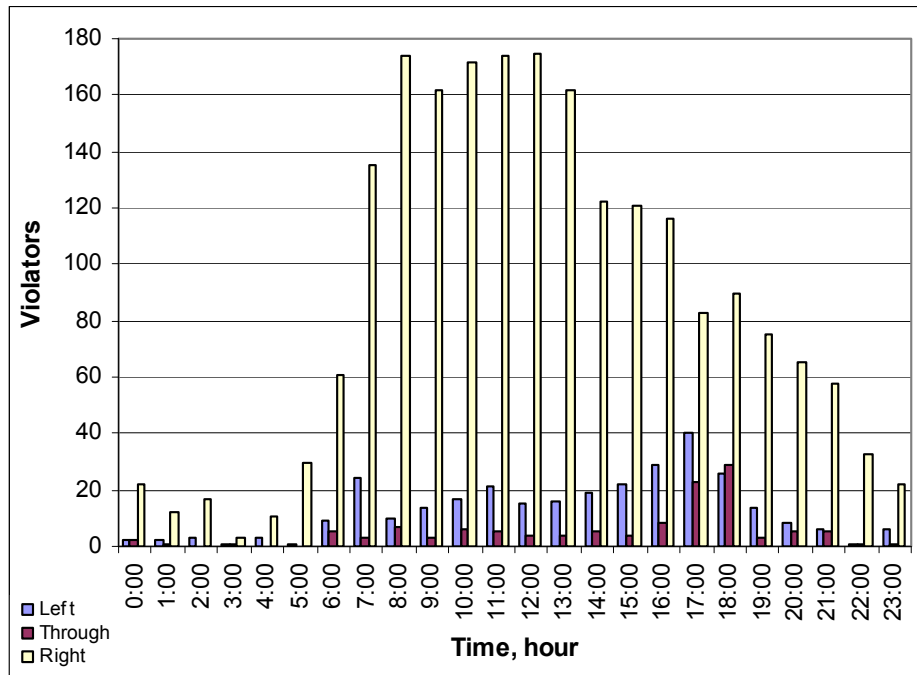
Figure 61 illustrates the total number of violations per hour of day for each northbound movement at 156<sup>th</sup> Street and Hickman Road. As shown, the right turning movements had the highest number of violators over all of the 24 hours, but were especially high between 8:00 AM and 1:00 PM. One possible reason for this might be the Dahl’s grocery store that has an access point on northbound 156<sup>th</sup> Street, and these times might correlate to when people go to the grocery store. Also shown, left and through movements had a gradual increase in RLR during the hours of 12:00 PM through 6:00 PM, likely due to commuters running a red light on their way home from work.

Figure 61. Total violations at northbound 156th Street and Hickman Road over a 24 hour period.
