# The effectiveness of Iowa's automated red light running enforcement programs

A thesis submitted to the graduate faculty  
in partial fulfillment of the requirements for the degree of  
MASTER OF SCIENCE

Major: Civil Engineering (Transportation Engineering)

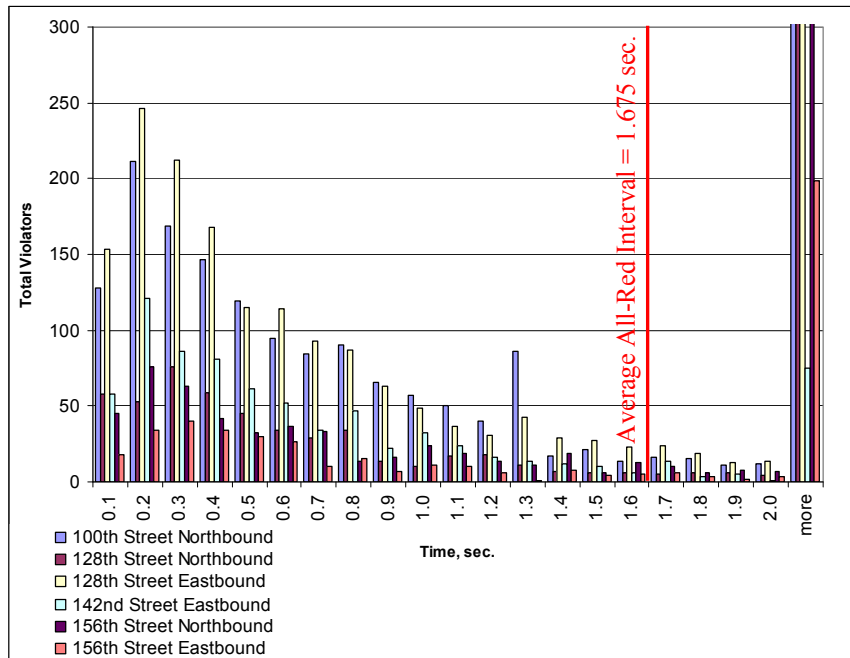
Although many violators ran the red light during the 1.675 average all-red phases, a majority of the RLR occurred after 2.1+ seconds on the red phase as shown in Figure 63. The highest number of 2.1+ second violators occurred at northbound 156<sup>th</sup> Street with over 1900 violations happening at 2.1+ seconds. To explore the reason behind why drivers might enter the intersection so late in the red phase, each movement for each intersection was studied in order to find an explanation or movement that contributed to when the driver entered the intersection. Figure 64 through Figure 69 present the times for each lane of the enforced approaches in Clive. As illustrated in Figure 64, the left and right turning movements had the highest number of violators for all of the measured times after the onset of the all-red phase at the intersection of 100<sup>th</sup> Street and Hickman Road. This intersection had the longest all-red clearance interval of Clive's camera enforced intersections. It was also found that this approach had the second highest number of violators between 0.1 and 2.0 seconds, but just the fourth highest number of violators that entered the intersection after 2.1+ seconds. Figure 65 and Figure 66 illustrate the RLR severity at the intersection of 128<sup>th</sup> Street and Hickman Road

Figure 63. RLR severity Totals at all camera enforced intersections.

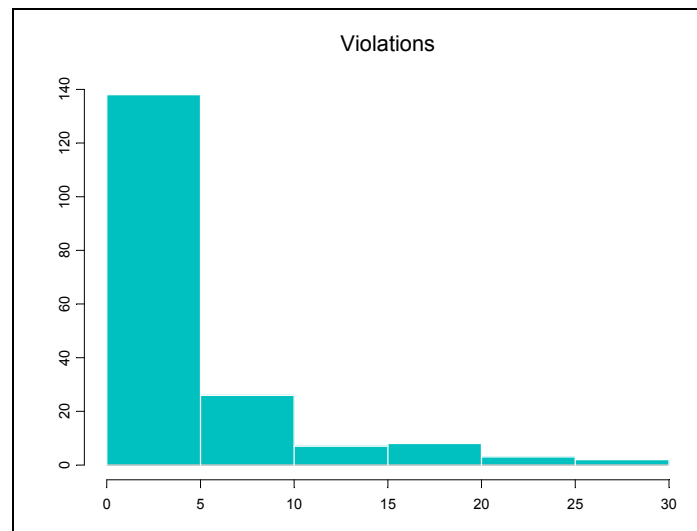
Figure 70. Histogram of the number of violations.

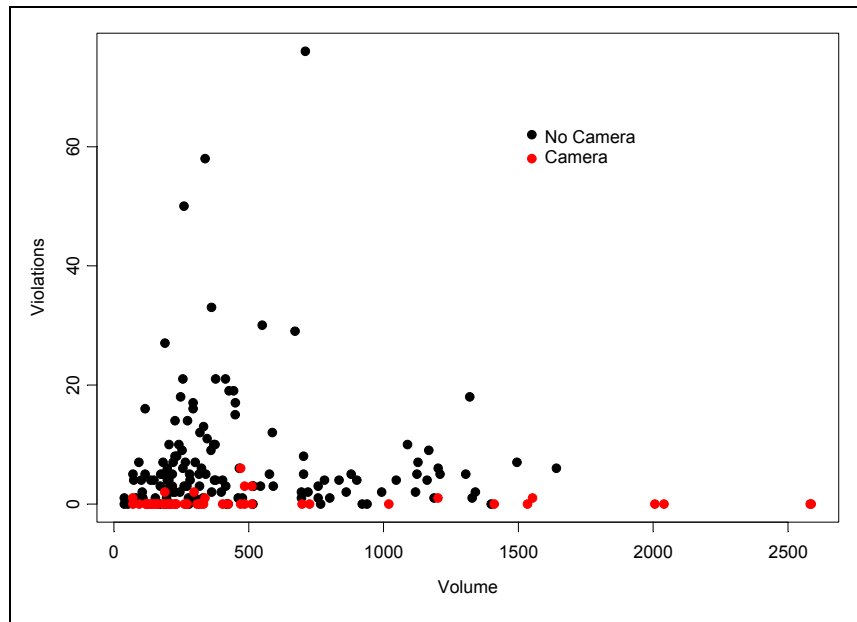
Figure 71. Scatter plot of sites with camera or no cameras vs. site traffic volume.

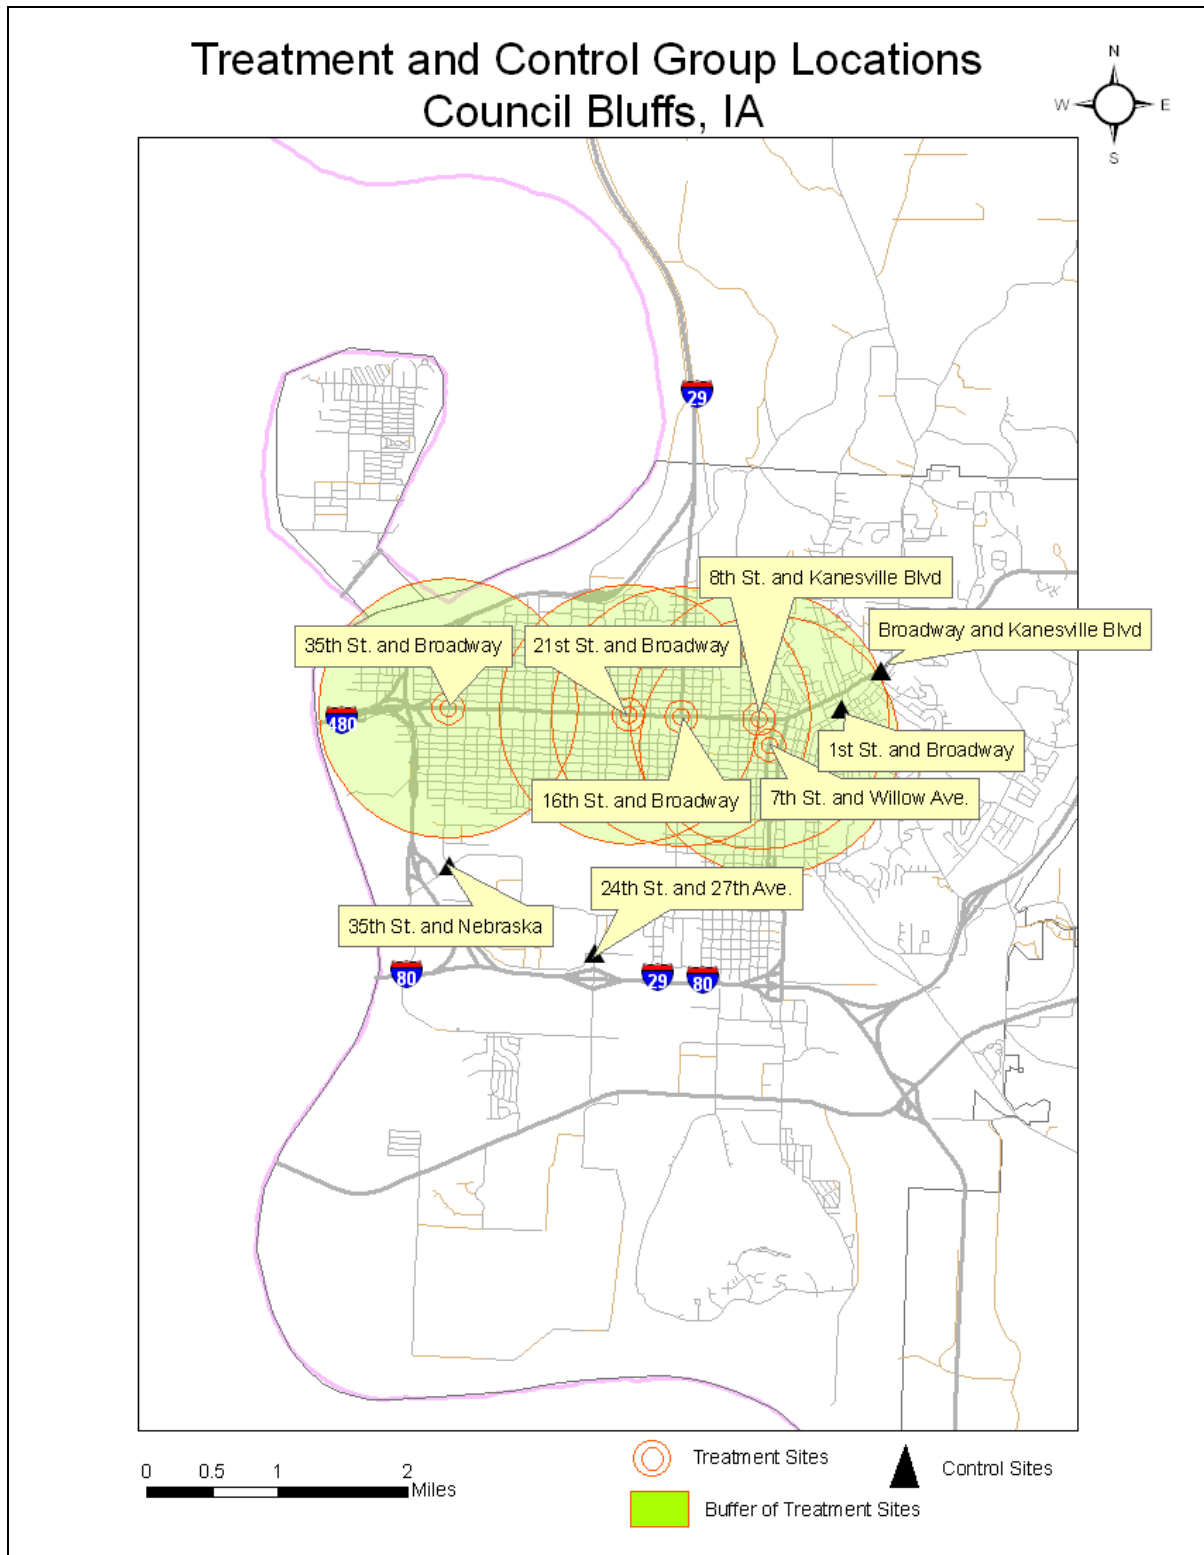
Figure 72. Location of Camera enforced and control intersections in Council Bluffs.

These intersections, along with the control intersections listed below are illustrated in Figure 72. Similar to Clive, it was assumed that the camera enforced intersections would have an affect on driving behavior within 1 mile of the enforced intersection. The control intersections selected for this study include the following.

As shown in Figure 72, two of these intersections lie within the 1 mile buffer zone of the camera enforced intersection and two lie outside of this zone.

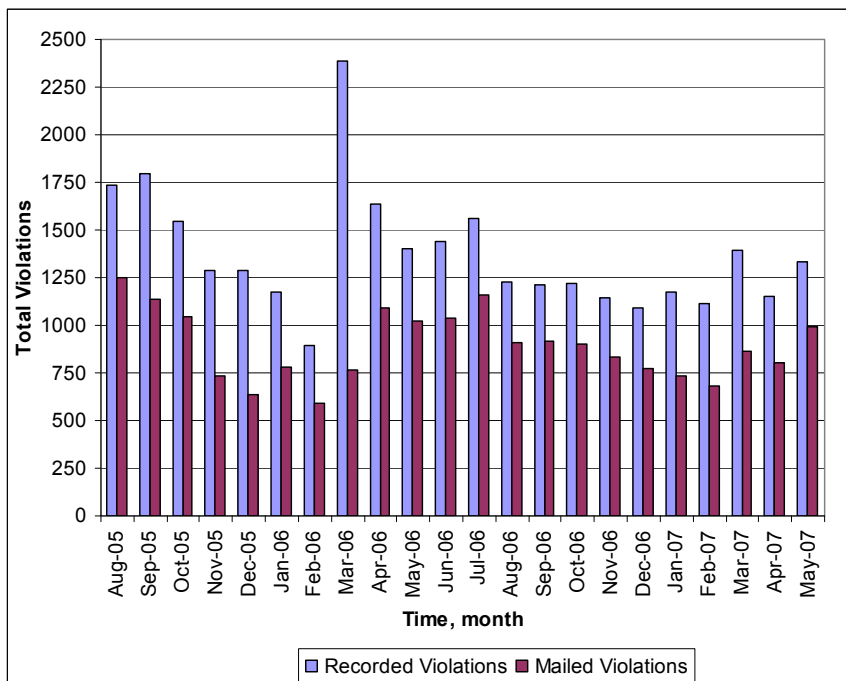
Figure 82. Monthly total violations versus mailed violations.

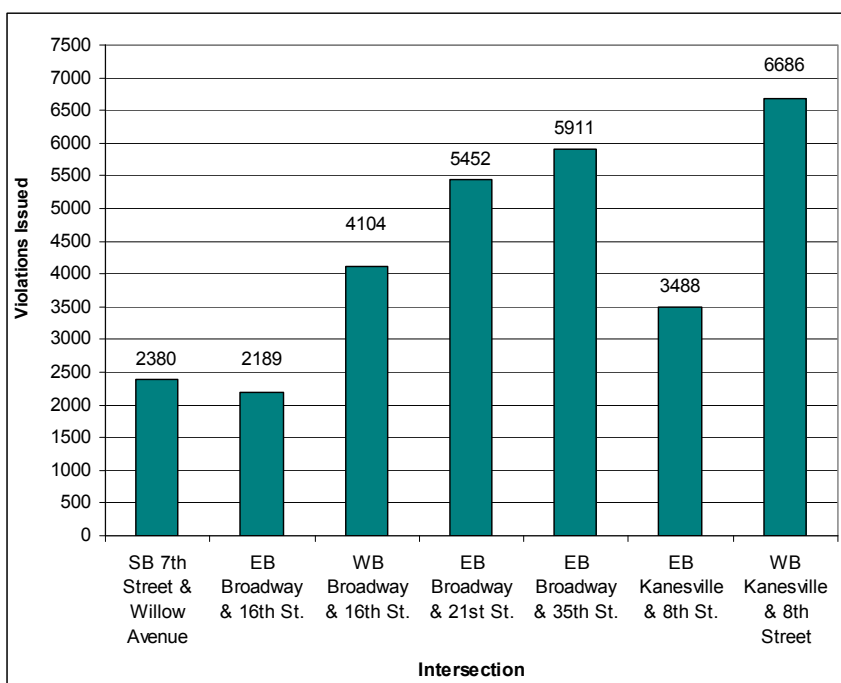
Figure 83. Total violations per enforced intersection between August 2005 and May 2007.

From the monthly violation data collected from the City of Council Bluffs, the total number of issued violations per intersection between the months of August 2005 and May 2007 were graphed and are shown in Figure 83.

As shown in Figure 83, the westbound approach of Kanesville Blvd. and 8<sup>th</sup> Street had the most violations while on the other hand, the eastbound approach of the same intersection had almost half the number of issued citations. From the results shown in Figure 83, the most violations were at intersections on the east and west ends of the Broadway corridor while intersections located between the two had moderate to lower number of violations. Using RLR data obtained from the City of Council Bluffs, the team investigated the average percentage decrease in overall violations, monthly data from each intersection approach with a RLR camera system was plotted and linear equation and trend line was found using Excel and the results are presented in Figure 84 through Figure 88.

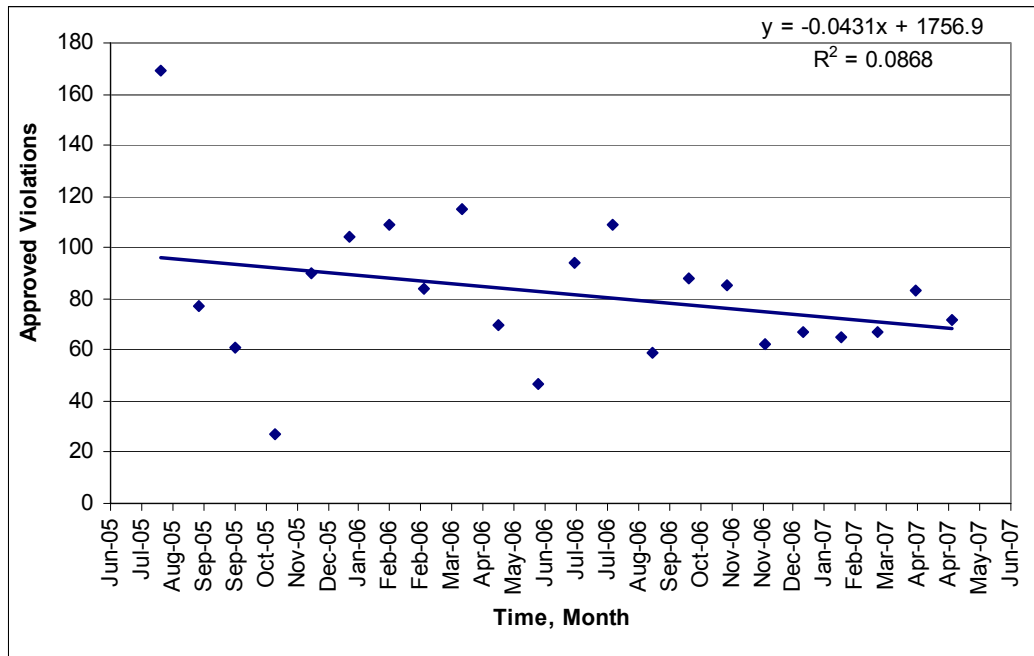
Figure 84. Linear regression of violations for 7th St. & Willow Ave.

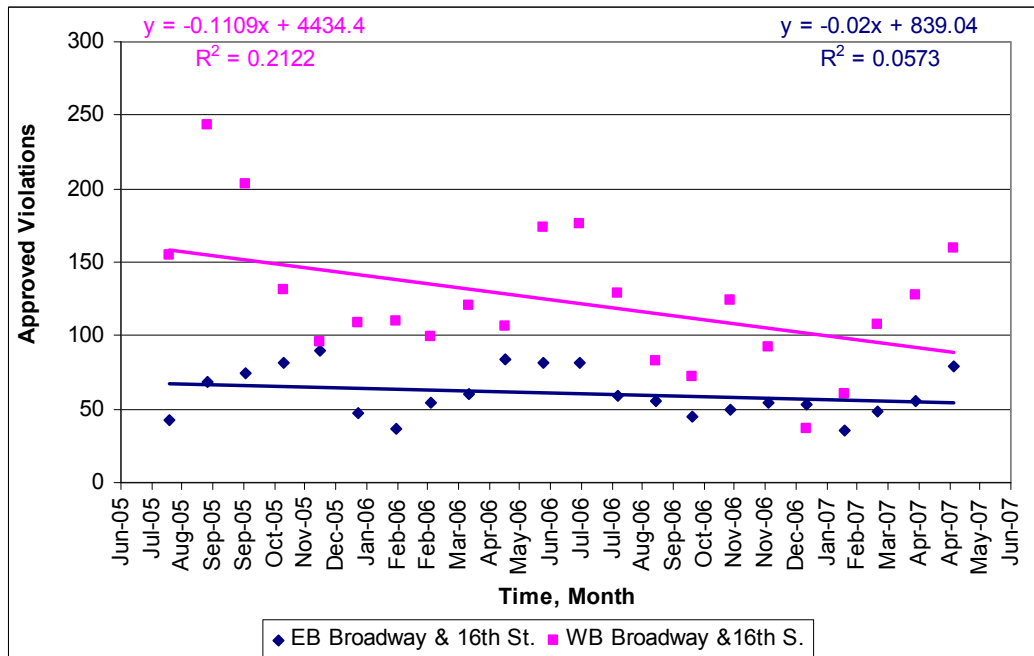
Figure 85. Linear regression of violations for Broadway & 16th St.

Figure 85 has the linear regressions for both westbound and eastbound approaches of Broadway and 16<sup>th</sup> Street. As shown, both directions have seen a decrease in the overall number of violations per month with the westbound approach having an average decrease of -11.09% and the eastbound approach had an average decrease of 2.0%.

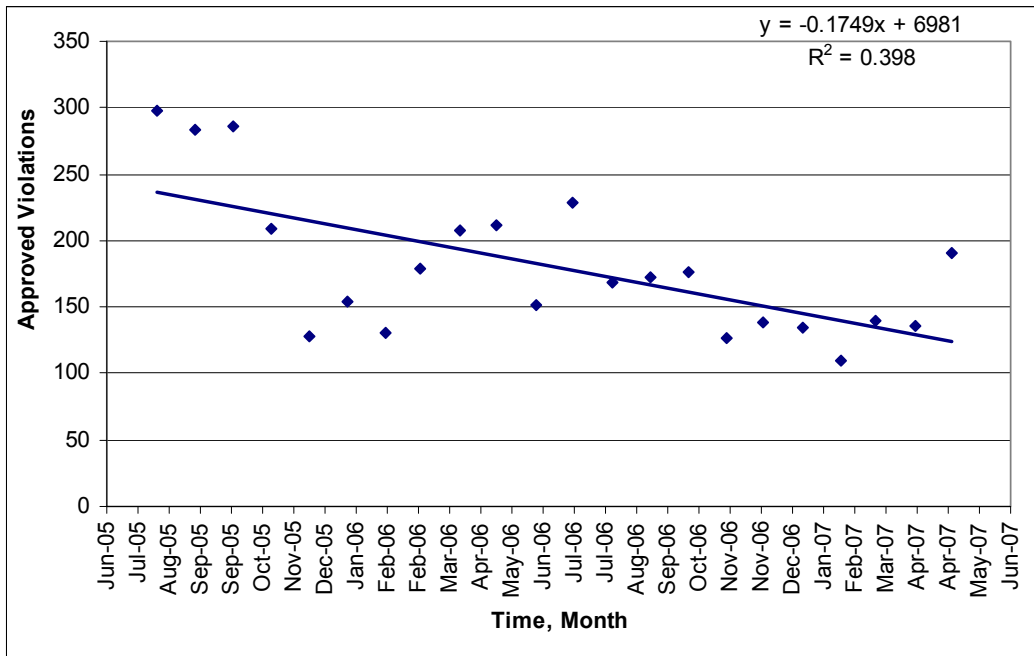
Figure 86. Linear regression of violations for Broadway & 21st St.

As shown in Figure 86, the eastbound approach of Broadway and 21<sup>st</sup> Street has seen the greatest overall average decrease of -17.49% over the entire enforcement period.

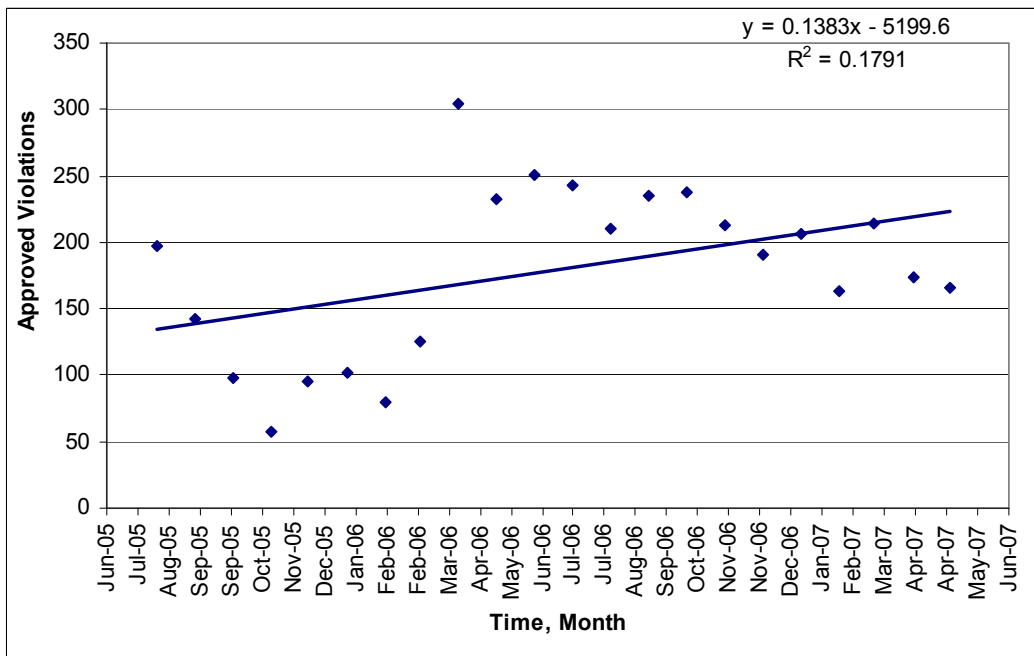
Figure 87. Linear regression of violations for Broadway & 35th St.

The only intersection that currently shows an increase in the average number of violations is the eastbound approach of Broadway and 35<sup>th</sup> Street which has a percentage increase of +13.83% and is shown in Figure 87. This intersection also has the second highest number of overall RLR violations.

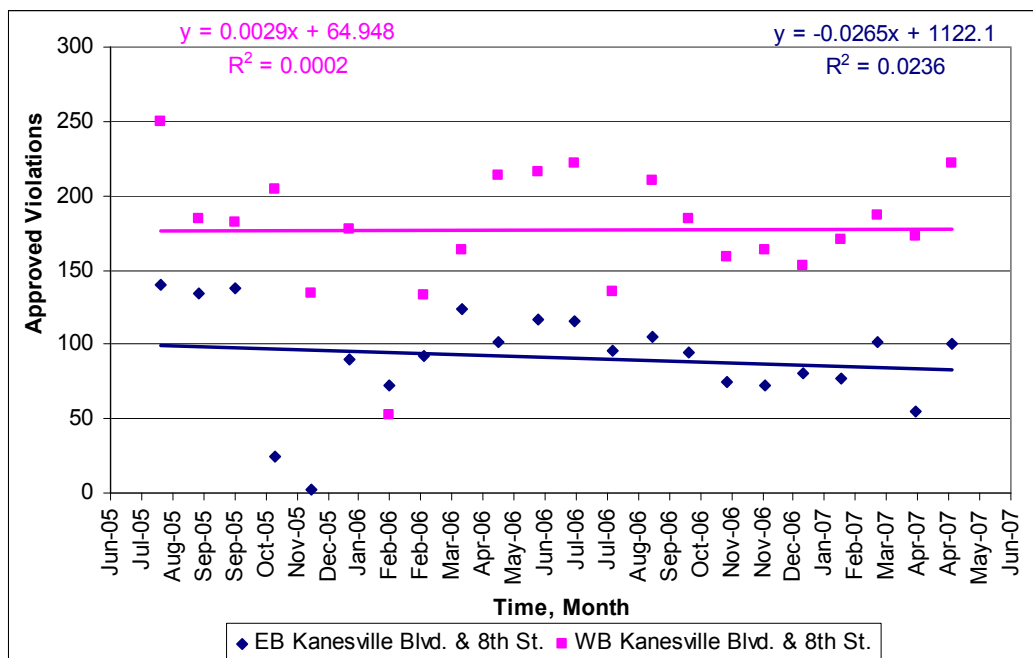
Figure 88. Linear regression of violations for Kanesville Blvd. & 8th St.

Figure 88 shows the linear regression for both the eastbound and westbound approaches for the intersection of Kanesville Blvd. and 8<sup>th</sup> Street. The westbound approach of this intersection has the highest number of RLR violations in Council Bluffs due to either drivers entering Council Bluffs from Omaha or interstate drivers who have exited the interstate. The eastbound approach is the fifth highest approach out of seven approaches with RLR violators.

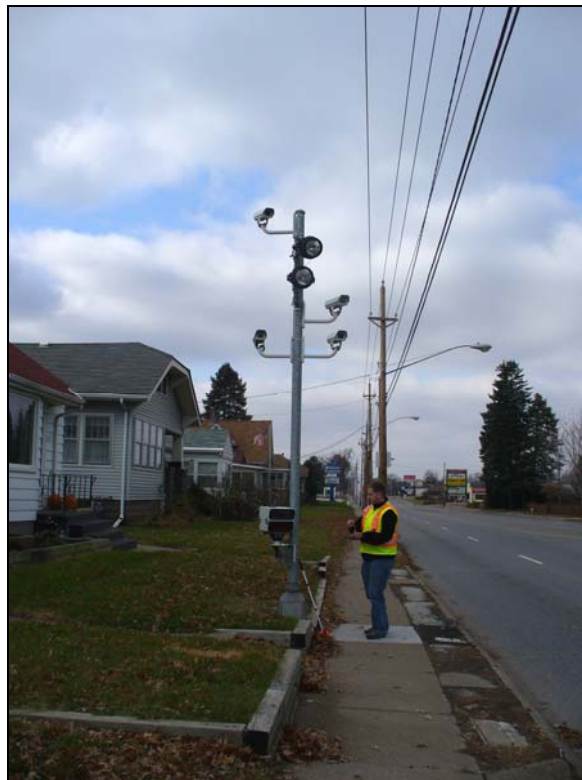
Figure 89. Davenport RLR and Automated Speed Camera System.

Unlike the camera systems in Council Bluffs and Clive, individual lanes are monitored by a single video camera and flash as shown in Figure 89. Advance warning signs with orange flags alert approaching vehicles of automated enforcement. Video is constantly dumped by the computer system until a violating vehicle's speed is detected by inductive loops (or the video detection system) triggering the video capturing sequence. There is no grace time built into the system and no approaching vehicle threshold speed to give the benefit of doubt to the driver. Short videos that are captured are transmitted to Transol in Arizona via a dedicated T1 phone line and are processed and filtered before sending images back to the Davenport Police Department for approval. Once a police officer has reviewed the video and license plate photo, approved violations are sent back to Transol and mailed to the owner of the vehicle. Unlike Clive, Davenport does not have a driver nomination ordinance to ticket the drivers of the registered vehicle.

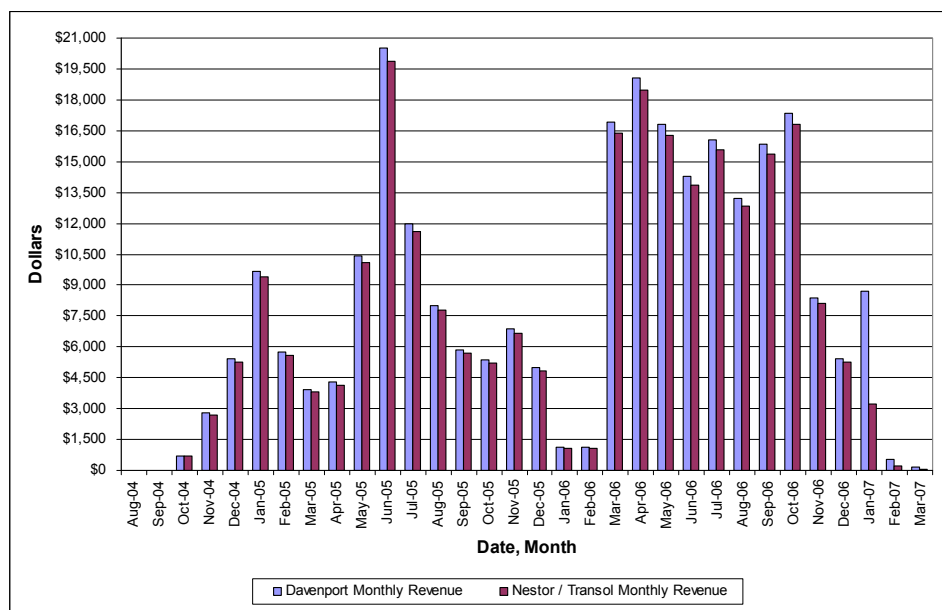
Figure 90. Total monthly revenue split between Davenport and Nestor each month of RLR enforcement.

The City of Davenport views automated enforcement as a balancing act between public acceptance and safety. The police department had hoped that revenue generated from the automated RLR and speed enforcement camera systems could benefit Davenport's citizens by creating such programs as alcohol safety, a juvenile crime unit, neighborhood enforcement, and possibly hiring more police officers. Since the beginning of the RLR enforcement program in 2004, the City of Davenport has collect over \$260,000 in paid citations to help public safety in Davenport. Shown in Figure 90 is the revenue collected by Nestor / Transol and the City of Davenport which showed almost a 50 / 50 split with revenue.

As illustrated, revenue took a sudden decline between the months January 2006 through February 2006 when the enforcement program changed companies from Transol to Nestor.

On September 1, 2005, the City of Davenport signed a memorandum of understanding with Nestor Traffic Systems, Inc. of Providence, Rhode Island, which took over Transol's RLR operations. Prior to this time, Nestor already had a contract with Davenport similar to Redflex to use automated LIDAR technology speed enforcement at the intersections with red light running cameras. The memorandum of understanding signed by city officials with Nestor included the same terms of agreement made with Transol. With a new contract in place, the fee to Nestor changed from the original \$32 to \$24 per violation, with the city receiving \$41 per violation. Between the January and February 2006, Nestor switch the system over which resulted in minimal violation capturing this can clearly be seen in Figure 90.

Also, the automated enforcement program went on hiatus in between February and March due to contract reorganization which resulted in minimal revenue.

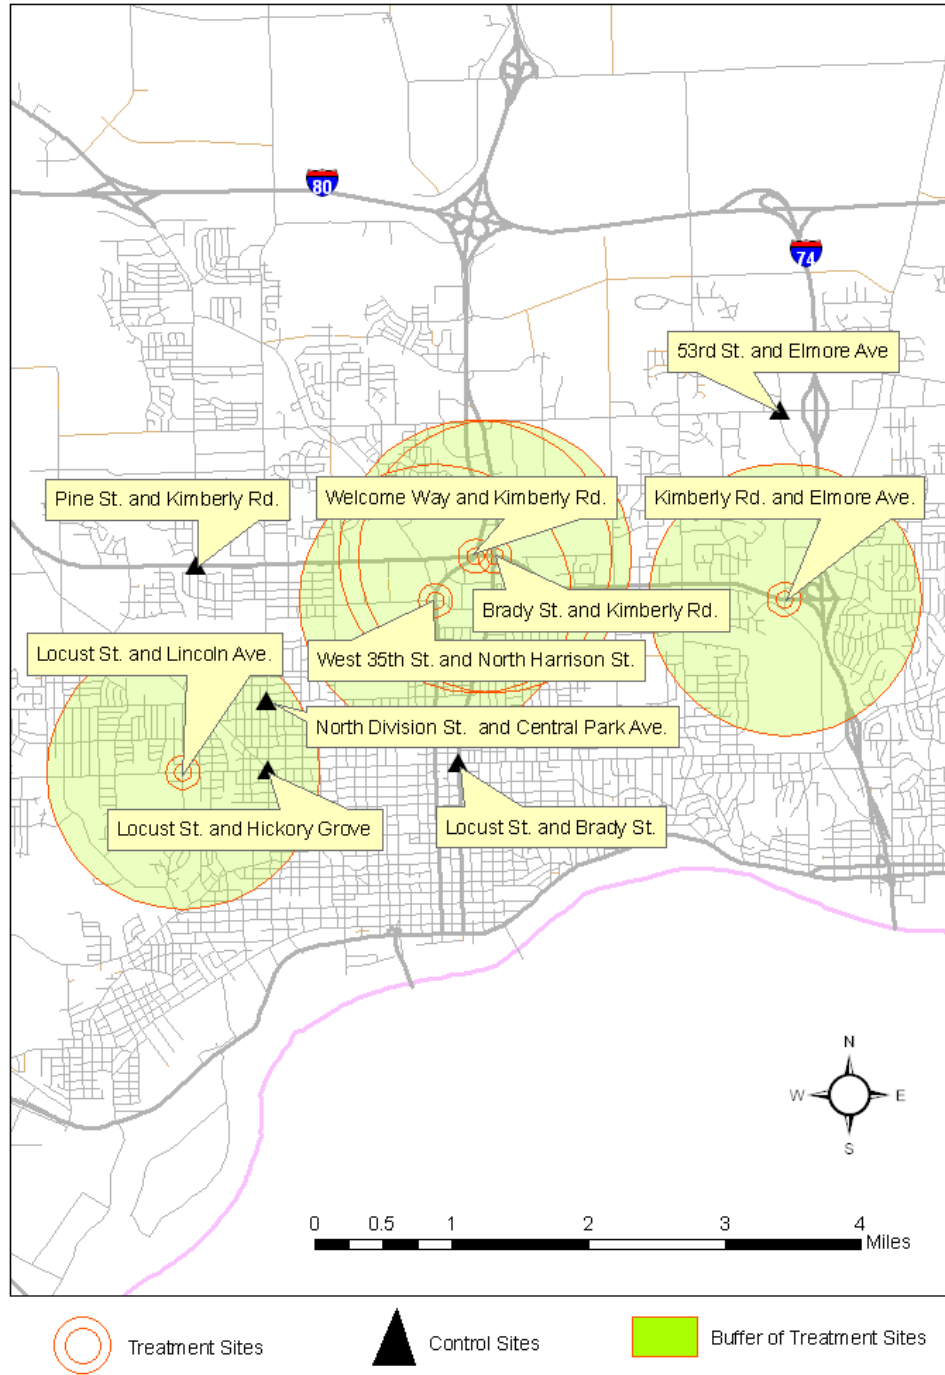
Figure 91. Camera enforced and control intersections in Davenport.

Shown in Figure 91 are the location of the camera enforced intersections and the selected control intersections. Similarly to Clive and Council Bluffs, it was assumed that driver behavior would change within the 1 mile radius buffer zone. The intersections selected as control intersections include the following.

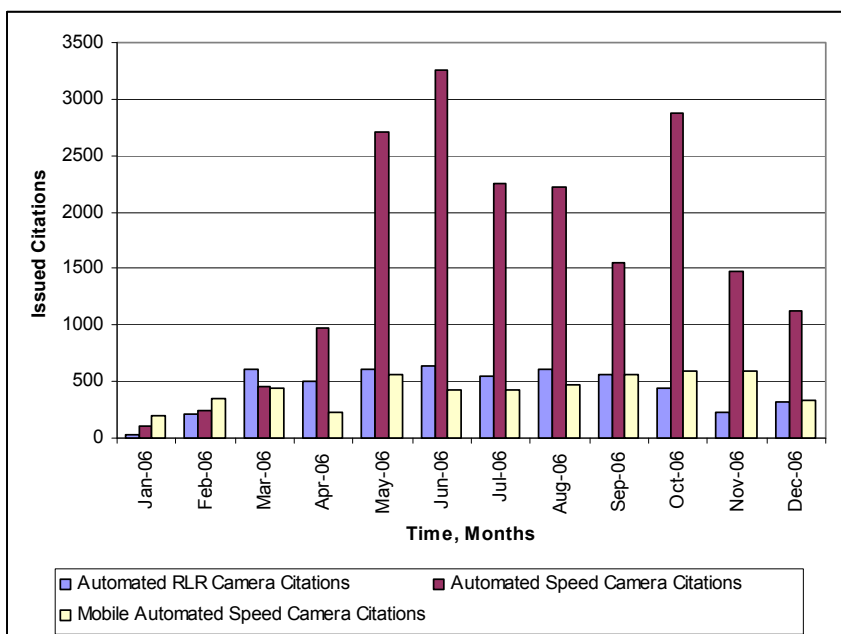
*Figure 104. Total monthly mailed citations based on type of automated enforcement.*

Figure 104 illustrates the number of mailed citations by type of automated enforcement that is used in Davenport. All three systems were operating after Nestor took over the RLR camera system in January 2006; monthly data were collect by both the Police Department and Nestor. Data prior to January 2006 could not be obtained from either the City of Davenport or Nestor because Transol disposed of them once it went out of business.

As shown in Figure 104, the largest number of citations was issued by the fixed speed enforcement camera system, collecting over 3,000 citations in the month of June 2006 alone. The Davenport Traffic Engineering Department explains that some of the differs in total monthly violations occurred because of improved progression along Kimberly Way, as well as other signal timing improvements to other intersections around the Kimberly Way / Welcome Way corridors.

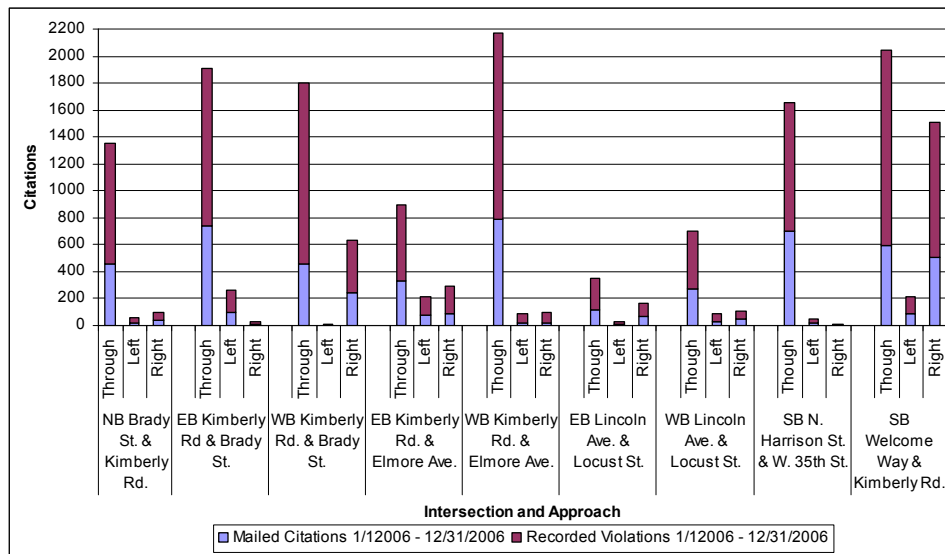
Figure 105. Recorded violations versus mailed citations at all RLR enforced intersections and approaches.

For this study, limited citation data were obtained for each intersection and are presented in Figure 105. As illustrated, the through movement at each enforced intersection had the highest count of possible and issued citations compared to left and right turning movements. The westbound approach at Kimberly Road and Brady Street and southbound approach at Welcome Way and Kimberly Road also reported high right turn RLR. Adding the total mailed citations for each of the nine enforced intersections, southbound approach at Welcome Way and Kimberly Road had the highest number of mailed citations which is currently 1,192. The intersection with the lowest number of total mailed citations is eastbound approach at Lincoln Avenue and Locust Street with 193 citations currently.

Also illustrated in Figure 105 are the differences between violations and citations. These differences are the number of rejected violations either by Nestor or the police department. To have a RLR violation be rejected by Nestor or the Davenport Police Department, there are three categories of rejection variable: discretionary factors, controllable factors, or uncontrollable factors. Discretionary factors include items that the police department will generally dismiss, variables such as construction, funeral processions, grace period, an officer directing traffic, a leased or rental vehicle, or an out of state vehicle that cannot be identified. Controllable factors are typically filtered by Nestor after the video has been transmitted to the company in which required elements, which the police would need to fully consider the offense RLR, are missing. Uncontrollable factors include such variables that neither Nestor or the police can control such as plate obstruction, sun glare, signal obstruction, speed change, no DMV record for the vehicle, or a sudden lane change. The average violation rejection rate was calculated to be 53.6% and the intersection with the highest violation rejection rate is southbound Harrison and 35<sup>th</sup> Street with a 69.9% violation rejection rate for the entire enforcement period. Westbound Kimberly Road and Elmore Avenue had the lowest average violation rejection rate of 36.9%.

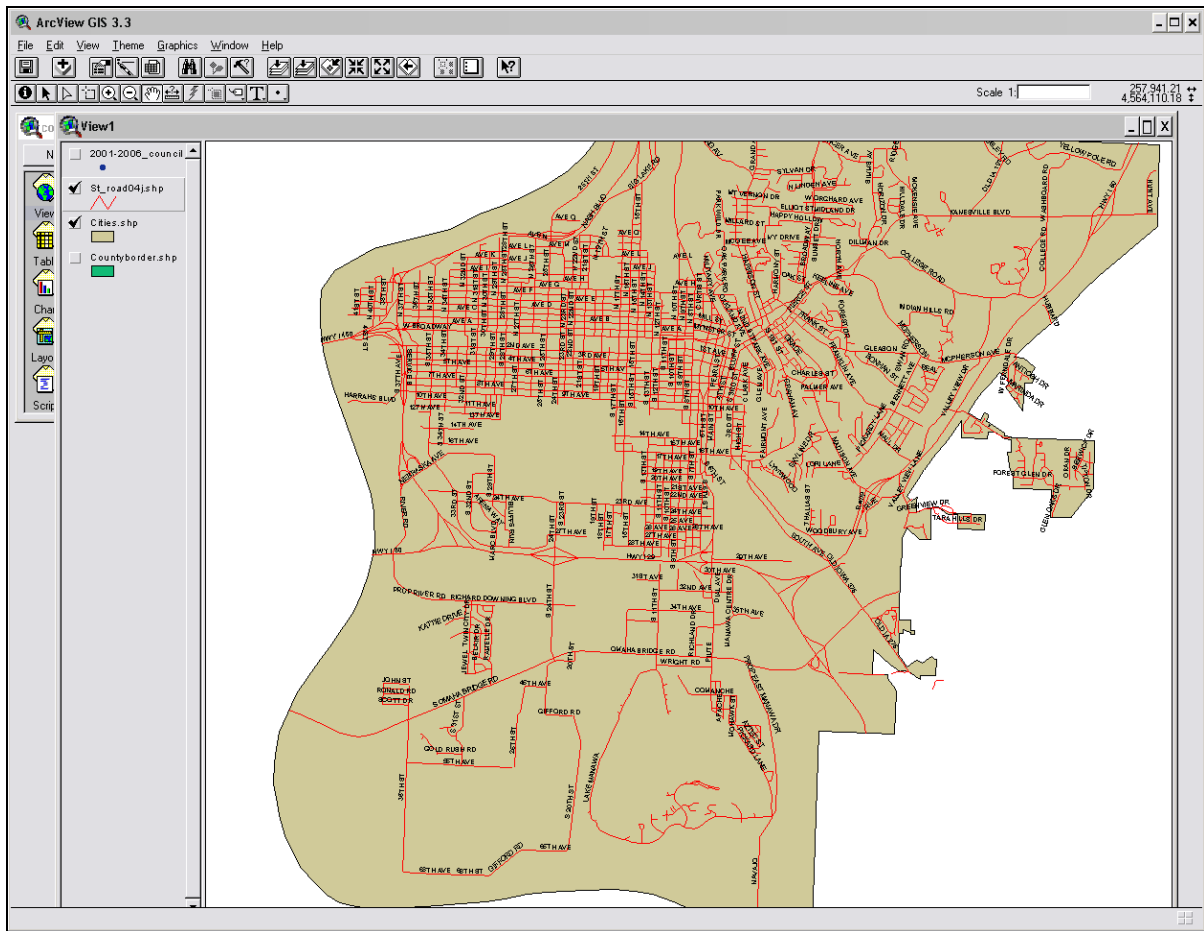
Figure D-1. ArcView GIS image of Council Bluffs.

To determine the exposure rate used for the crash rate equation, the daily entering vehicle count was needed. With the aid of ArcView and the Iowa DOT's state road, intersection, and city databases, a GIS project for Council Bluffs and Davenport was created. As illustrated in Figure D-1, a GIS map of Council Bluffs was created that shows the street network (red lines) and labels (black lettering) within the city limits (tan area).

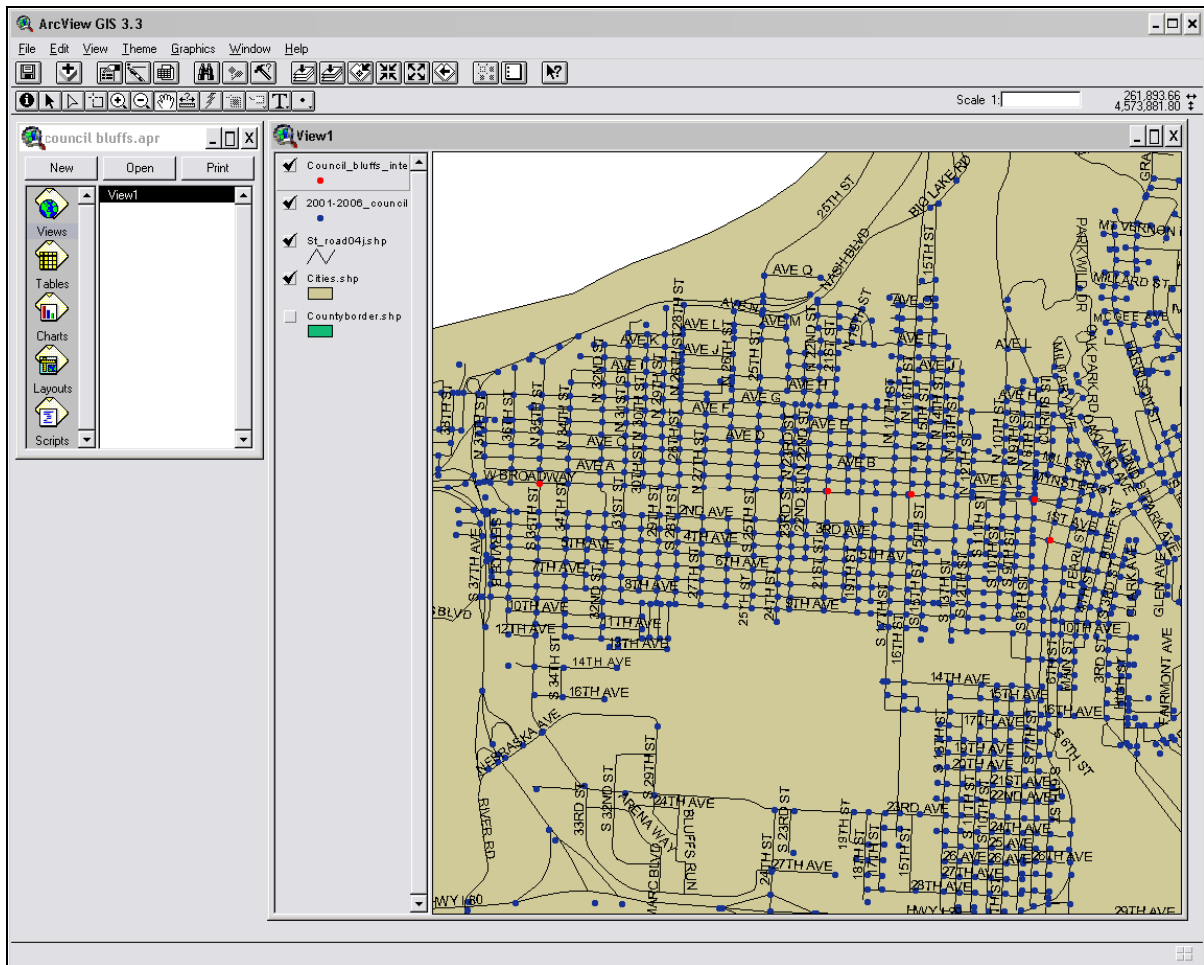
Figure D-2. Camera and control intersection point overlay.

As shown in Figure D-2, the blue dots represent an intersection where three or more line segments meet. The red dots shown represent the signalized intersections in Council Bluffs where RLR cameras are currently located.

A statewide intersection database was developed for Iowa based on the 1999 GIMS snapshot linework from the Iowa DOT. This database represents the intersection of any location where 3 or more approaches join and is shown in Figure D-2. Intersection databases were matched with 2001 through 2005 road network shape files and each year was treated as a separate analysis.

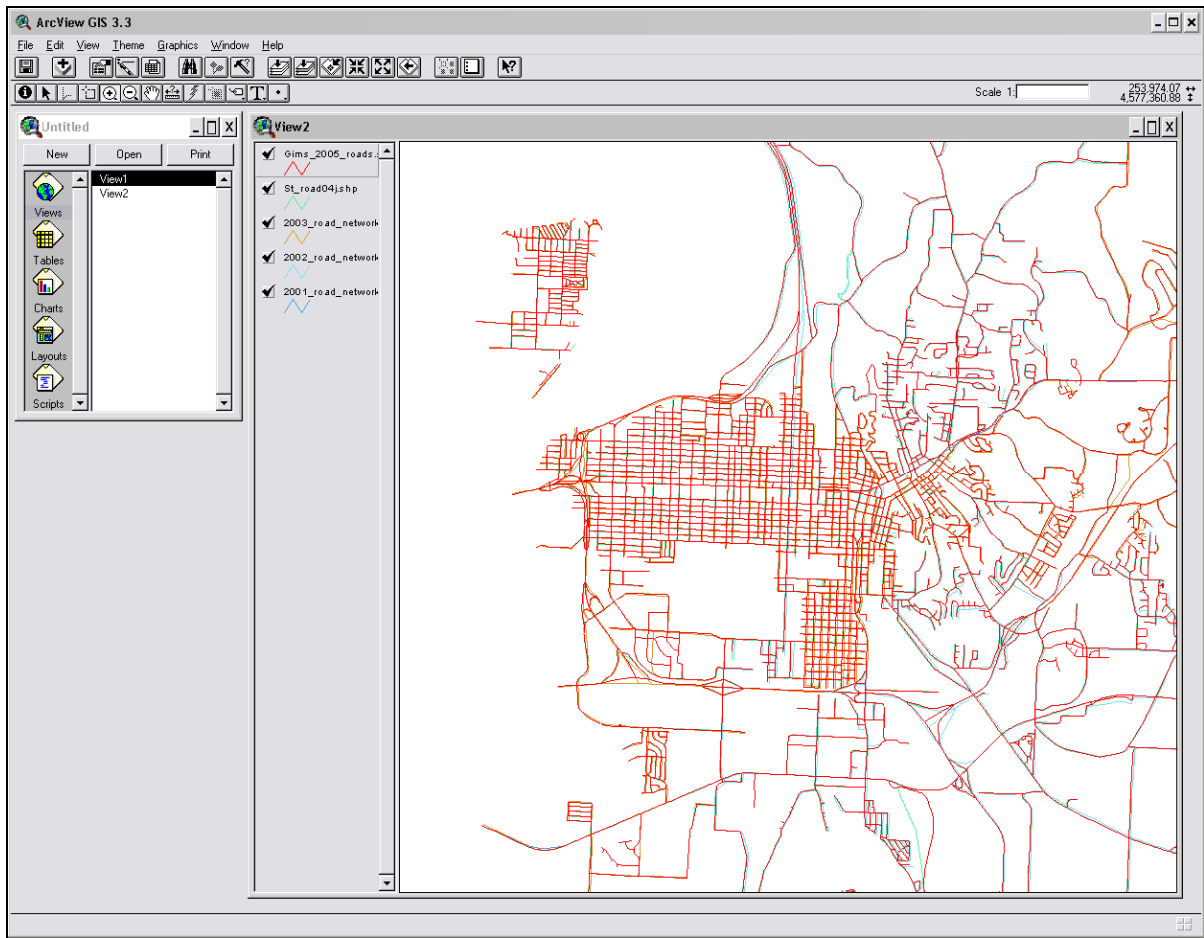
*Figure D-3. Combined 2001 - 2005 state road networks.*

As shown, each road network theme listed under the title “View2” has a corresponding color, and all of the themes are turned on. The resulting image illustrated in Figure D-3 indicates that many of the roads were close to matching, while other roads were hundreds of feet to miles off due to road reconstruction and known system changes or errors year to year. To determine how far the road network and intersection points were off, the road network and intersection point shape files were all loaded and turned on. The results can be seen in Figure D-4.

To find the change in DEV for the specified camera enforced and control intersections, it was determined to ultimately combine the data for the four years into one or two shape files. The first step was to determine if the road network shape files for 2001 through 2005 lined up with each other. The results are illustrated in Figure D-3.

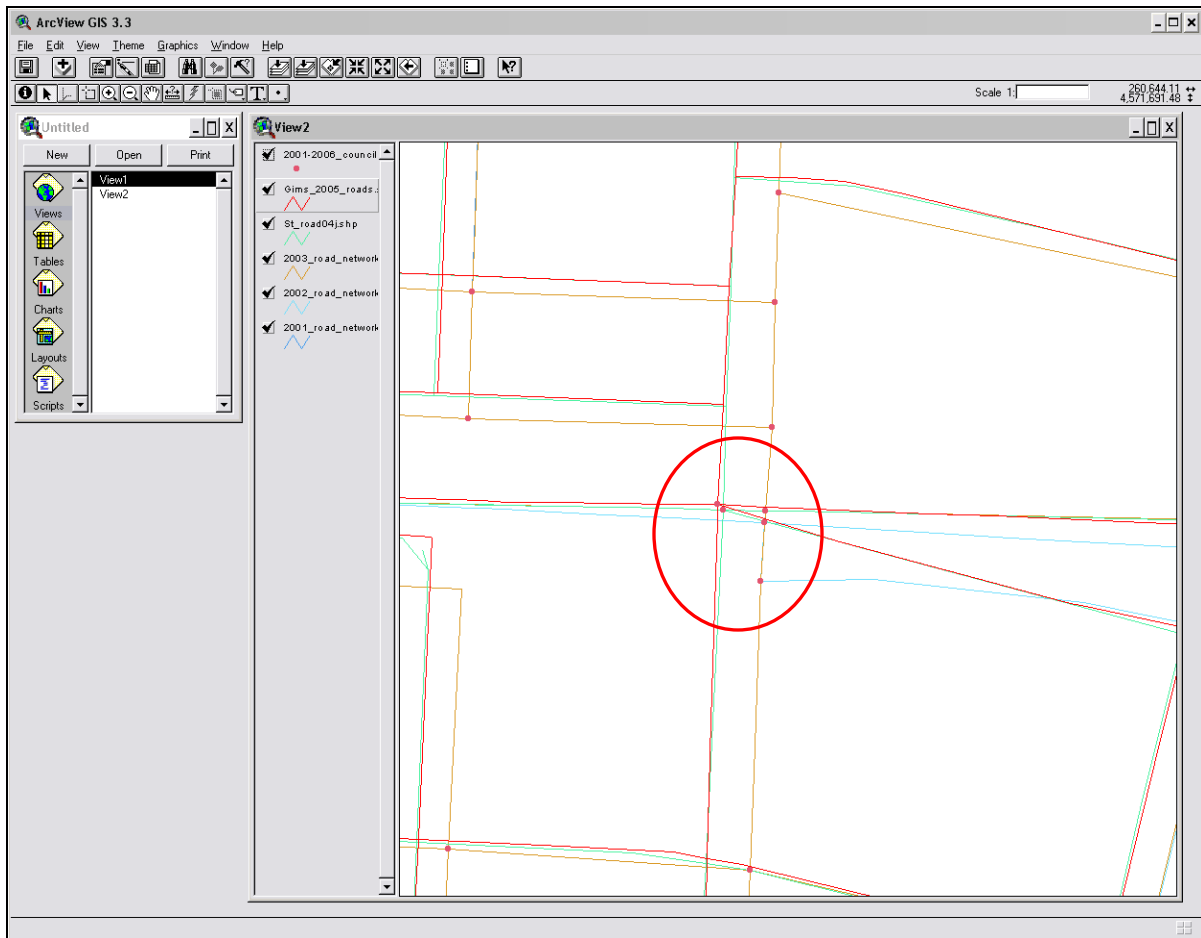
FigureD-4. Combined 2001 - 2005 road network and intersection mismatched points and segments.

As illustrated in Figure D-4, most of the intersection points and corresponding road networks were not exact. Within the red circle, in these 5 red dots represent the intersection points for each of the years from 2001 through 2005. It was determined by the research team that the script to find the yearly DEV for each of the points within the red circle would be run separately. The script entitled “get AADT” created by Dr. Shauna Hallmark in 2003 was loaded into ArcView and is shown in Figure D-5.

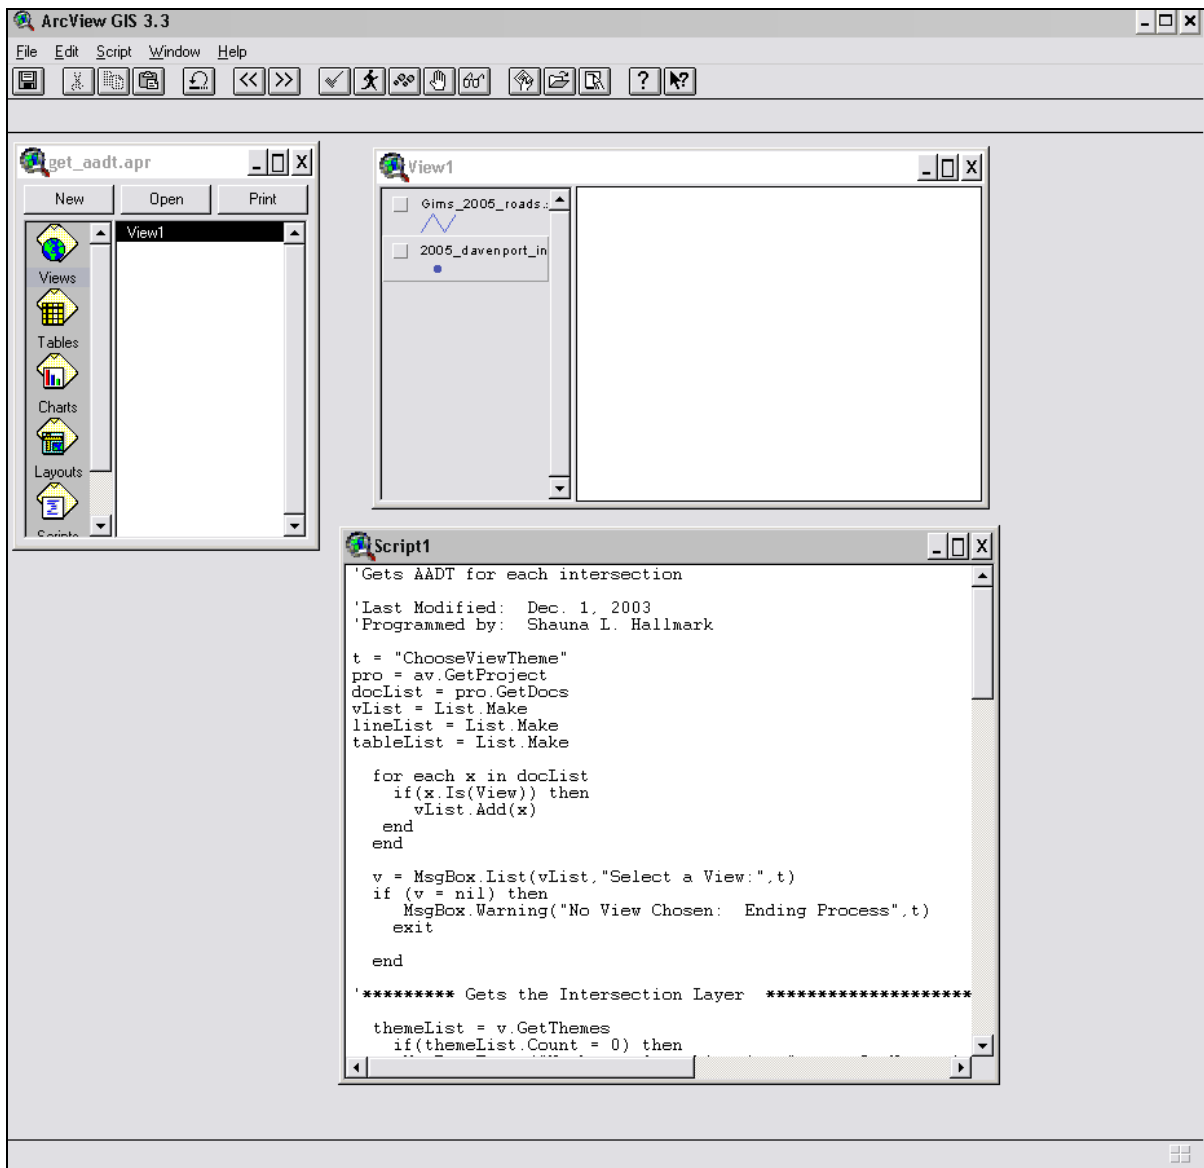
Figure D-5. Running the "get AADT" script for 2005 road network and intersection points.

As illustrated in Figure D-5, the script used was specifically programmed for ArcView and the Iowa DOT's database of road network and intersection shape files. The script is written to find the DEV for an intersection point by gathering the data of segments that are within a 5 meter radius of the intersection point. After running the script for each year, it was found that many of the intersections in Council Bluffs and Davenport resulted in 0 daily entering vehicles when the research team knew that vehicles were entering the intersection. Upon further investigation, it was found that not only did the 2001 through 2005 road network shape files not line up (as shown in D-4), but the intersection points did not lie within 5 meters of the road segments as shown in D-6.

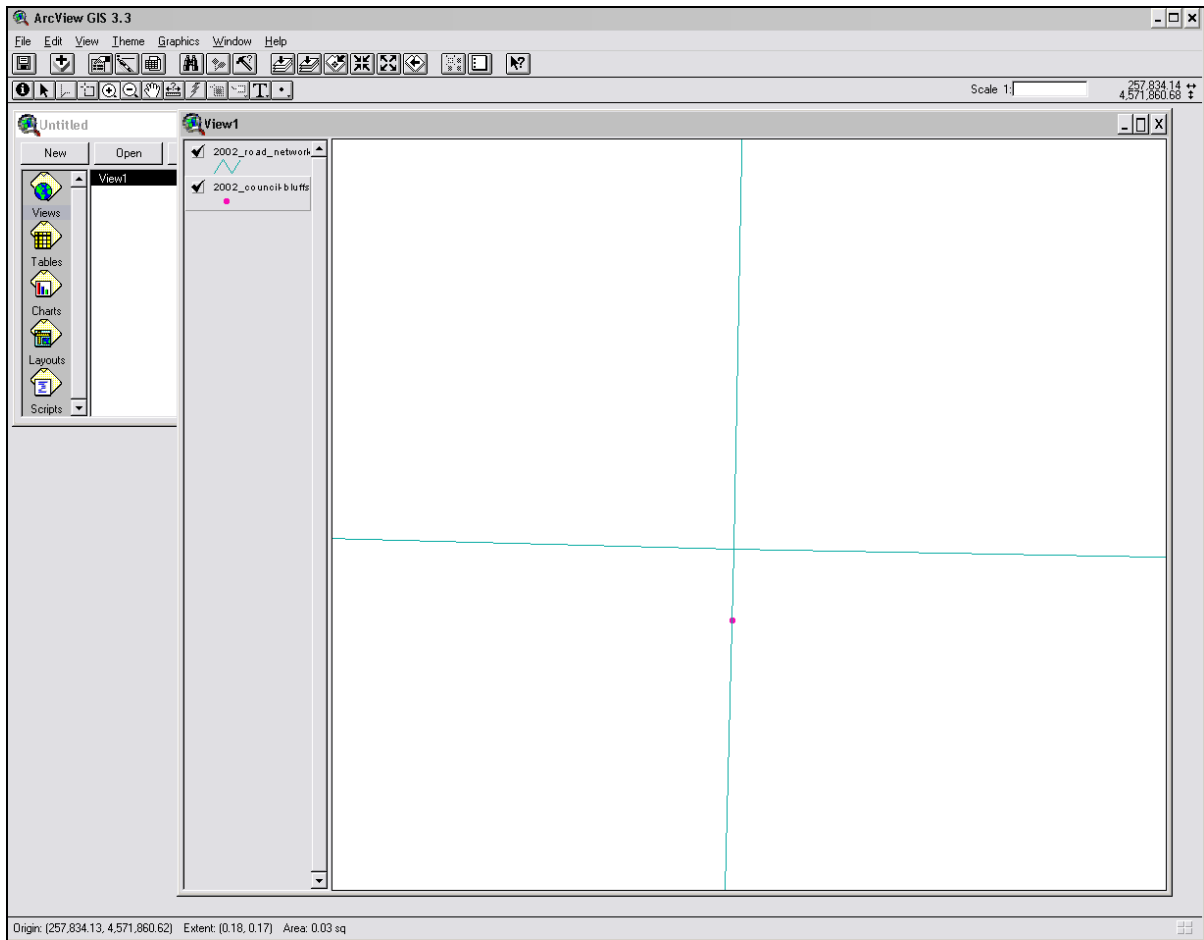
*Figure D-6. 2002 intersection point mismatch with the 2002 road network shape file.*

As illustrated in Figure D-6, the pink dot represents the intersection point of Broadway and 21<sup>st</sup> Street in Council Bluffs. It was found that because the pink dot was not within 5 meters of the actual intersection (the intersection of the blue lines), the script would not be able to find the segment's AADT and would report a 0 for DEV. To fix this problem, the editing feature in ArcView was used to move the intersection point. To move the intersection point within 5 meters of the road segments, the view was zoomed in as close as possible and intersection was moved to the point where the road segments crossed. The script was then performed again for each year, resulting in a DEV for the specified intersections. Once this task was completed, the shape files with the yearly DEV were combined as shown in Figure D-7.
