# The effectiveness of Iowa's automated red light running enforcement programs

A thesis submitted to the graduate faculty  
in partial fulfillment of the requirements for the degree of  
MASTER OF SCIENCE

Major: Civil Engineering (Transportation Engineering)

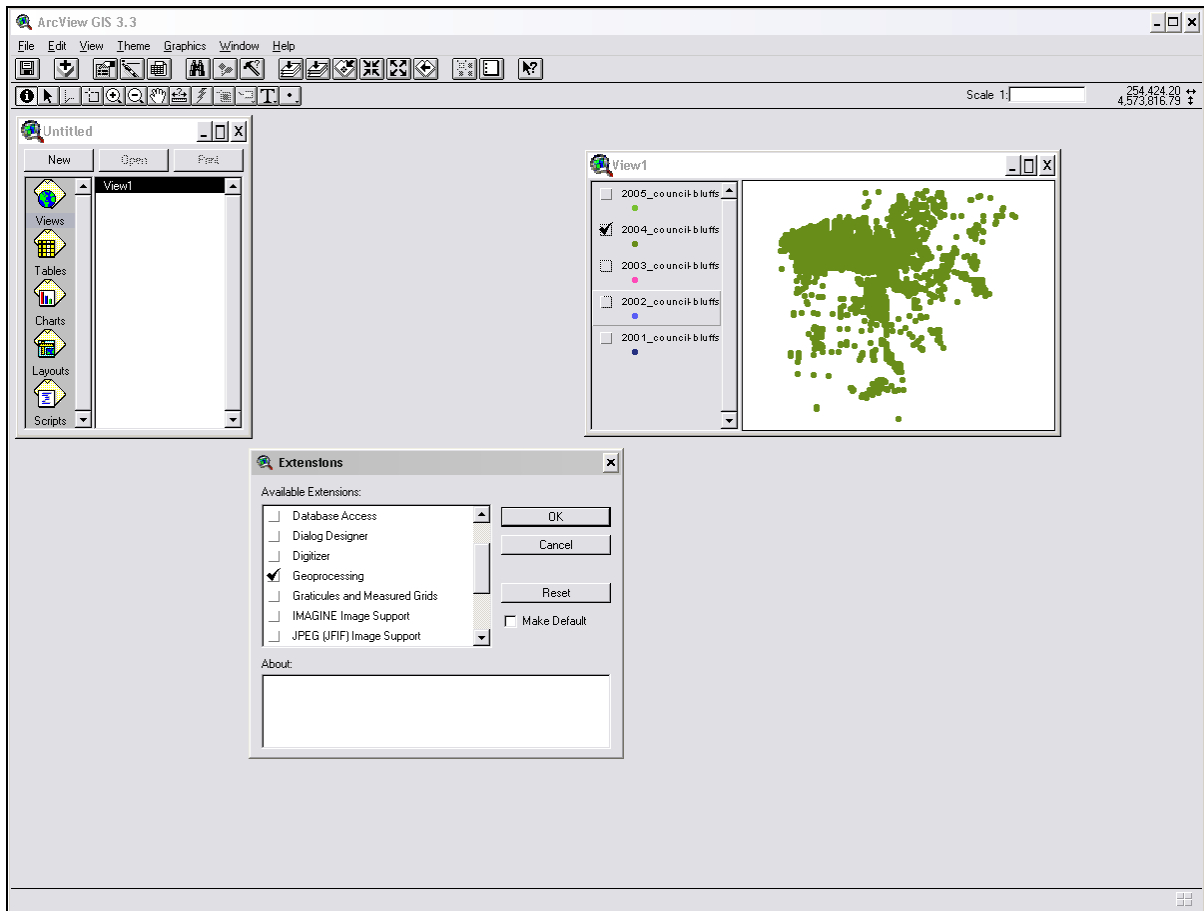
Figure D-7. Changing each post-script intersection shape file's extension to "Geoprocessing"

As illustrated in Figure D-7, each yearly intersection shape file's extension needed to be changed to Geoprocessing which enabled the feature to merge all of the intersection data together. Once the shape file extensions were changed, the merge feature under the Geoprocessing option was performed and is shown in Figure D-8.

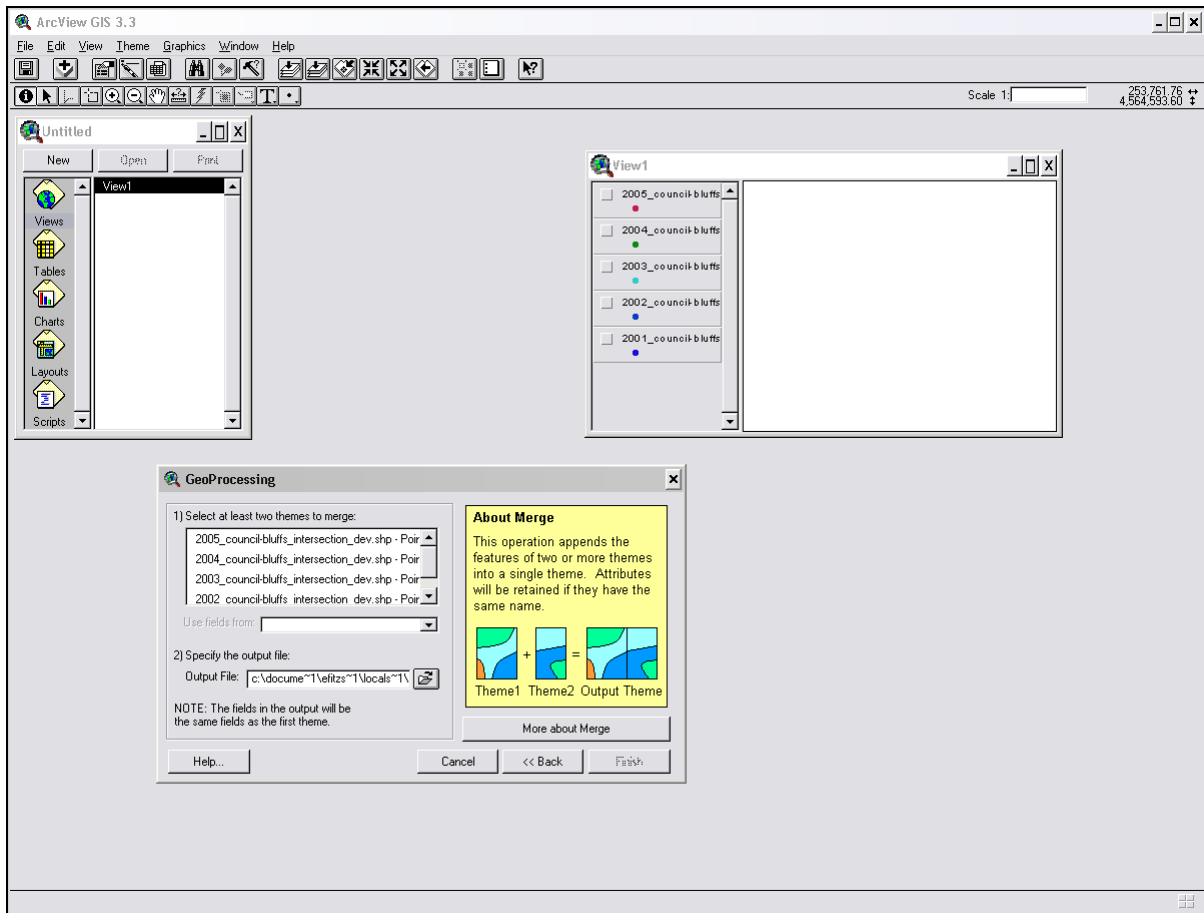
FigureD-8. Merging the post-script intersection shapefiles to one theme.

As shown in Figure D-8, the merge feature allows one shape file to be created out of the five separate themes which included the DEV for each year. By creating a shape file with all of the combined themes and data, this file would be able to give the DEV for each year with one click as shown in Figure D-9.

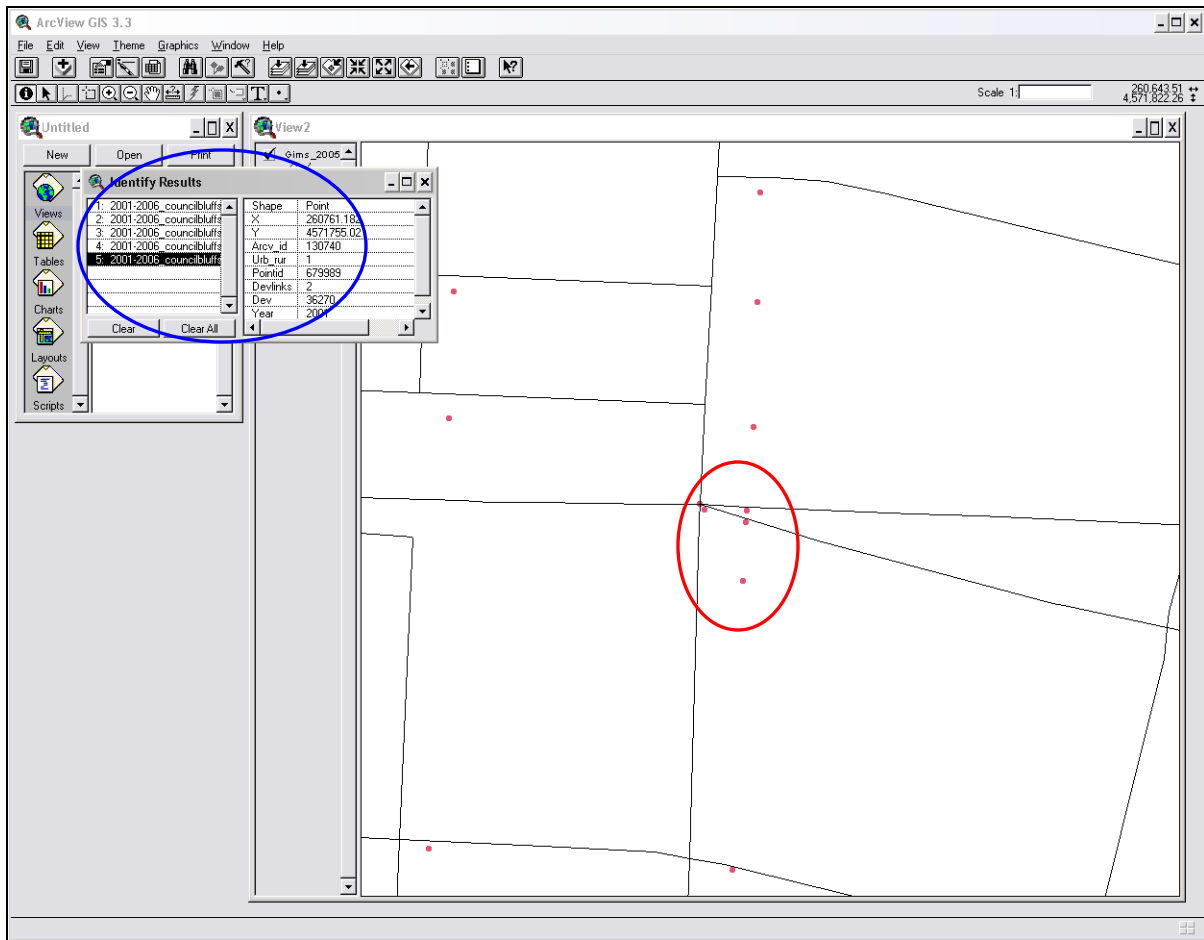
Figure D-9. Post-merge intersection theme and 2005 road network.

As illustrated in Figure D-9, the intersection points for 2001 through 2005 are shown as red dots. The red circle represents all of the intersection points for 2001 through 2005 for the intersection of Kanesville Boulevard and 8<sup>th</sup> Street. For reference purposes the 2005 road network shape file was loaded to find the intersection. Using the ArcView identity tool, the intersection point closest to where the road segments join was selected. Once the intersection point was selected, the “Identify Results” box appeared which had the 5 years listed on the left side and the DEV for the year selected on the right side as shown within the blue circle. Depending on what road network shape file was loaded, any point within the red circle could have been selected to get the same identity results.

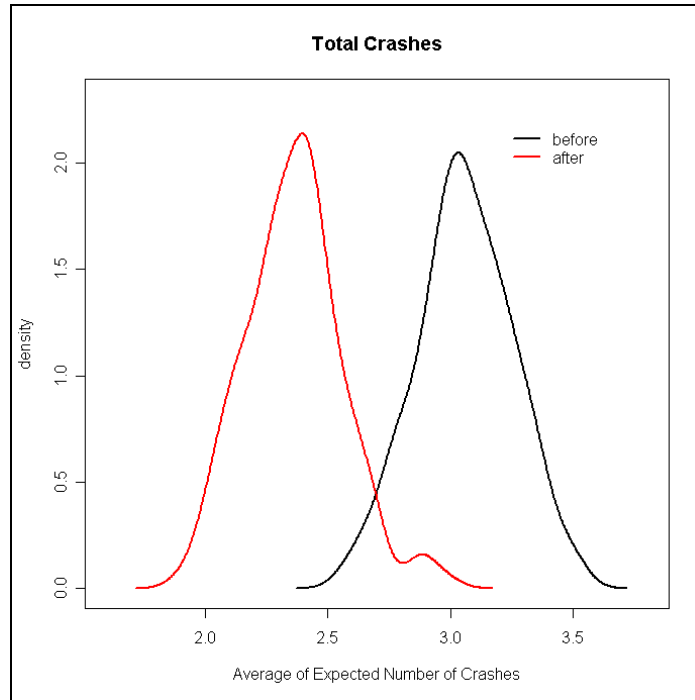
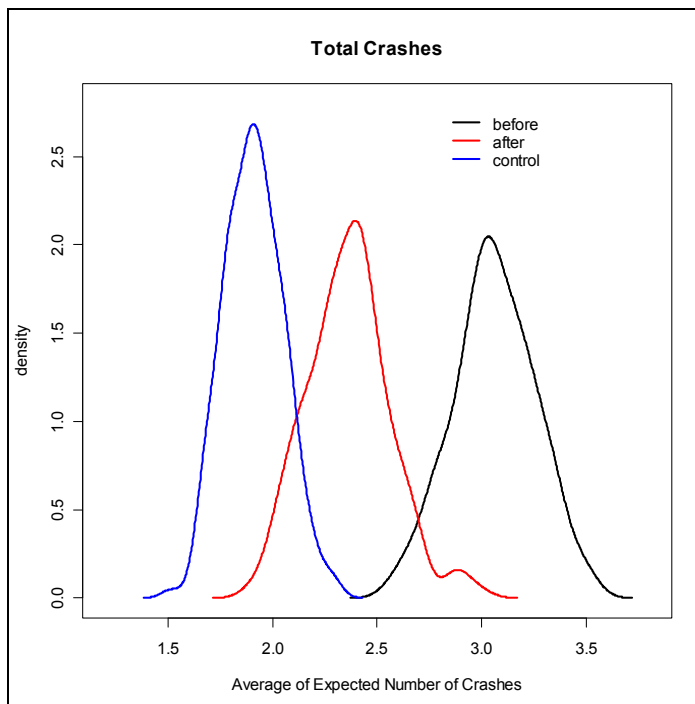
*Figures E-1 & E-2. Posterior distributions of the average total crashes over sites expected crash frequencies for control, treatment before and treatment after.*

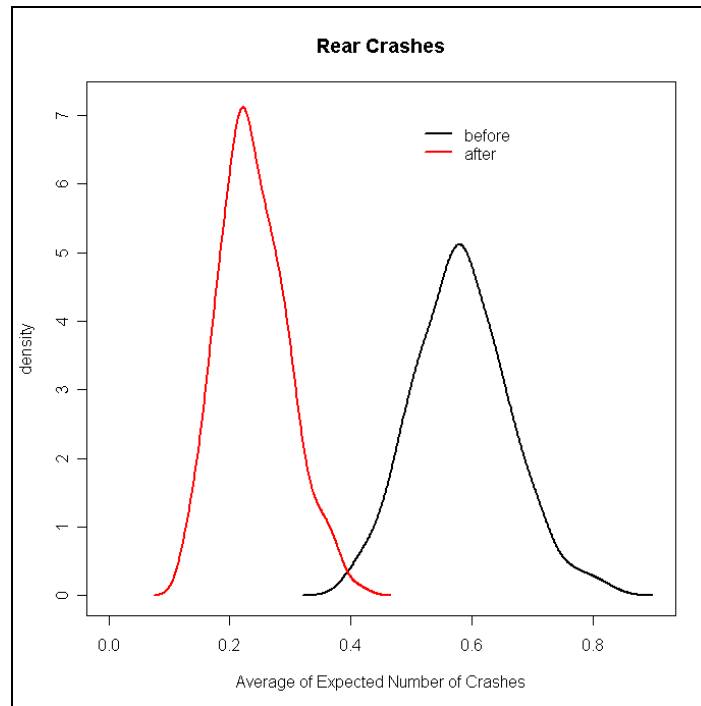
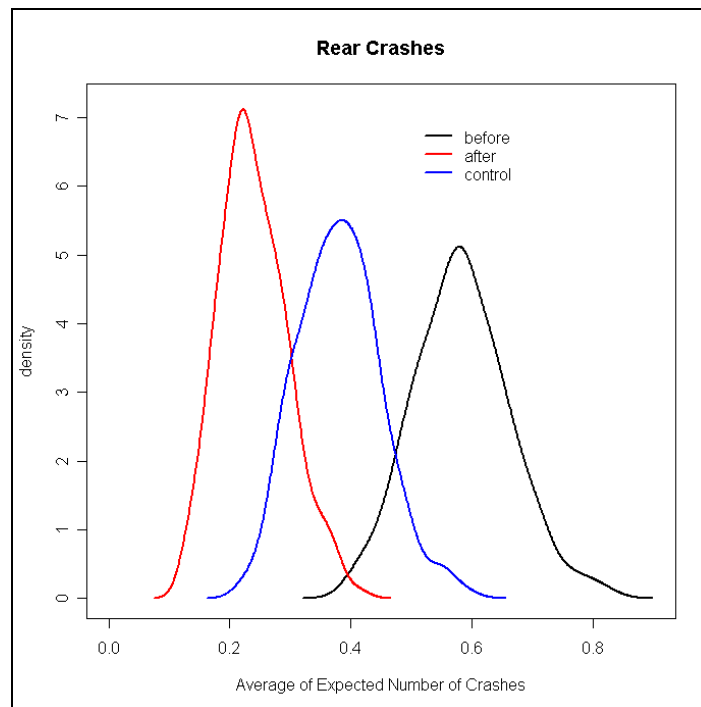
Figures E-3 & E-4. Posterior distributions of the average rear-end crashes over sites expected crash frequencies for control, treatment before and treatment after.

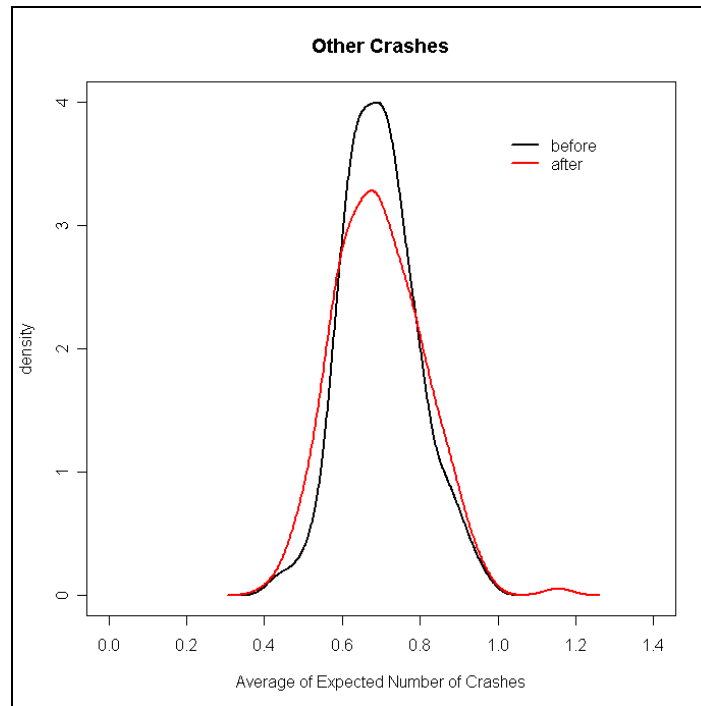
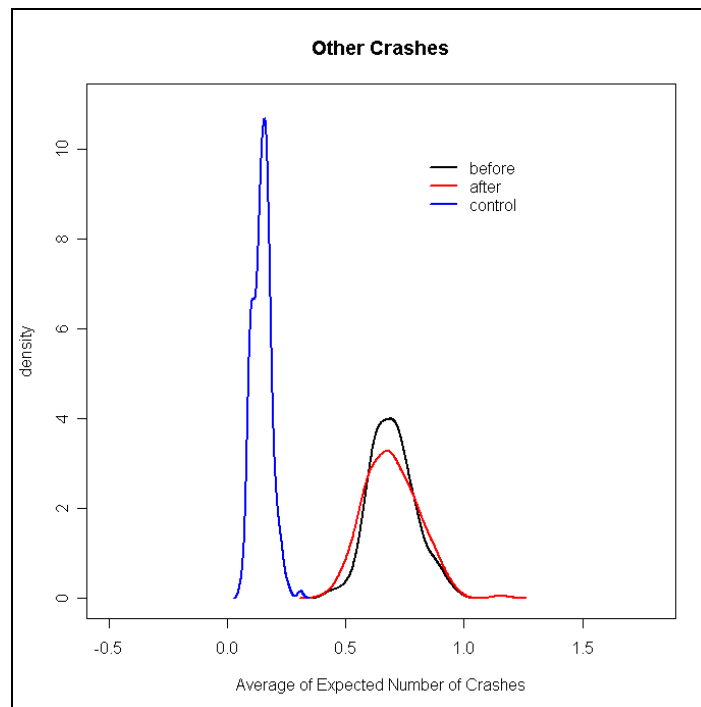
Figures E-4 & E-5. Posterior distributions of the average other RLR type crashes over sites expected crash frequencies for control, treatment before and treatment after.

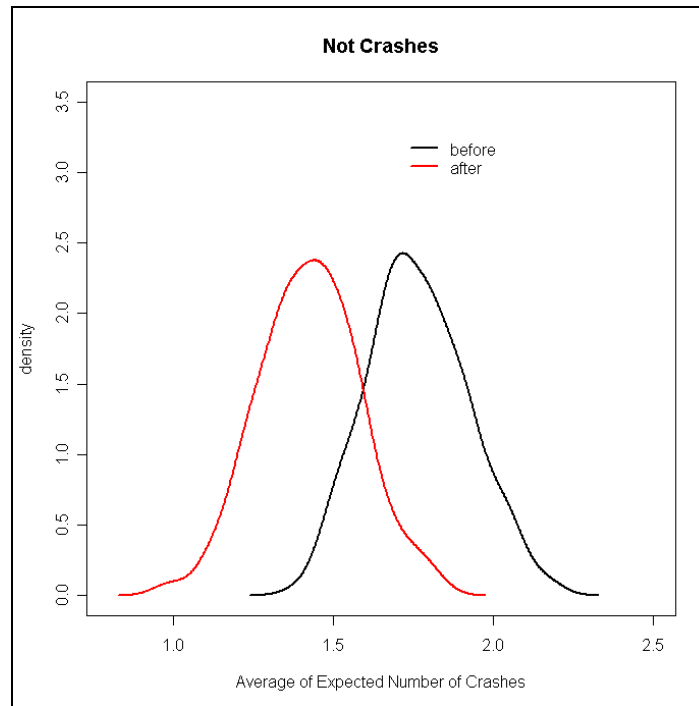
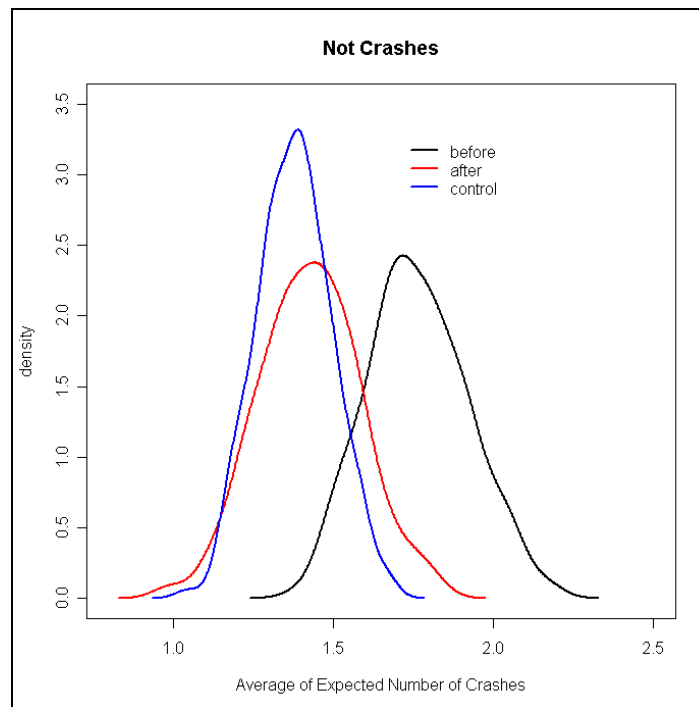
Figures E-6 & E-7. Posterior distributions of the average non-RLR type crashes over sites expected crash frequencies for control, treatment before and treatment after.
