Vibration-based damage detection with new operational response and waveform analysis methodology

Kyle D. Hudson
University of Iowa

A thesis submitted in partial fulfillment
of the requirements for the
Master of Science degree in Civil and Environmental Engineering
in the Graduate College of
The University of Iowa

December 2010

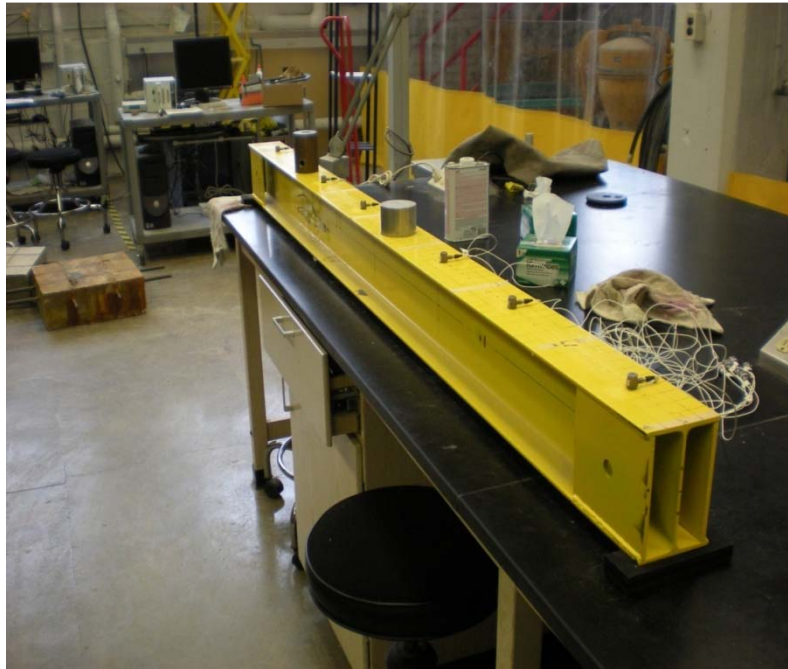
Figure 3.3 Typical laboratory I-beam setup with six fixed accelerometers and two damage zones simulated by fixing masses to the top flange of the structure

During a roving excitation test, the I-beam was impacted at each node and six accelerometers were fixed to various nodes on the structure. Both baseline and damaged forced excitation tests were run on the I-beam. Damage was simulated by fixing masses of different sizes to the centerline of the top flange of the beam, thereby creating a local change in mass and stiffness in the region surrounding each mass. Figure 3.3 shows a picture of a typical roving excitation setup with two damage locations. As shown in Figure 3.4, accelerometers were fixed on nodes 4, 16, 26, 43, 55, and 74 and masses of 1.7 kg and 0.5 kg were fixed to the top flange between nodes 60 and 62 and nodes 33 and 36, respectively.

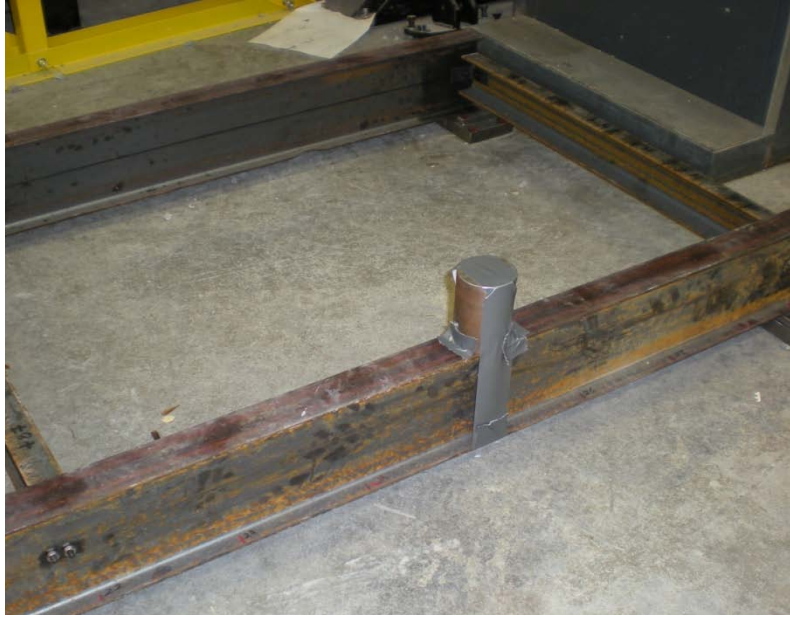
Figure 3.27 Mass (1500 g) added to top flange of the right beam, 20 inches from the far end

Damage was added to one of the beams of the scale bridge to determine if the highly stiffened region in the middle of the structure has an effect on damage detection using the FRF curvature method. For this experiment, a 1500 g mass was fixed to the top flange of the right beam 20 inches from the far end (on node 16), as shown in Figure 3.27. This mass represents 3.2% of the total structure's mass (excluding the bearing plates) and 7.5% of the right beam only. Response points for this test were the same 98 points shown in Figure 3.22.

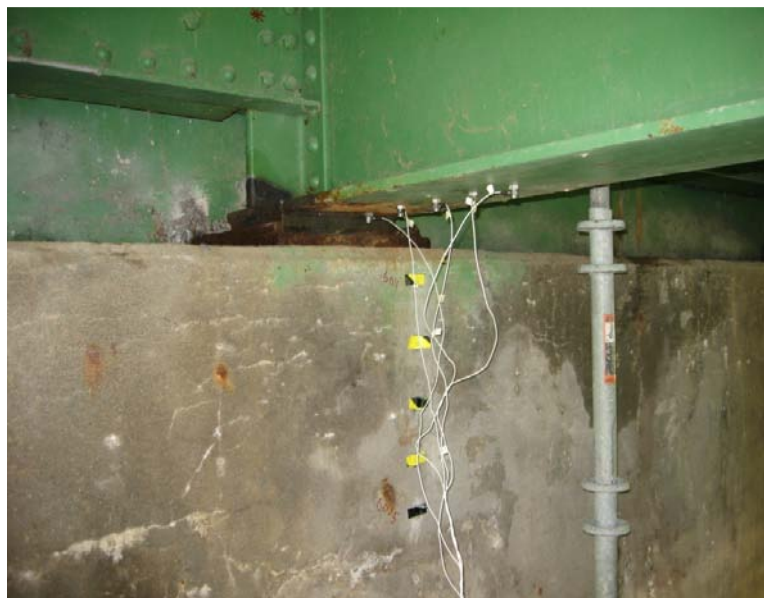
Figure 4.25 Operational vibration response measurement of a beam near the boundary condition

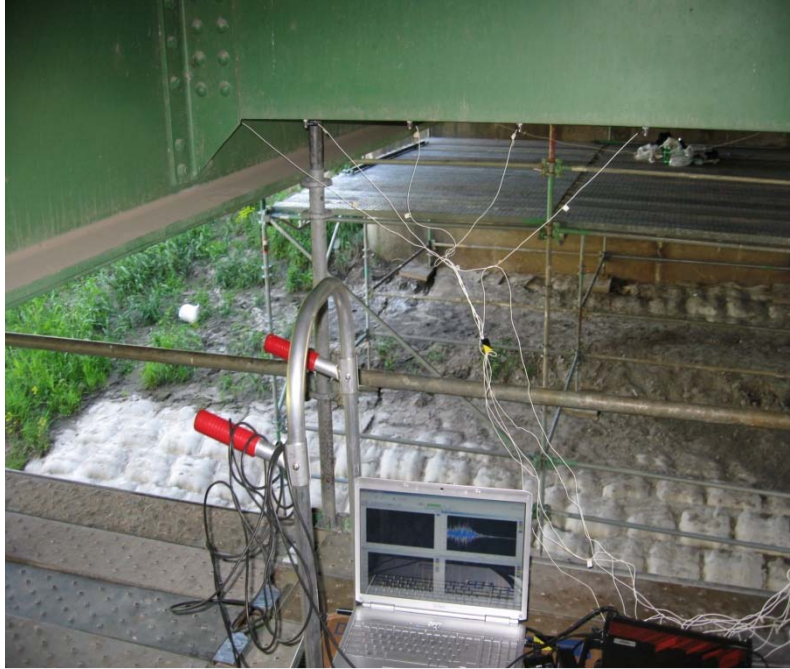
Figure 4.26 Operational vibration response measurement of a diaphragm member

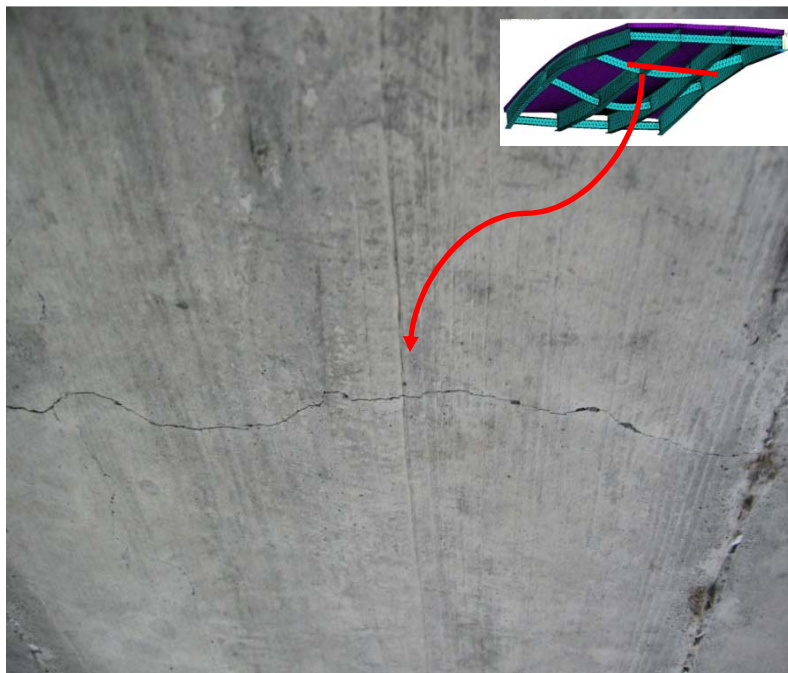
Figure 4.41 Lateral surface crack in concrete deck near midspan of bridge

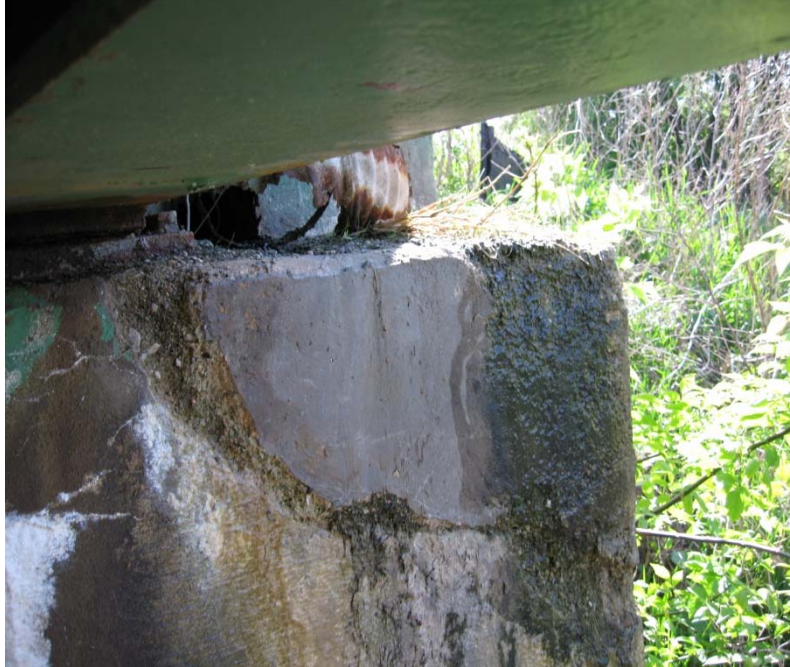
Figure 4.45 Large diagonal crack in the northeast abutment wall beneath beam 4

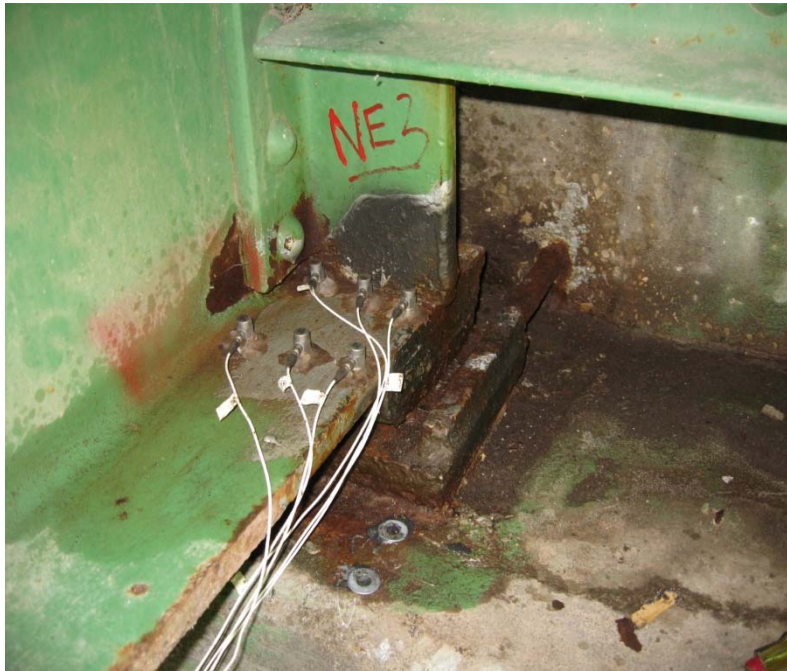
Figure 4.47 Forced vibration response measurement of northeast end and boundary condition of beam 3

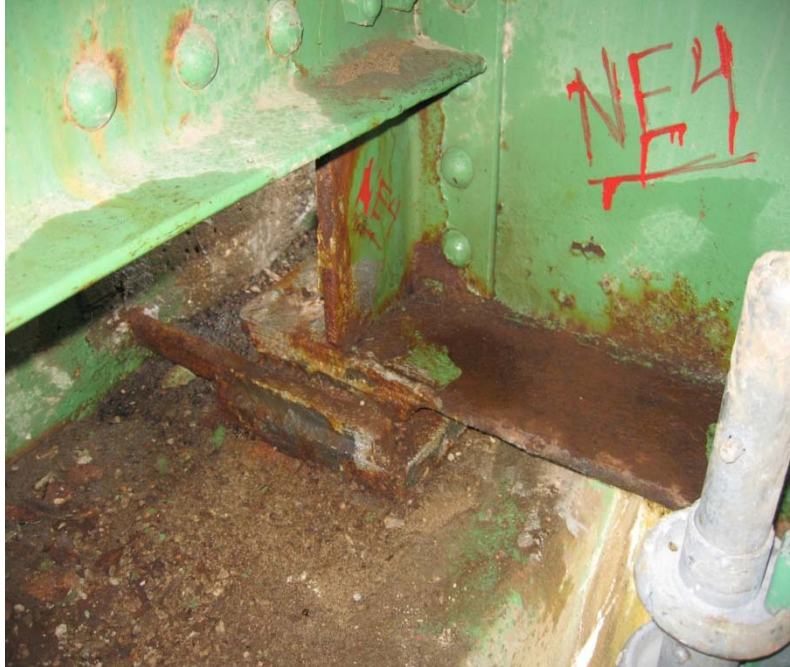
Figure 4.48 Forced vibration response measurement of northeast end and boundary condition of beam 4 with noticeable deterioration of the bottom flange
