# Characteristics of Indicators for Insulation Deterioration in 26 kV Generator Stator Windings

Power Generation Laboratory, Korea Electric Power Corporation (KEPCO) Research Institute, Dae-jeon, South Korea

Soo-hoh Lee, Hee-dong Kim, Tae-sik Kong. Characteristics of Indicators for Insulation Deterioration in 26 kV Generator Stator Windings. *American Journal of Electrical Power and Energy Systems*. Vol. 8, No. 6, 2019, pp. 145-151. doi: 10.11648/j.epes.20190806.11

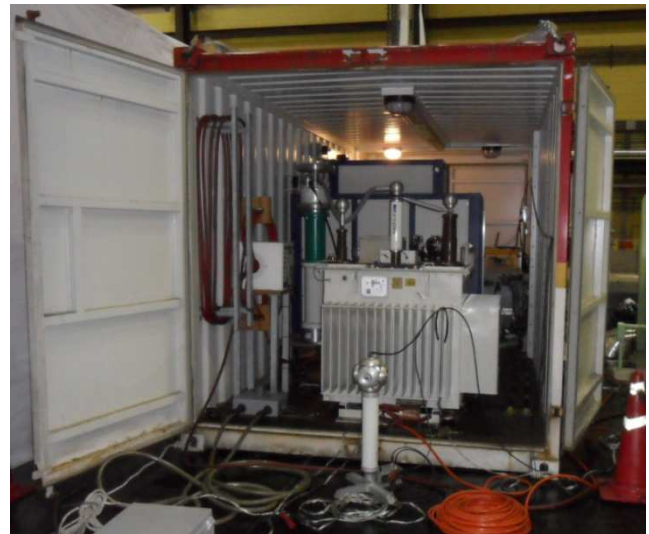
Figure 1. Construction of the insulation diagnosis and overvoltage test equipment.

After the completion of the off-line insulation diagnosis test, a overvoltage test was conducted to determine whether the windings acquired the minimum insulation dielectric strength required for the operation of the generator. In the case of the overvoltage test, the HV supply (50kV) and the bridge (Type 2819) were used to increase the voltage by 1 kV and permit 32.5 kV, 125% of the line-to-line voltage, for 1 min.

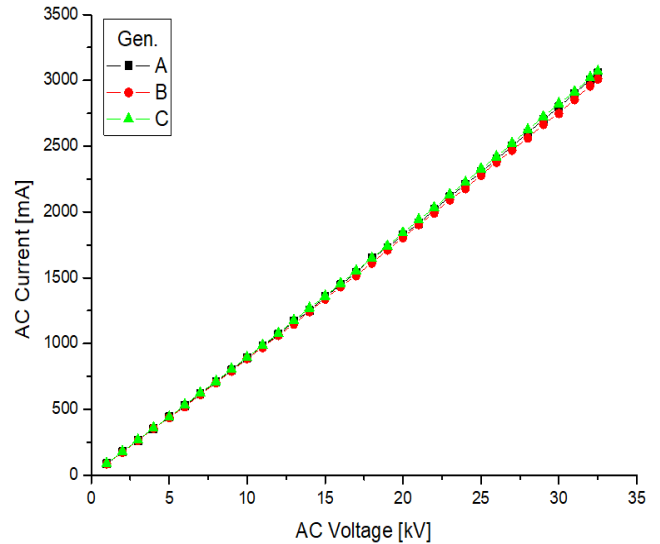
Figure 4. Characteristics of AC current vs. AC voltage in generator stator windings (Just after the occurrence of ground fault).

In this test, the neutral point of the steam turbine generator was separated, and AC voltage by phase was increased by 1 kV up to 1.25 times of nominal voltage at 26 kV, i.e., up to 32.5 kV, to measure the AC current. The test resulted in the AC current–voltage characteristics shown in Figure 4. Based on this, ΔI, a factor that shows the overall insulation integrity of the stator windings, was determined. ΔI can be derived from the following equations.

Meanwhile, the voltage at the point where the current surges is called current surge voltage, expressed as  $P_{i1}$ . As shown in Figure 4, the current surge voltage appearing at phases A, B, and C was 8.6, 8.7, and 8.9 kV, respectively. The AC current surge point was caused by the discharge within micro voids, which will be discussed later, and there appears slightly higher voltage than the partial discharge inception voltage or  $\tan\delta$  surge voltage, and this shows that AC current surges not in the initial inception of the discharge but at the point when discharge occurs in the overall windings.
