Case Report

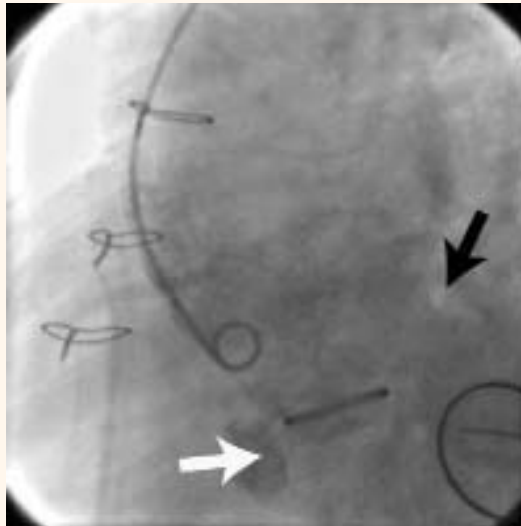
Figure 1: Contrast medium angiograph showing fistulae to the left atrium (white arrow) and pulmonary artery (black arrow) in a 47-year-old woman with a dissected ascending aortic aneurysm.

both lung fields. A transthoracic echocardiogram (TTE) revealed normal functioning of the prosthetic mitral and aortic valve and a giant ascending AA involving the sinuses of Valsalva. The dissection flap was not detected by TTE. The aneurysm's transverse diameter was measured as 7.5 cm with an aortic root contrast injection [Figure 1].
