THESIS

EVALUATING THE LONG-TERM DURABILITY OF FIBER REINFORCED
POLYMERS VIA FIELD ASSESSMENTS OF REINFORCED CONCRETE
STRUCTURES

Colorado State University

Fall 2011

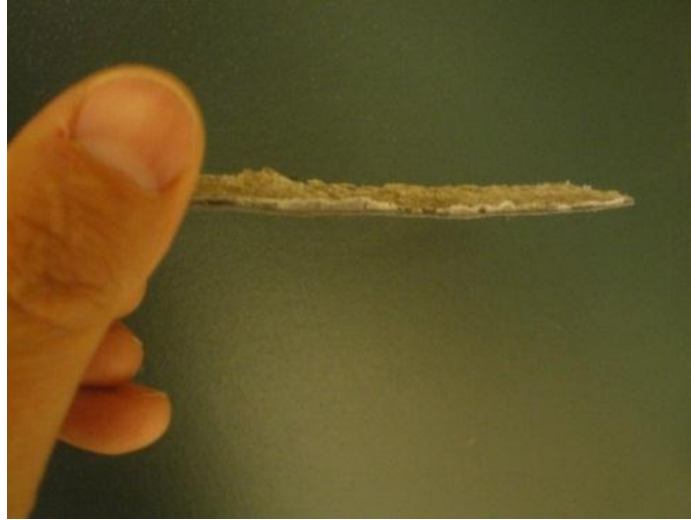
The thickness of the CFRP strips varied significantly due to the rough contour of the adhered side of the CFRP. As previously discussed in sections 3.2.4 and 3.2.5, a thick filler resin was applied to smooth the surface of the substrate prior to adhering the CFRP fabric to the arches. This process can be seen above in section 3.1.1.2 in Figure 3.12. A photograph of the rough texture is below.

Figure 3.61. The rough contour of a tensile test strip of CFRP

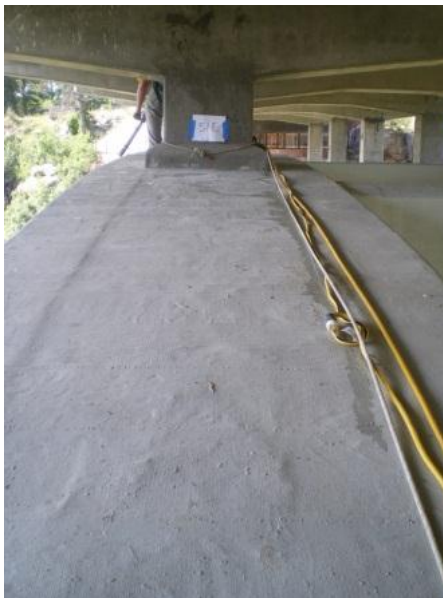
Figure A14. Bay 5NE

Bay 5NE: No Defects Found

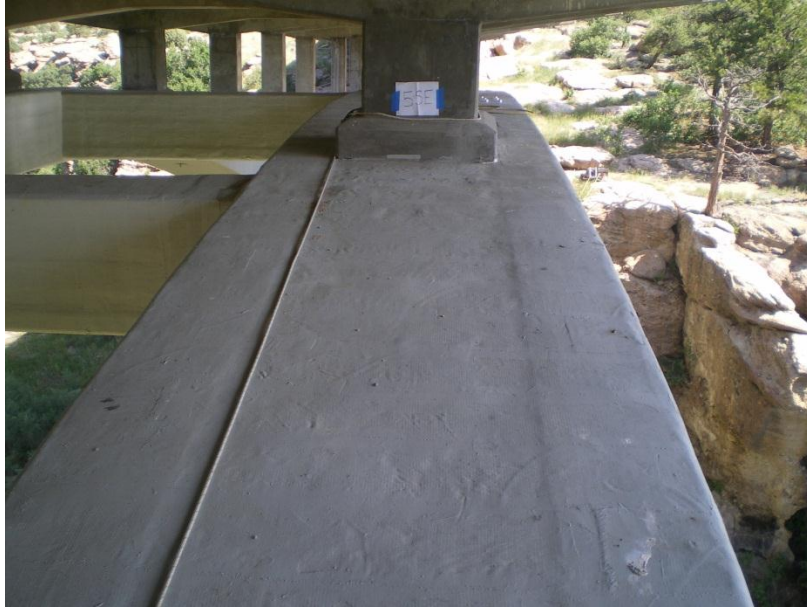
Figure A15. Bay 5SE

Bay 5SE: No Defects Found

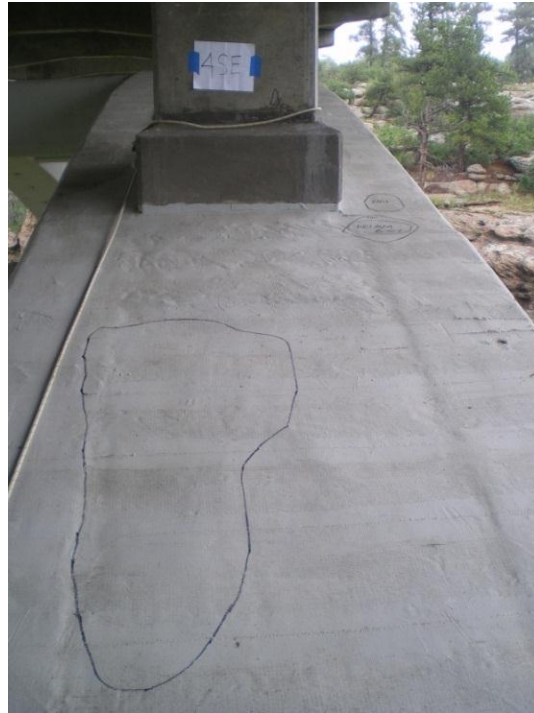
Figure A16. Bay 4SE

Bay 4SE: 3 Voids, 1 Was Identified in 2007

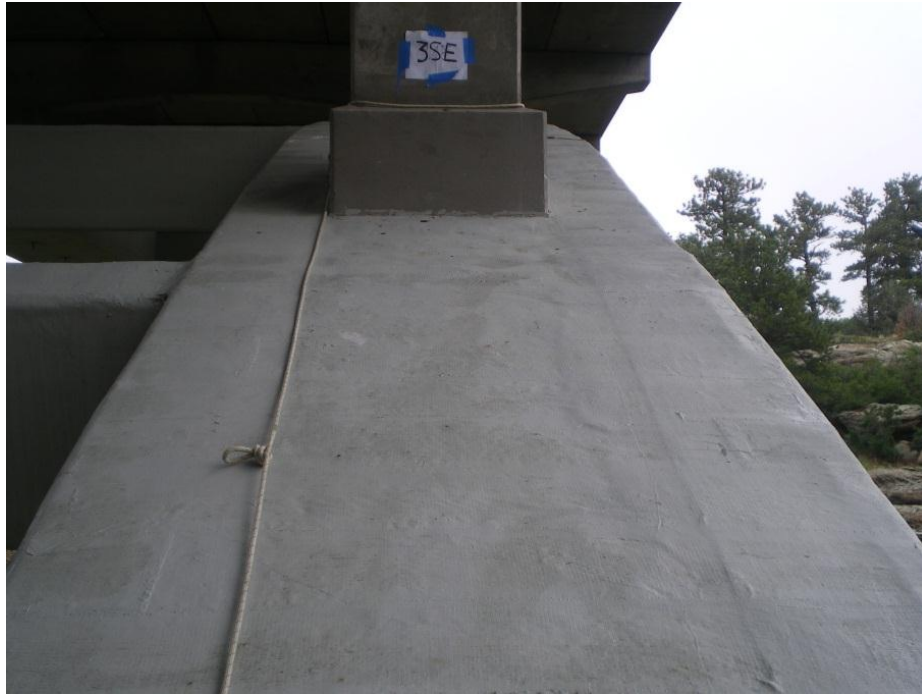
Figure A18. Bay 3SE

Bay 3SE: 2 Voids, 1 Crack

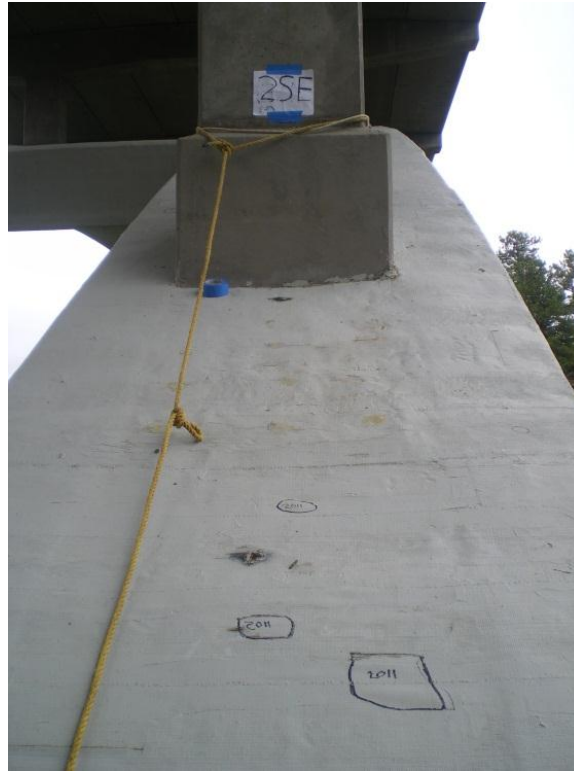
Figure A20. Bay 2SE

Bay 2SE: 3 Voids

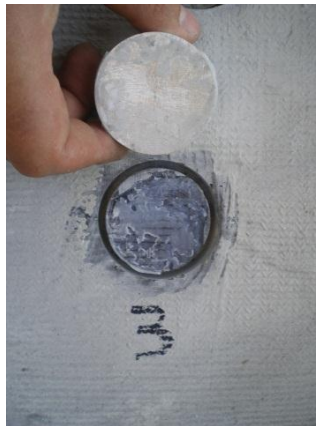
Figure B3. Test No.3, Photograph of Test No.4 is not available

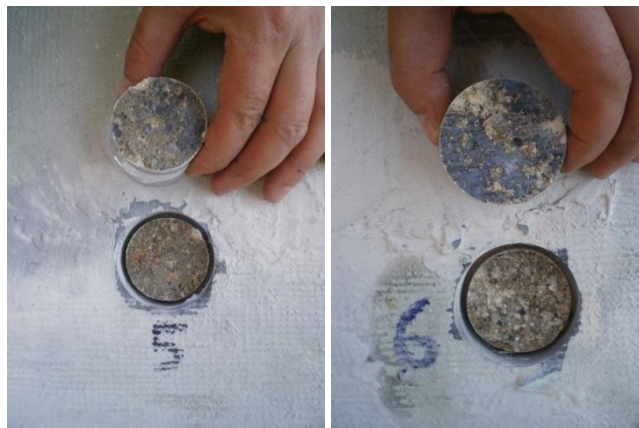
Figures B4 and B5. Test No.5, note puck slid off of center while epoxy was setting, and Test No. 6
