# **EXPERIMENTAL SEISMIC STUDY OF PRESSURIZED FIRE SPRINKLER PIPING SUBSYSTEMS**

Yuan Tian

November 9<sup>th</sup>, 2012

A dissertation submitted to the  
Faculty of the Graduate School of  
the University at Buffalo, State University of New York  
in partial fulfillment of the requirements for the  
degree of

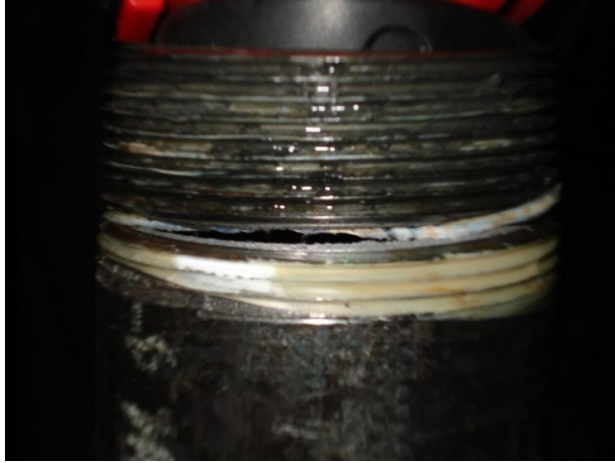
(c) Opening of threads in the pipe

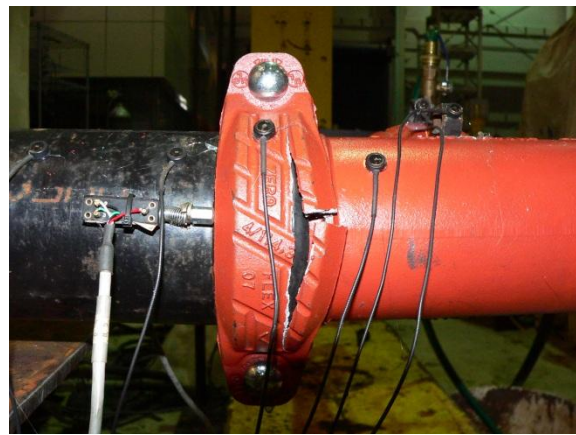
- 1) Fracture was initiated either from the angle pad in contact with the other coupling flange (*Figure 3-17 a*), and housing keys that were designed to be engaged in the groove in the tee joint (*Figure 3-17 b and Figure 3-17 c*), or from the coupling holes for the bolts (*Figure 3-17 d*);

(b) Fracture of coupling flange initiated from the housing key

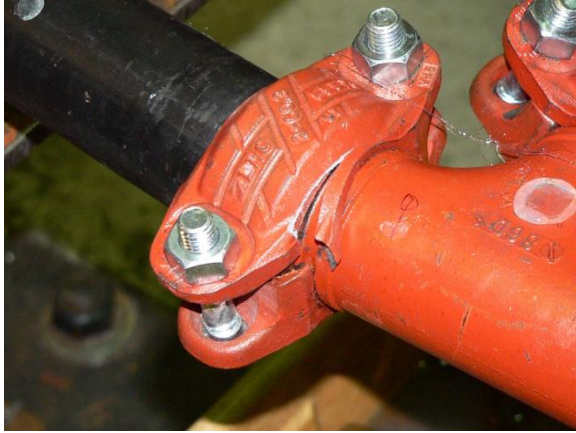
*(c) Fracture of coupling flange initiated from the housing key*

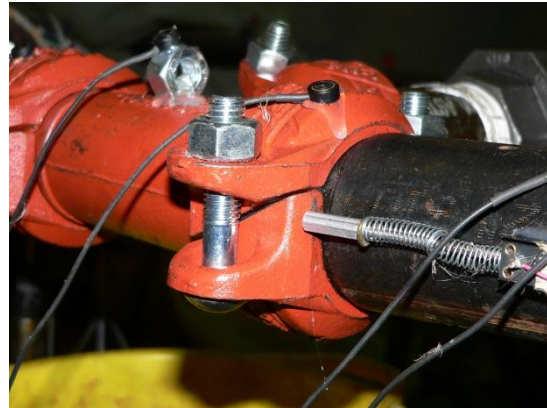
- 2) In some instances, only damage state DS<sub>1</sub> was reached, and the coupling flanges remained intact after the test. However, the hexagonal nuts were pushed outwards and a gap was generated between the angled pads of the two coupling flanges (*Figure 3-18 b*);
- 3) Significant inelastic deformation was observed in the cross section between the end of the pipe and the groove (*Figure 3-18 c*);
- 4) The outer surfaces of the pipes around the edge of groove showed significant wearing damage due to interaction with the coupling flanges (*Figure 3-18 d*).

(b) Gap generated between angled pads

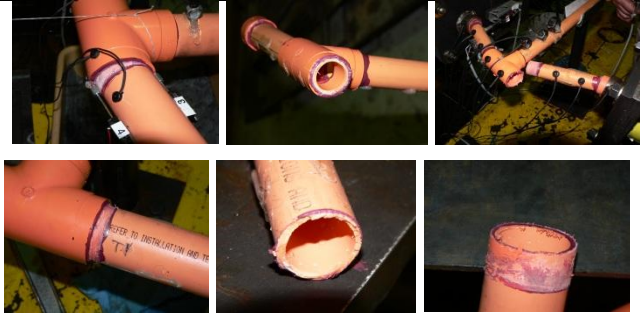
CPVC with Cement Joints	<p>Cement glue slips;</p> <p>Pipe pulls out from tee joint;</p> <p>Pipe peels off the inner surface of tee joint;</p> <p>Pipe fractures at the edge of tee;</p> <p>Pipe end bends due to imposed rotation.</p>

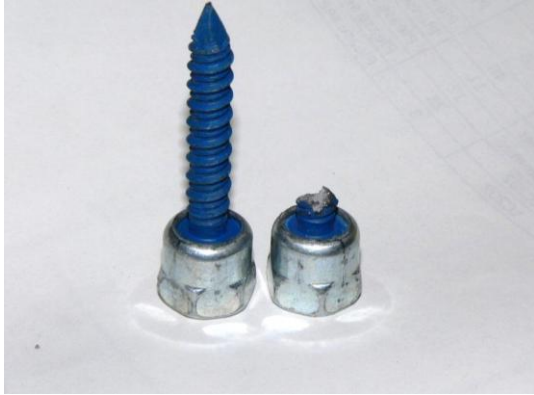
The vertical hanger attached to the LCR-17 load cell (*Figure 4-29*) supporting the branch line on the first level pulled out from the concrete slab due to the failure of the building-attached component at 100% of MCE level. Although the data recorded by the miniature load cell indicated that the axial force was within half of the pullout strength limit of the SAMMY screw, it obviously showed that the failure mechanism of the SAMMY screw was dominated by the shear force in this case (*Figure 4-33*). In addition, as shown in *Figure 4-34*, the vertical hanger attached to the LCR-13 load cell (*Figure 4-29*) supporting the main line on the first level buckled when the first level of the fire sprinkler piping system was fully braced and separated from the vertical riser, indicating that there was substantial vertical displacement.

(a) SAMMY screw sheared off  
(Configuration 1-5, 100% MCE level)

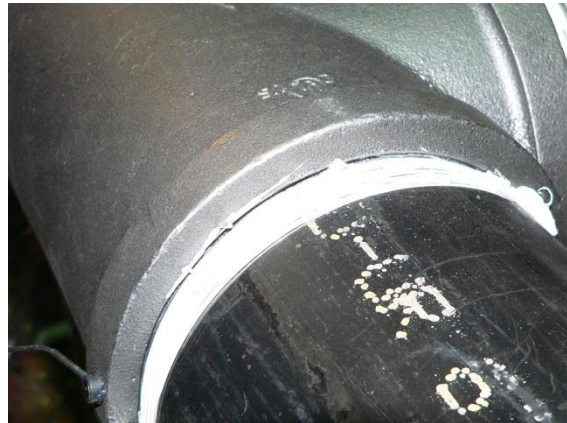
**CYCLIC TEST #2 FOR 6" BLACK IRON PIPES WITH THREADED JOINTS**

Gap generated between pipe and tee joint due to imposed bending

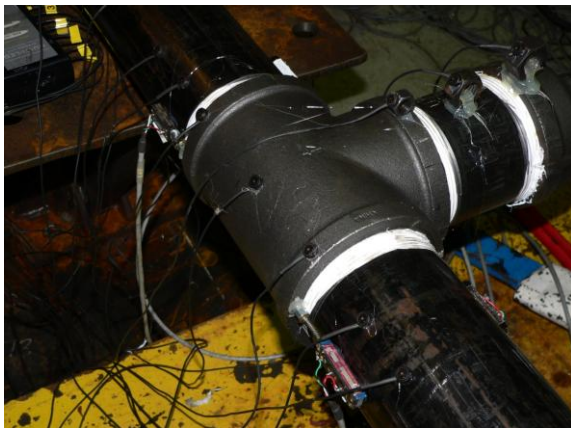
Gap generated between pipe and tee joint due to imposed bending

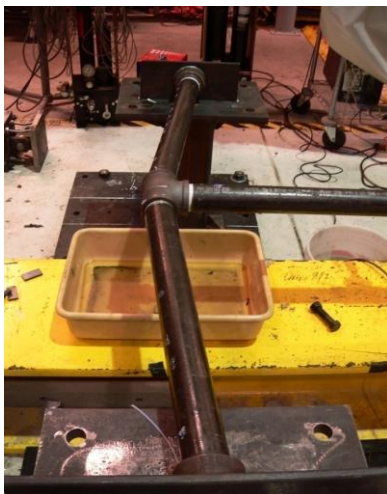
Pipe end bends due to imposed rotation

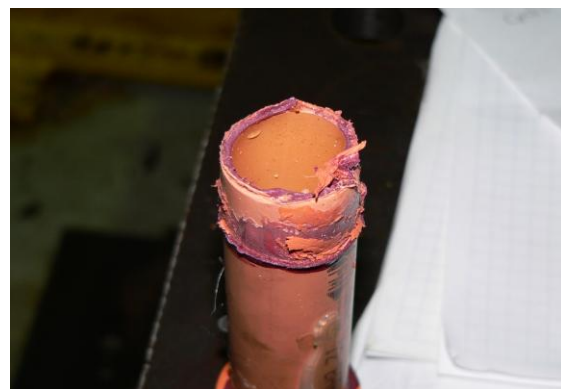
Pipe peeled off the inner surface of tee joint

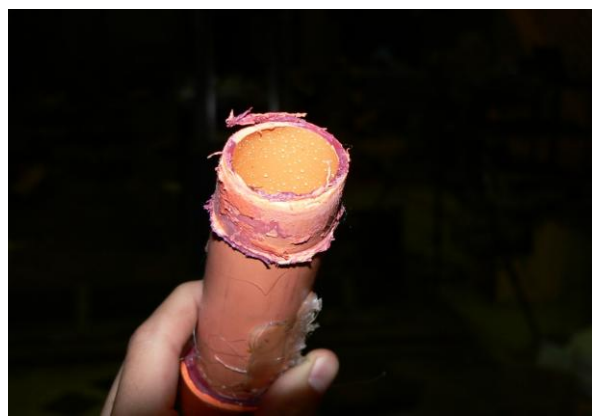
Pipe peeled off the inner surface of tee joint

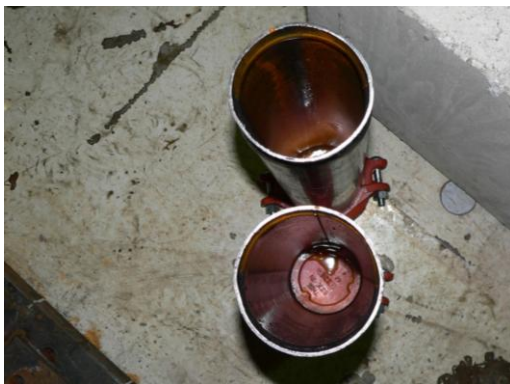
Cross section of pipe yielded and deformed
