## Low velocity impact damage assessment in IM7/977-3 cross-ply composites using 3D computed tomography

A thesis submitted in partial fulfillment  
of the requirements for the Master of  
Science degree in Mechanical Engineering  
in the Graduate College of  
The University of Iowa

May 2015

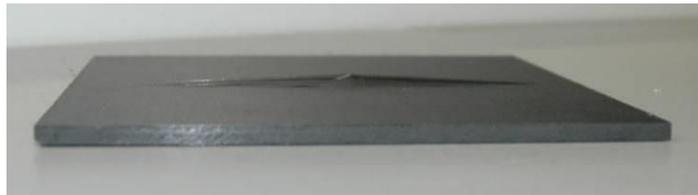
To reduce the amount of damage produced during impact, the impact energy was decreased to half of the initial value, resulting in an impact energy of 37.76 J. To achieve this, the same mass was used (12.831 kg) and the height was decreased to 0.30 m. Specimen 2 was clamped into the impact testing machine and impacted at this energy. The specimen damage, seen in Figure 3.4 through Figure 3.6, was moderate in scope with a large dent on the top surface and raised delamination on the back surface. While the damage was less than that for specimen 1, it was still more severe than desired.

Figure 3.6: Side View of Impact Damage on the Bottom Surface of Specimen 2

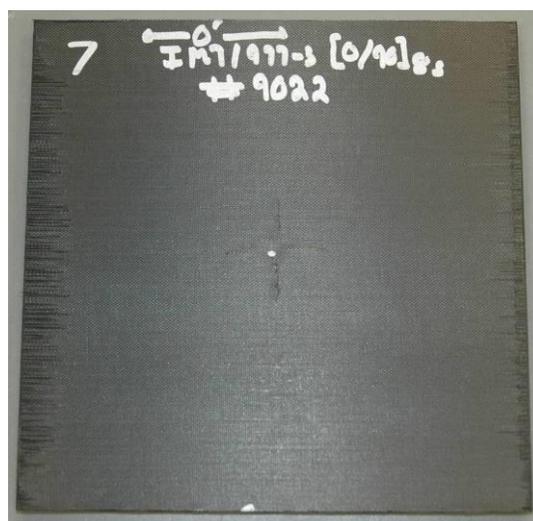
Figure 3.20: Impact Damage on the Top Surface of Specimen 7

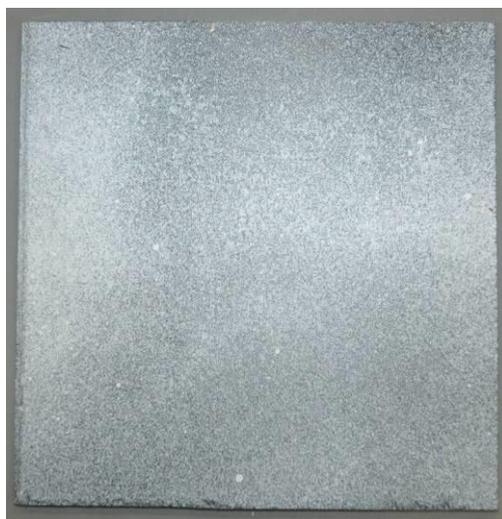
Figure 3.31: Impact Damage on the Bottom Surface of Specimen 9

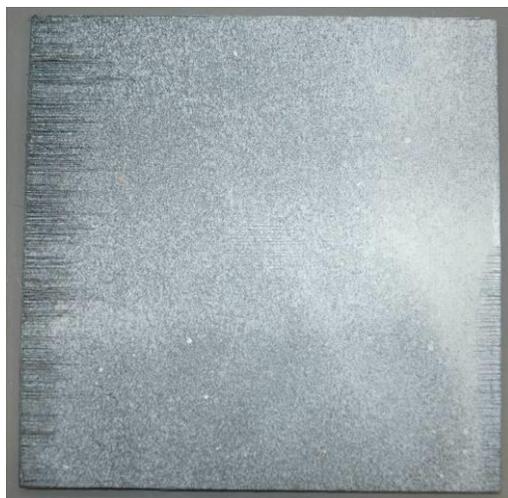
Figure 3.35: Impact Damage on the Bottom Surface of Specimen 11
